CORROSION PREVENTION PROGRAM

BOEING COMMERCIAL AIRPLANE GROUP ■ 707/727/737 DIVISION

D6-40719
AUGUST 1972

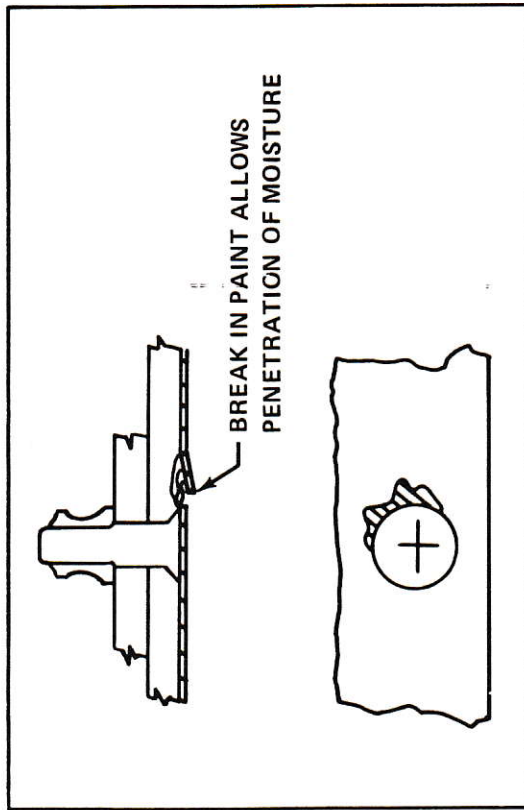
Intergranular corrosion has appeared around nonaluminum fasteners in the lower wing skin, as shown in Figure 2. To eliminate this problem, airplanes delivered after early 1973 will have all nonaluminum fasteners on the wing lower surface installed with wet sealant (or primer) in the countersink, as illustrated in Figure 3. Additionally, airplanes delivered after early 1973 will incorporate the use of an improved paint system in this area.

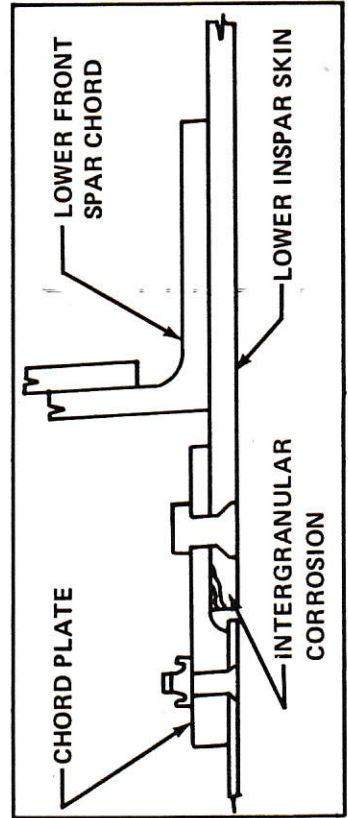
Figure 4.

Intergranular corrosion of the lower wing inspar skin at the front spar chord plate interface has occurred in service (see Figure 4). Elimination of this problem has been accomplished by installing a faying surface seal between the spar chord plate and lower inspar skin (see Figure 5). Airplanes delivered after early 1970 have this improvement incorporated.

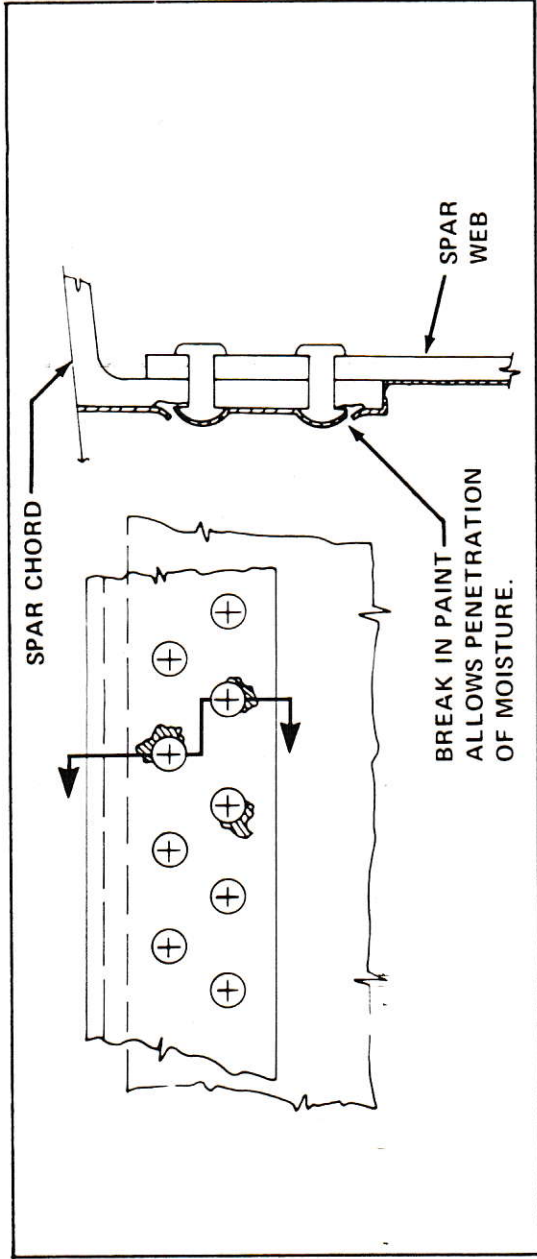
Intergranular corrosion has been encountered around wing front and rear spar chord fasteners due to penetration of moisture under the paint at fastener locations as shown in Figure 6.

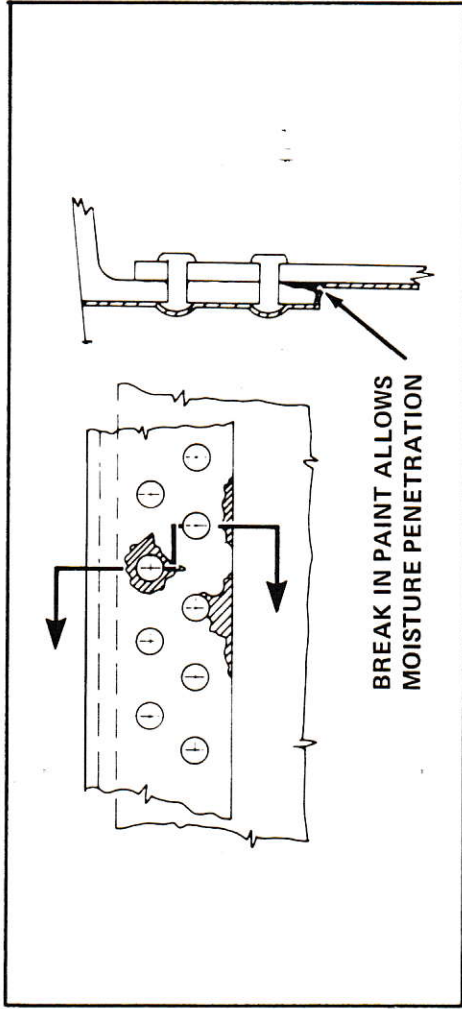
Figure 8.

Intergranular corrosion of the front and rear spar chords, originating at the edge of the spar web/spar web interface, has been found (see Figure 8).

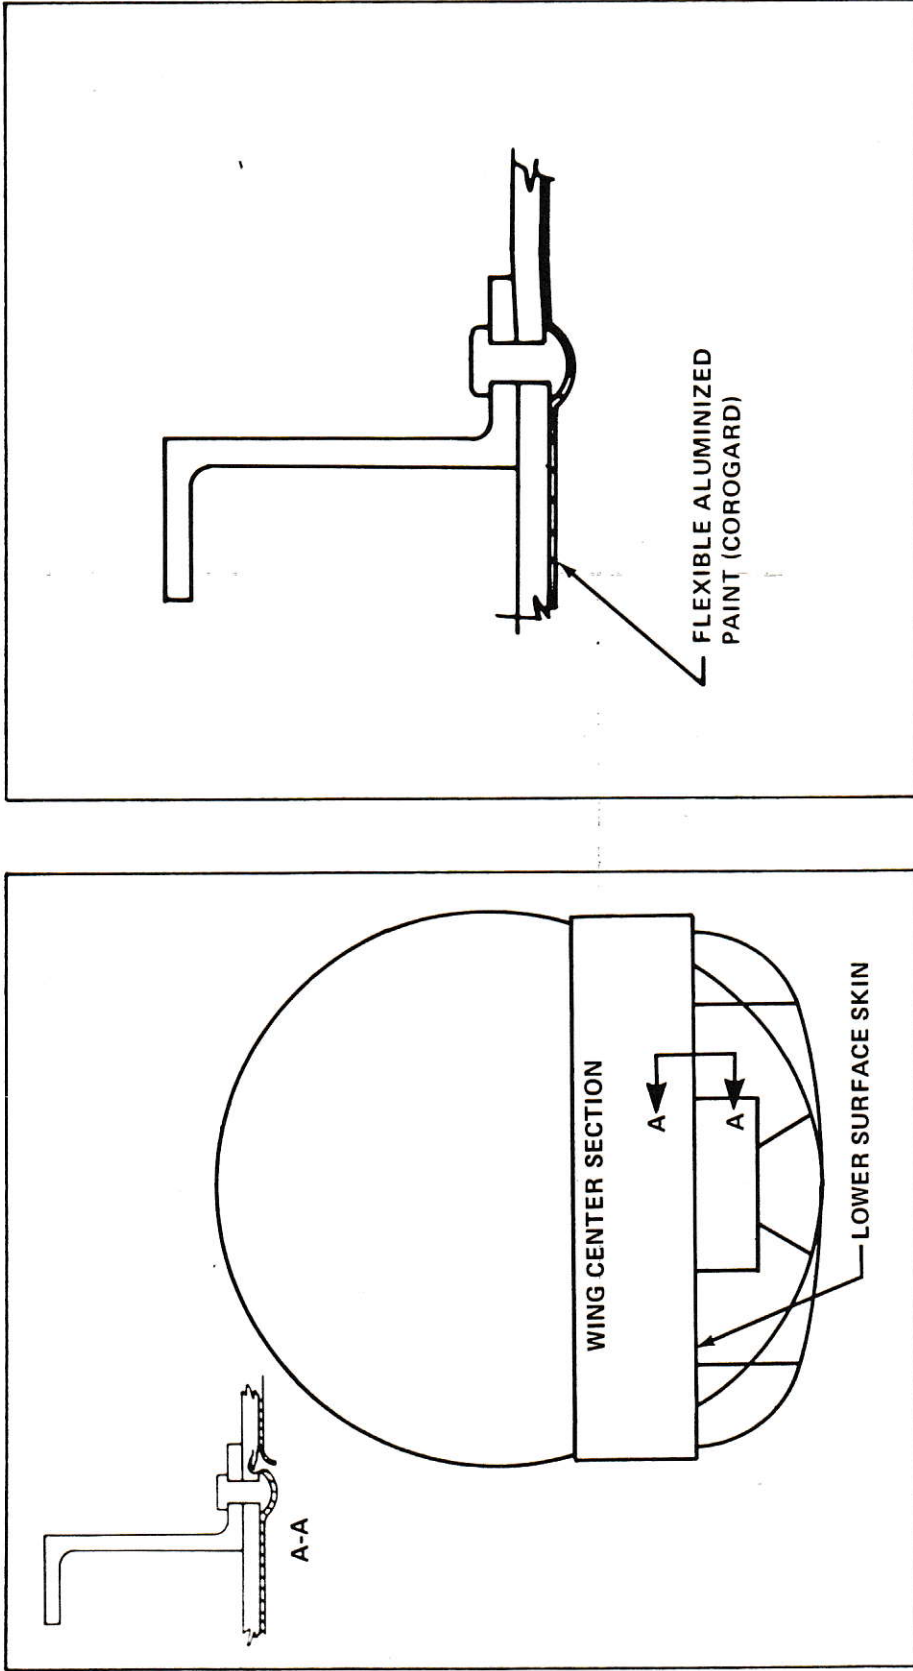
Figure 10.

Intergranular corrosion around fastener heads on the external surface of the lower wing skin (wing center section) in the area of the ram air inlet has been reported (see Figure 10).

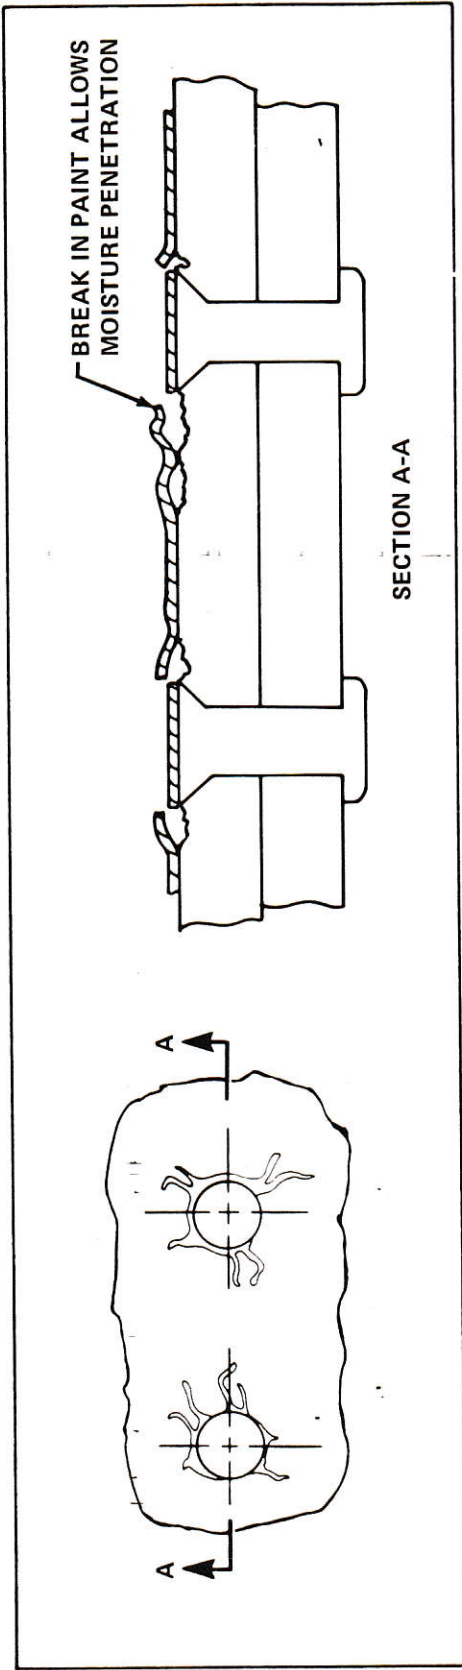
Decorative painted exterior skins have experienced filiform corrosion at fasteners under the decorative paint, as illustrated in Figure 13.

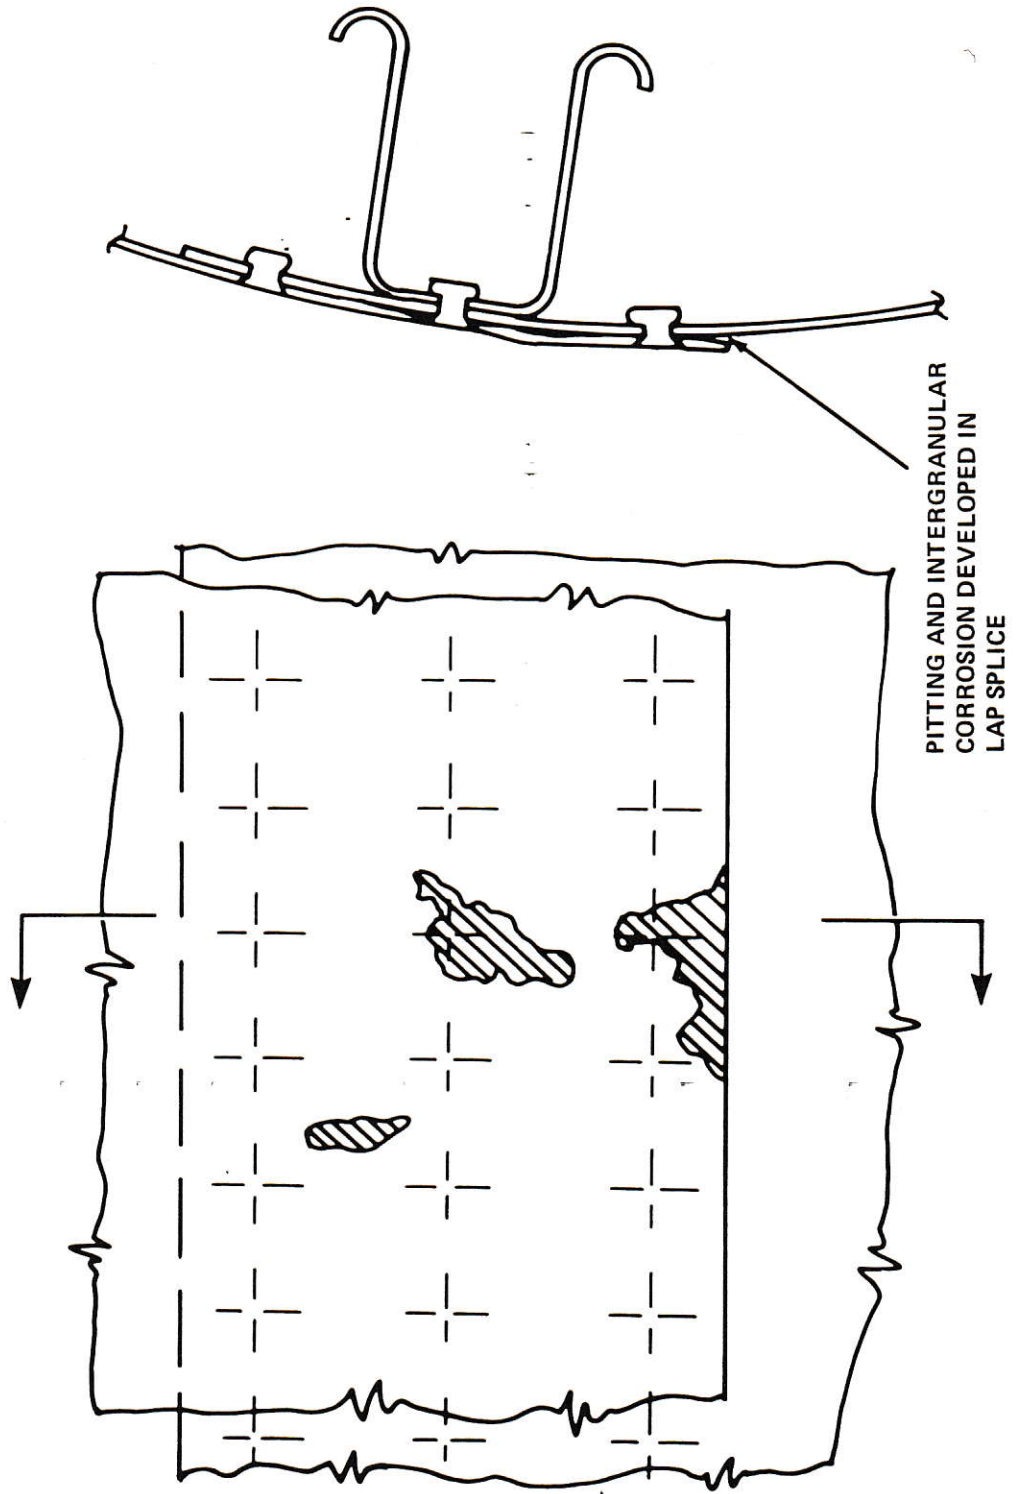
Figure 15.

Pitting and intergranular corrosion in fuselage lap splices bonded with BMS 5-10 room temperature curing adhesive has occurred on the 727 airplane (see Figure 15).

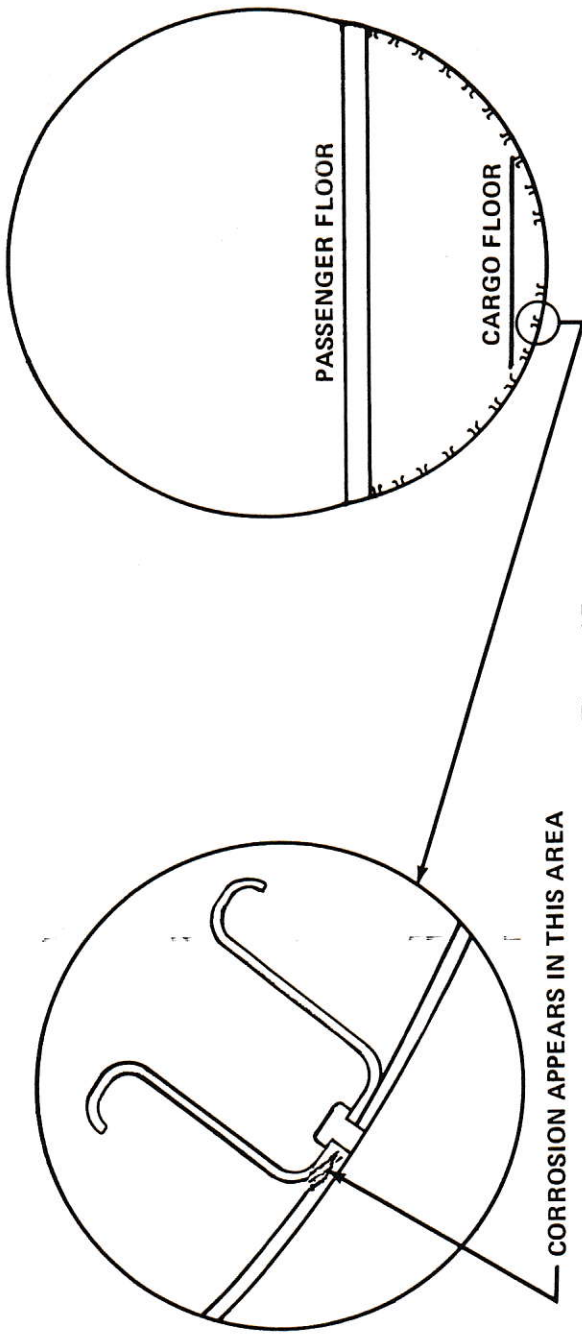
Figure 17.

Intergranular and pitting corrosion of body lower lobe skins and stringers has been found on some aircraft (see Figure 17).

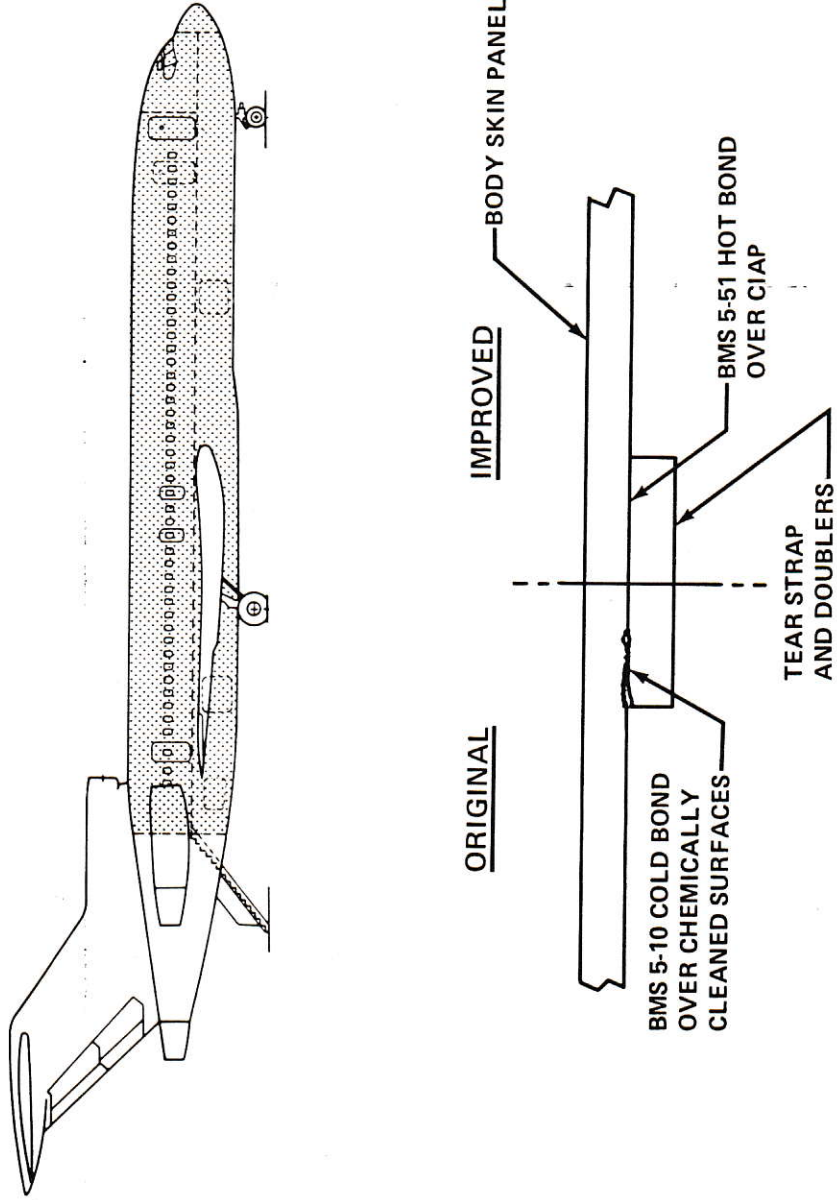
Figure 19.

Intergranular corrosion of fuselage skin and fail straps at bonded surfaces has been eliminated by adding corrosion-inhibiting adhesive primer (CIAP) to all bonded skin panels and replacing the cold bond method of attaching doublers and tear straps with a hot bond process on airplanes delivered after October 1969 (see Figure 19). In addition, a fillet seal has been added to the edges of the body "Buttock Line 0" bonded fail-safe strap on airplanes delivered after November 1969.

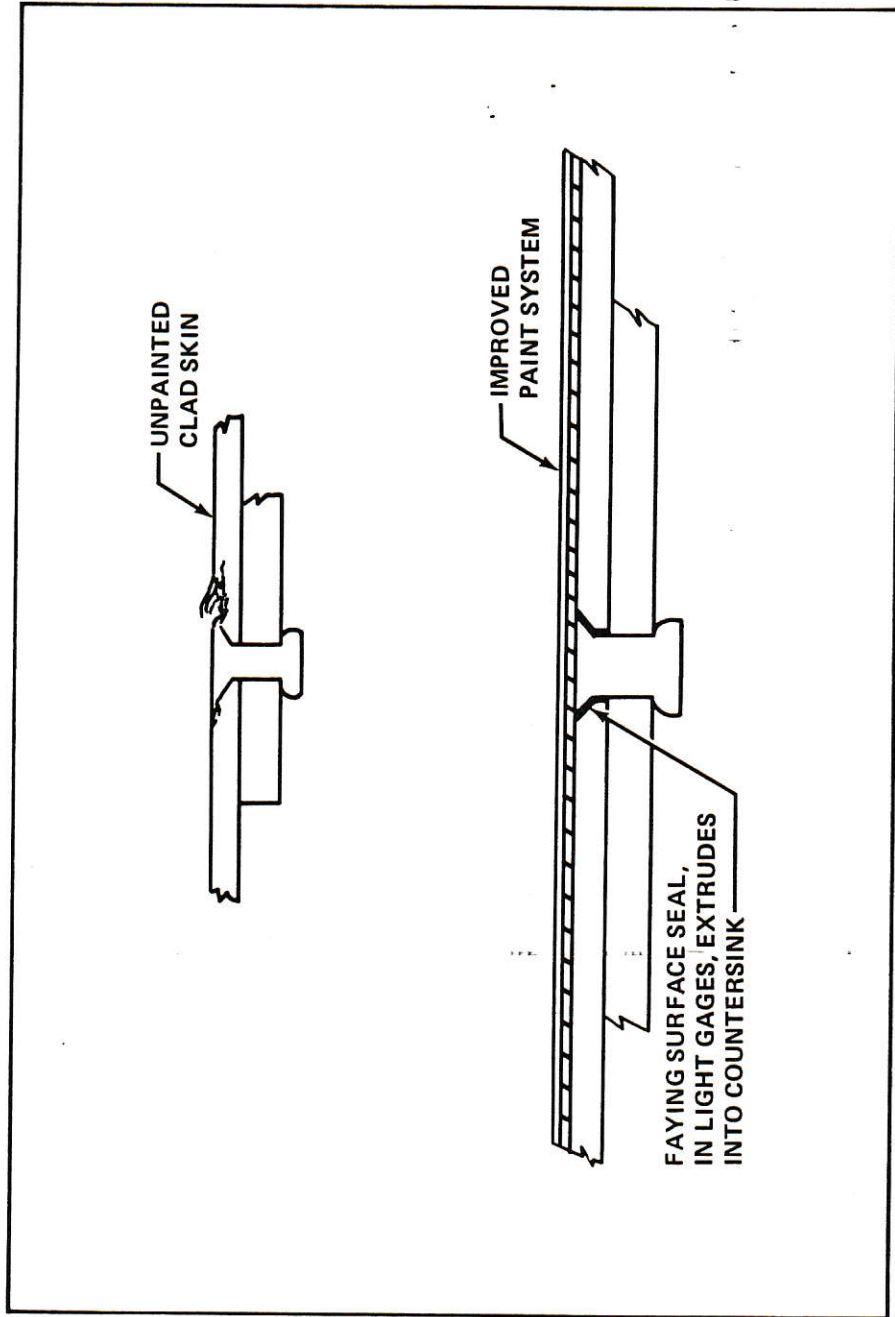
Figure 22.

Intergranular corrosion of the horizontal stabilizer skin at spar fasteners has occurred in service. An improved decorative paint system, replacing the epoxy primer and polyurethane enamel system, will be applied to airplanes delivered after mid-1972 as a product improvement. In addition, a faying surface seal has been added between the inspar skin and spar chords on airplanes delivered after mid-1972 (see Figure 22).

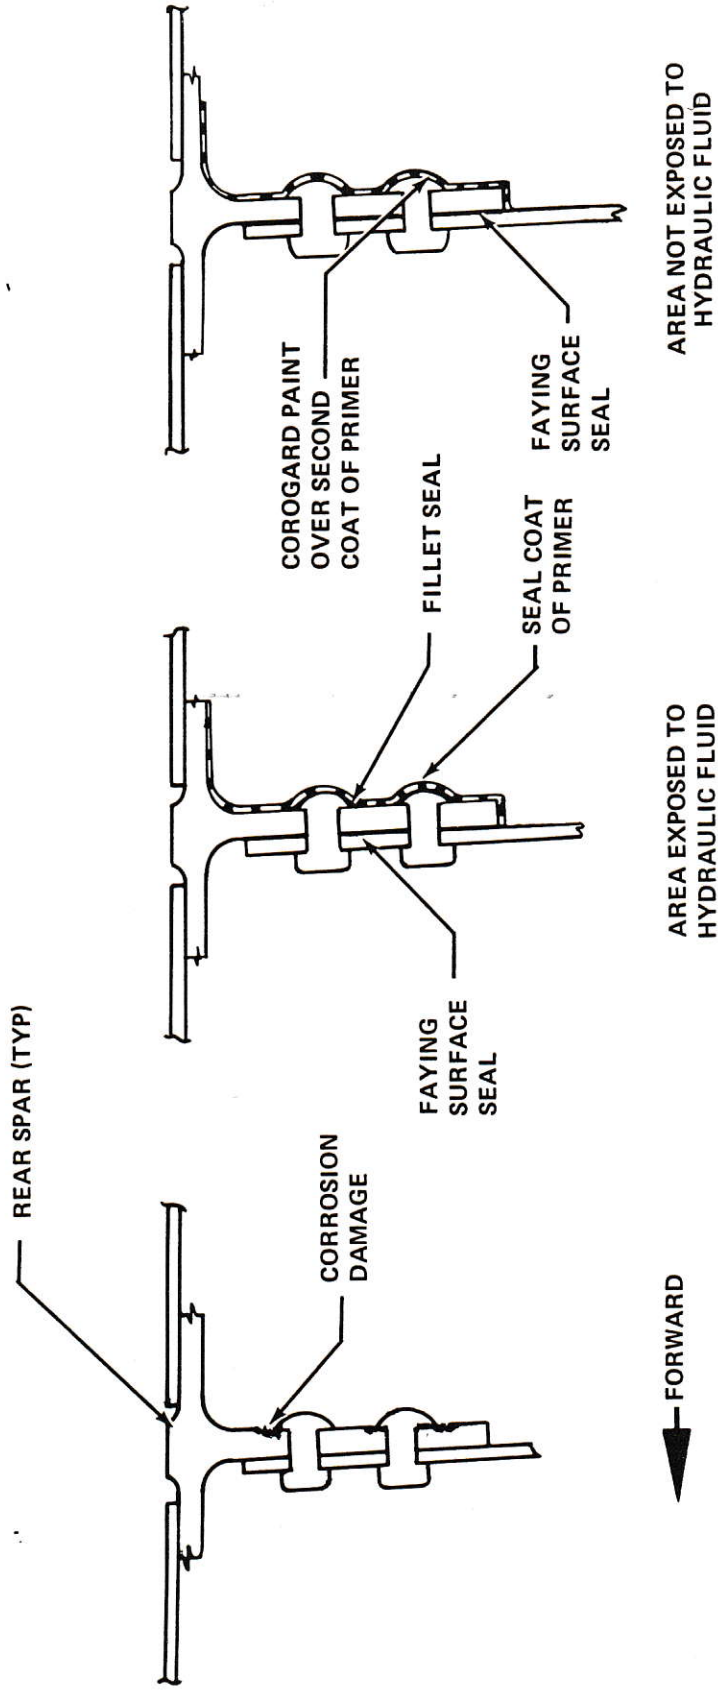
Figure 23.

Intergranular corrosion of the horizontal stabilizer rear spar chord at fasteners common to the spar web has occurred on some 727 airplanes. Corrosion resistance has been improved by fillet sealing fasteners that are subject to hydraulic fluid contamination through the rear spar chord and common to the spar web. Exposed spar surfaces in this area also receive a second coat of primer. Exposed spar surfaces not subject to hydraulic fluid contamination receive a second coat of primer and Corogard paint. These changes are illustrated in Figure 23 and are incorporated in airplanes delivered after early 1972.

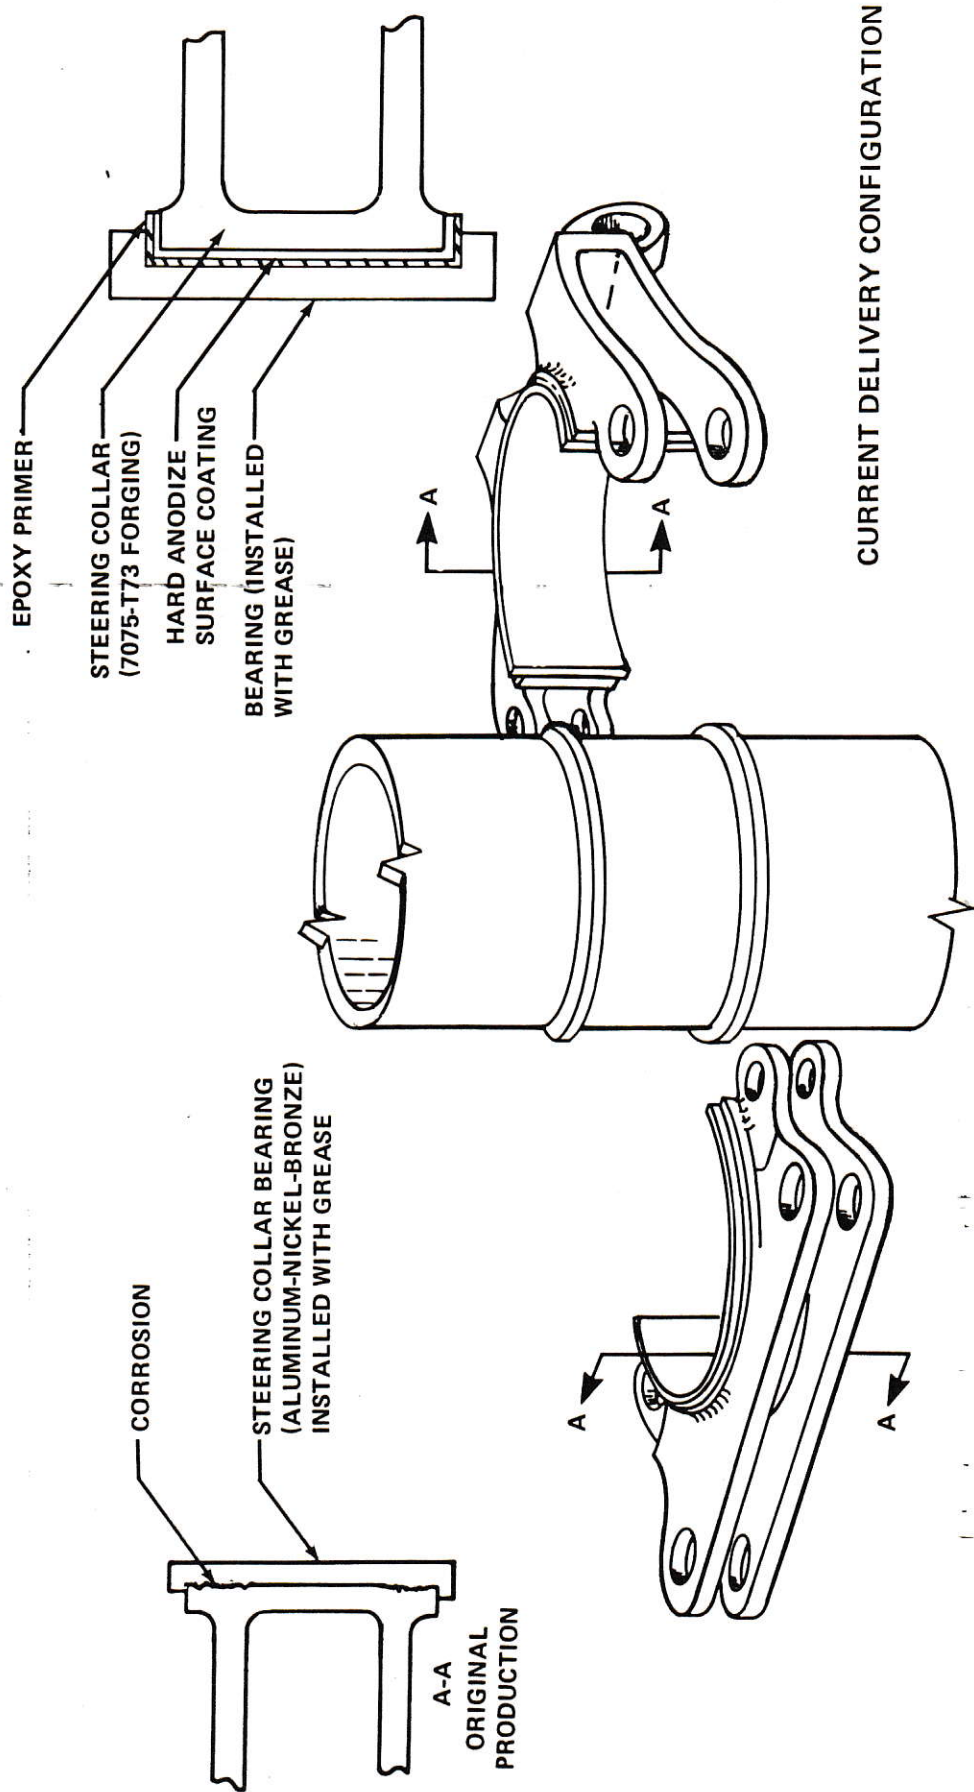
Figure 25.

Intergranular corrosion of the nose landing gear steering collar, at the bushing-to-collar interface, has occurred in service. In April 1969, a coat of epoxy primer was added to the steering collar at the bearing faying surface to eliminate corrosion. Airplanes delivered after mid-1972 have been further improved by changing the steering collar forging material from 7079-T6 to the highly corrosion-resistant 7075-T73, and a hard anodize coating has been added to the steering collar at the bearing faying surface. Figure 25 illustrates the corrosion area and the improvements being incorporated.

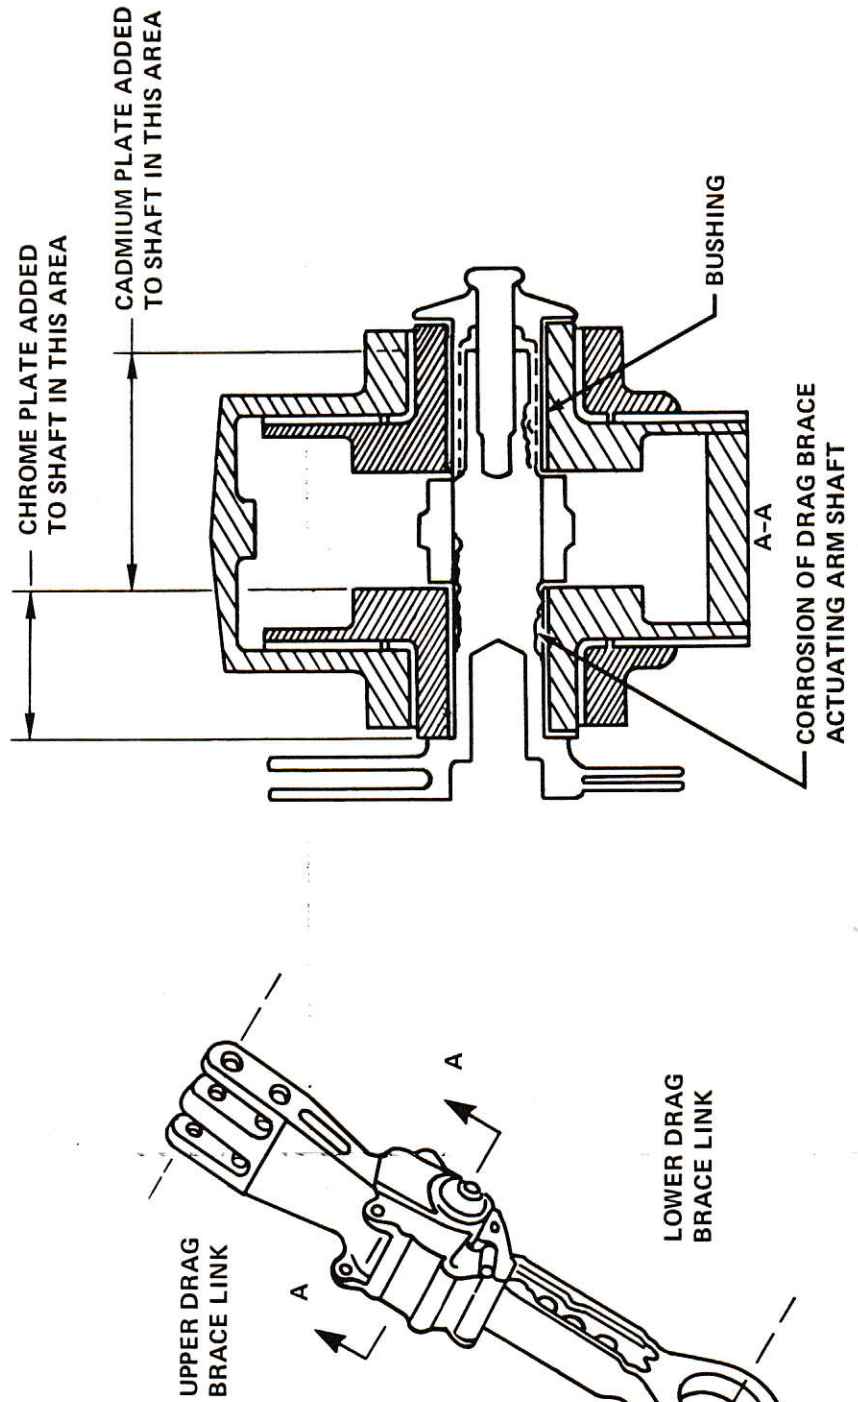
Figure 26.

Pitting corrosion of the nose landing gear drag brace actuating arm shaft, at bearing surfaces and in splines, occurred on some airplanes delivered prior to February 1971. Airplanes delivered since that time incorporate the following changes, which are illustrated in Figure 26:

- Elimination of dry film lubricant from actuating arm shaft and splines
- Chrome plate actuating arm shaft and thrust face
- Cadmium plate splines and actuating arm shaft
- Addition of grooves and holes to bushings to provide positive grease flow to shaft and splines
