Office of the Chief Investigator
Transport and Marine Safety Investigations

**Rail Investigation
Report No 2009/03**

Fire on Tram
W Class Tram 946
La Trobe Street
15 January 2009

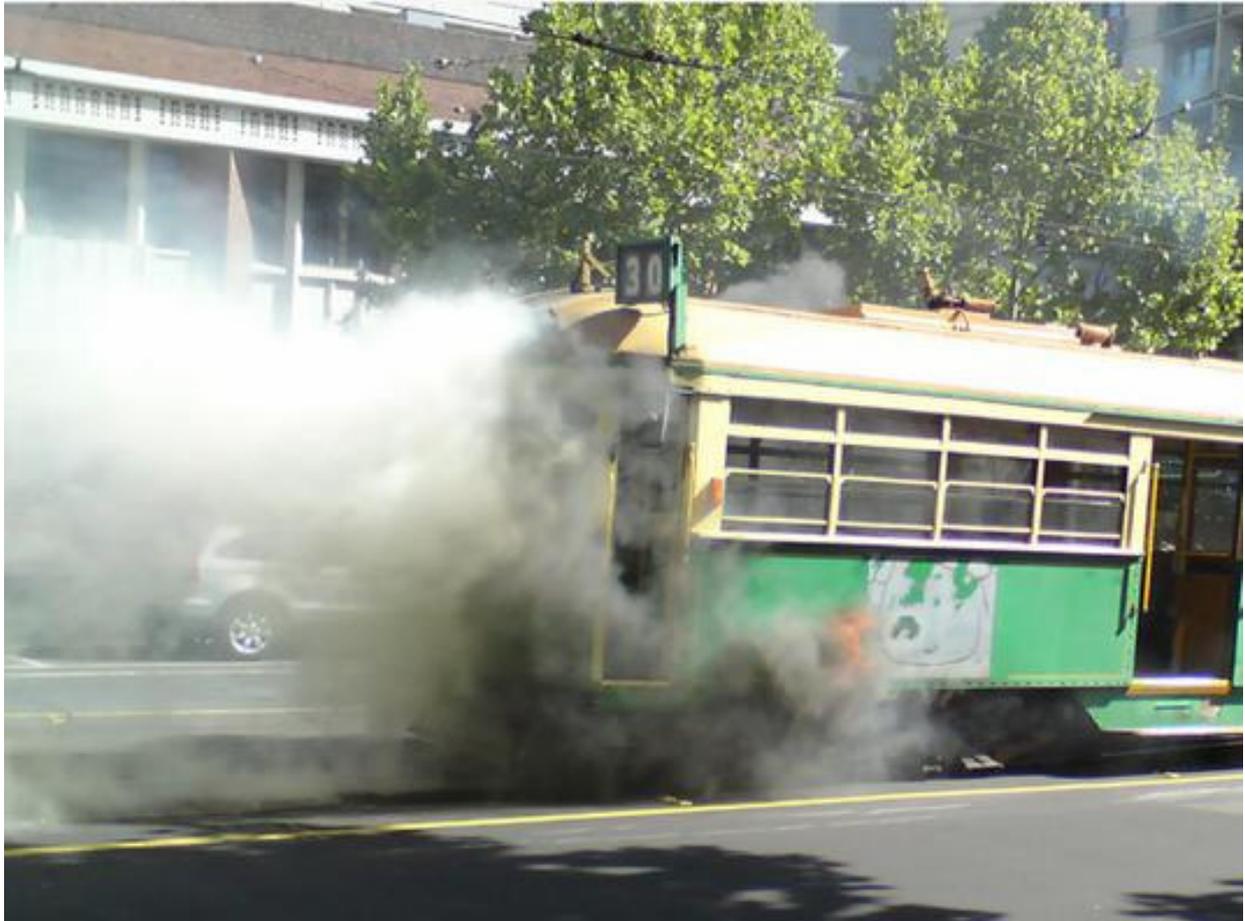
Figure 2 - Tram 946 fire (Photo: Courtesy Fairfax photos)

The traction motor fire was subsequently extinguished by the Metropolitan Fire Brigade.

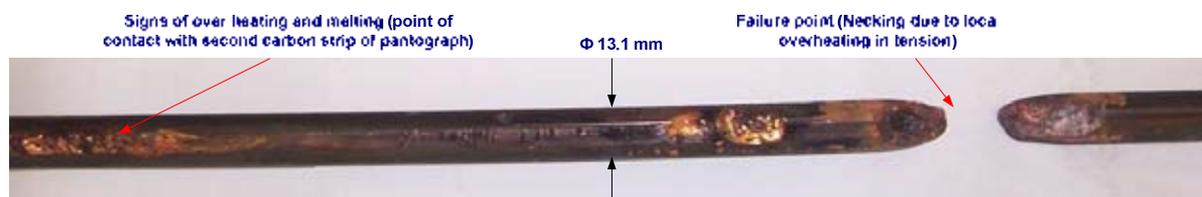
The Latrobe Street overhead cable was renewed in April 1994. Typically a new cable is approximately 13.5 millimetres in diameter and is replaced when it wears down to eight millimetres. The overhead cable at the incident site was observed to have suffered overheating in tension, melted and parted. The overhead cable diameter before the point of failure was approximately 13 millimetres and was in good condition with minimal wear. Signs of overheating and melting were also observed approximately 100 millimetres from the point of failure (Figure 3). This area is the location of contact with the second carbon strip of the pantograph.

Figure 3 - Damaged overhead cable

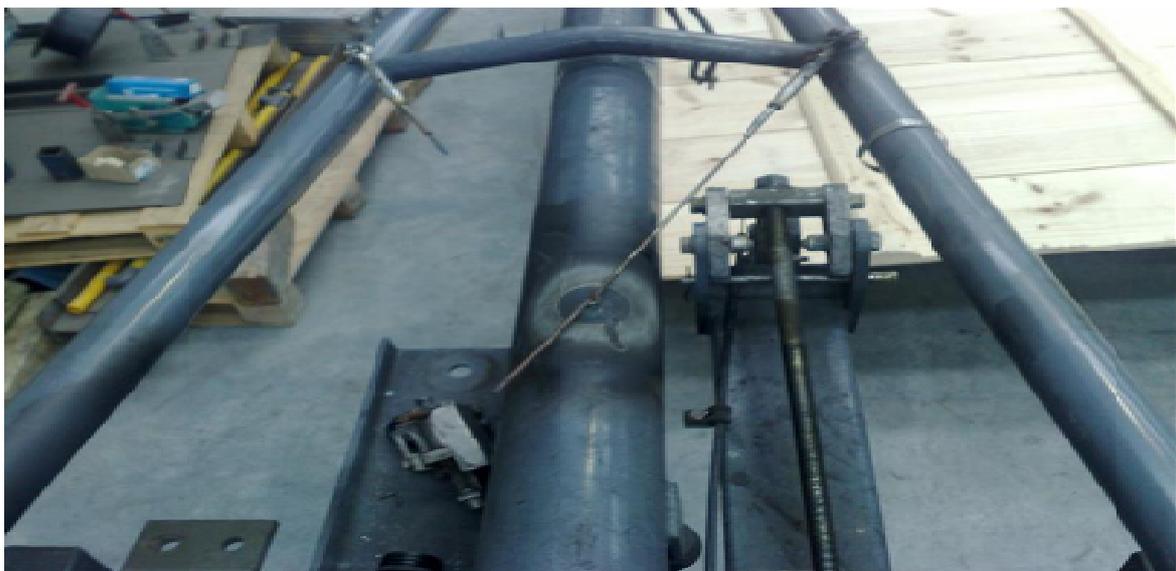
Figure 5 – Damage to pantograph caused by arcing

The pantograph frame sustained heat damage due to 'arcing'¹ as a result of the contact with the overhead cable (Figure 5).

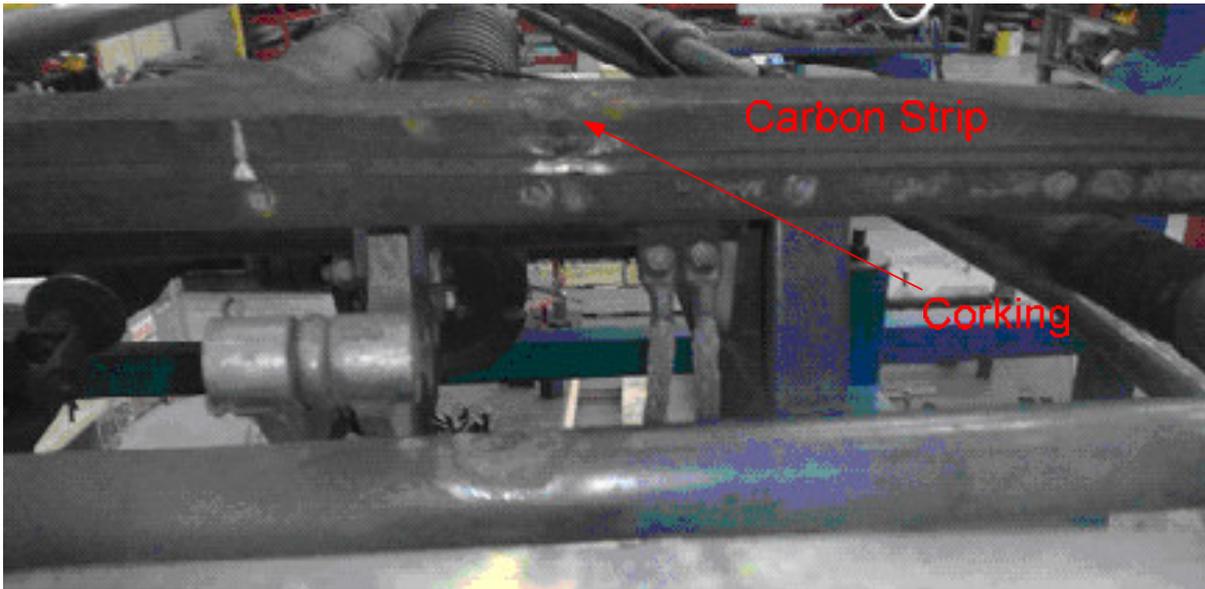
The carbon collector strips on the pan head overheated and suffered 'corking'² due to heat generated by the extremely high current flow (Figure 6).

Figure 6 – Corking of carbon strip of pantograph due to arcing

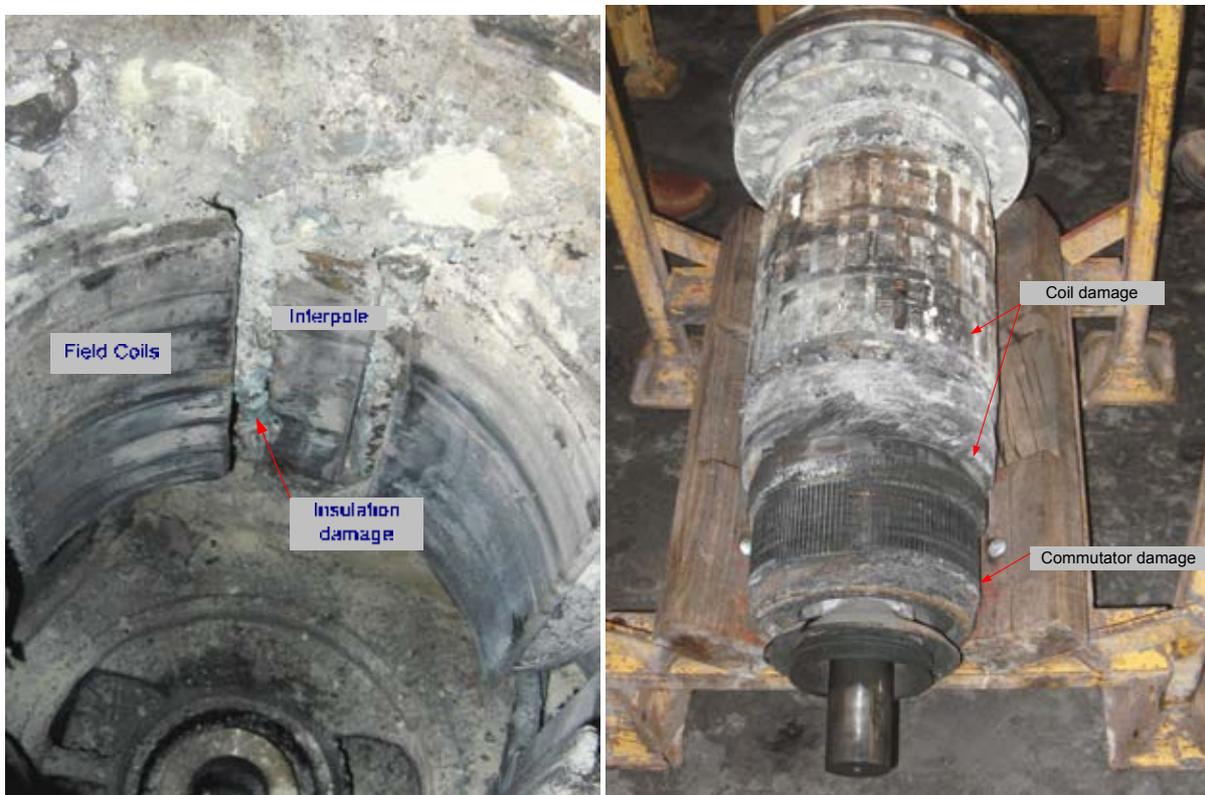
No.1 and No.3 motors sustained fire damage to armature coils, commutators, field coils and insulation. The structural components of the undercarriage of the tram and electrical cabling also sustained fire damage. The paint-work on the left side of the tram exterior sustained fire damage. The Line Breaker over current coil and the shunt strap overheated and sustained damage due to excessive short circuit current flow. The pantograph sustained damage due to arcing. The overhead cable melted due to local overheating and parted.

Figure 11 – Traction motor damage

The traction motors on W Class Tram 946 are series-wound DC motors, operating on approximately 600 volts. Each tram has four traction motors which are mounted in groups of two on either end of the tram and are suspended between the bogie frame and the driven axle. No.1 and No.3 motors sustained fire damage to armature coils, commutators, field coils and insulation.

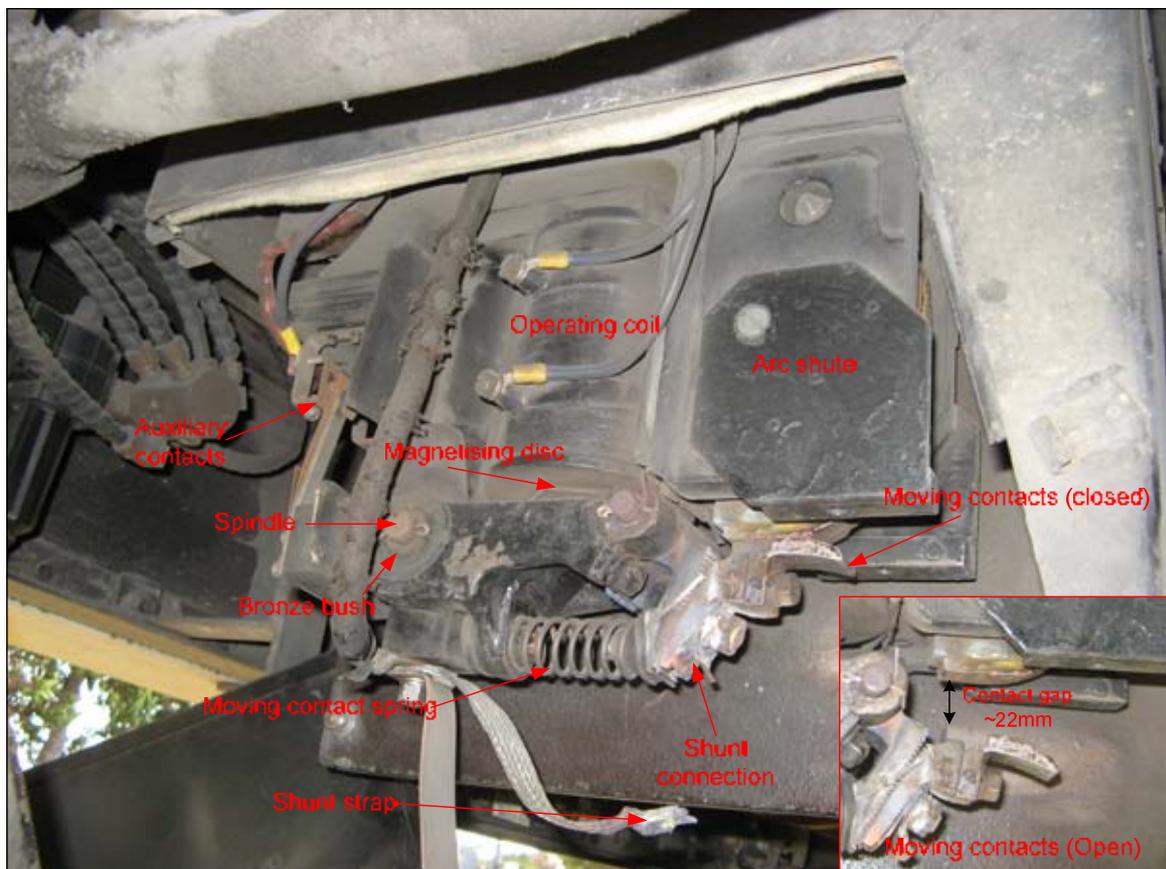
Post incident inspection of the Line Breaker revealed that the moving contacts were seized in the closed position. The contacts were seized due to friction between the moving contact arm spindle and the bronze bush as a result of corrosion. The current shunt strap was detached from the moving contact and the tension in the moving contact spring was weak.

The seized contacts were prised open and the clearance between the contacts was measured to be 22 millimetres. The specified gap for this type of Line Breaker is 16 millimetres (Figure 12).

The spring clips on the cover of the Line Breaker were slack, hence the cover did not firmly close and the cover was also cracked, exposing the components to moisture and debris from the road and rails.

Figure 12 – Line Breaker

It is highly unlikely that the fire in No.1 traction motor would have occurred if the Line Breaker had operated correctly. The excessive clearance between the contacts resulted in reduced moving contact spring pressure, which in turn was inadequate to assist in the opening of the contacts. The corrosion and resulting friction between the moving contact arm spindle and the bronze bush ensured that the contacts remained in the closed position despite the operation of the over-current relay in the Line Breaker.

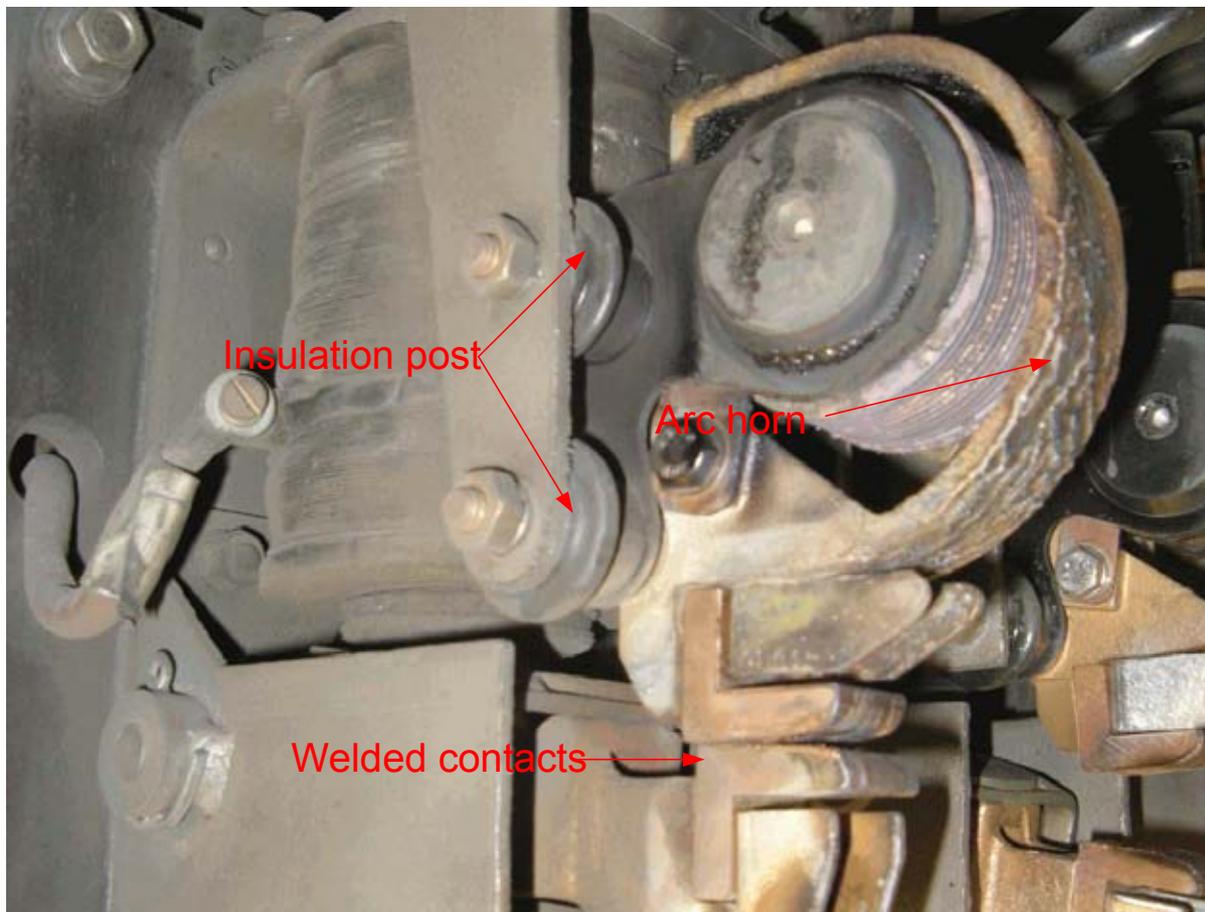
The grouping contactor LS1 contacts stay closed during ‘series’ and ‘parallel’ operation of the motor banks M1 and M2. Post incident inspection of this grouping contactor revealed that the moving contacts were welded in the closed position. The insulation post was also found to have suffered overheating damage (Figure 12).

Figure 13 – Grouping contactor LS1

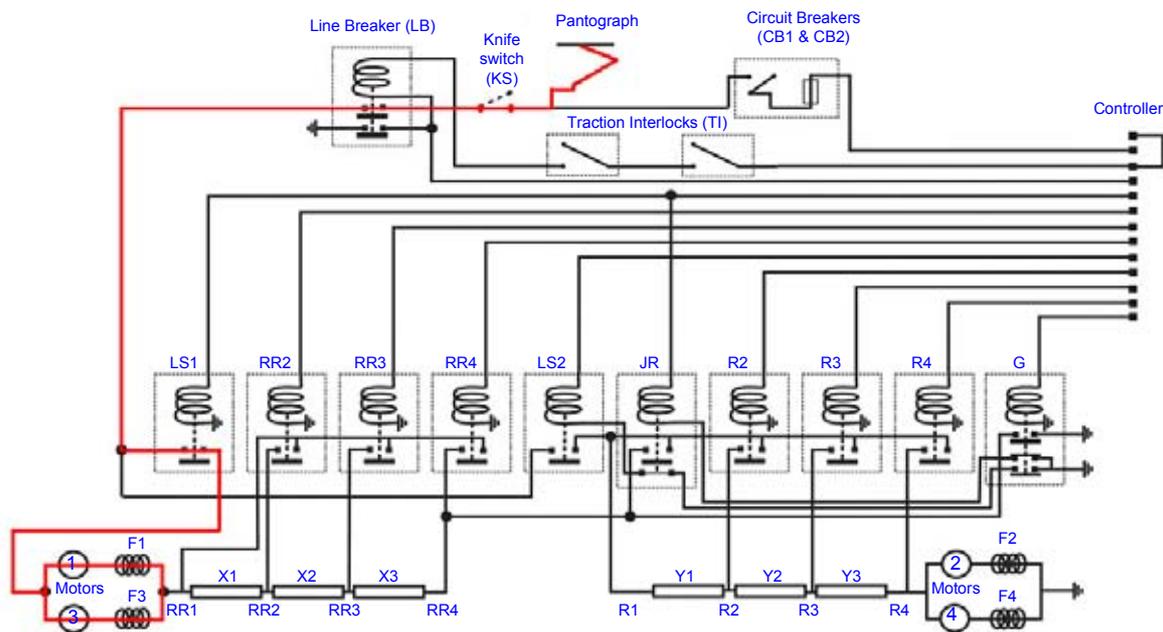
It is most probable that the No.1 traction motor field insulation failure resulted in the initial short circuit in the system. The short circuit caused an abnormally high current to pass through No.1 traction motor, Line Breaker (LB), Grouping Contactor (LS1) and No.3 Traction Motor. The Line Breaker is the primary over-current protection device on the tram. As the Line Breaker contacts were mechanically seized in the closed position, the current flow was not interrupted and resulted in the overheating and welding of the contacts on the grouping contactor and the overheating and damage to No.3 Traction Motor and overheating and fire in Traction Motor No.1.

Figure 14 – Traction system circuit diagram with short circuit

In this instance the rate of change of current and the peak current value during the short circuit on the traction motor did not exceed the tripping threshold of the substation feeder circuit breaker. As a result, the substation circuit breaker did not operate to interrupt the abnormally high short circuit current and extremely high temperatures were generated between the overhead line and the pantograph carbon strips resulting in the melting and parting of the overhead cable.
