Arboricultural Report

Tree Management Plan

Ballarat Tram Museum, 100 Gillies St Nth, Ballarat, Victoria

Inspections commenced on Thursday 7th March 2019

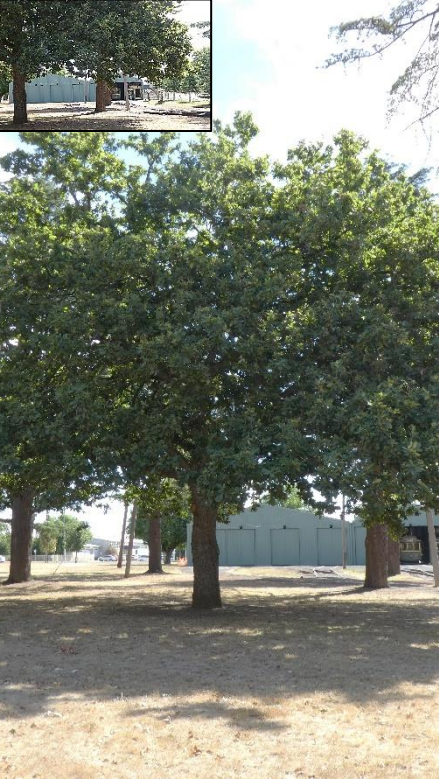
Tree #1

Botanical name	<i>Quercus robur</i>
Common name	<i>Common Oak</i>
Structure	<i>Good</i>
Health	<i>Fair</i>
ULE (years)	<i>25+</i>
Retention Value	<i>Very high</i>
TPZ (m)	<i>9.1</i>
SRZ (m)	<i>2.9</i>
Comments	<i>Powdery mildew, limbs pruned will depend on precise track location</i>

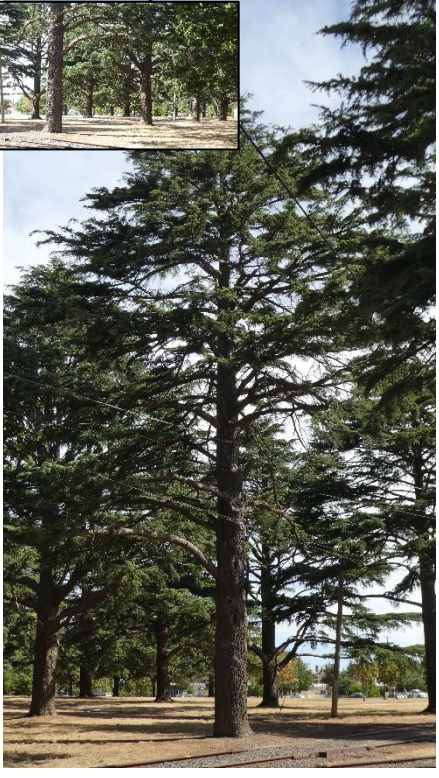
Tree #2

Botanical name	<i>Cedrus deodara</i>
Common name	<i>Himalayan Cedar</i>
Structure	<i>Fair</i>
Health	<i>Fair</i>
ULE (years)	<i>25+</i>
Retention Value	<i>Very high</i>
TPZ (m)	<i>10.4</i>
SRZ (m)	<i>3.2</i>
Comments	<i>Minor limb pruning may be necessary</i>

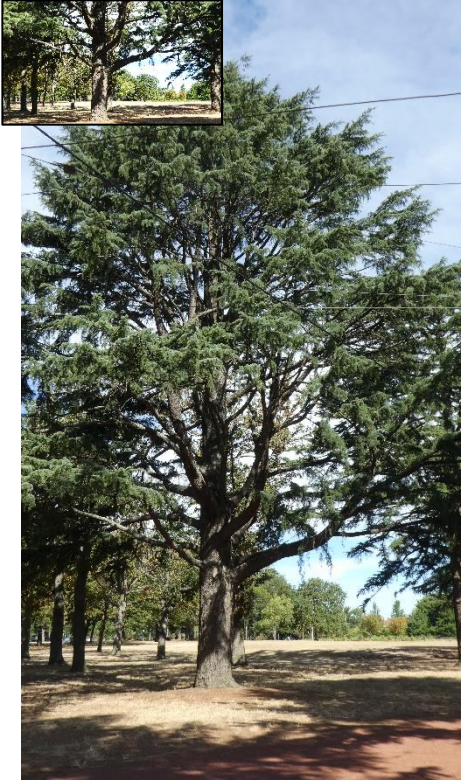
Tree #3

Botanical name	<i>Cedrus deodara</i>
Common name	<i>Himalayan Cedar</i>
Structure	<i>Good</i>
Health	<i>Good</i>
ULE (years)	25+
Retention Value	<i>Very high</i>
TPZ (m)	10.9
SRZ (m)	3.2
Comments	<i>Minor limb pruning may be necessary</i>

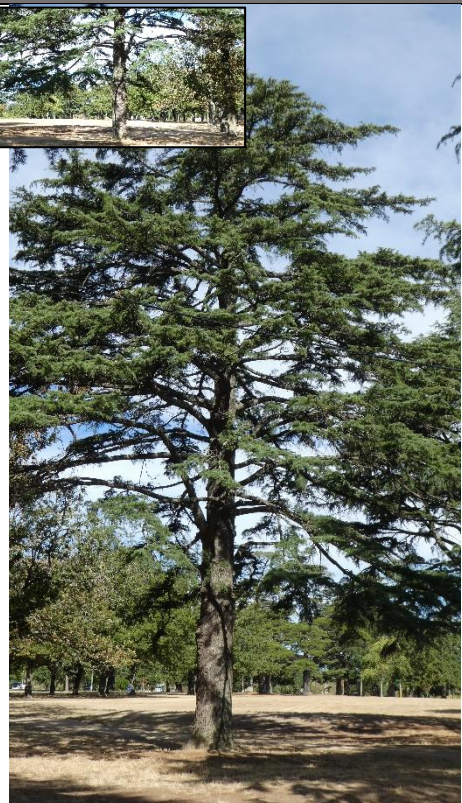
Tree #4

Botanical name	<i>Cedrus deodara</i>
Common name	<i>Himalayan Cedar</i>
Structure	<i>Good</i>
Health	<i>Fair</i>
ULE (years)	25+
Retention Value	<i>Very high</i>
TPZ (m)	9.6
SRZ (m)	3.1
Comments	<i>Minor limb pruning may be necessary</i>

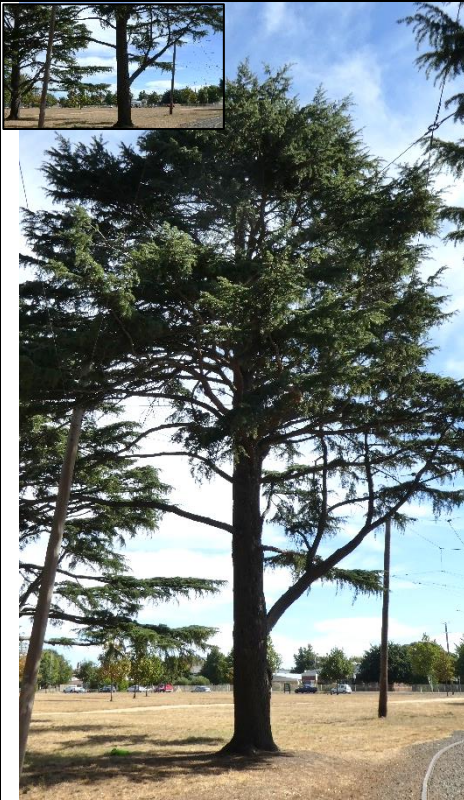
Tree #5

Botanical name	<i>Cedrus deodara</i>
Common name	<i>Himalayan Cedar</i>
Structure	<i>Good</i>
Health	<i>Fair</i>
ULE (years)	<i>25+</i>
Retention Value	<i>Very high</i>
TPZ (m)	<i>10.9</i>
SRZ (m)	<i>3.3</i>
Comments	<i>Pruning unlikely to be required</i>

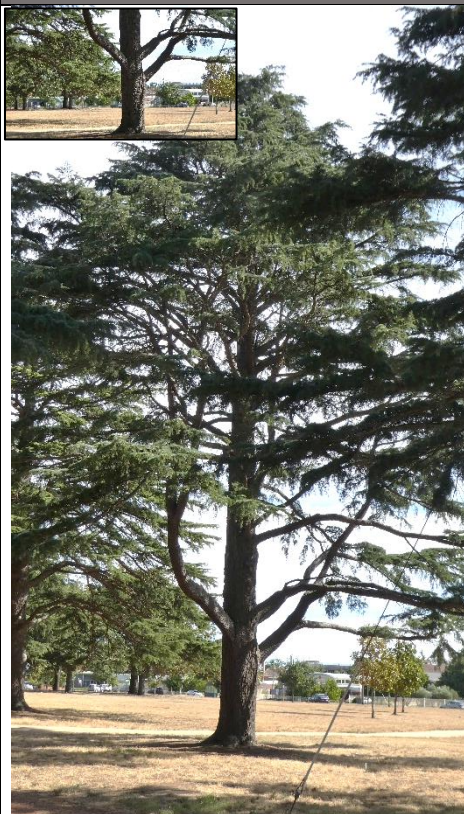
Tree #6

Botanical name	<i>Cedrus deodara</i>
Common name	<i>Himalayan Cedar</i>
Structure	<i>Good</i>
Health	<i>Good</i>
ULE (years)	<i>25+</i>
Retention Value	<i>Very high</i>
TPZ (m)	<i>11.2</i>
SRZ (m)	<i>3.3</i>
Comments	<i>Pruning necessary, level unknown</i>

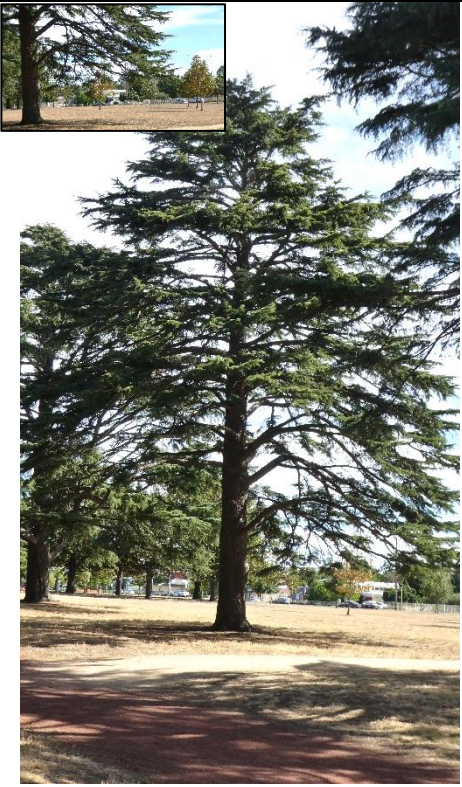
Tree #7

Botanical name	<i>Cedrus deodara</i>
Common name	<i>Himalayan Cedar</i>
Structure	<i>Good</i>
Health	<i>Good</i>
ULE (years)	<i>25+</i>
Retention Value	<i>Very high</i>
TPZ (m)	<i>10.4</i>
SRZ (m)	<i>3.2</i>
Comments	<i>Pruning necessary, level unknown</i>

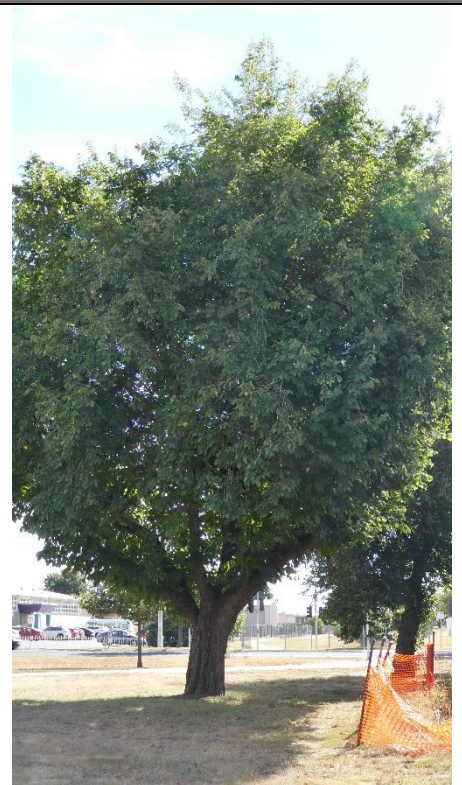
Tree #8

Botanical name	<i>Ulmus procera</i>
Common name	<i>English Elm</i>
Structure	<i>Fair</i>
Health	<i>Fair</i>
ULE (years)	<i>25+</i>
Retention Value	<i>Moderate</i>
Comments	<i>Removal required for proposed building development</i>

These trees are in the building envelope of the proposed new tram museum building and cannot be retained in light of the proposed development.

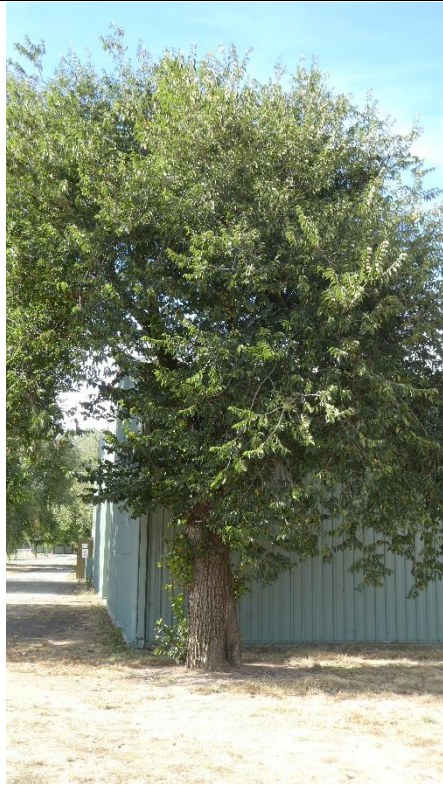
Tree #9

Botanical name	<i>Ulmus procera</i>
Common name	<i>English Elm</i>
Structure	<i>Fair</i>
Health	<i>Fair</i>
ULE (years)	<i>15-25</i>
Retention Value	<i>Moderate</i>
Comments	<i>Removal required for proposed building development</i>

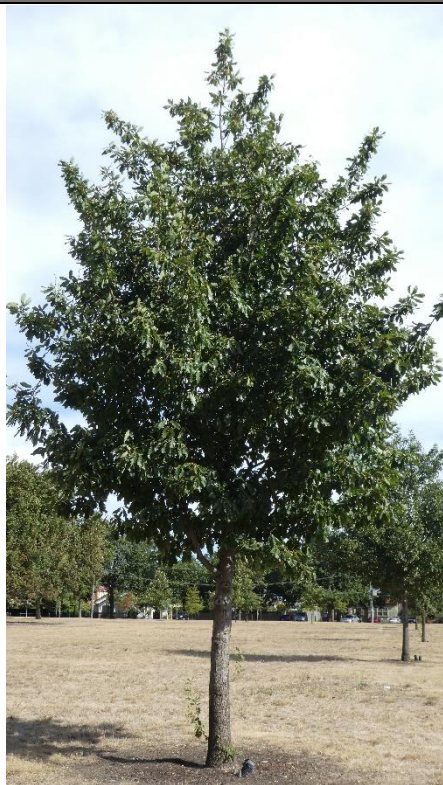
Tree #10

Botanical name	<i>Quercus robur</i>
Common name	<i>Common Oak</i>
Structure	<i>Good</i>
Health	<i>Good</i>
ULE (years)	<i>25+</i>
Retention Value	<i>Moderate</i>
Comments	<i>Removal required for proposed building development</i>

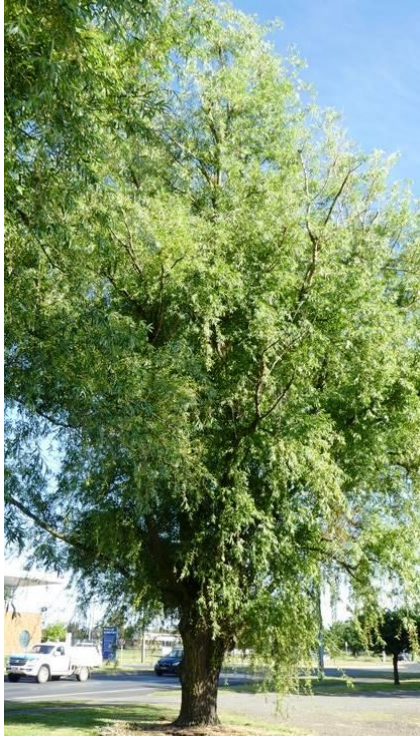
Tree #11

Botanical name	<i>Salix x sepulcralis</i> <i>'Chrysocoma'</i>
Common name	<i>Weeping Willow</i>
Structure	<i>Fair</i>
Health	<i>Fair</i>
DBH cm	89
DAB cm	91
TPZ m	10.7
SRZ m	3.2
ULE (years)	5-15
Retention Value	<i>Moderate</i>
Comments	<i>Significant root decay, tip dieback, deadwood, decay</i>

These trees are both in the direct path of the proposed carpark and cannot be retained in light of the proposed carpark construction.

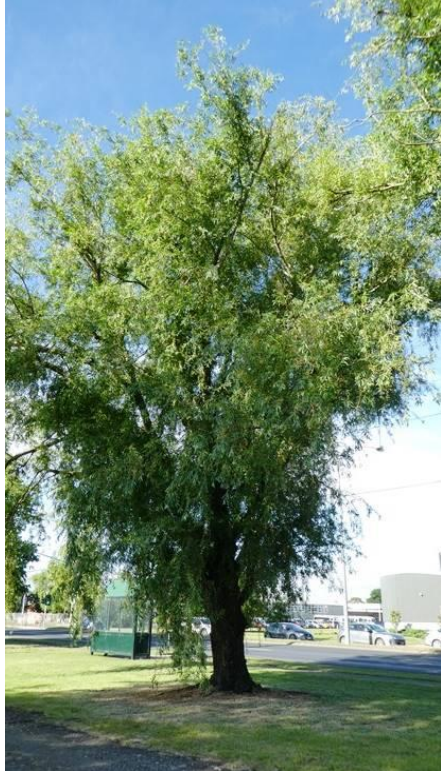
Tree #12

Botanical name	<i>Salix x sepulcralis</i> <i>'Chrysocoma'</i>
Common name	<i>Weeping Willow</i>
Structure	<i>Fair</i>
Health	<i>Fair</i>
DBH cm	72
DAB cm	78
TPZ m	8.6
SRZ m	3
ULE (years)	5-15
Retention Value	<i>Moderate</i>
Comments	<i>Significant root decay, tip dieback, deadwood, decay</i>

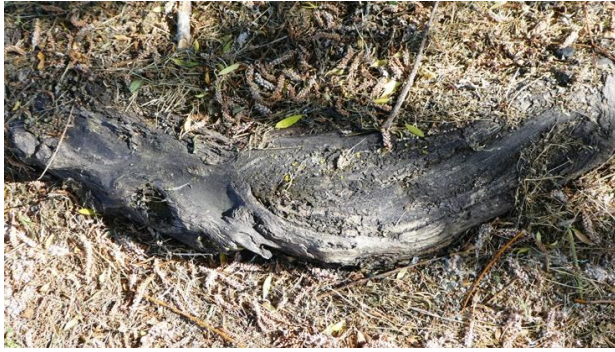
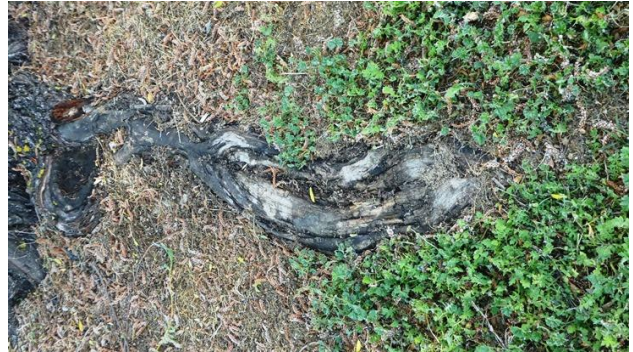
The trees are in a stressed and senescent state. The root damage likely to be caused by traffic and other mechanical means is substantial.

Figure 1 and 2: The significant decay in the roots of the Willow trees at the Ballarat Tram Museum

Root decay can be seen in a variety of places around both trees. This decay has travelled up the tree and is now impacting the longevity of both trees.

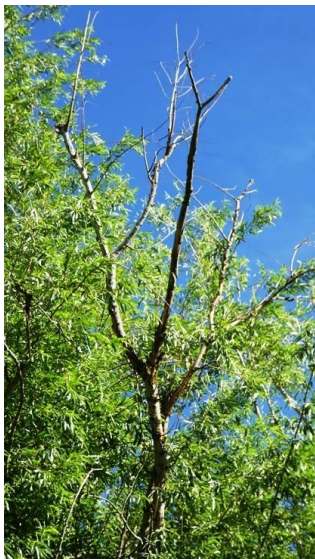
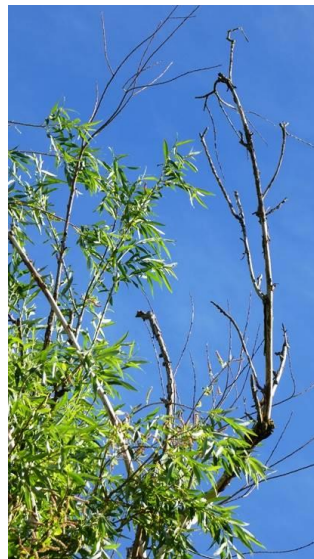
Figure 3 and 4: The tip dieback in both Willow trees caused by decay in the roots at the Ballarat Tram Museum

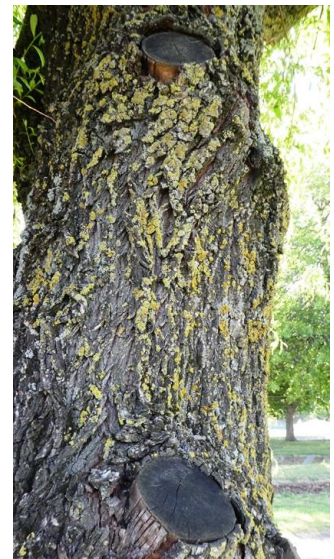
Previous pruning cuts have not calloused well which is another indication of the declining state of the trees.

Figure 2: Old pruning cuts that have not calloused at the Ballarat tram Museum
