# Villa Alba

## Condition Survey and Stabilization of critical surfaces

14 February 1997

prepared by Andrew Thorn

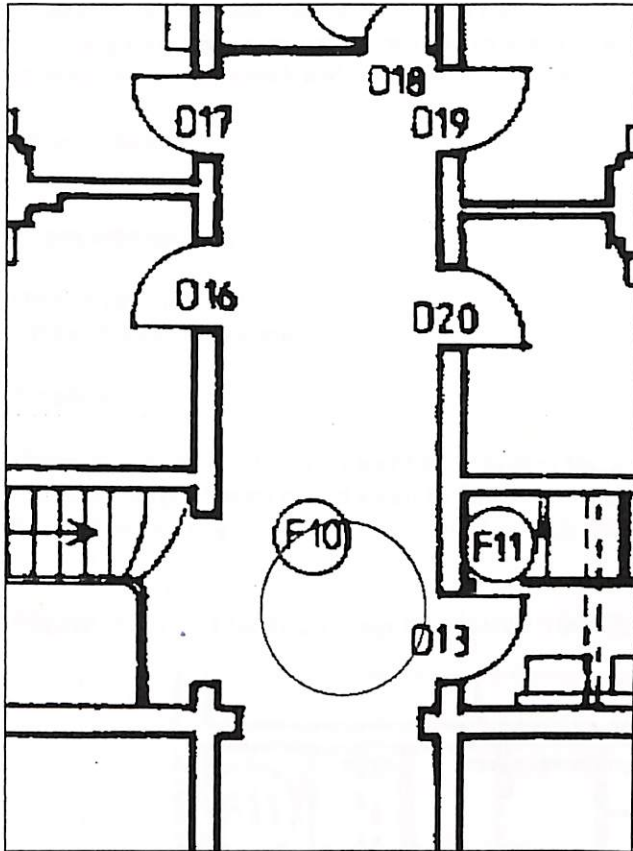
*Figure 5. Location of the detaching papers. Paper detachments are located within the red outline and have occurred all over this area.*

The following figure defines the extent of detaching paper. All areas outside this area were stable and within the red line several areas of isolated detachment were reattached.

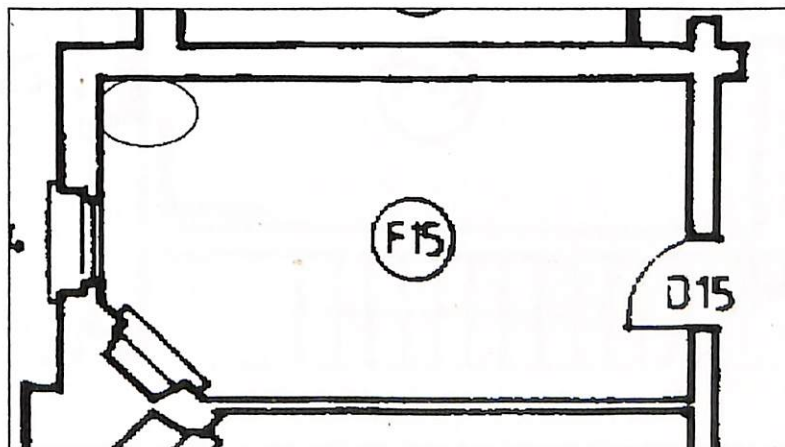
In 1994 a section of ceiling, west of the central rose, collapsed. The damage was limited to the plain central panel but the rose itself had become unstable as well. The ceiling was stabilized from above by Artcare using an epoxy system employed on previous occasions.

Additional consolidation carried out above to the NE corner. This area is now stable.

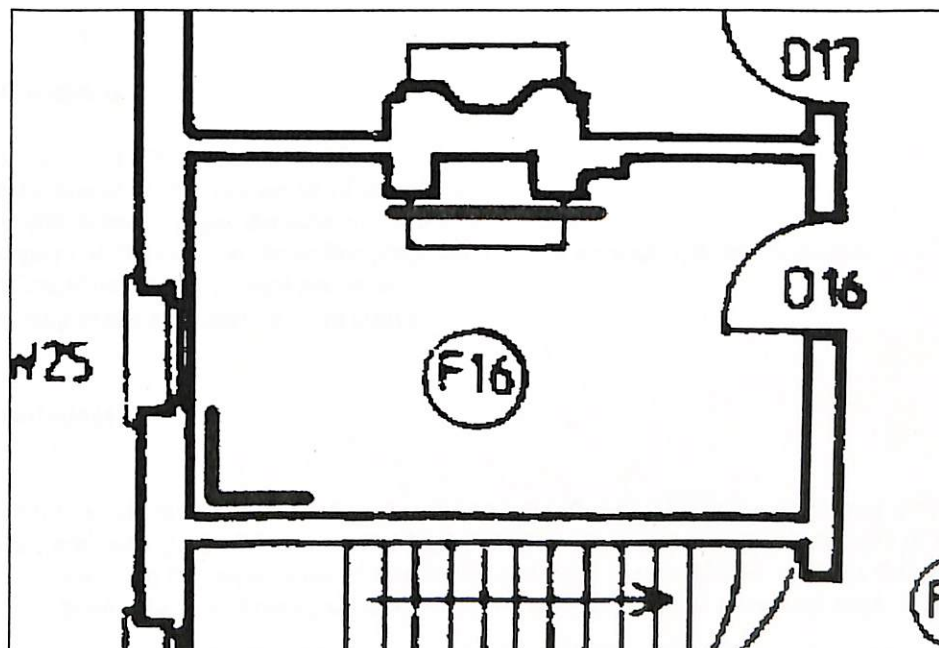
**Figure 1.** Location of cornice consolidation.

*Treatments occur in small isolated pockets in each of these areas.*

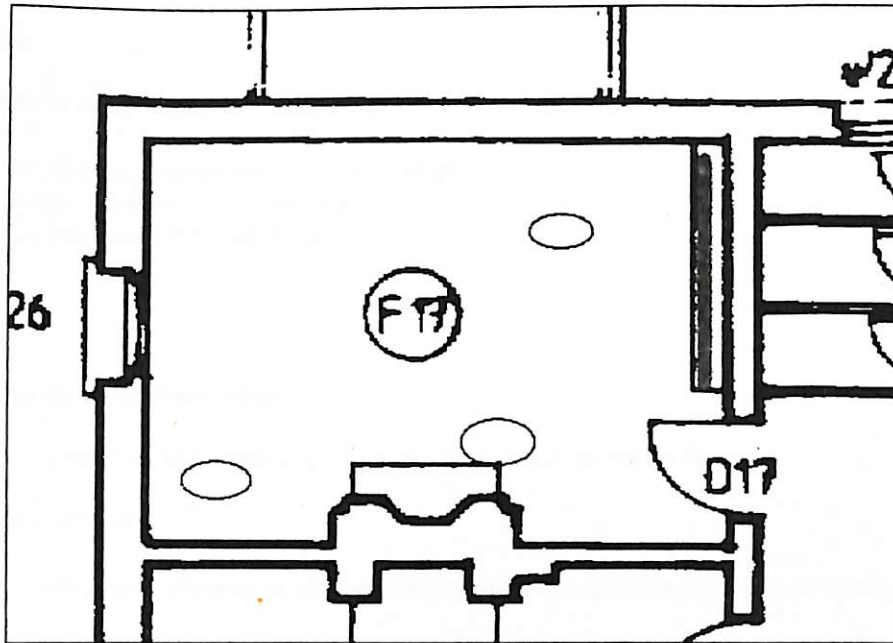
**Figure 1.** *Location of treatments.*

1. Paper detachment SW corner 400x 200.
2. Paper detachment in pink border W of fire-place.
3. Several other areas of paper detachment on a smaller scale.
4. Crude repairs on the cornice above fire-place and cornice on wall opposite fire-place.
5. Areas of instability in the cornice and rose.
6. Entire ceiling needs stabilization from above.

Ellipses indicate areas of ceiling paper reattachment. Vertical bar indicates wall plaster stabilization zone.

It is clear that this ceiling has continued to detach from the plaster. This is not surprising given that the room has not been occupied with consequent high humidity causing loss of bond strength in the starch adhesive. It is felt given the importance of this ceiling and the collapse of other ceilings that it should be secured from above. This stabilization should be carried out on all of the more important ceilings.

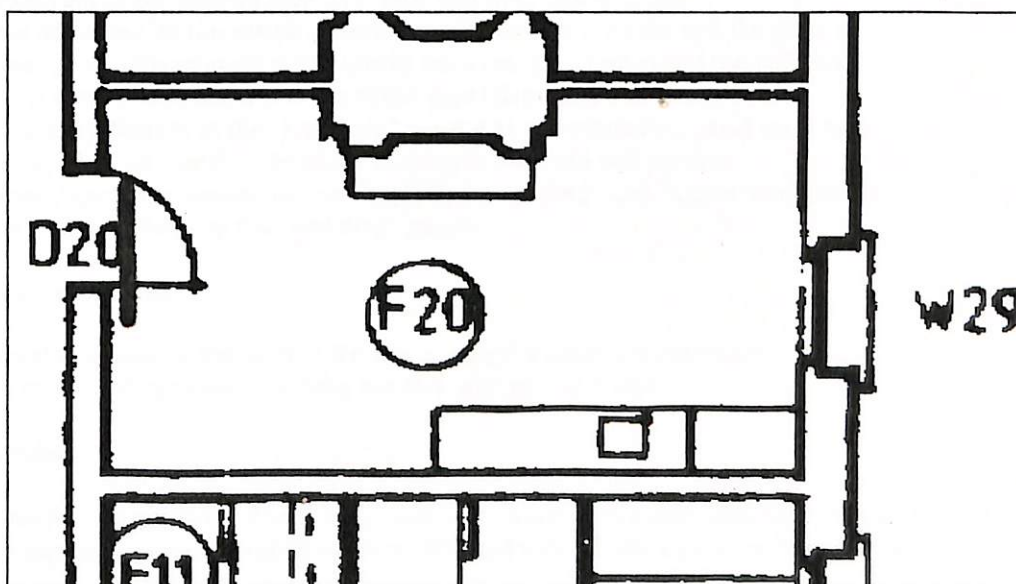
**Figure 1.** Location of cornice stabilization

1. Cornice in centre of west wall is very unstable. This is the same area as observed in 1986 but has become less stable in the intervening decade.

Cornice stabilized with acrylic AC235 and filler.

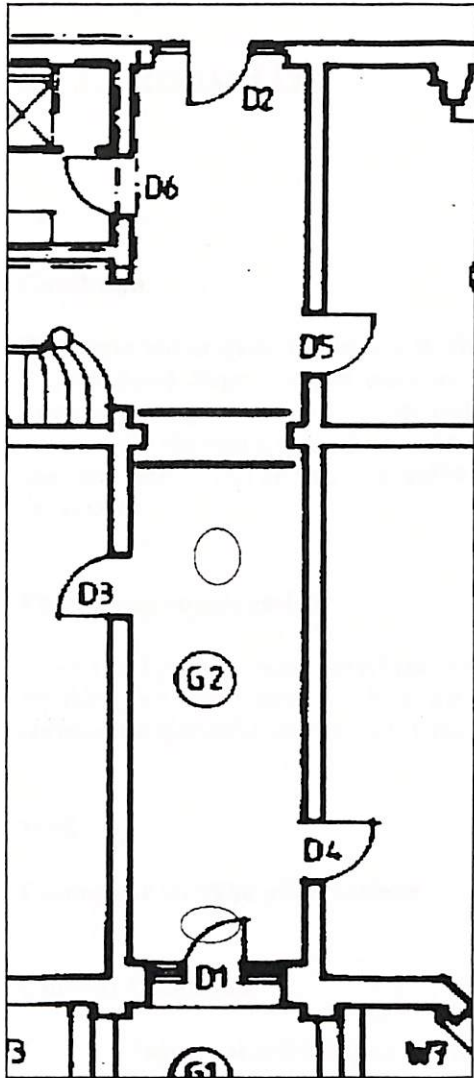
**Figure 1. Location of reattachments**

1. Powdering of the painted area over blue and gold components.
2. Area of flaking, in the eastern grisaille panel between cherubs and the door.
3. Minor paper detachments along cracks between the cherubs and the arch-way.
4. Major areas of detachment in the frieze panel depicting a drawing class.
6. Major detachments in the "sculpture" panel and corresponding panel on N side.
7. A row, of three modillion brackets missing in northern hall cornice.
8. Minor paper detachments in "bowling", "pole-vaulting" and "tug of war" panels
9. 2 large detachments in the "sprinting" panel.

The lines indicate the area of detachment in the Frieze

All detached papers in the Frieze have been reattached with acrylic emulsion / cellulose ether adhesive. All ceiling deterioration areas have been stabilized with acrylic emulsion diluted with water.

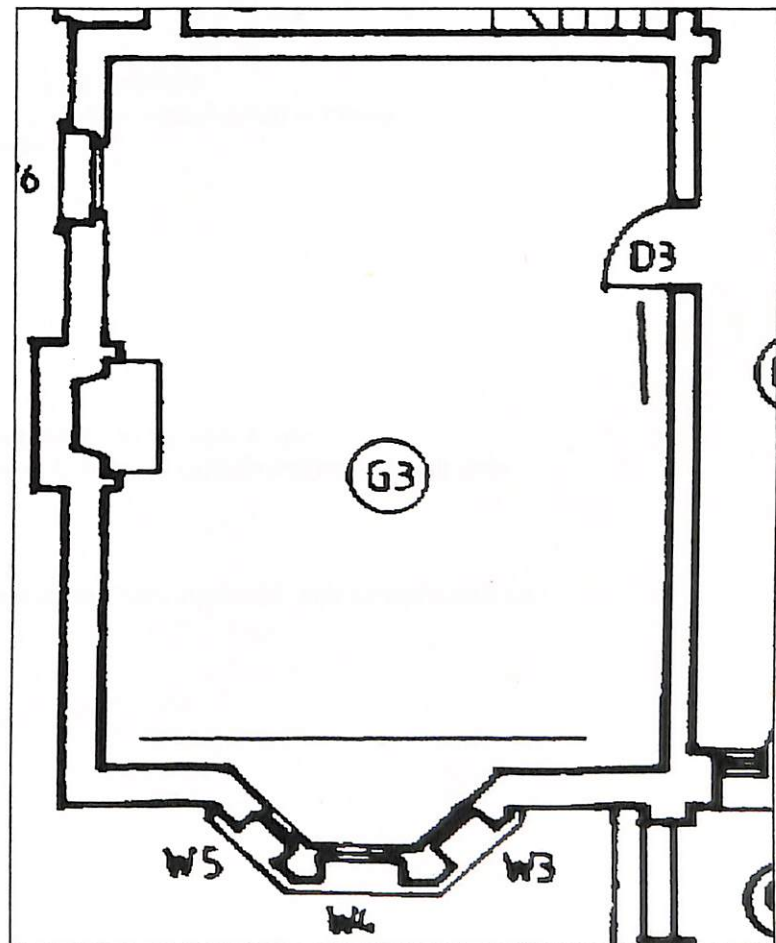
A more detailed study of the plaster deterioration in the ceiling at the south end of the room indicates that the building has moved dramatically in the last ten years. This can also be seen in the ceiling above in Room F14. It appears that rather than further movement outwards the building has moved inwards with a resultant buckling of crack edges in the plaster. The 1996 Condition Survey identified an isolated

area of crumbling plaster but further inspection revealed this to extend the length of a crack running east west across the room. It has now become essential to monitor the movements of this end of the building. Artcare commenced this process in 1986 however all of the monitoring devices have been removed in subsequent years. One was removed by the plasterer while repairing cracks in the Vestibule and others presumably by people decorating the rooms during fund raising events.

The downpipe at the north east corner of G3 has leaked for some time before 1986 and repaired in the early 1990s. Thus it can feasibly be assumed that during the period of leakage the soil swelled and has since the repairs entered a phase of contraction. This may sound like a gentle return to the previous position however this will only happen if the soil moisture levels return to their state at construction. Should the soil dry out further than original levels there is a danger of enormous compressive stresses being placed on all elements within the zone of movement. It can be assumed that timber components will survive such movements but equally that brittle material such as plaster will not fare well.

Damage has begun to occur in the ceiling due to compression as the two edges have come together. No other damage has occurred yet simply because there is no disturbance until surfaces begin to compress into each other. Why the ceiling only has begun to compress is not clear but may be due to stretching of the ceiling plaster during the initial outward movement of the south wall.

Vertical line indicates zone of detached cornice

Horizontal line indicates position of crack in ceiling from which plaster is beginning to deform.

The only sensible approach is to monitor the movement of this end of the building or to at least initiate more regular inspections of the building. Condition Surveys at ten year intervals can be considered too irregular given the extent of damage that has occurred from 1986 to present. It is recommended that this ceiling be inspected biennially and it would be wise to survey the whole building at similar intervals.

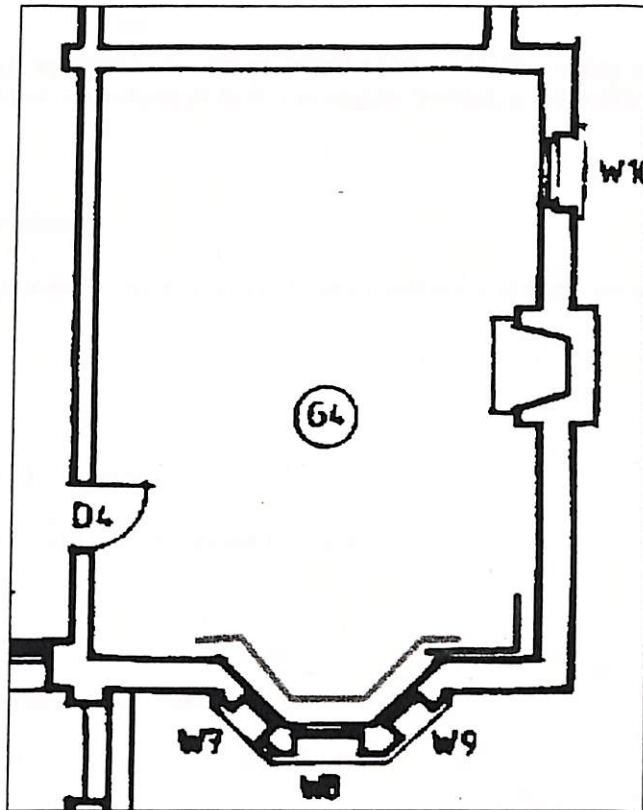
**Figure 1.** *Location of consolidation in cornice and Bay window.*

Green line represents the area of the Bay and associated columns.  
Red line indicates the location of cornice stabilization.

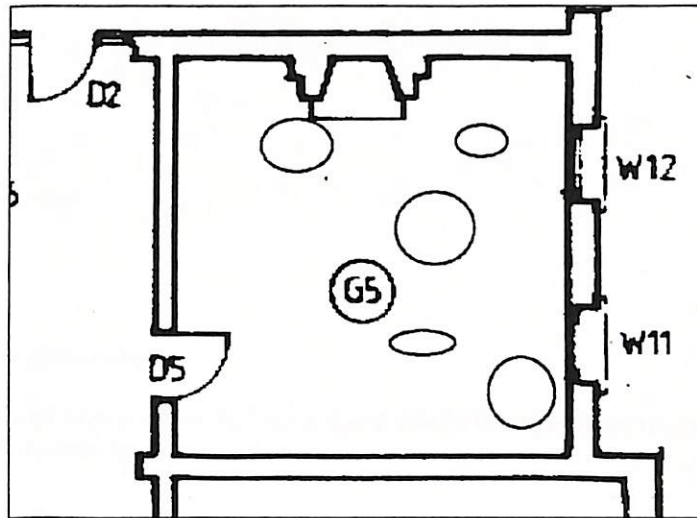
**Figure 1.** Locations of detaching papers on the ceiling. Note that not all detachments include the original paper. Those remaining unattached consist only of overpaint.

The detached areas are quite brittle and to be able to flatten them and attach them to the ceiling heat has been preferred to moisture that was unable to successfully relax the cupping. Visual inspection of the room after treatment shows that some flakes are still hanging from the ceiling. These areas are the blue paint applied direct to the plaster and do not contain any original decoration. They have been left unattached to facilitate removal at a later time. They may in fact fall off before further work is undertaken on this ceiling.
