Villa Alba

Condition Survey 2004

prepared for
Villa Alba Museum

17 February 2004

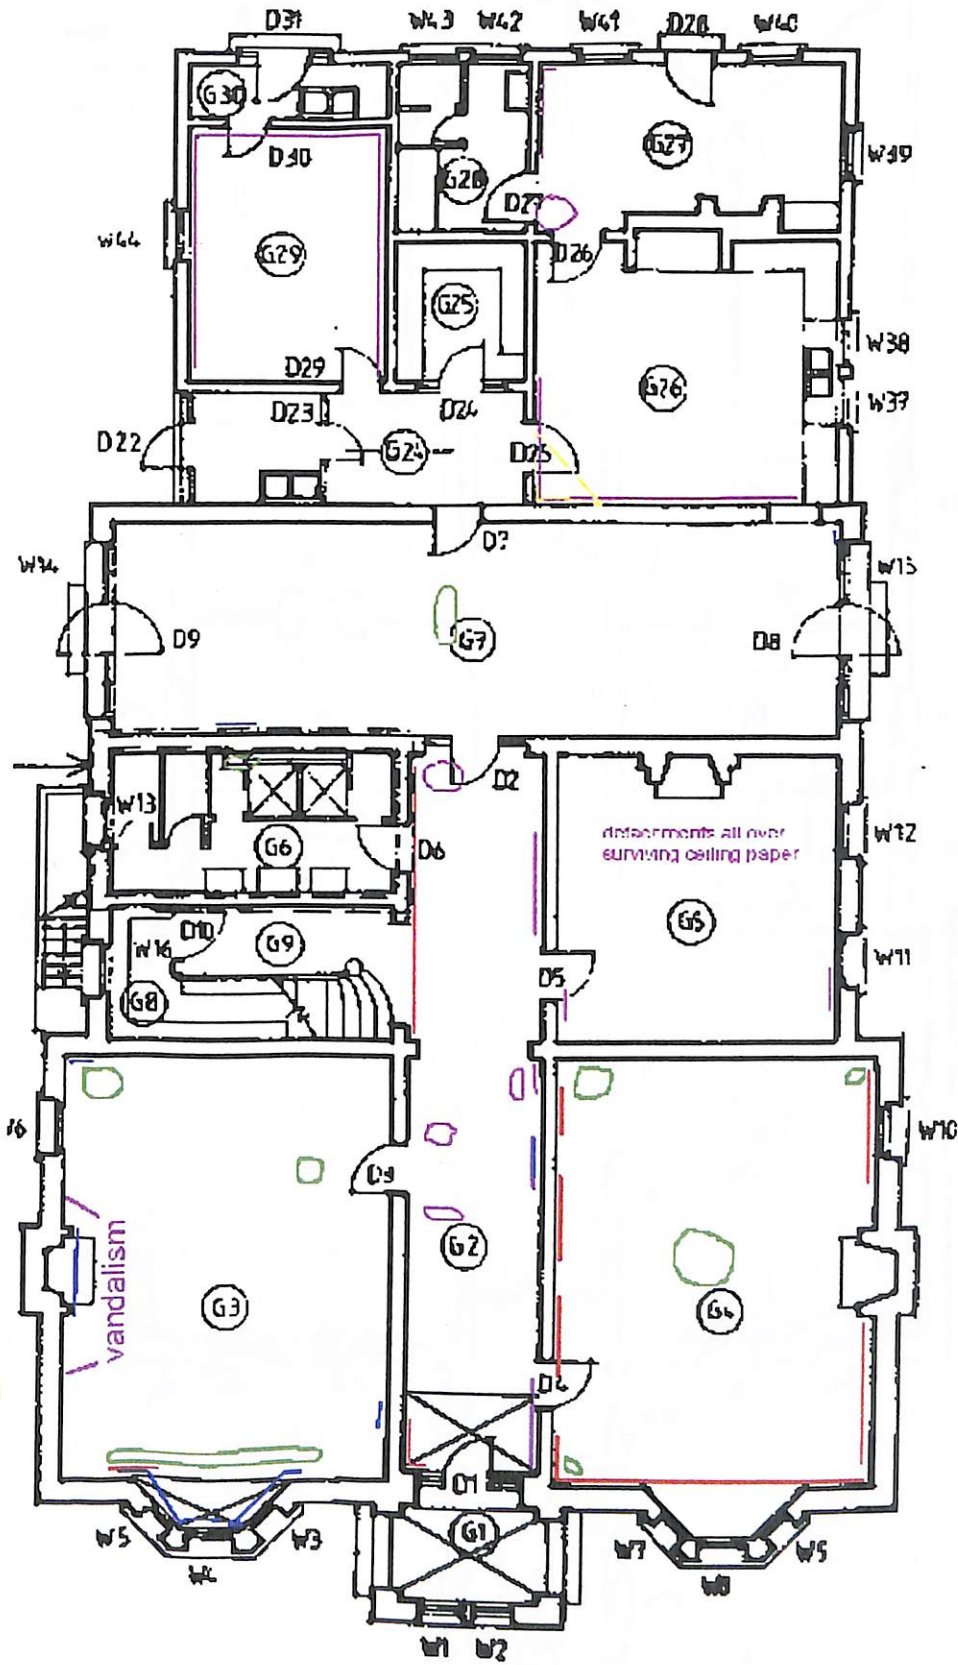
Figure 3 Condition of Level 1 (Ground Floor)

The plaster of the ceiling is quite stable but a number of minor paper detachments from the plaster have been documented.

There appears to have been further water ingress in the northern section. Some of this corresponds to the plaster fall in the hall above while other paper detachments occur below the bathroom above.

One section of cornice above the door is severely detaching. One piece is completely loose. Three modillion brackets in the north section are now missing without trace. Previously only one of these was gone

The plaster is stable but a few significant areas of paper detachment occur. These are marked on the plan.

As reported on earlier, the ceiling has undergone some compression in the south end. A newly developed, yet similar movement has taken place along the northern edge in more recent times. Crack monitors have been installed at both locations to monitor future movements.

One section of cornice has become loose since last inspection. This is located above the bay window, as marked.

A more recent and quite severe damage has happened at the right hand end of the panel above the fireplace. This is a recent damage that appears to be the result of a serious leak. No knowledge of this leak has been brought to the conservator's attention. Someone has been engaged to paint over the damage. Not only has this not addressed the issue but has caused considerable disfigurement to the frieze painting and the cornice above. It is difficult to imagine how such vandalism has been allowed to take place.

The ceiling is generally stable except for the three corners identified on the drawing. Combining this with the seemingly recent instability in the cornice suggests the destabilization has occurred in recent years.

The plaster of the ceiling is quite stable but the paper supporting the decoration is detaching in almost every part of the ceiling. There is approximately 20% detachment across the ceiling but it is unclear at this stage whether the detaching paper is in fact that supporting the painted scheme in all places.

Stable in all but one area with some paint flaking. This is believed to be overpaint with no original decoration intact. An investigation of the ceiling is currently underway.

Stable except for two small areas. The plaster around the removed western flue is severely detached in small areas. A minor detachment occurs above the left side of the east door. All paint is now securely attached.

Detachment around flue penetrations through ceiling, as marked.

Allow 5 hours to stabilize these surfaces.

Allow 10 hours to stabilize and rectify previous damages.

Allow 20 hours to reattach the paper onto plaster in the ceiling.

Allow 2 hours for paint and plaster stabilization in the walls.

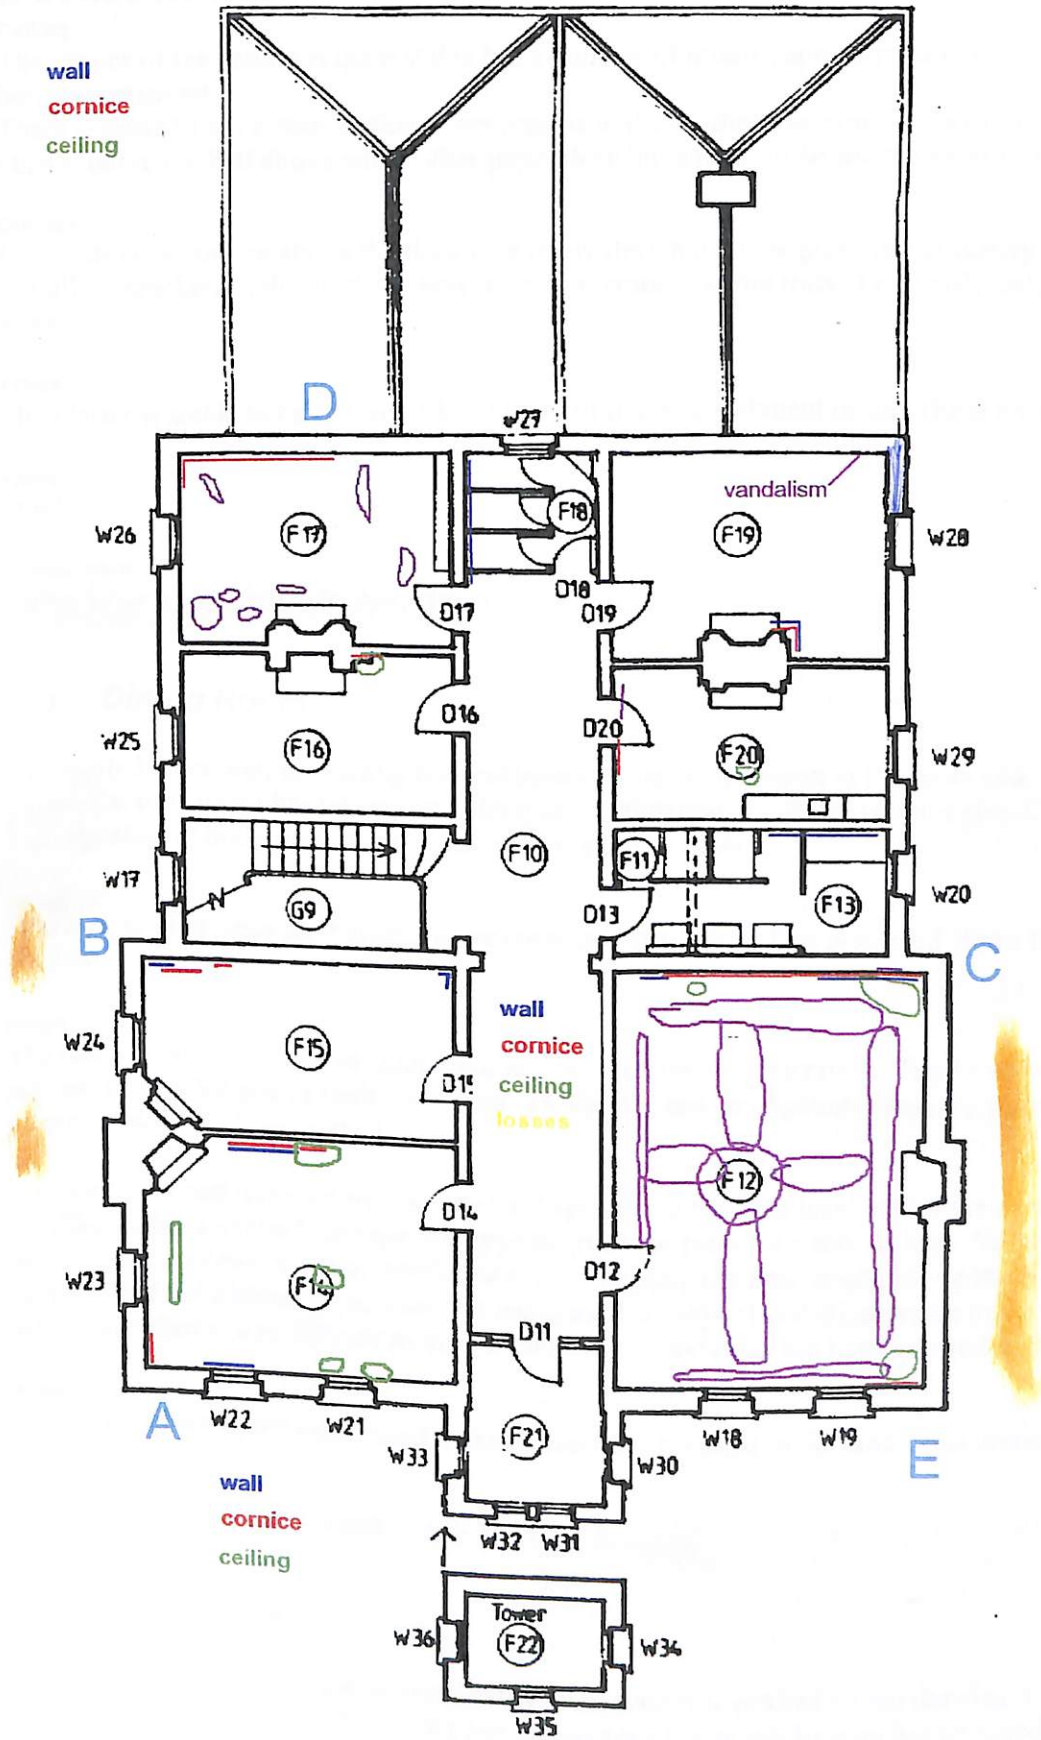
Figure 4 Condition of Level 2.

Evidence of pin fixing damage causing paint and plaster loss.

Compression of plaster along western wall line as marked.

An area of plaster, filled at some earlier stage, has folded out and is very hollow behind. This area should be properly secured now.

One section of the ceiling rose is loose as a result of movement and detachment of the ceiling supporting it.

Evidence of compression through movement, particularly near the NW downpipe area.

The ceiling has suffered from continual movement since last inspection. This has resulted in several areas of buckled plaster skim coat. The ceiling has been stabilized from above but this is limited to attaching the whole plaster mass to the laths and joists above. The current detachments are between the outer skim coat and the thicker brown coat that bonds to the laths. Previous stabilization to the skim coat remains effective and should be continued.

In addition to the minor areas of detached plaster, the painted surface continues to detach. This has been documented on the plan and is confined to the foliage border decoration. There are some detachments to the inner plain cream panels but this paint is an overpaint.

Plaster is detaching from the northern cornice in particular. A visible line of detachment runs almost the entire length of cornice.

One small section of frieze plaster has detached in the NE corner, associated with the building movement in this corner.

A section of cornice to the east side of the chimney is severely detaching. This cornice retains its exposed original scheme. All other cornice is stable despite its heavily cracked appearance.

The north cornice has moved considerably in recent years causing compression and failure within the cove. A major crack perpendicular to the cornice is now being monitored for movement.

Allow 3 hours to secure plaster in cornice and rose.

Allow 20 hours for stabilization of ceiling, cornice and frieze.

Allow 3 hours to stabilize frieze and cornice details.

Allow 8 hours to reattach ceiling papers.

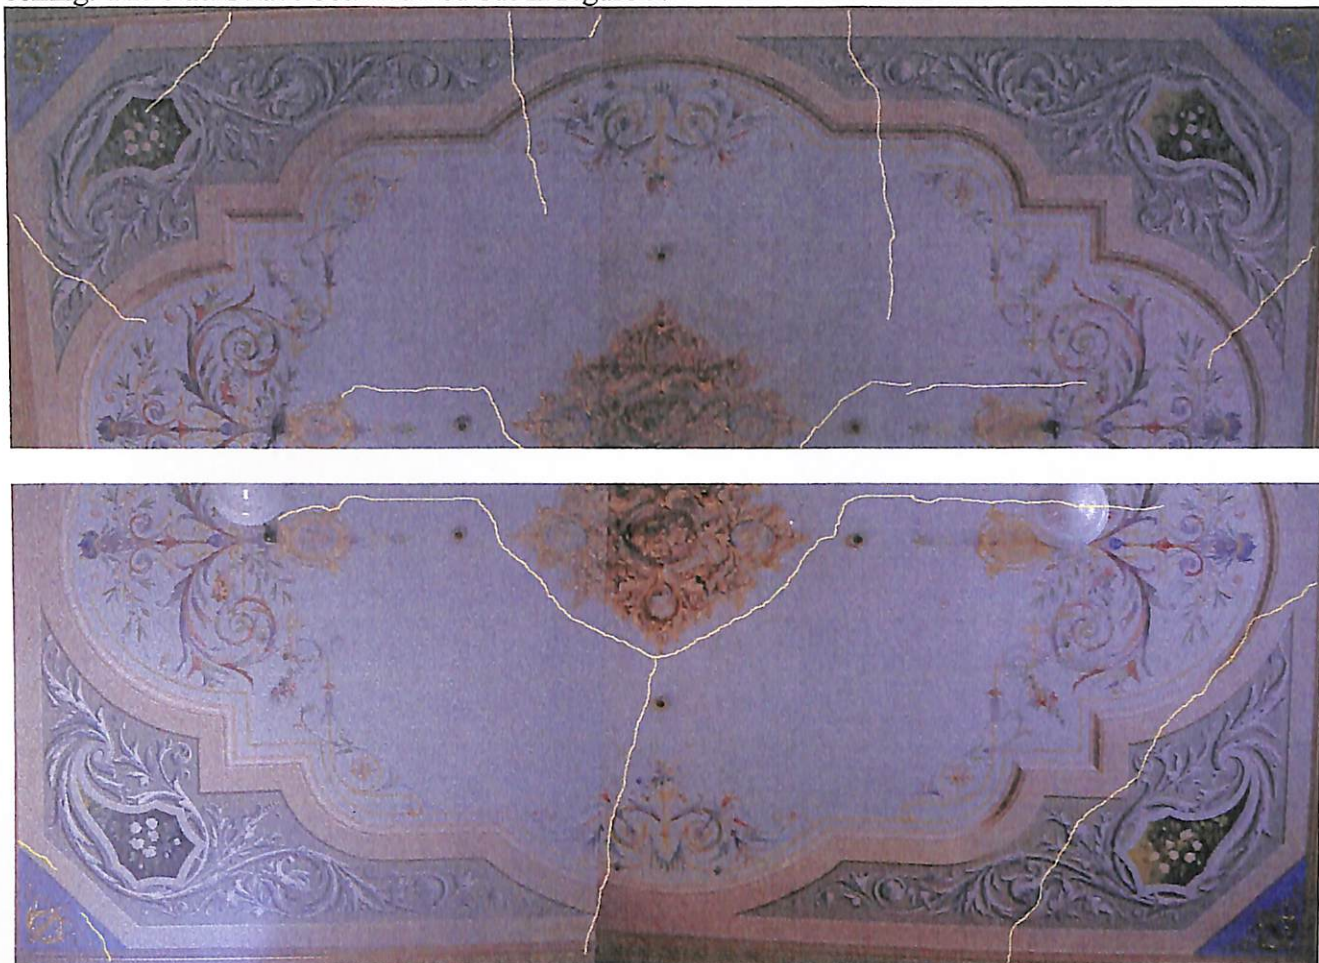
There is clear evidence of damage to the ceiling from recent open house installations. The central rosette of the centrepiece is broken through and the general area around appears less stable than other parts of the ceiling. The cracks have been marked out in Figure 5.

Figure 5 Cracking to the plaster in G4. The yellow lines mark the extent of cracks in January 2004.

The central rosette of the ceiling centrepiece has been broken off during installation of chandeliers during open days. The ceiling itself appears more disturbed in this central area.
