# CURVE VICTORIA STREET.

OPPOSITE HEUGLE'S SHOP (NEAR HODDLE ST.)

LINE 2.

LINE 2. PLAN B6.

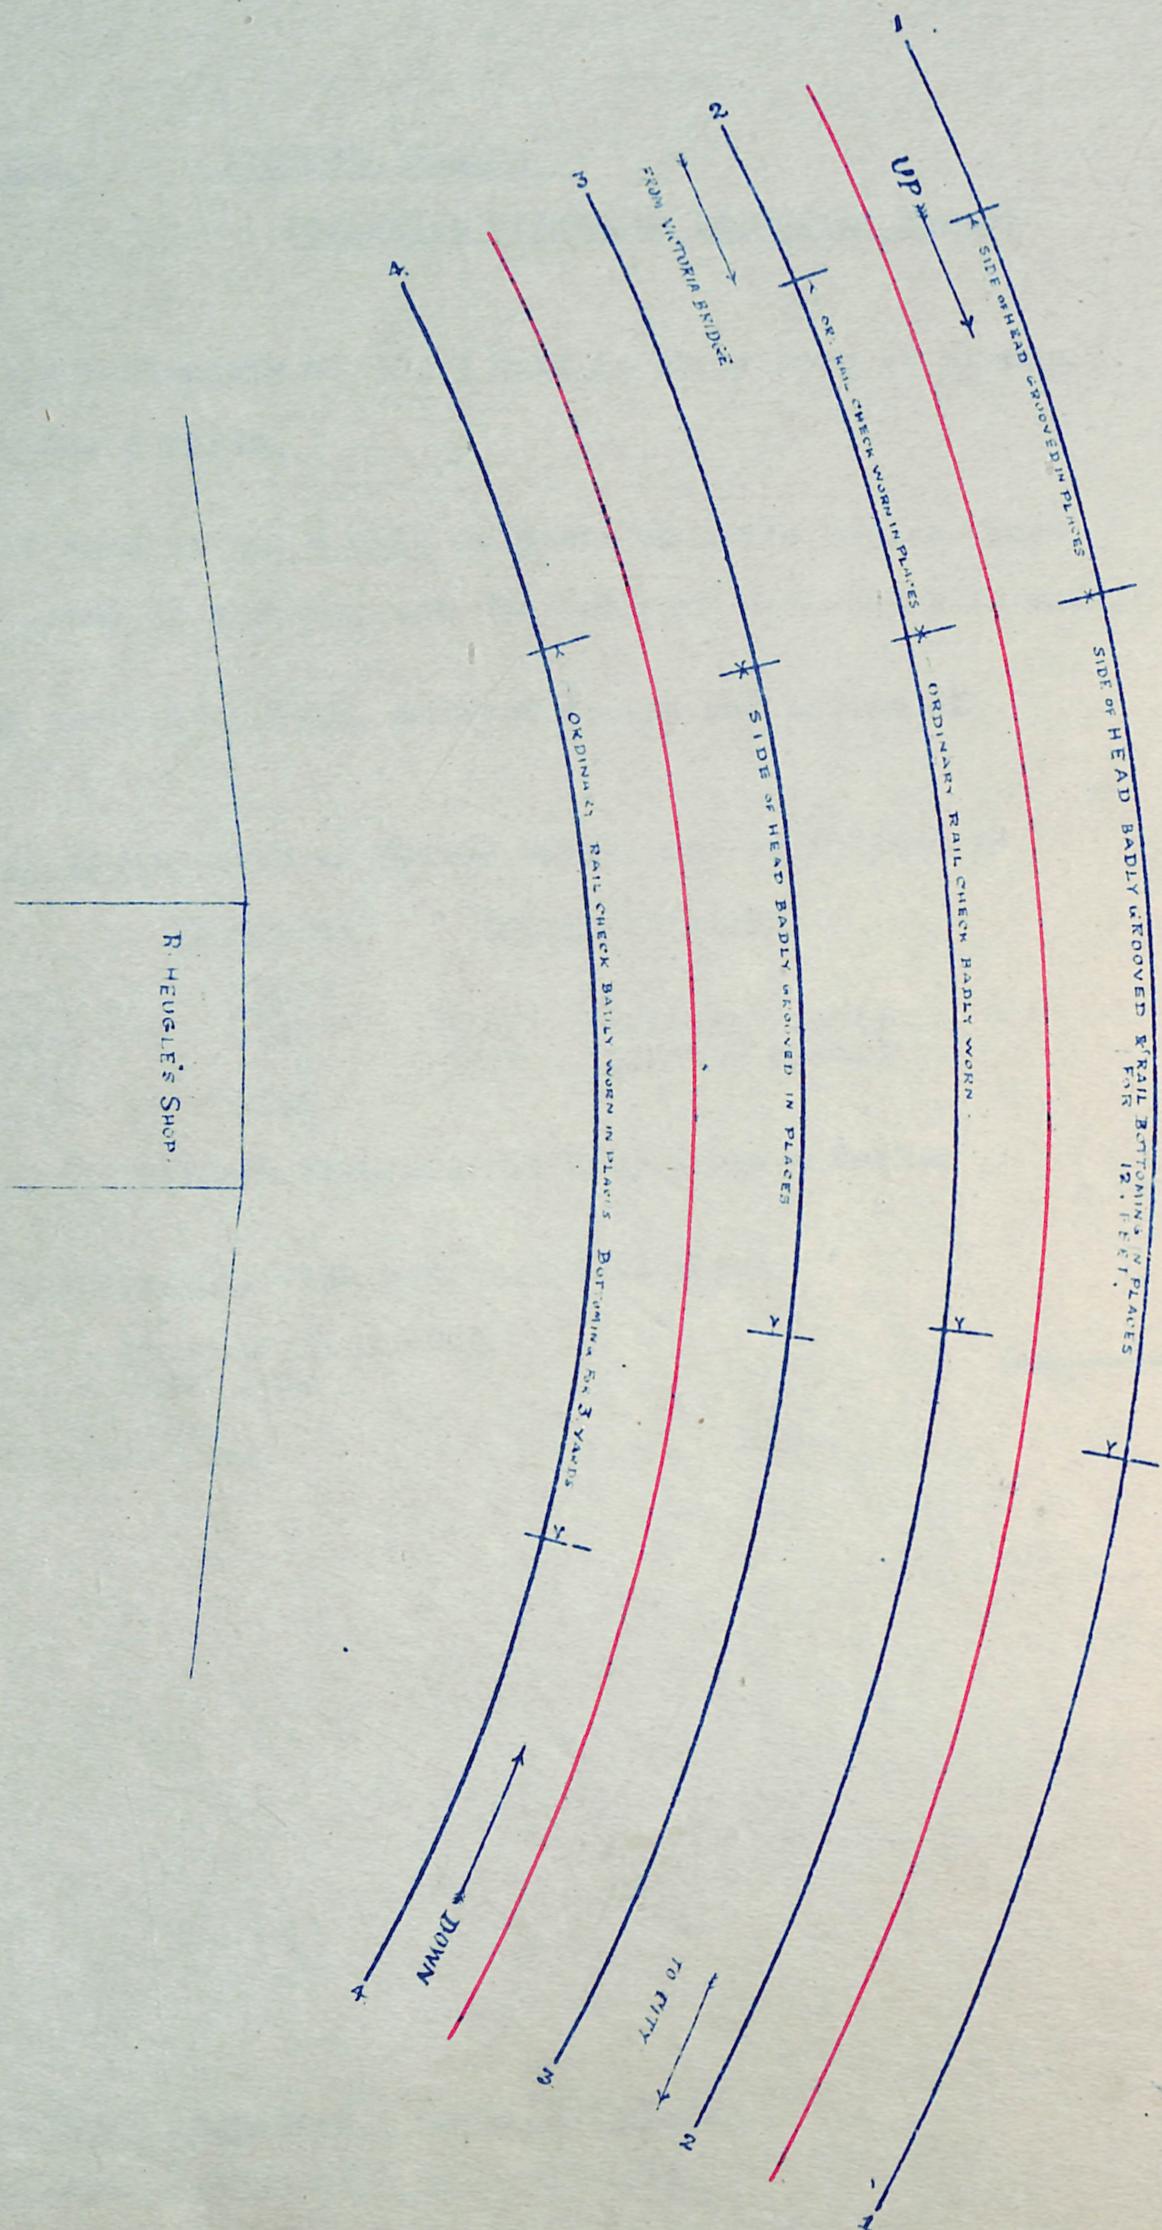
PLAN B6.

SLIGHT CURVE - VICTORIA STREET (Opposite Hengle's Shop).

1. The Ordinary rail-Checks (Nos. 2 and 4 Rails) are badly worn in places.
2. The sides of heads of ordinary rails are badly grooved in places as a result of the above check-wear.
3. No. 1 Rail is bottoming for 3 yards in places.

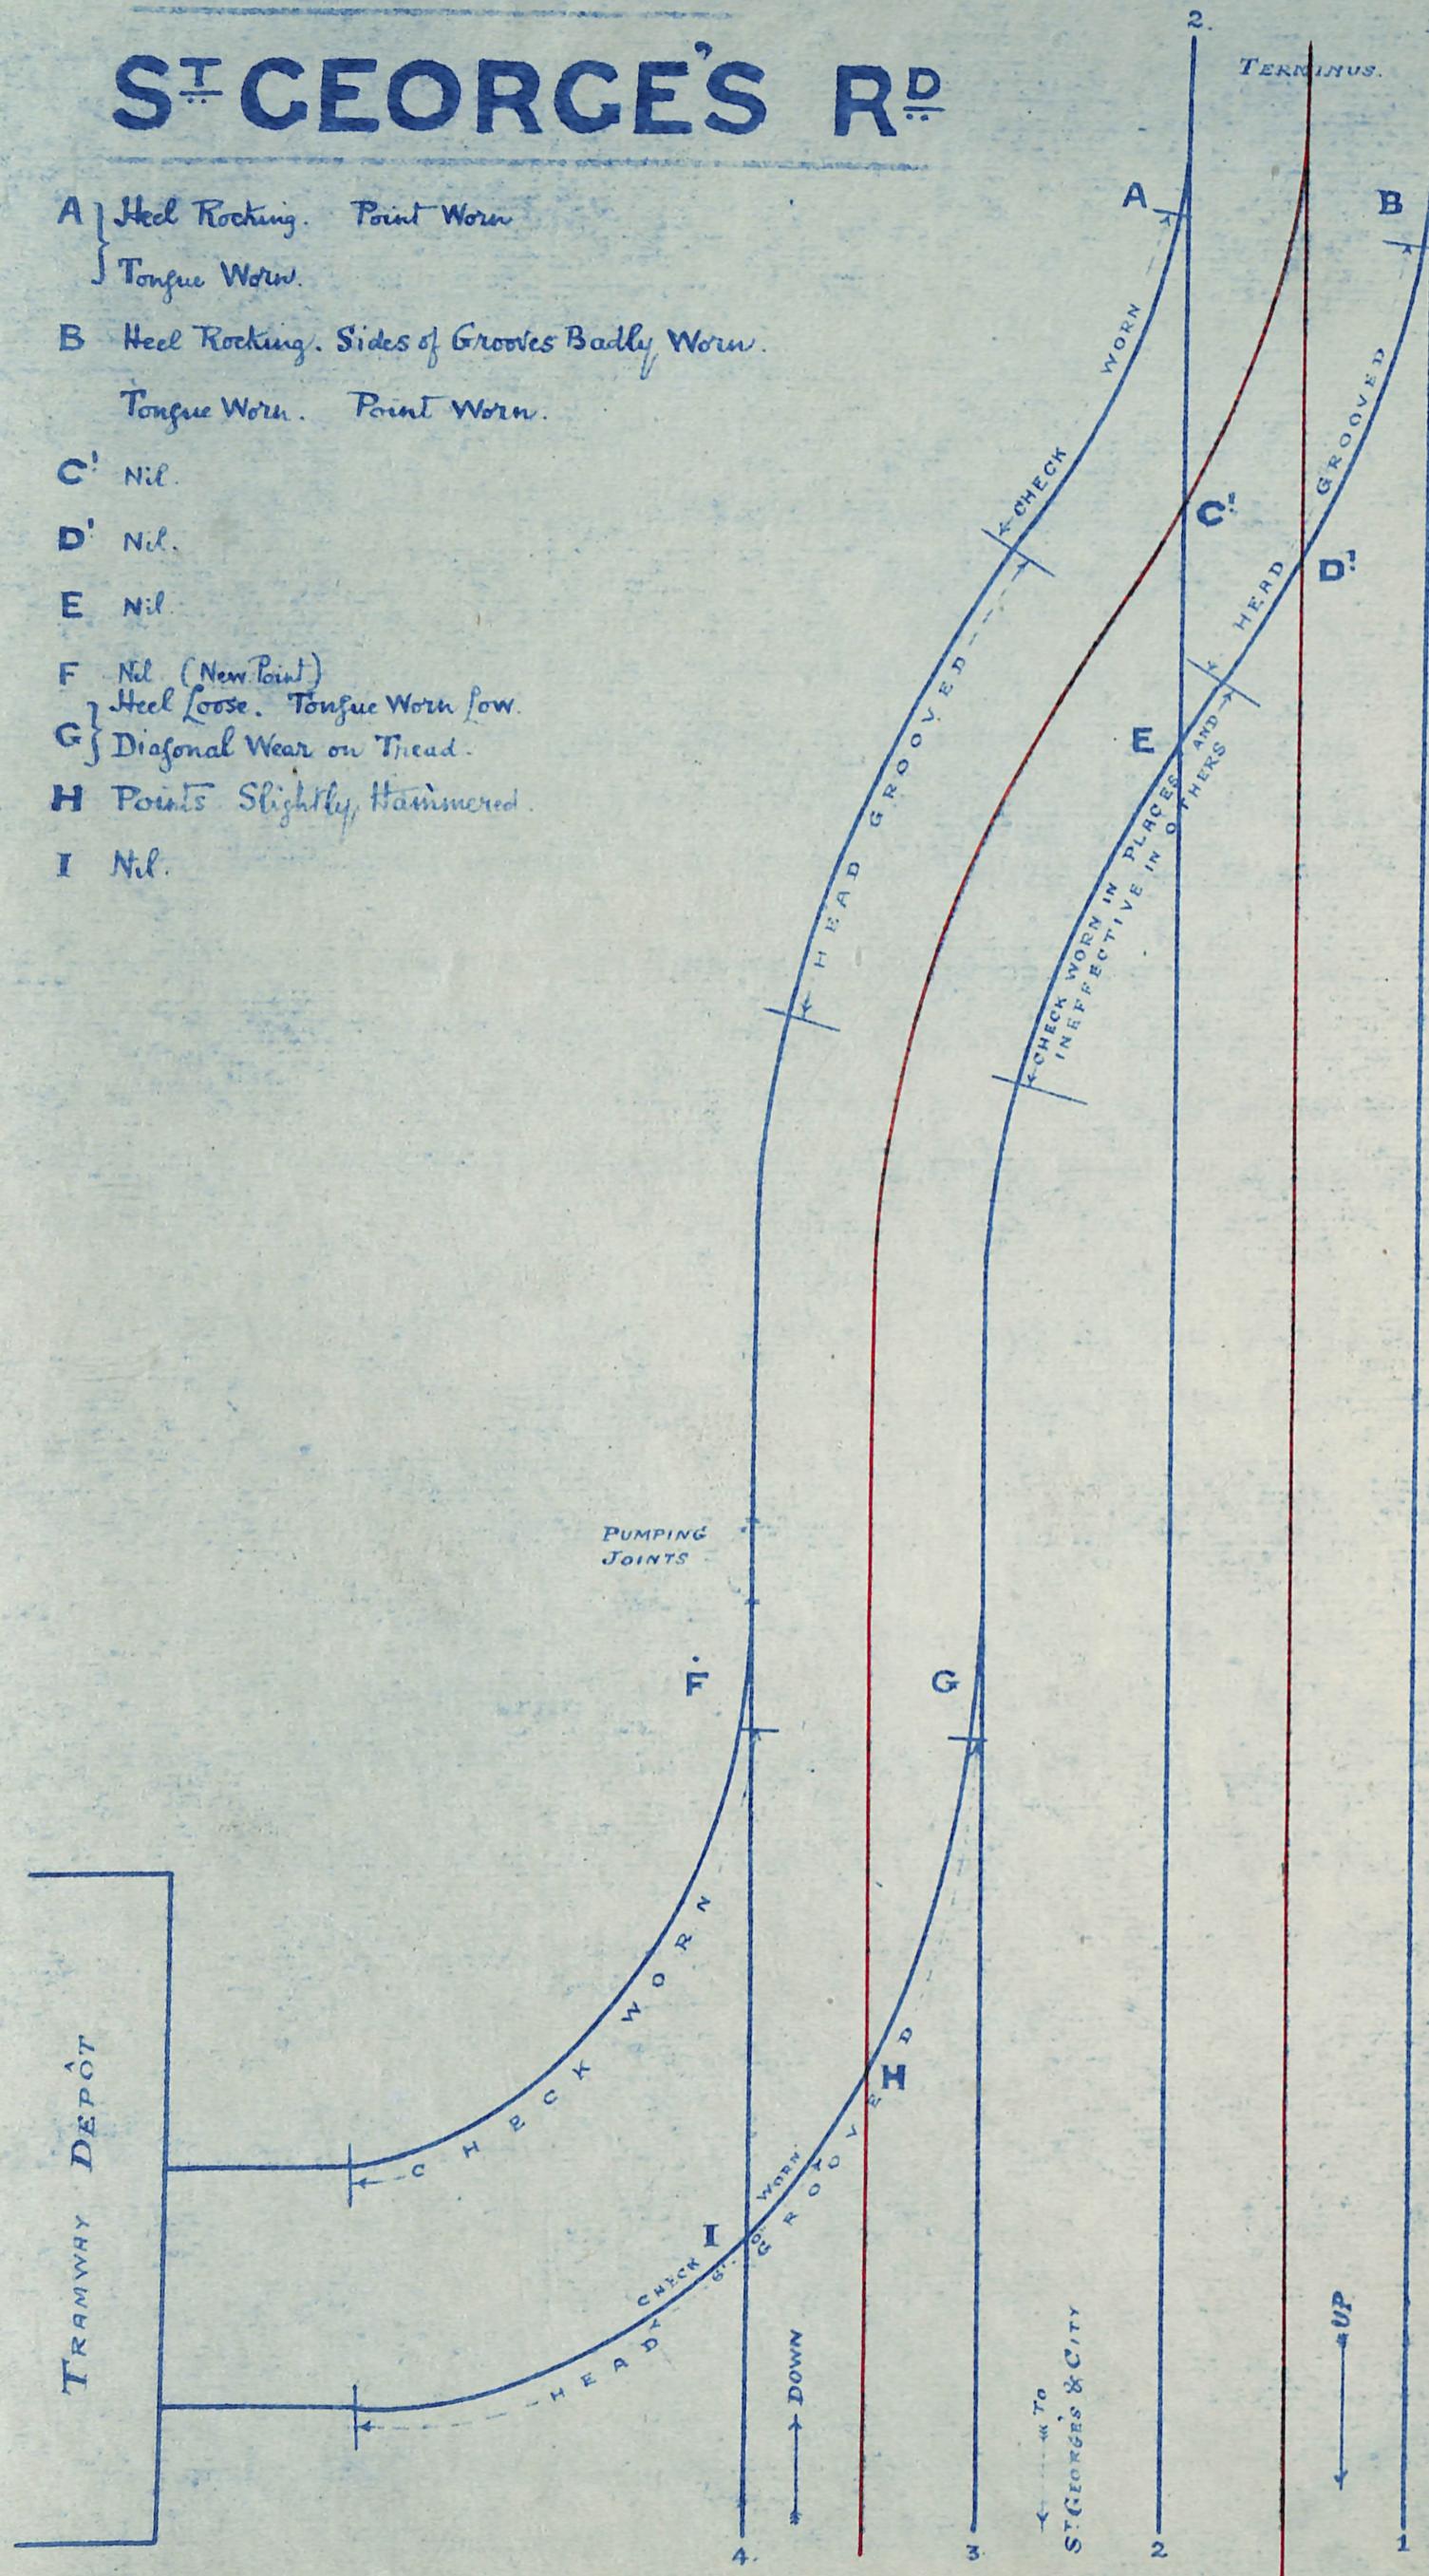
LINE 2  
PLAN. C.1.

1. E. The Checks of special Check-rails leading from Terminus to Car Depot are worn, whilst sides of heads of opposite rails are grooved, as a result of the above check-wear. Special checks are loose and ineffective in places.
2. I. The heels of three of the four Points are of bad fit, and rocking. On two of these points there is considerable diagonal wear on tread. Tongues are worn to varying degrees.
3. On No.4 Rail (near point of Turn-In to Car Depot) a short length of rail is pumping, and the fish-plates are presumably loose.
4. At the crossing-intersections, also at intersections of slot-rails with Tram-rails, hammering is taking place, to varying degrees.
5. Four of the joints of tram rails adjacent to Points, are wide, (varying from  $1/4"$  to  $3/8"$ ), and in several cases are hammered.

- A } Heel Rocking. Point Worn  
} Tongue Worn.
  - B Heel Rocking. Sides of Grooves Badly Worn.  
Tongue Worn. Point Worn.
  - C Nil.
  - D Nil.
  - E Nil.
  - F Nil (New Point)
  - G } Heel Loose. Tongue Worn Low.  
} Diagonal Wear on Tread.
  - H Points Slightly Hammered.
  - I Nil.

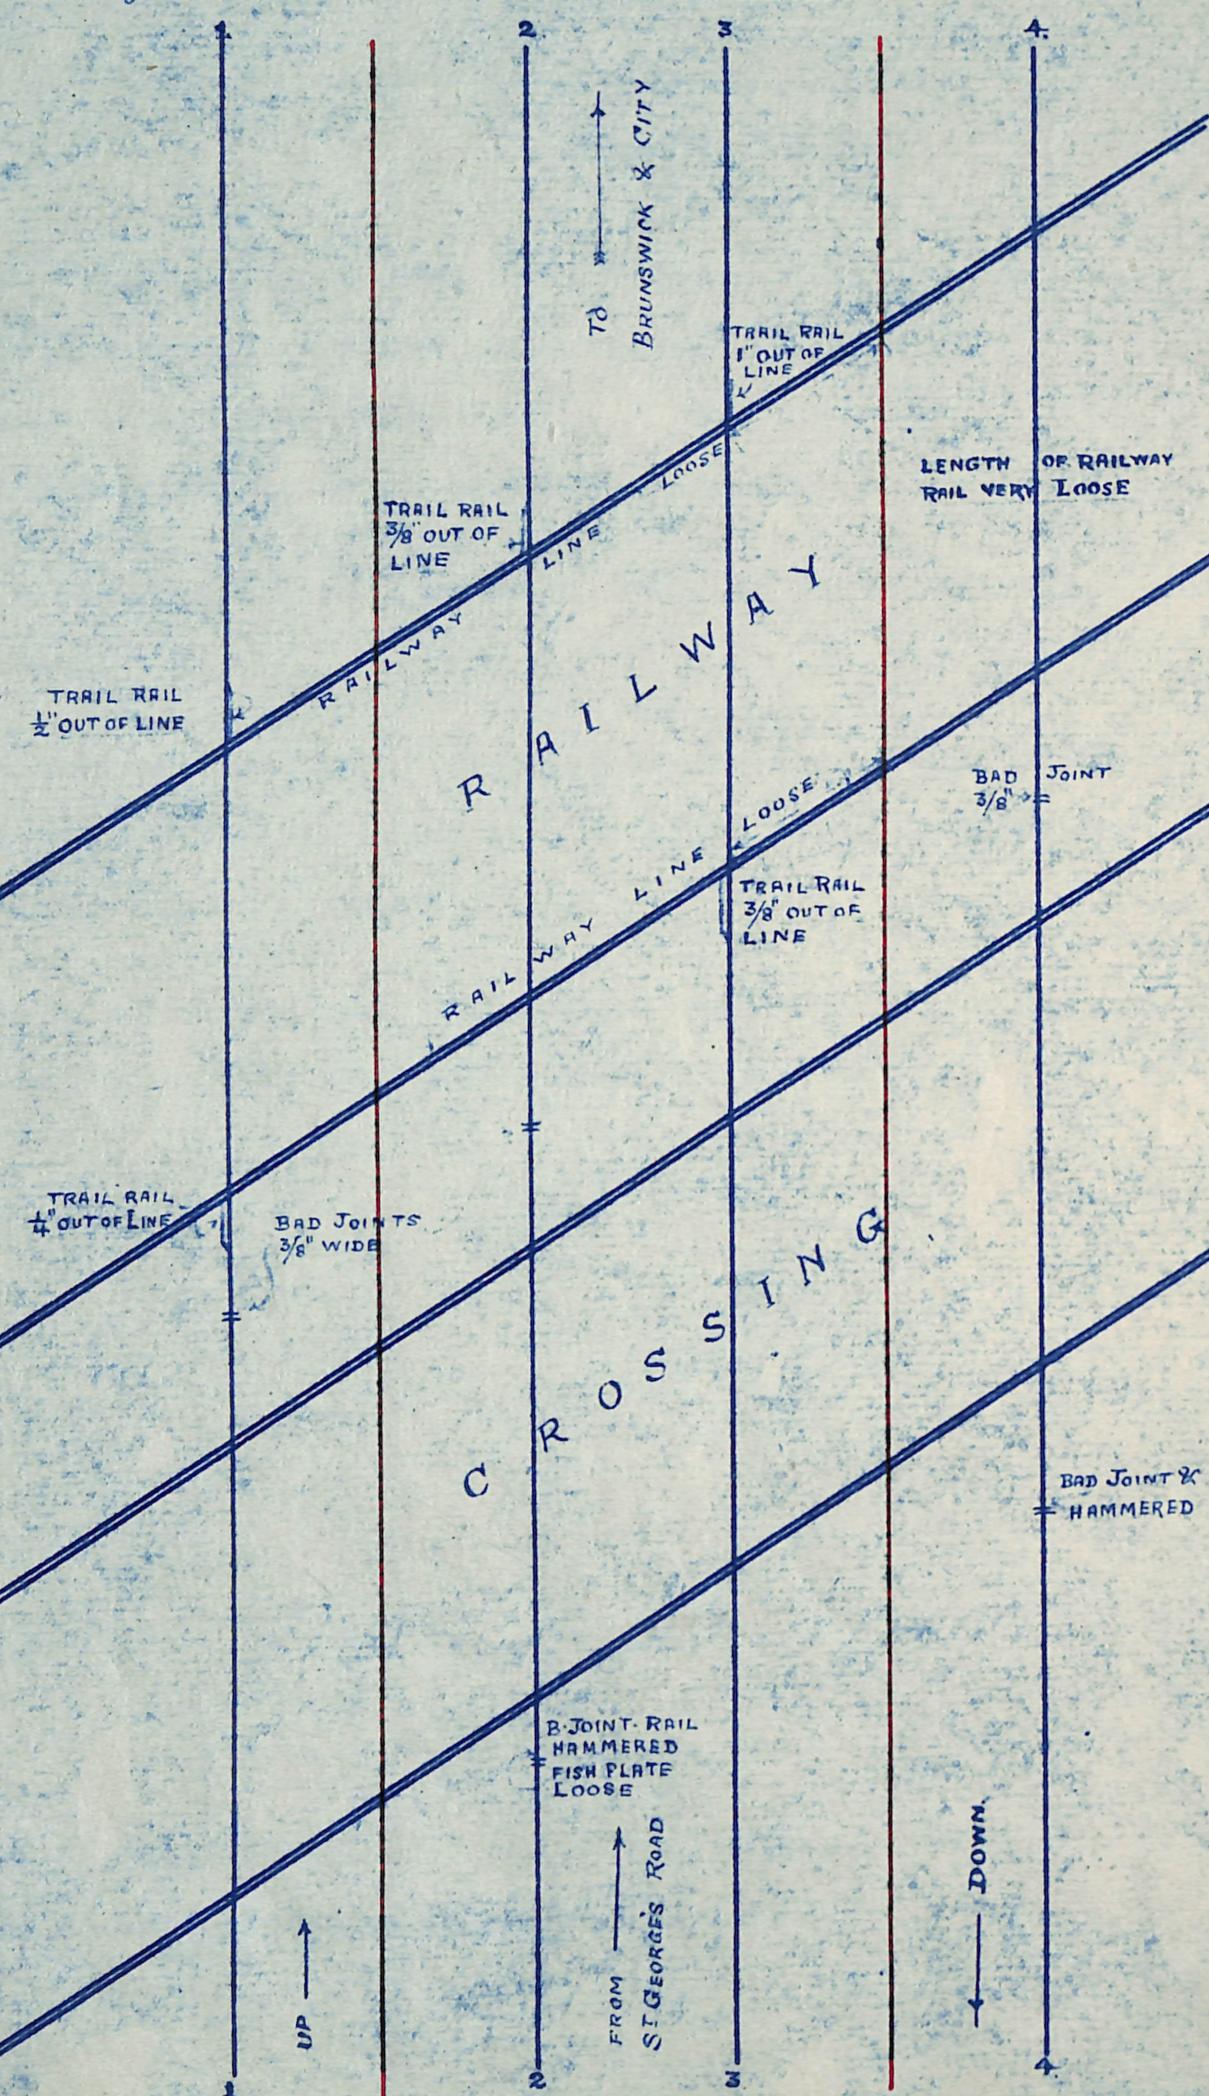
LINE 2  
PLAN C.2.

1. Tram-rails at four Places, near the intersections with railway rails are out of alignment with adjoining tram-rails - varying from  $3/8"$  to  $1"$  causing excessive wear on rail checks and side of head of rails. This defect appears to be due to bad original construction.

2. Tram-rails are not level with railway rails and railway guard-rails in many places to a serious amount, resulting in excessive hammering and wear at intersections. Where this hammering occurs, a sympathetic hammering has resulted from this to the tread of adjoining rail.

3. There are four wide joints to Tram-rails (varying from  $3/8"$  to  $1/2"$ ) and these joints are hammered, and the fishplates presumably loose. There is also hammering of some of the other joints, and want of lineability of the Tread-surfaces.

4. Pair of Railway-rails on South West side of Tram-track between No. 3 Tram-rail and Slot-rail are loose in their chairs, causing excessive vibrations and loosening of adjacent paving.

5. The paving blocks at several places are loose, and some of them shattered.

All Intersections Hammering, with bad Wear in many Cases.

Fish Plates loose. Paving loose, and shattered in several places.

Tram-Rails not level with Railway rails, and Railway Guard-rails.

Sympathetic Hammering on Trail-rails opposit Intersections.

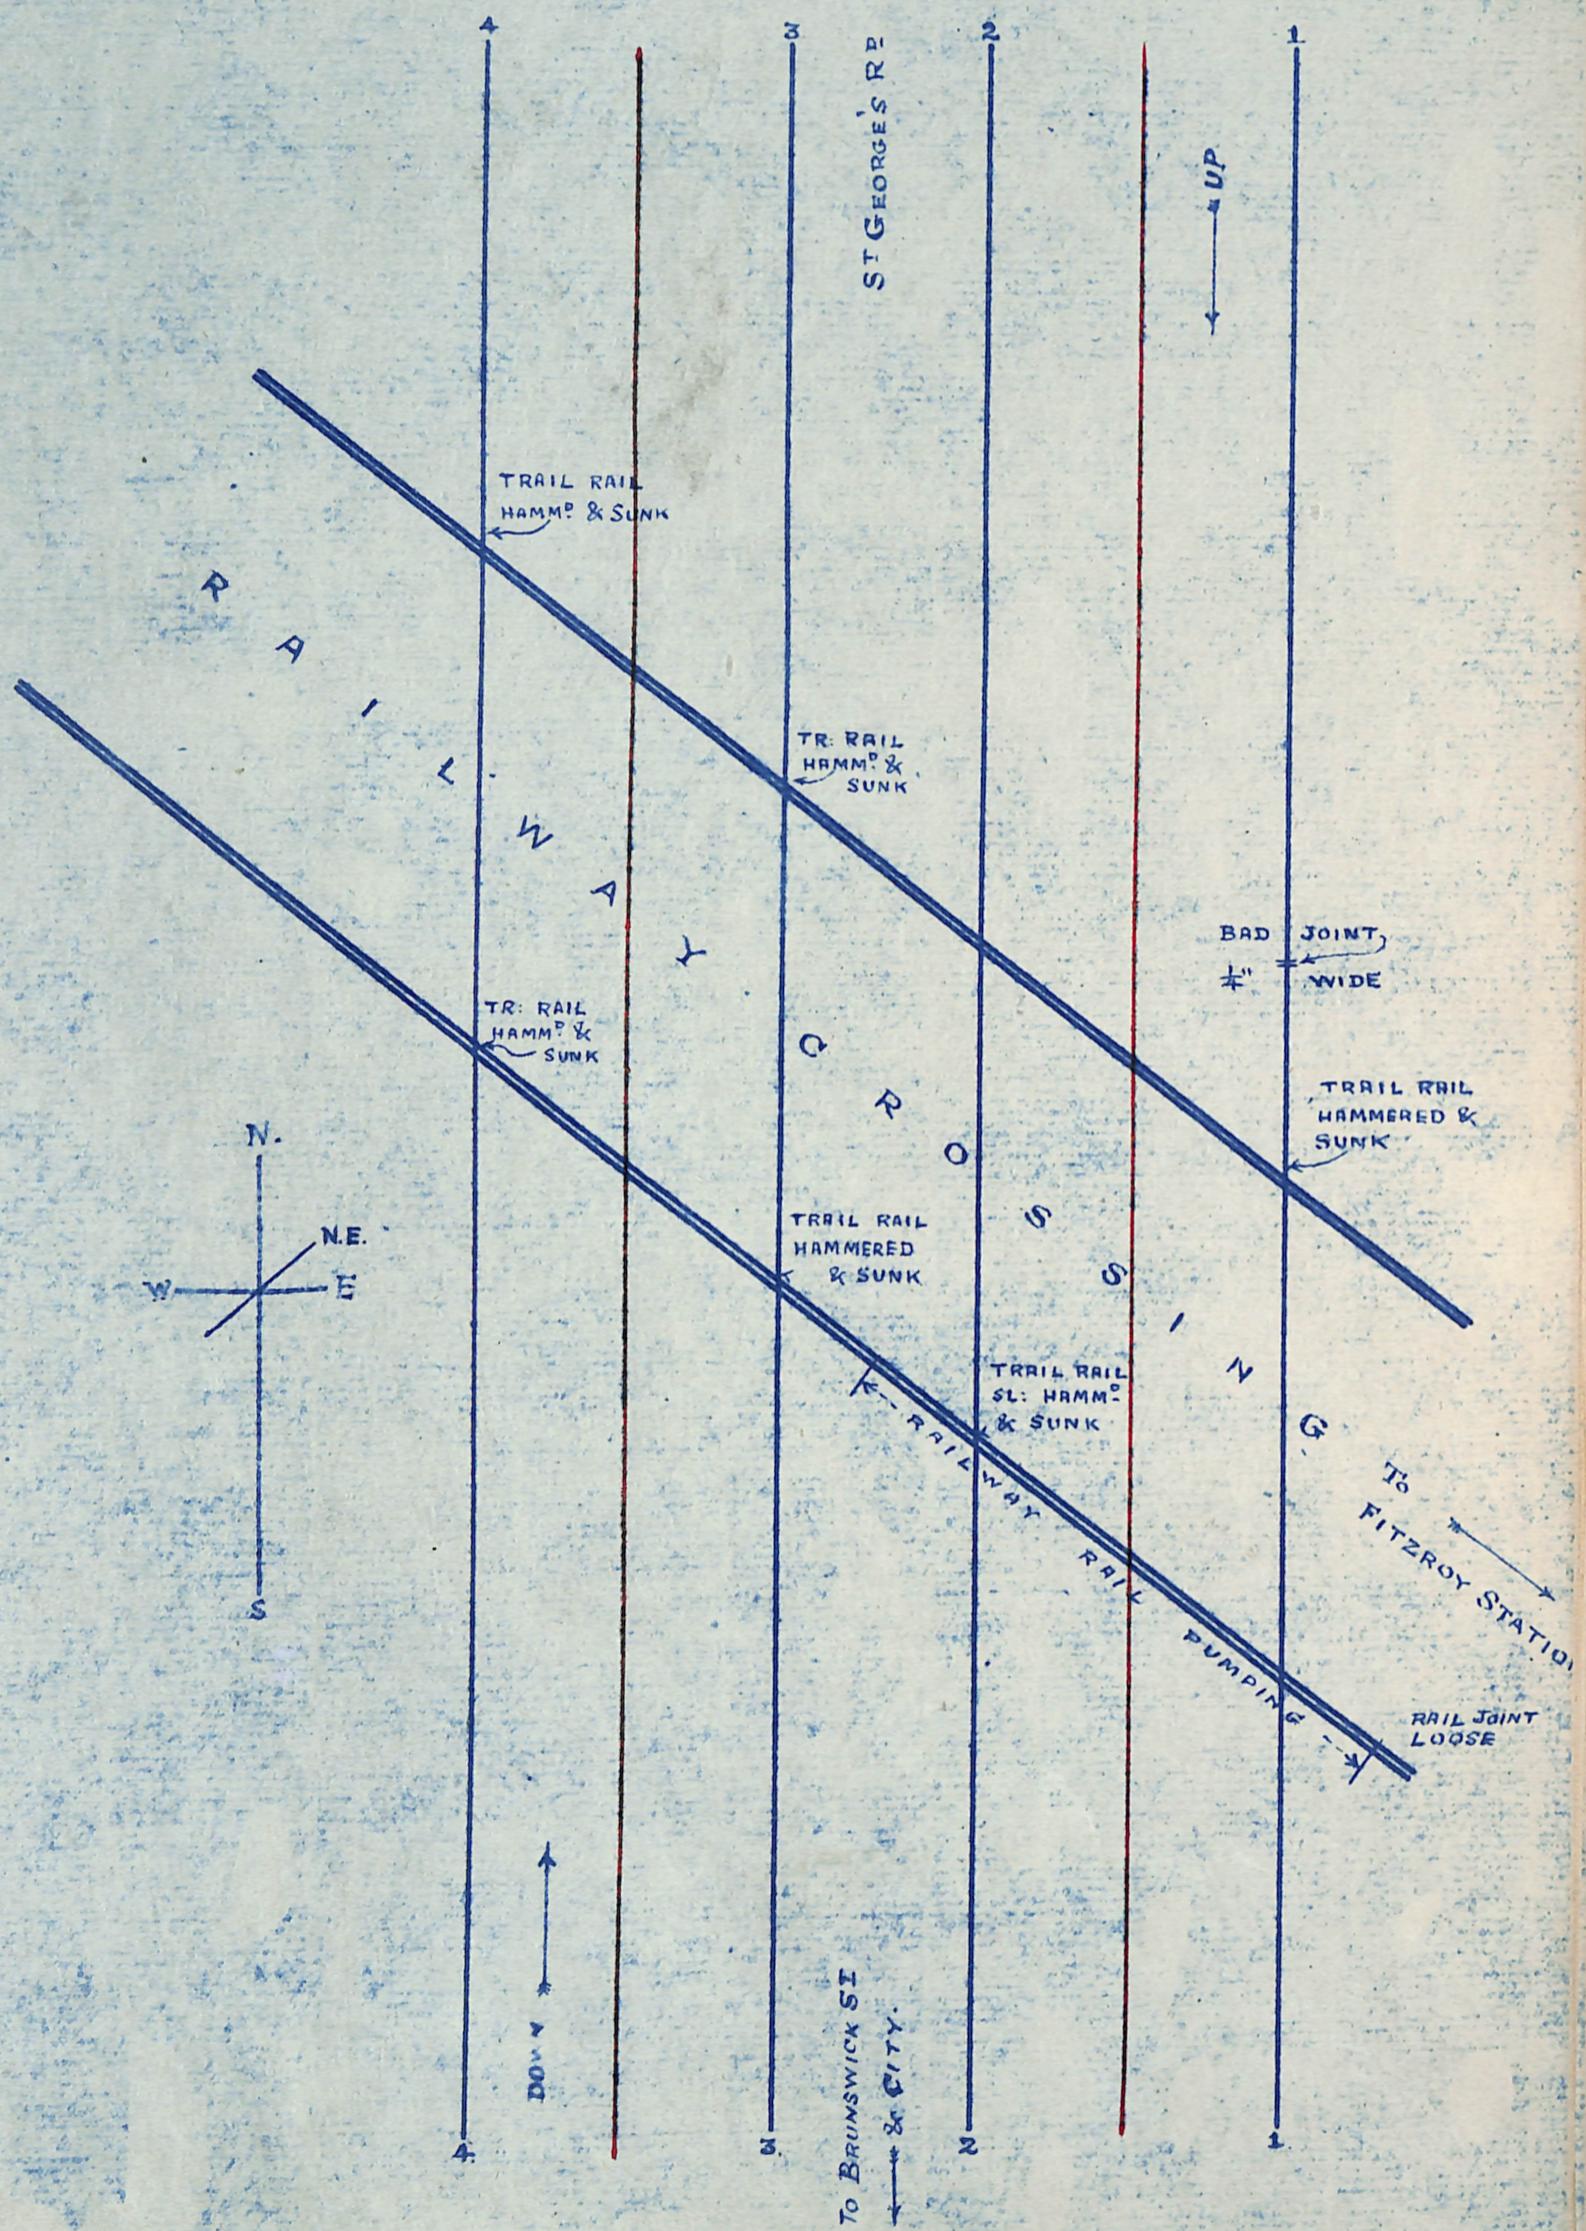
PLAN C.3.

1. Tram-rails at seven places near their intersections are not level with railway rails and railway guard rails, resulting in hammering and wear at intersections.  
Hamm'd & Sunk  
Fish-plates are presumably loose at several intersections.
2. There is a wide joint ( $1/4"$ ) on No. 1 Rail, on North East side of railway-crossing.
3. Length of Railway-rail (about 6'0") on South side of Tram track (between Nos. 1 and 3 rails) is loose in its chairs, causing excessive vibration, and loosening of adjacent paving.  
BAD JOINT  
WIDE  
TR. RAIL  
HAMMERED & SUNK
4. Paving blocks are loose, and tar surface shattered in places, presumably due to angle fishplates being loose.  
TRAIL RAIL  
SL. HAMM.  
& SUNK  
PAVING  
BLOCKS  
SHATTERED  
ANGLE  
FISHPLATES  
LOOSE  
TROY STATION  
RAIL JOINT  
LOSE

Fish-Plates loose at Several Intersections.

Paving loose in places.

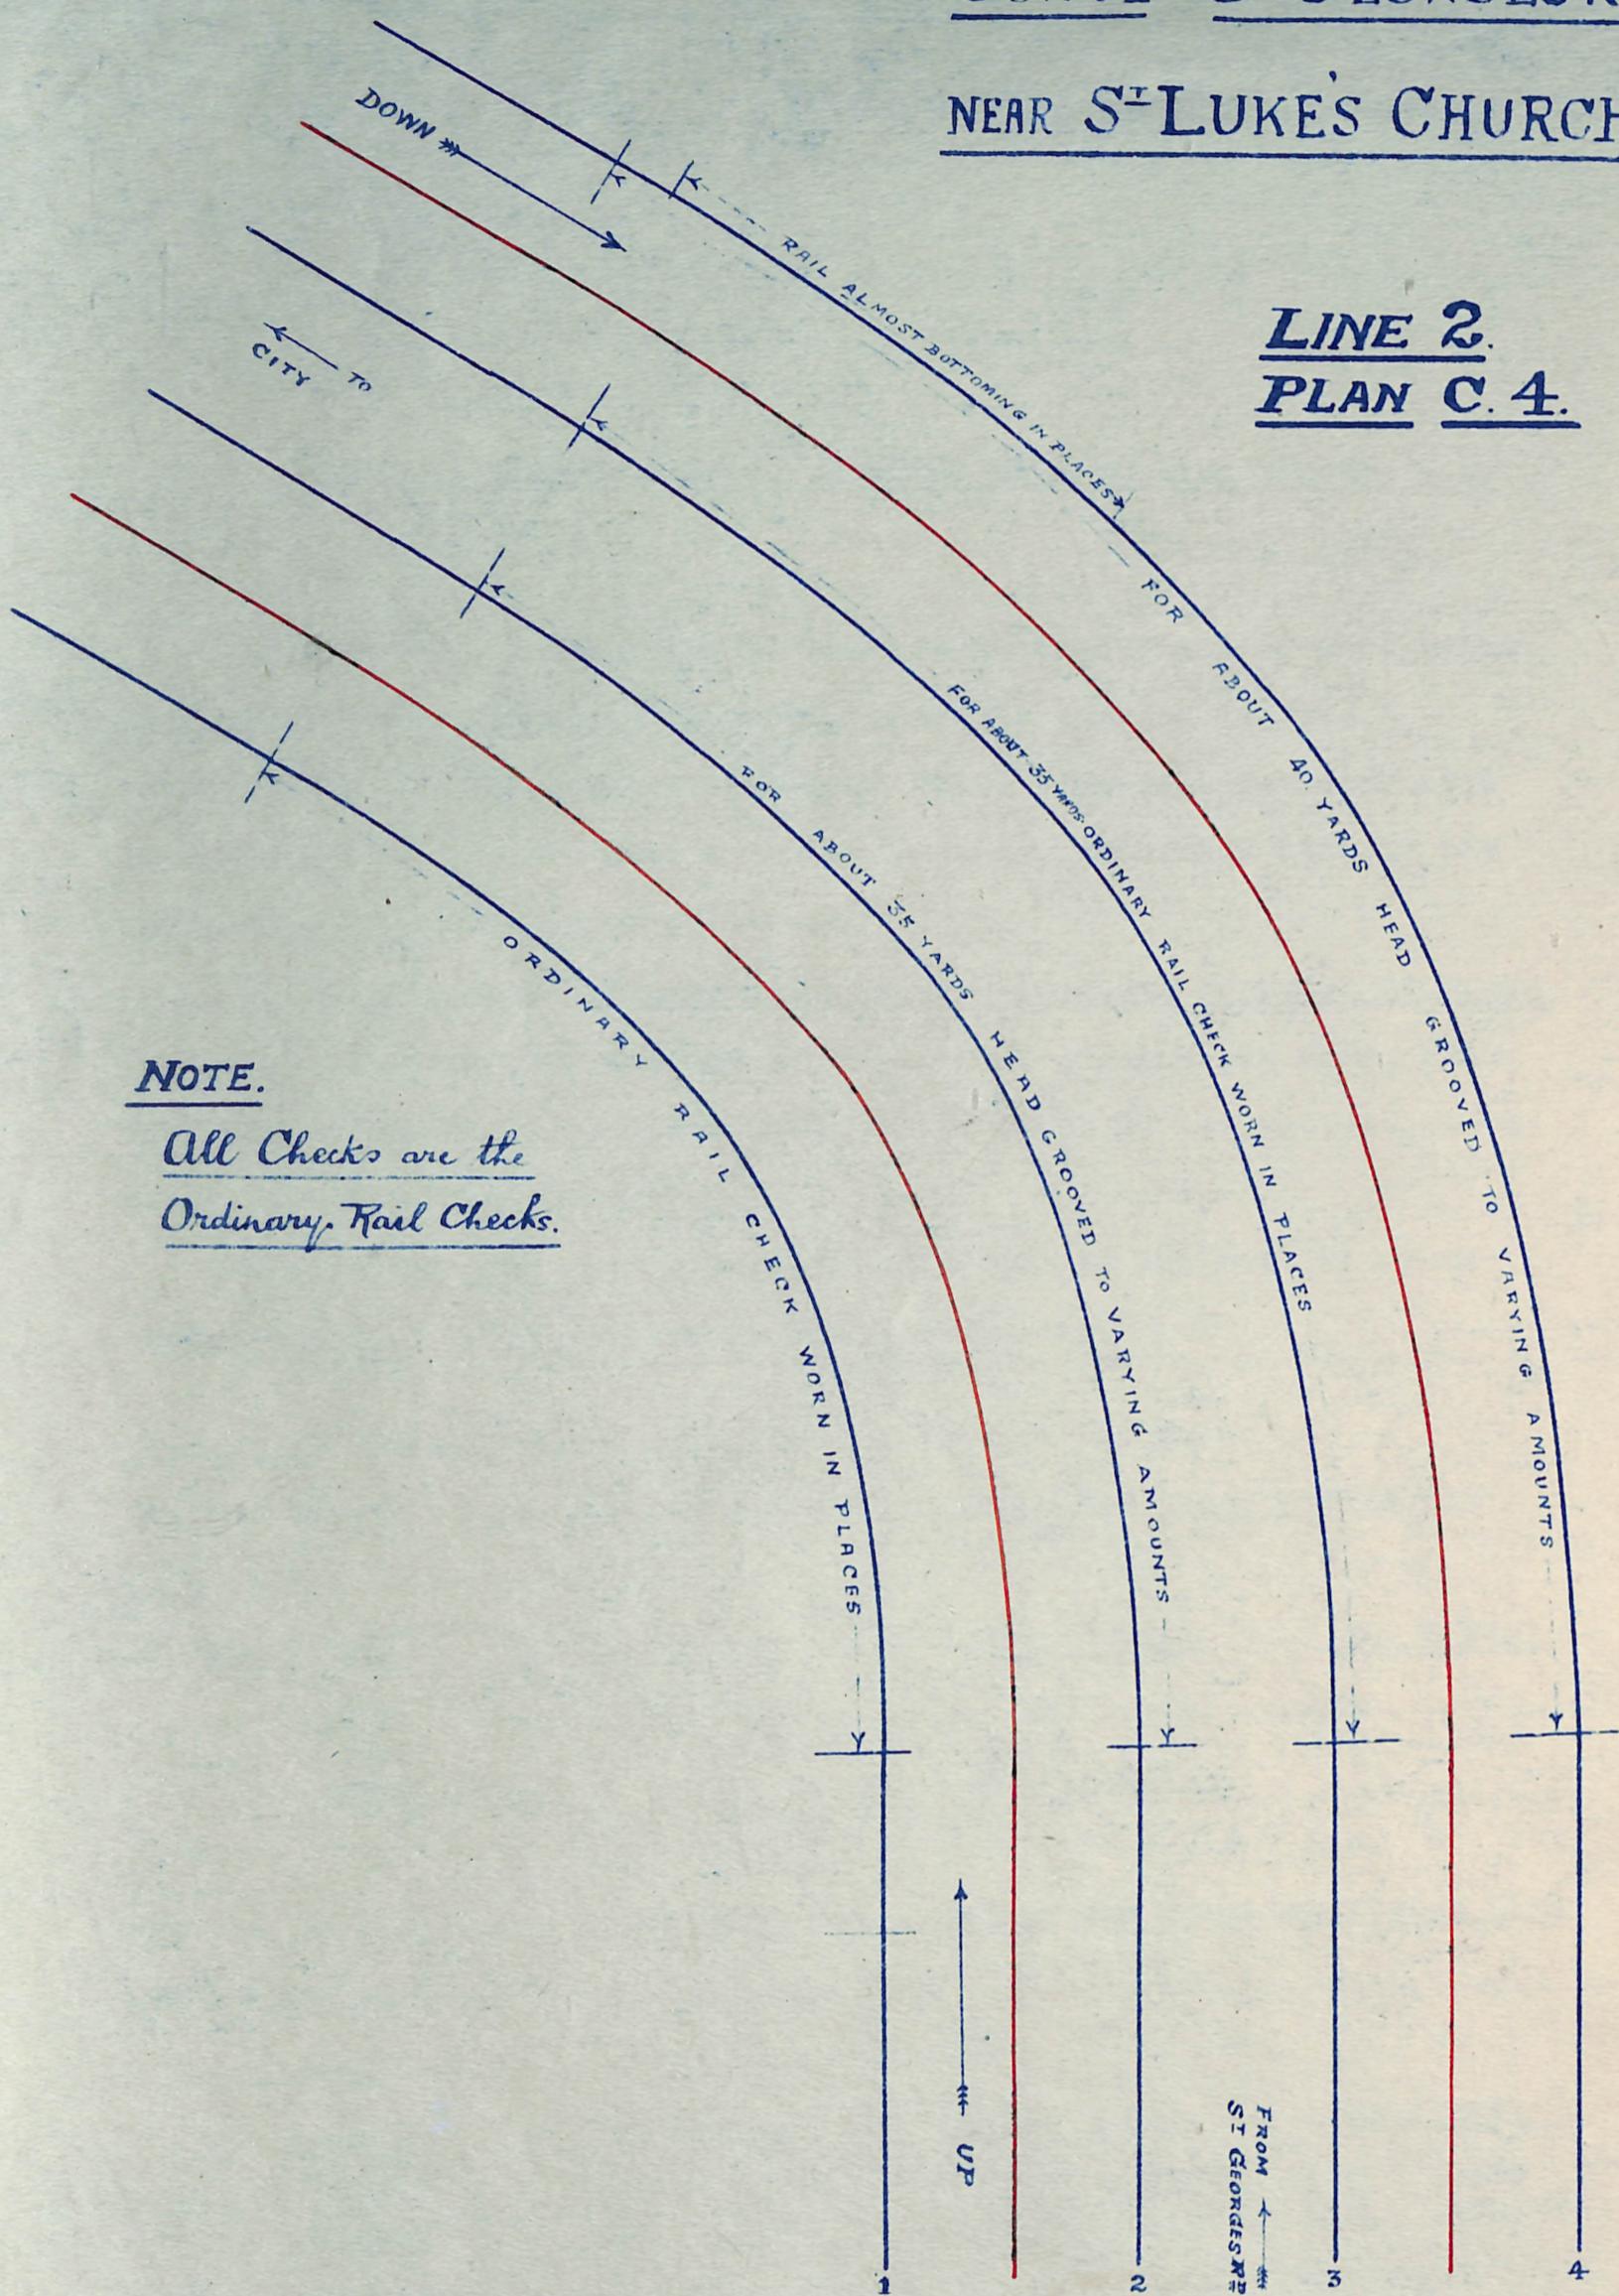
LINE 2.  
PLAN C. 4.

1. The Checks of Ordinary rails of Nos. 1 and 3 Rails, are worn, to varying amounts for a distance of about 35 yards.

The sides of heads of opposite rails (Nos. 2 and 4) are grooved to varying degrees, for a distance of about 40 yards, as a result of the above check-wear.

2. NOTE: No. 4 Rail is almost bottoming in several places.

All Checks are worn  
Length of Curve 130 feet.

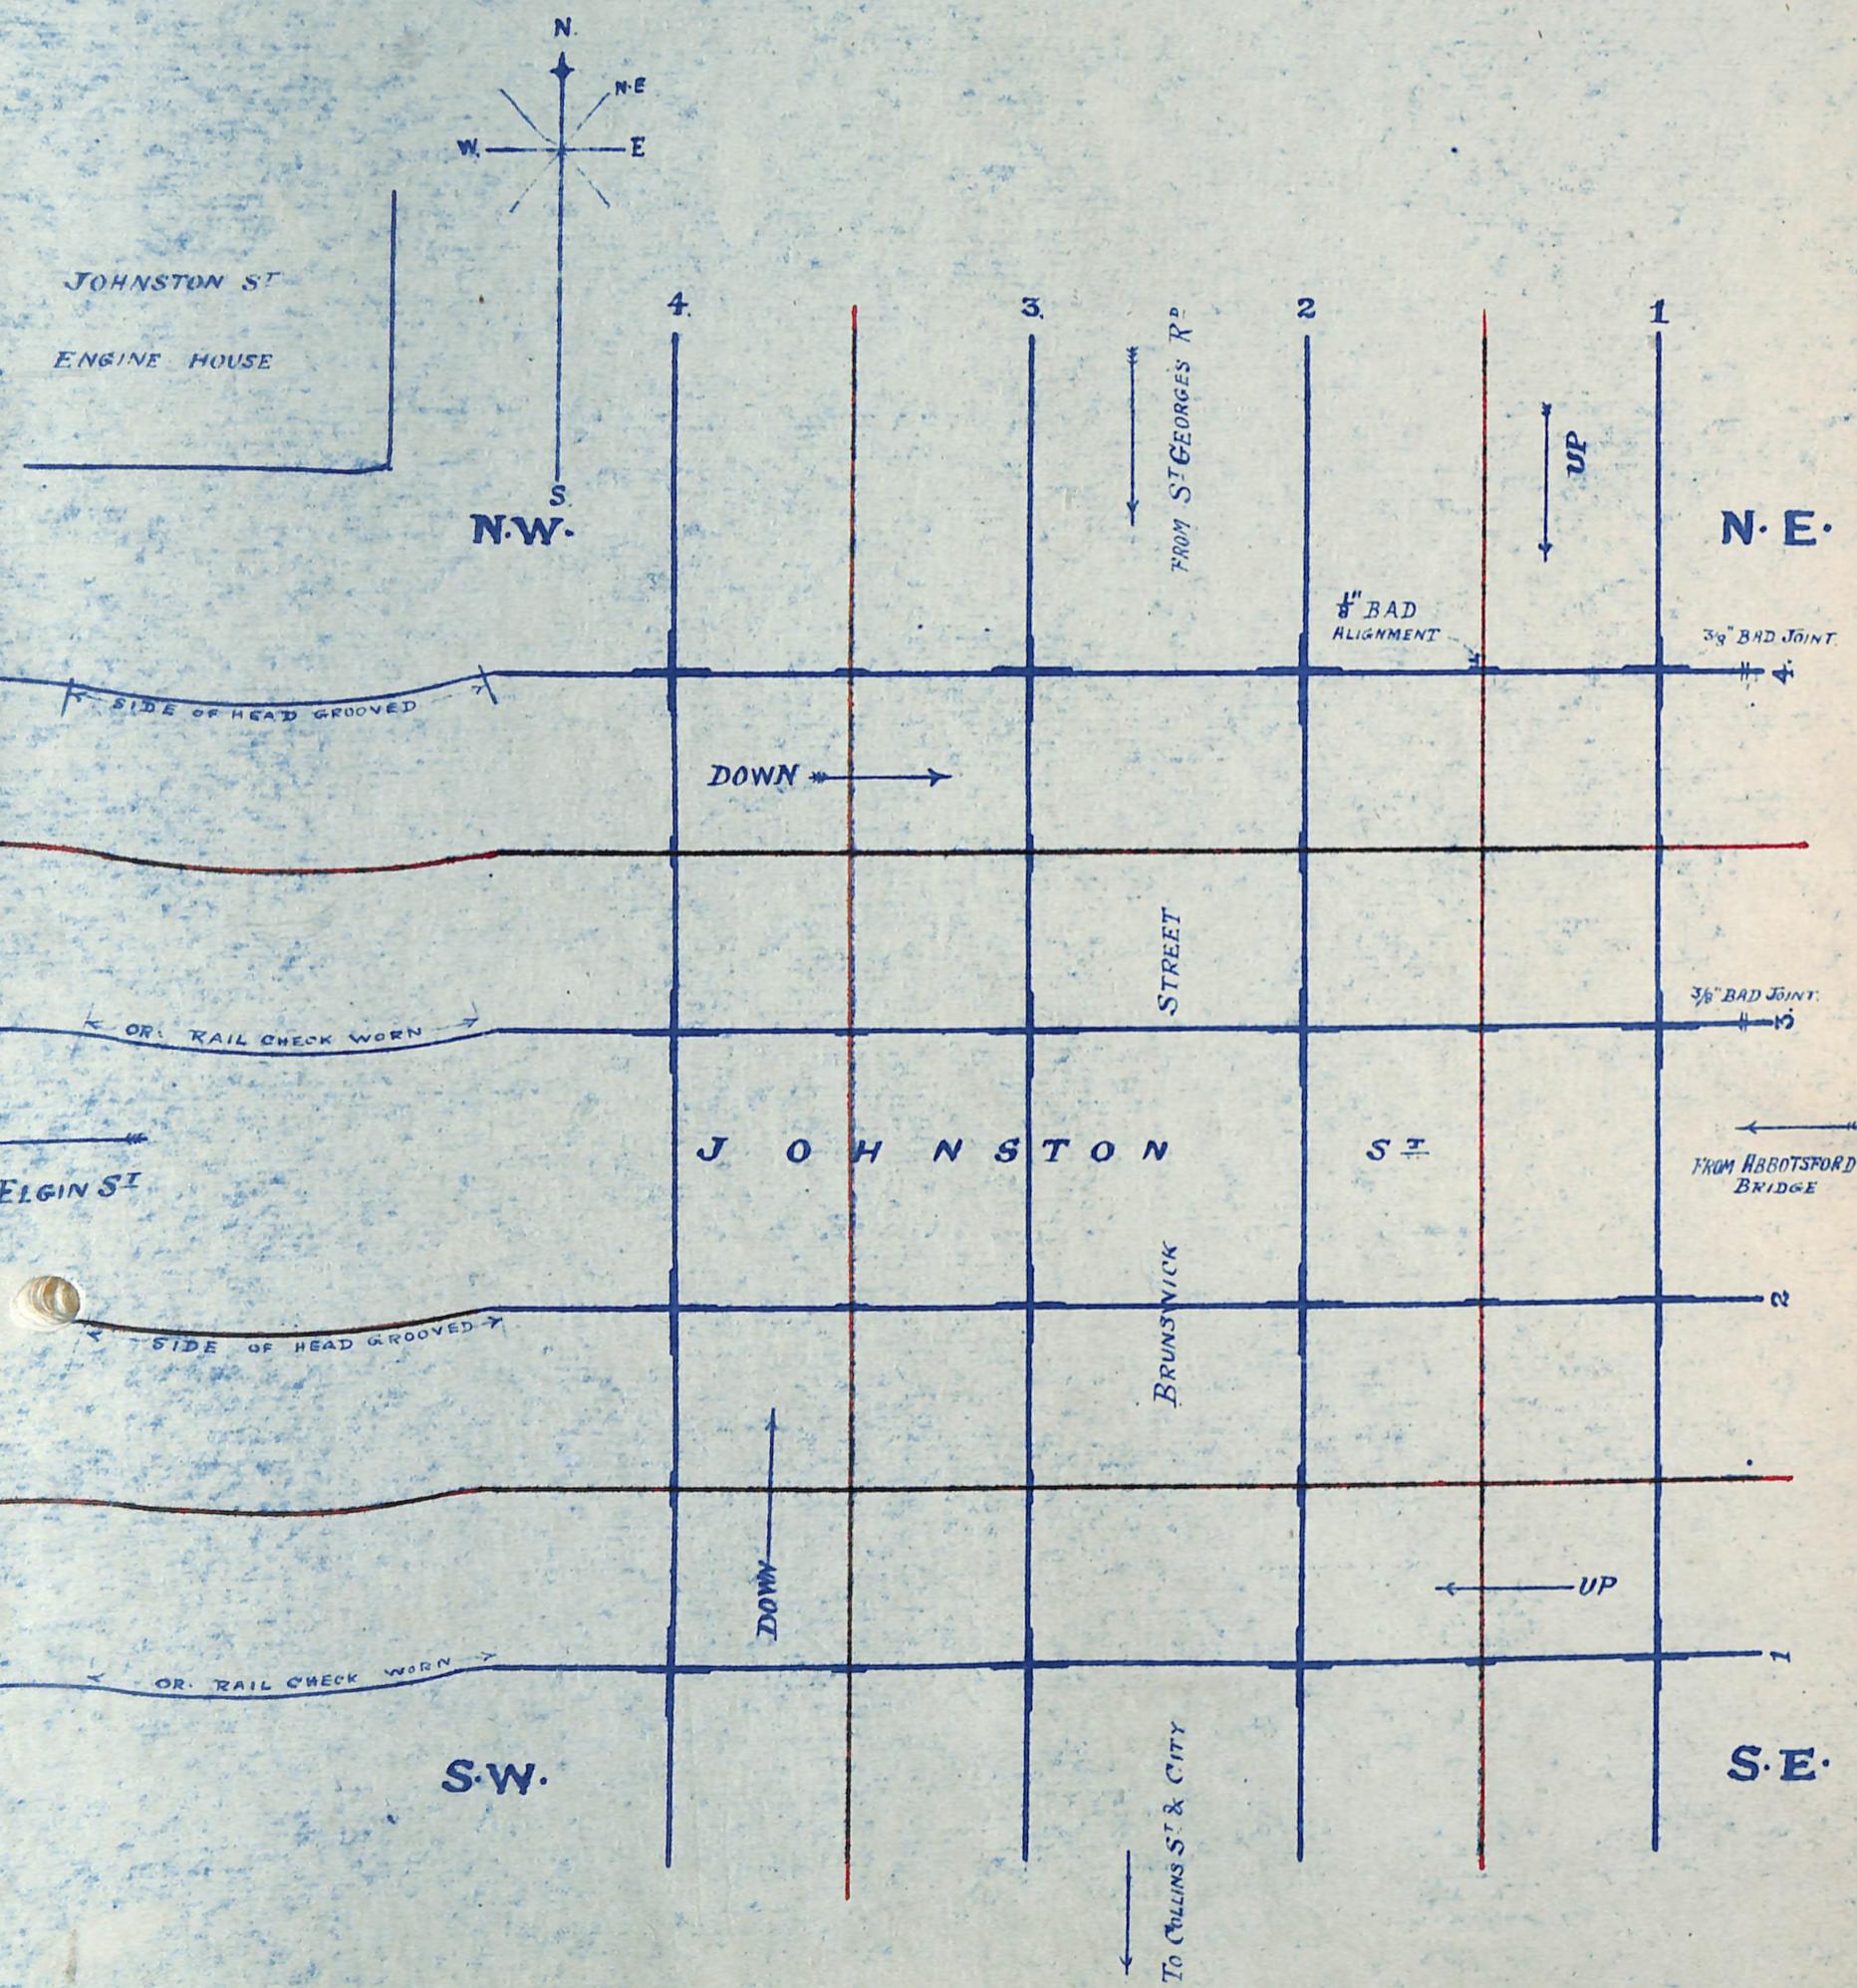
LINE 2.  
PLAN C.5.

- At Tram-rail intersections, also at intersections of Slot-rails with tram-rails, hammering is taking place to varying degrees.
- At the intersection of Tram-rail (No. 4 Down-rail Johnston St.) with Slot-rail (between Nos. 1 and 2 Up-rails, Brunswick Street) the Tram-rails are  $1/8"$  out of alignment.

- Slightly curved Rails on Main Track - Opposite Johnston St. Power Station. Ordinary Rail-checks of Nos. 1 and 3 rails are worn, and the sides of heads of opposite rails (Nos. 2 and 4) are grooved, as a result of the above check-wear.

- Two of the Joints of tram-rails adjacent to the rail intersections, are each  $3/8"$  wide and both are hammered.
