# CURVE VICTORIA STREET.

OPPOSITE HEUGLE'S SHOP (NEAR HODDLE ST.)

LINE 2.

LINE 2. PLAN B6.

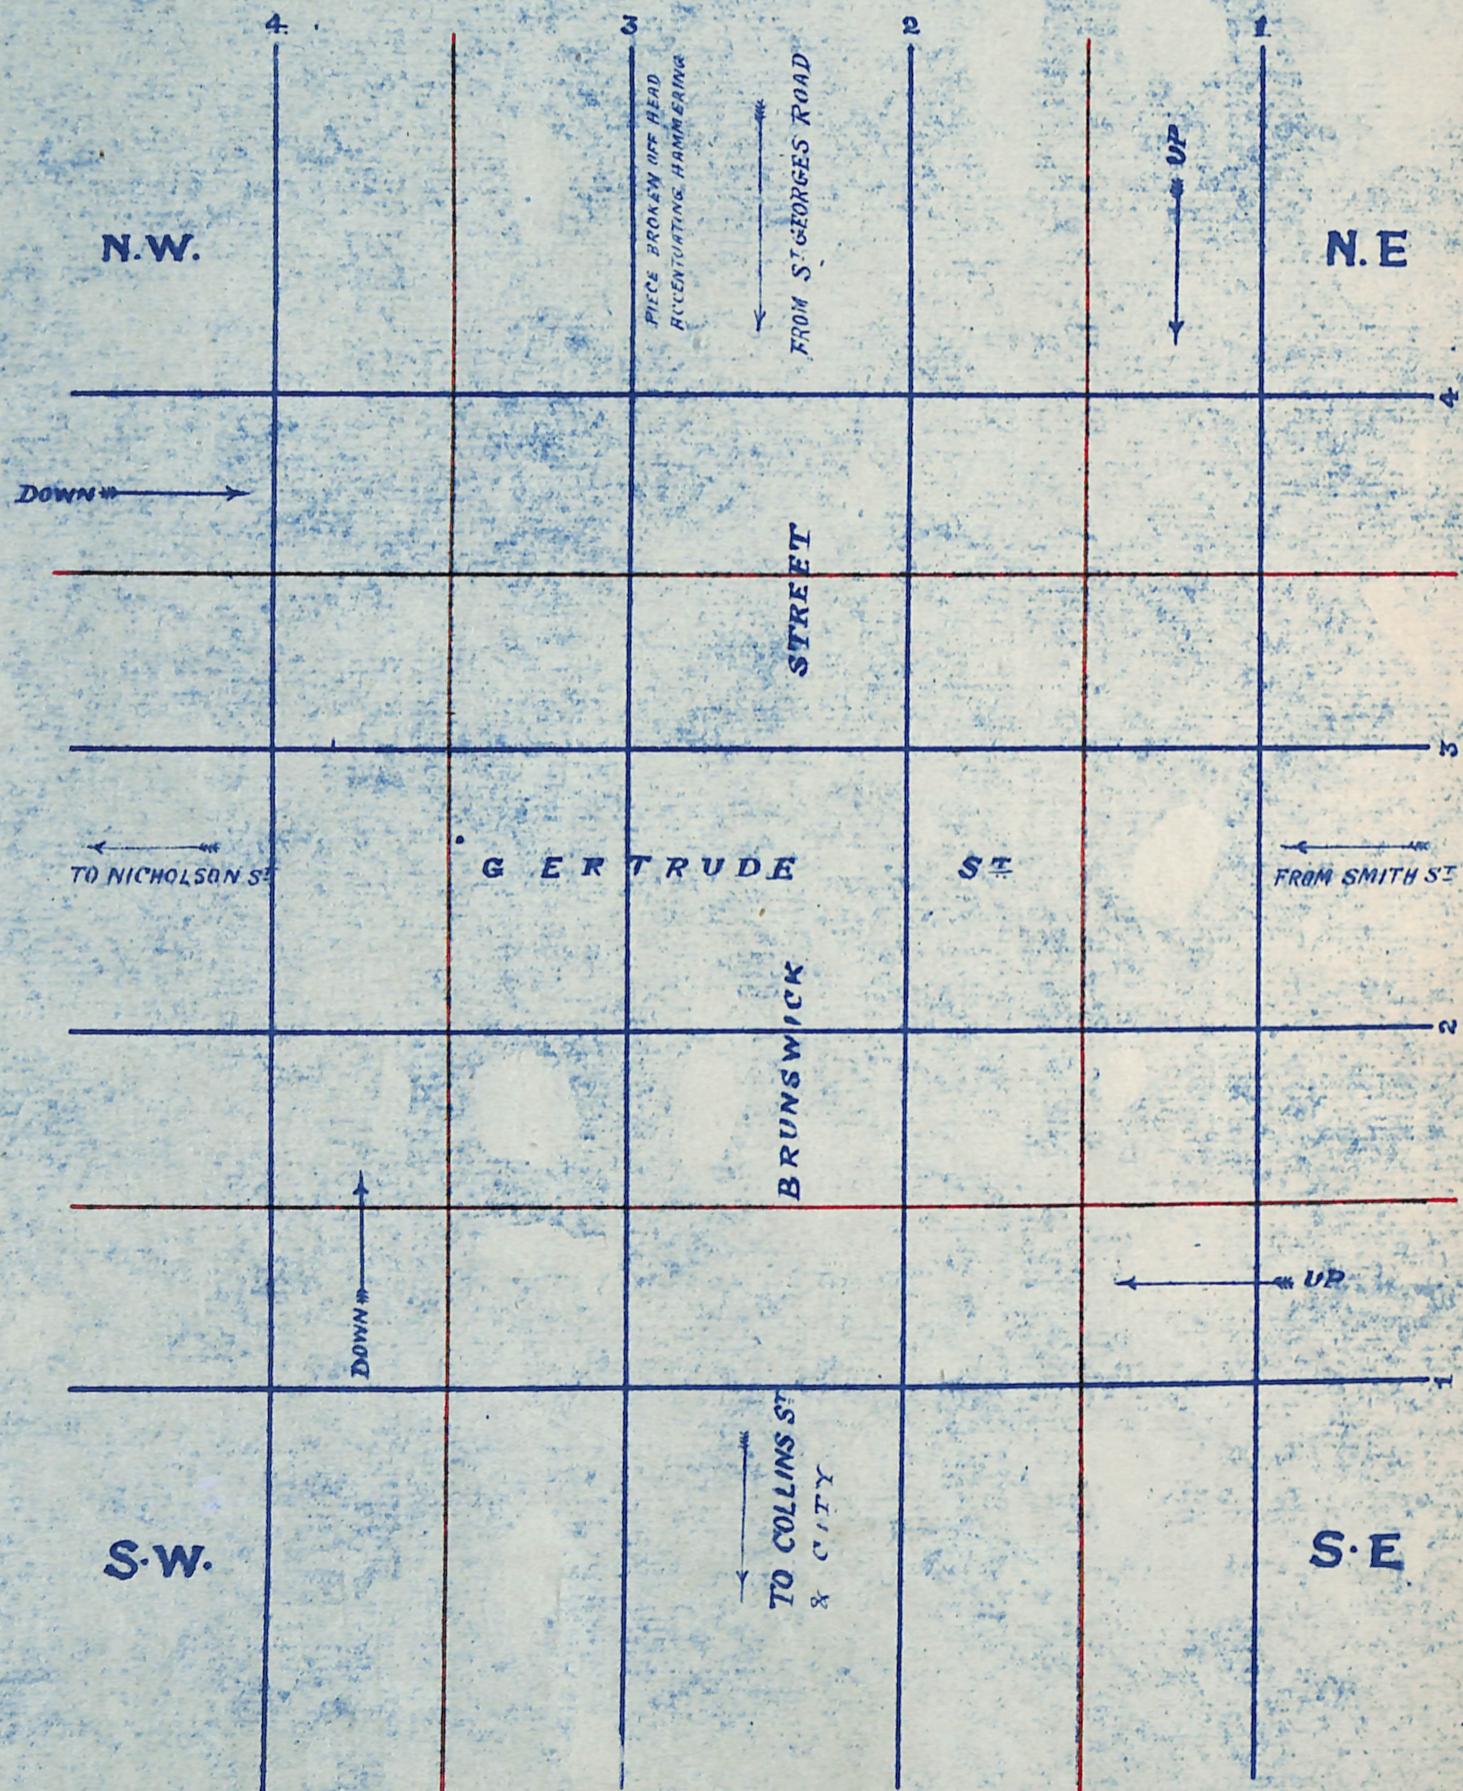
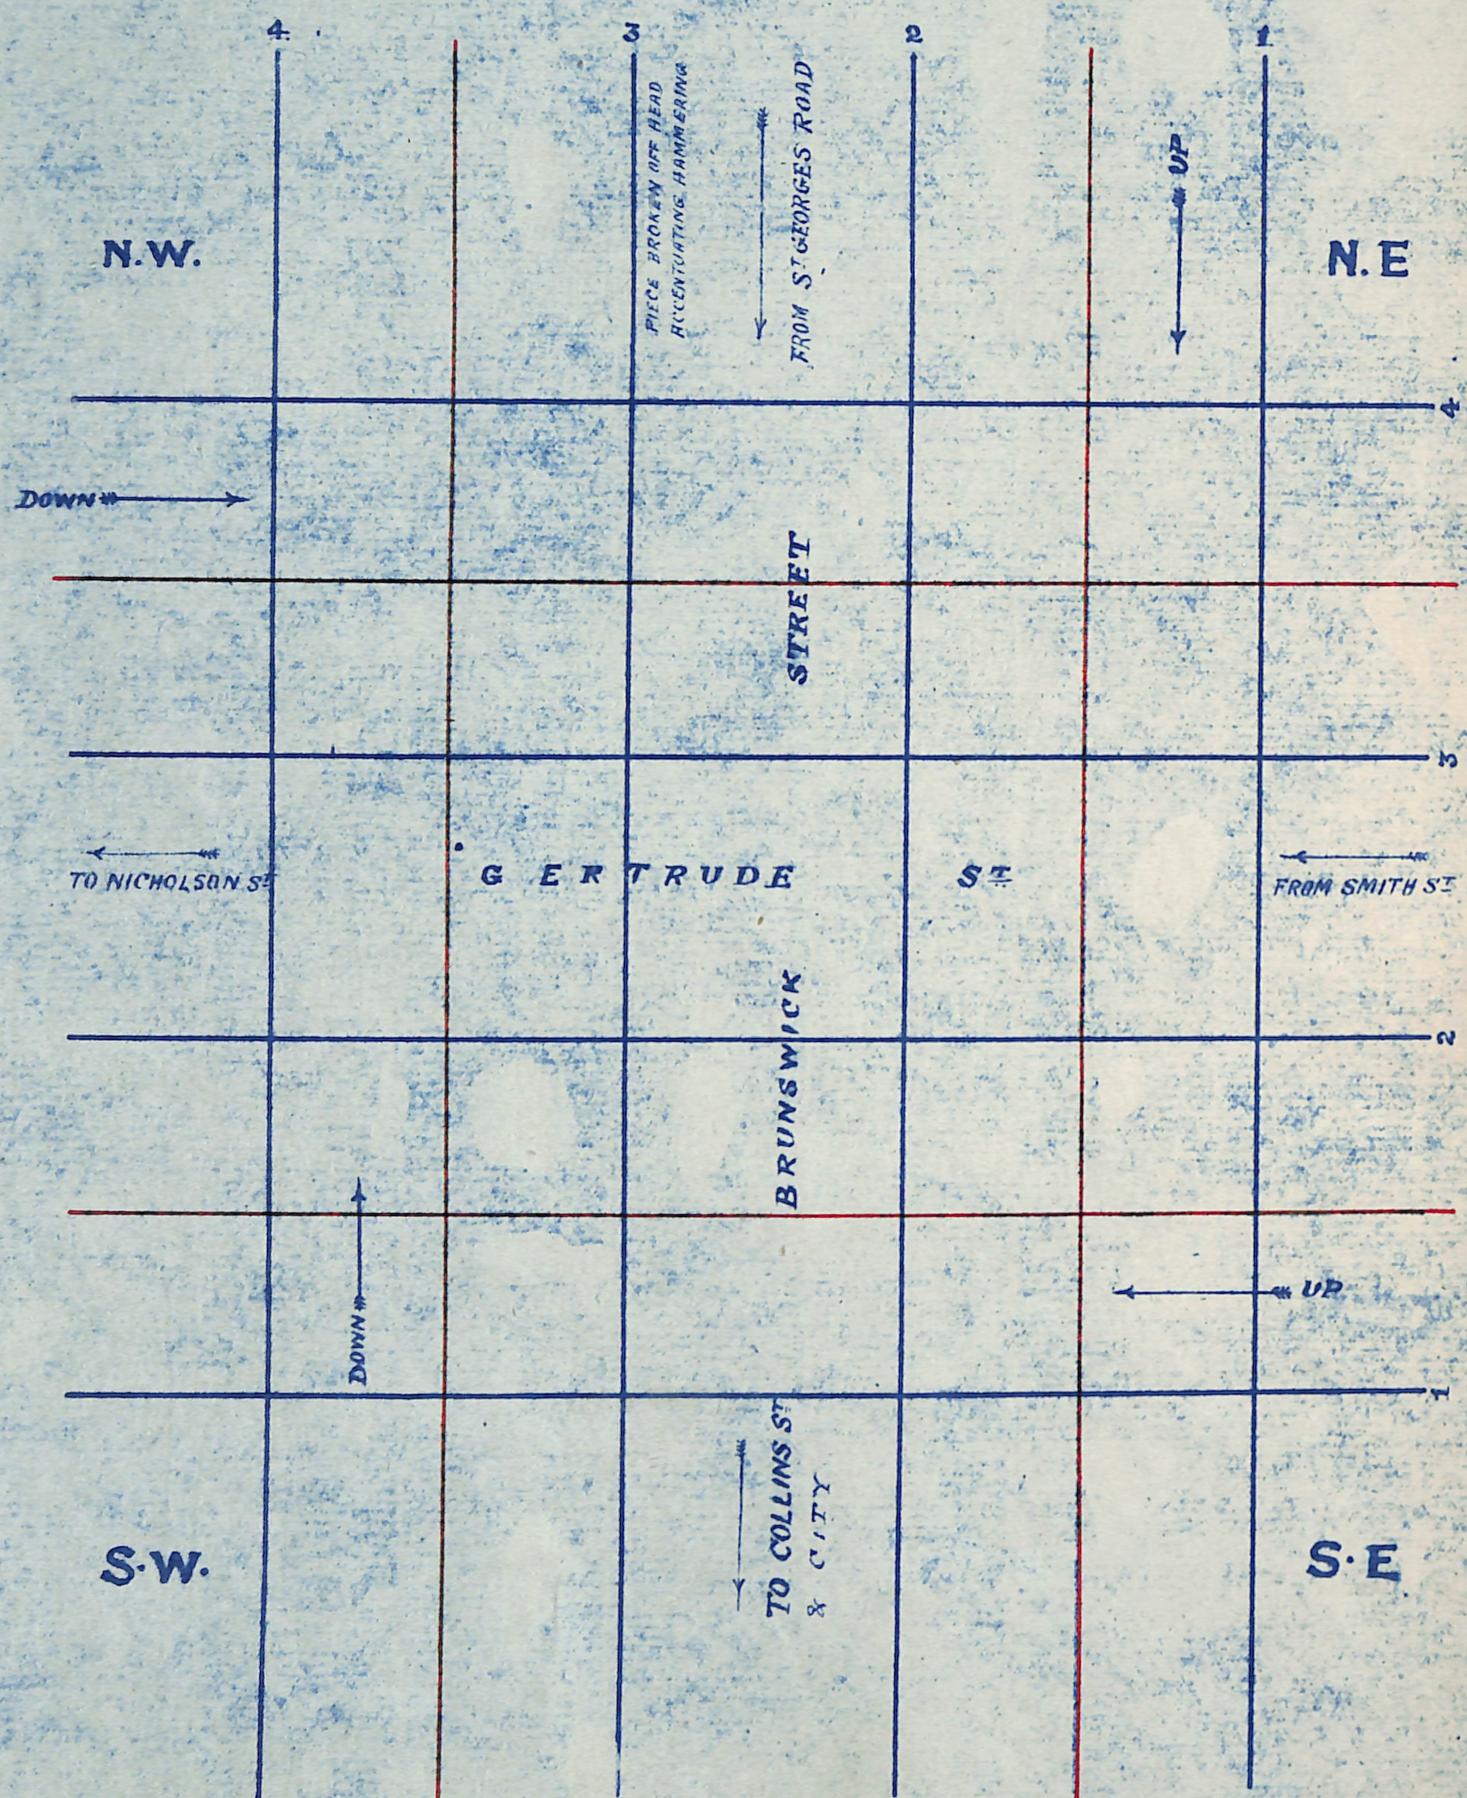
LINE 2.  
PLAN C.6.

1. There is considerable wear on the Tram-rails at the intersections resulting in excessive hammering.

At the intersections of Tram-rails with Slot-rails, hammering is taking place, to varying degrees.

2. No. 3 Rail Brunswick St. Track. There is a piece broken off head of rail which accentuates hammering.

3. There is hammering of some of the joints of Tram-rails adjacent to the rail-intersections to varying amounts. N.E

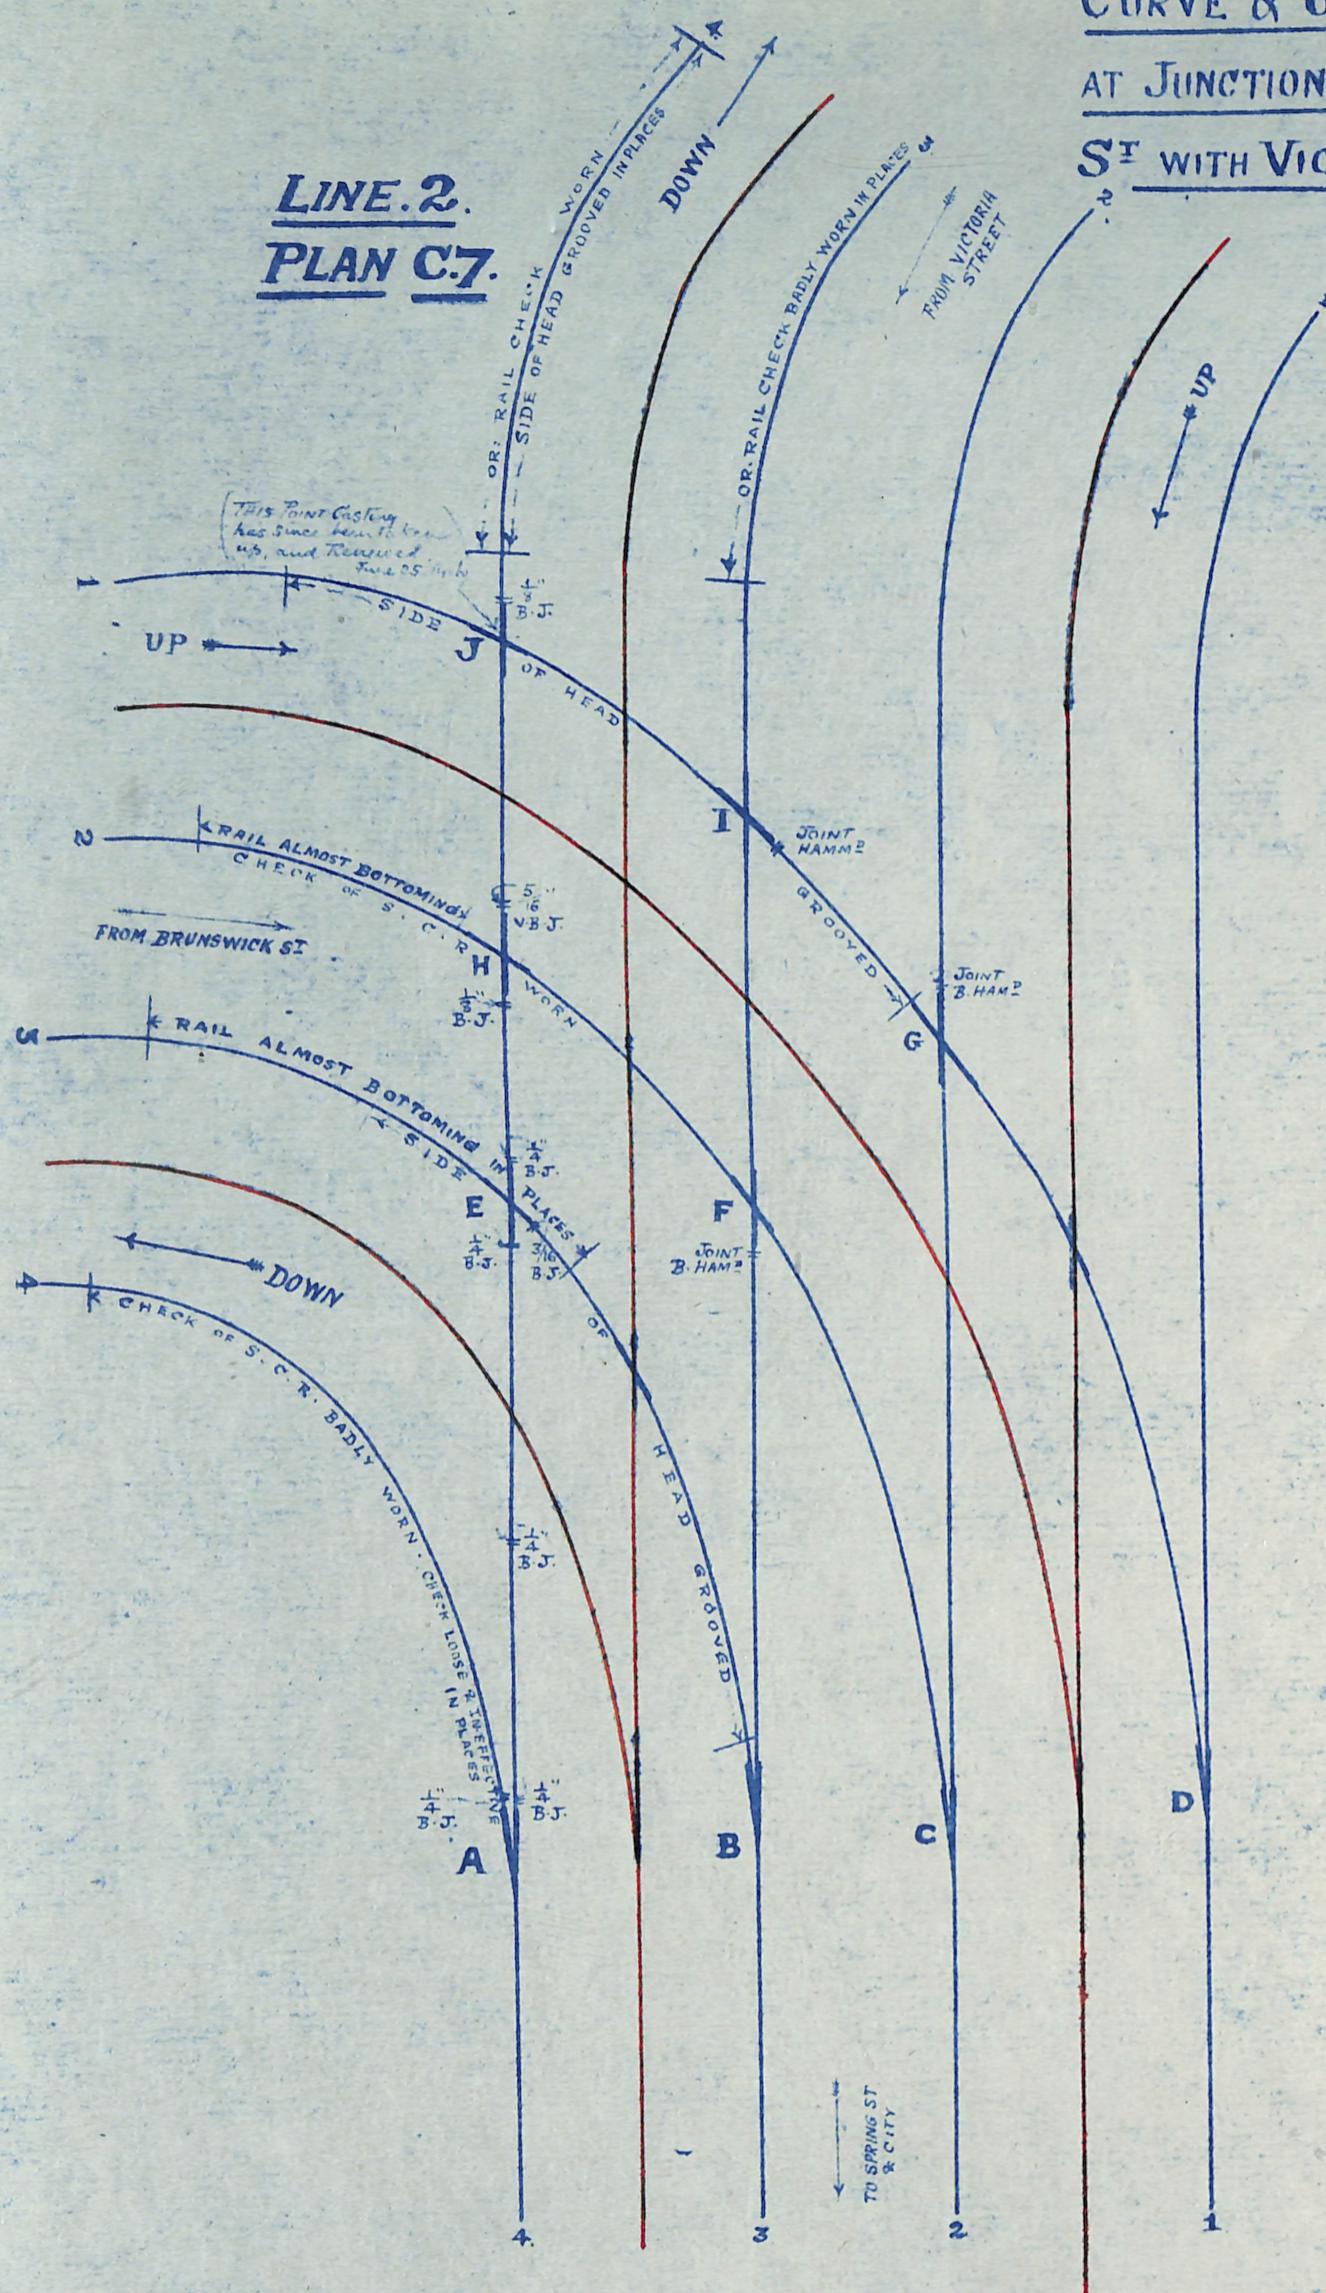
## LINE. 2. PLAN C.7.

1. The Checks of Special check-rails (Nos. 2 and 4 Rails Brunswick Street) are worn, and in places badly so, and No. 2 rail (opposite Letter Pillar Box) is almost bottoming, also No. 3 in places. The check-rail of No. 4 Rail is loose, and in many places ineffective. The sides of heads of opposite rails (Nos. 1 and 3) are grooved, as a result of the above check-wear.
2. Two of the heels of points are of loose fit and rocking. Tongues are worn to varying amounts. The Tread of one of the point-castings is diagonally grooved.
3. At the crossing intersections, also at intersections of slot-rails with tram-rails, hammering is taking place to varying degrees.
4. Nine of the joints of tram-rails, adjacent to rail-crossings and Points are wide (varying from  $1/8"$  to  $5/16"$ ) and, in several cases, hammered. There is also hammering of some of the other joints to varying degrees.

A. Lipped Heel Rocking. Tongue Worm

B. Ordinary Heel Rocking. Tongue Worm. Diagonal shooting on head of Point-Casting.

C. Rocking Rocking Tongue Worm

D. Rocking Rocking Tongue Worm

E. Hammering at Intersections.

NOTE Since the above Junction was first inspected and particulars noted, the old Point-Casting at intersection of No. 4 Rail Victoria Parade, and No. 1 Rail Brunswick Street, has been taken up and removed, and a new Point-Casting fixed in lieu of same, on June 25th. 1916.
