LINE 3.

# SHUNTS AT TERMINUS SYDNEY ROAD

SHUNTS (2) AT TERMINUS - SYDNEY ROAD

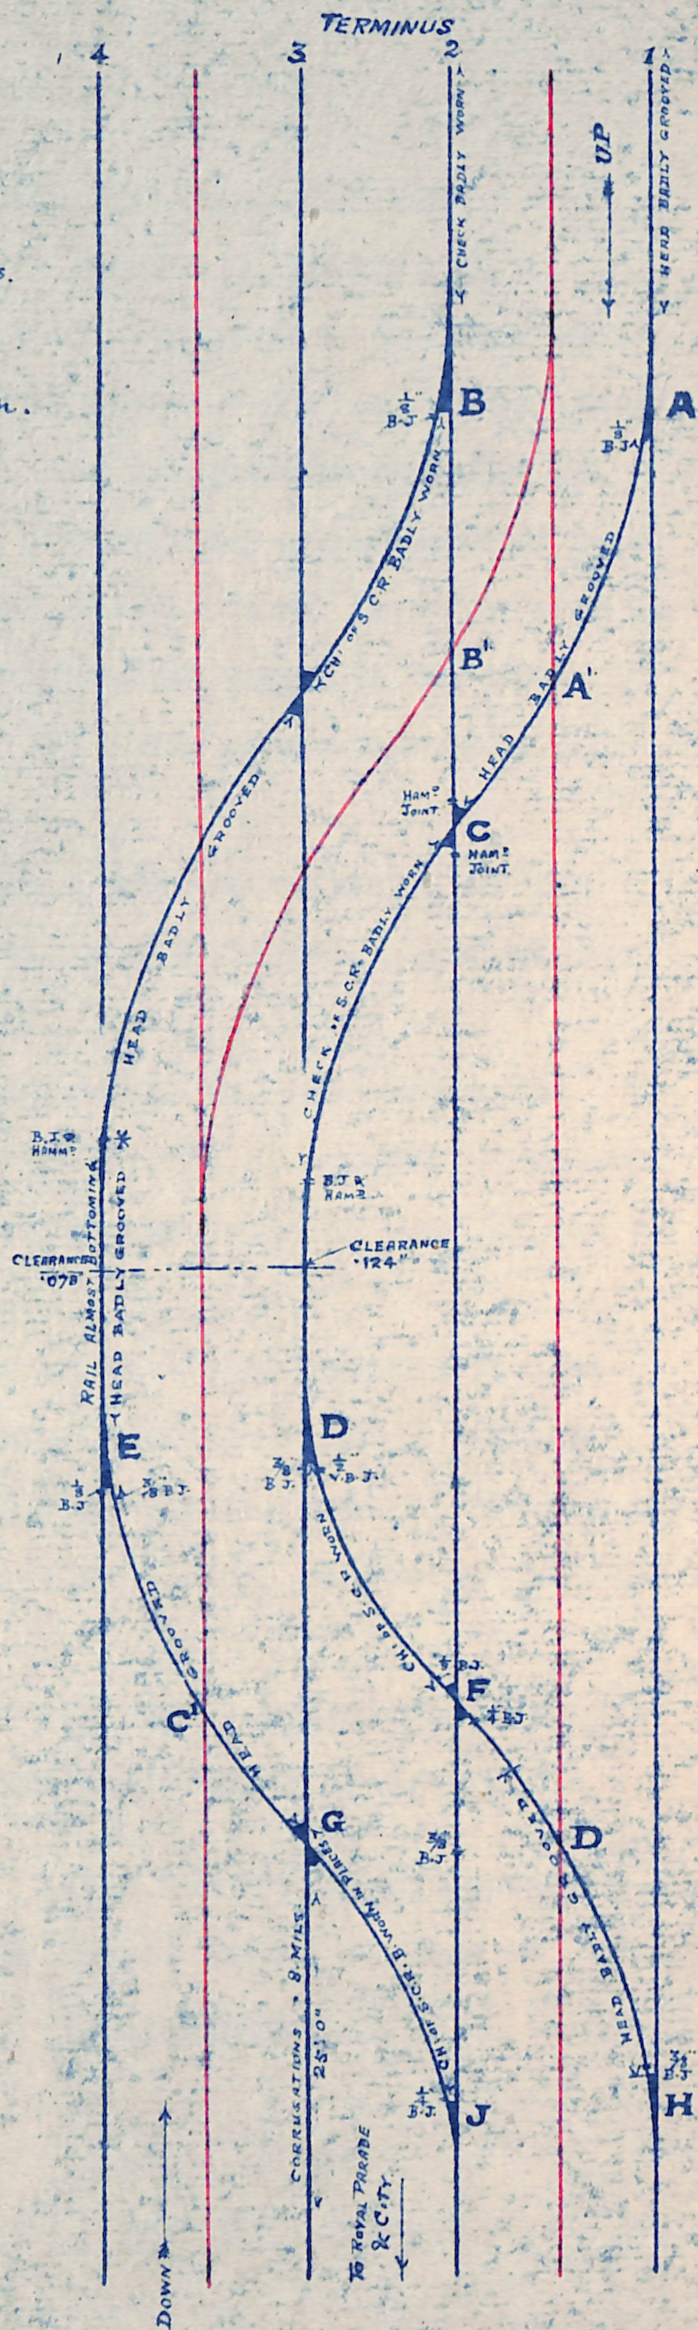
1. The Checks of Special Check Rails to the four Inner Curve Rails of Dummy and Trailer Shunts are worn to varying amounts, and in places, badly so. The sides of heads to the four Outer Curve Rails of Dummy and Trailer Shunts are grooved, and badly so in places, as a result of the above check-wear.

2. Nos. 1 and 2 Rails (Up Track). The side of head of No. 1 rail between Point of Shunt and Terminus is badly grooved, as a result of the check of opposite rail (No. 2) being badly worn.

3. Four of the heels of the 6 Points are of loose fit and rocking. There is also diagonal wear on tread of one of the Point-Castings. Tongues are worn to varying degrees.

4. At the Crossing intersections, also at intersections of slot-rails with Tram rails, hammering is taking place to varying amounts.
5. 13 of the Joints of Tram-rails, adjacent to rail crossings and Points, are wide, (varying from  $1/8"$  to  $3/8"$ ) and in many cases are hammered. There are other joints where hammering is taking place, and fishplates are presumably loose.

6. Paving Blocks, at several places, are loose, and tarred surface shattered.
7. NO. 3 RAIL (DOWN TRACK). A length of Tram-rail (about 25 ft) has slight corrugations up to 8 Mils.

8. NO. 4 RAIL has side of head badly grooved, and rail is almost bottoming.

- A. Heel Rocking. Tongue Worn.
- B. Heel Rocking. Tongue Badly Worn.
- C. Very Bad Hammering at Rail Intersections.
- D. Lipped Heel F. Good Fit. Tongue Worn.
- E. Ordinary Heel F. Good Fit. Tongue Worn.
- F. Bad Hammering at Intersection
- G. Bad Hammering D: D:
- H. Heel Rocking. Tongue Worn.
- J. D: D: Diagonal Wear on  
Tread of Point-Casting.

### A' Bad Hammering at Intersections.

## D' Hammering at Intersections

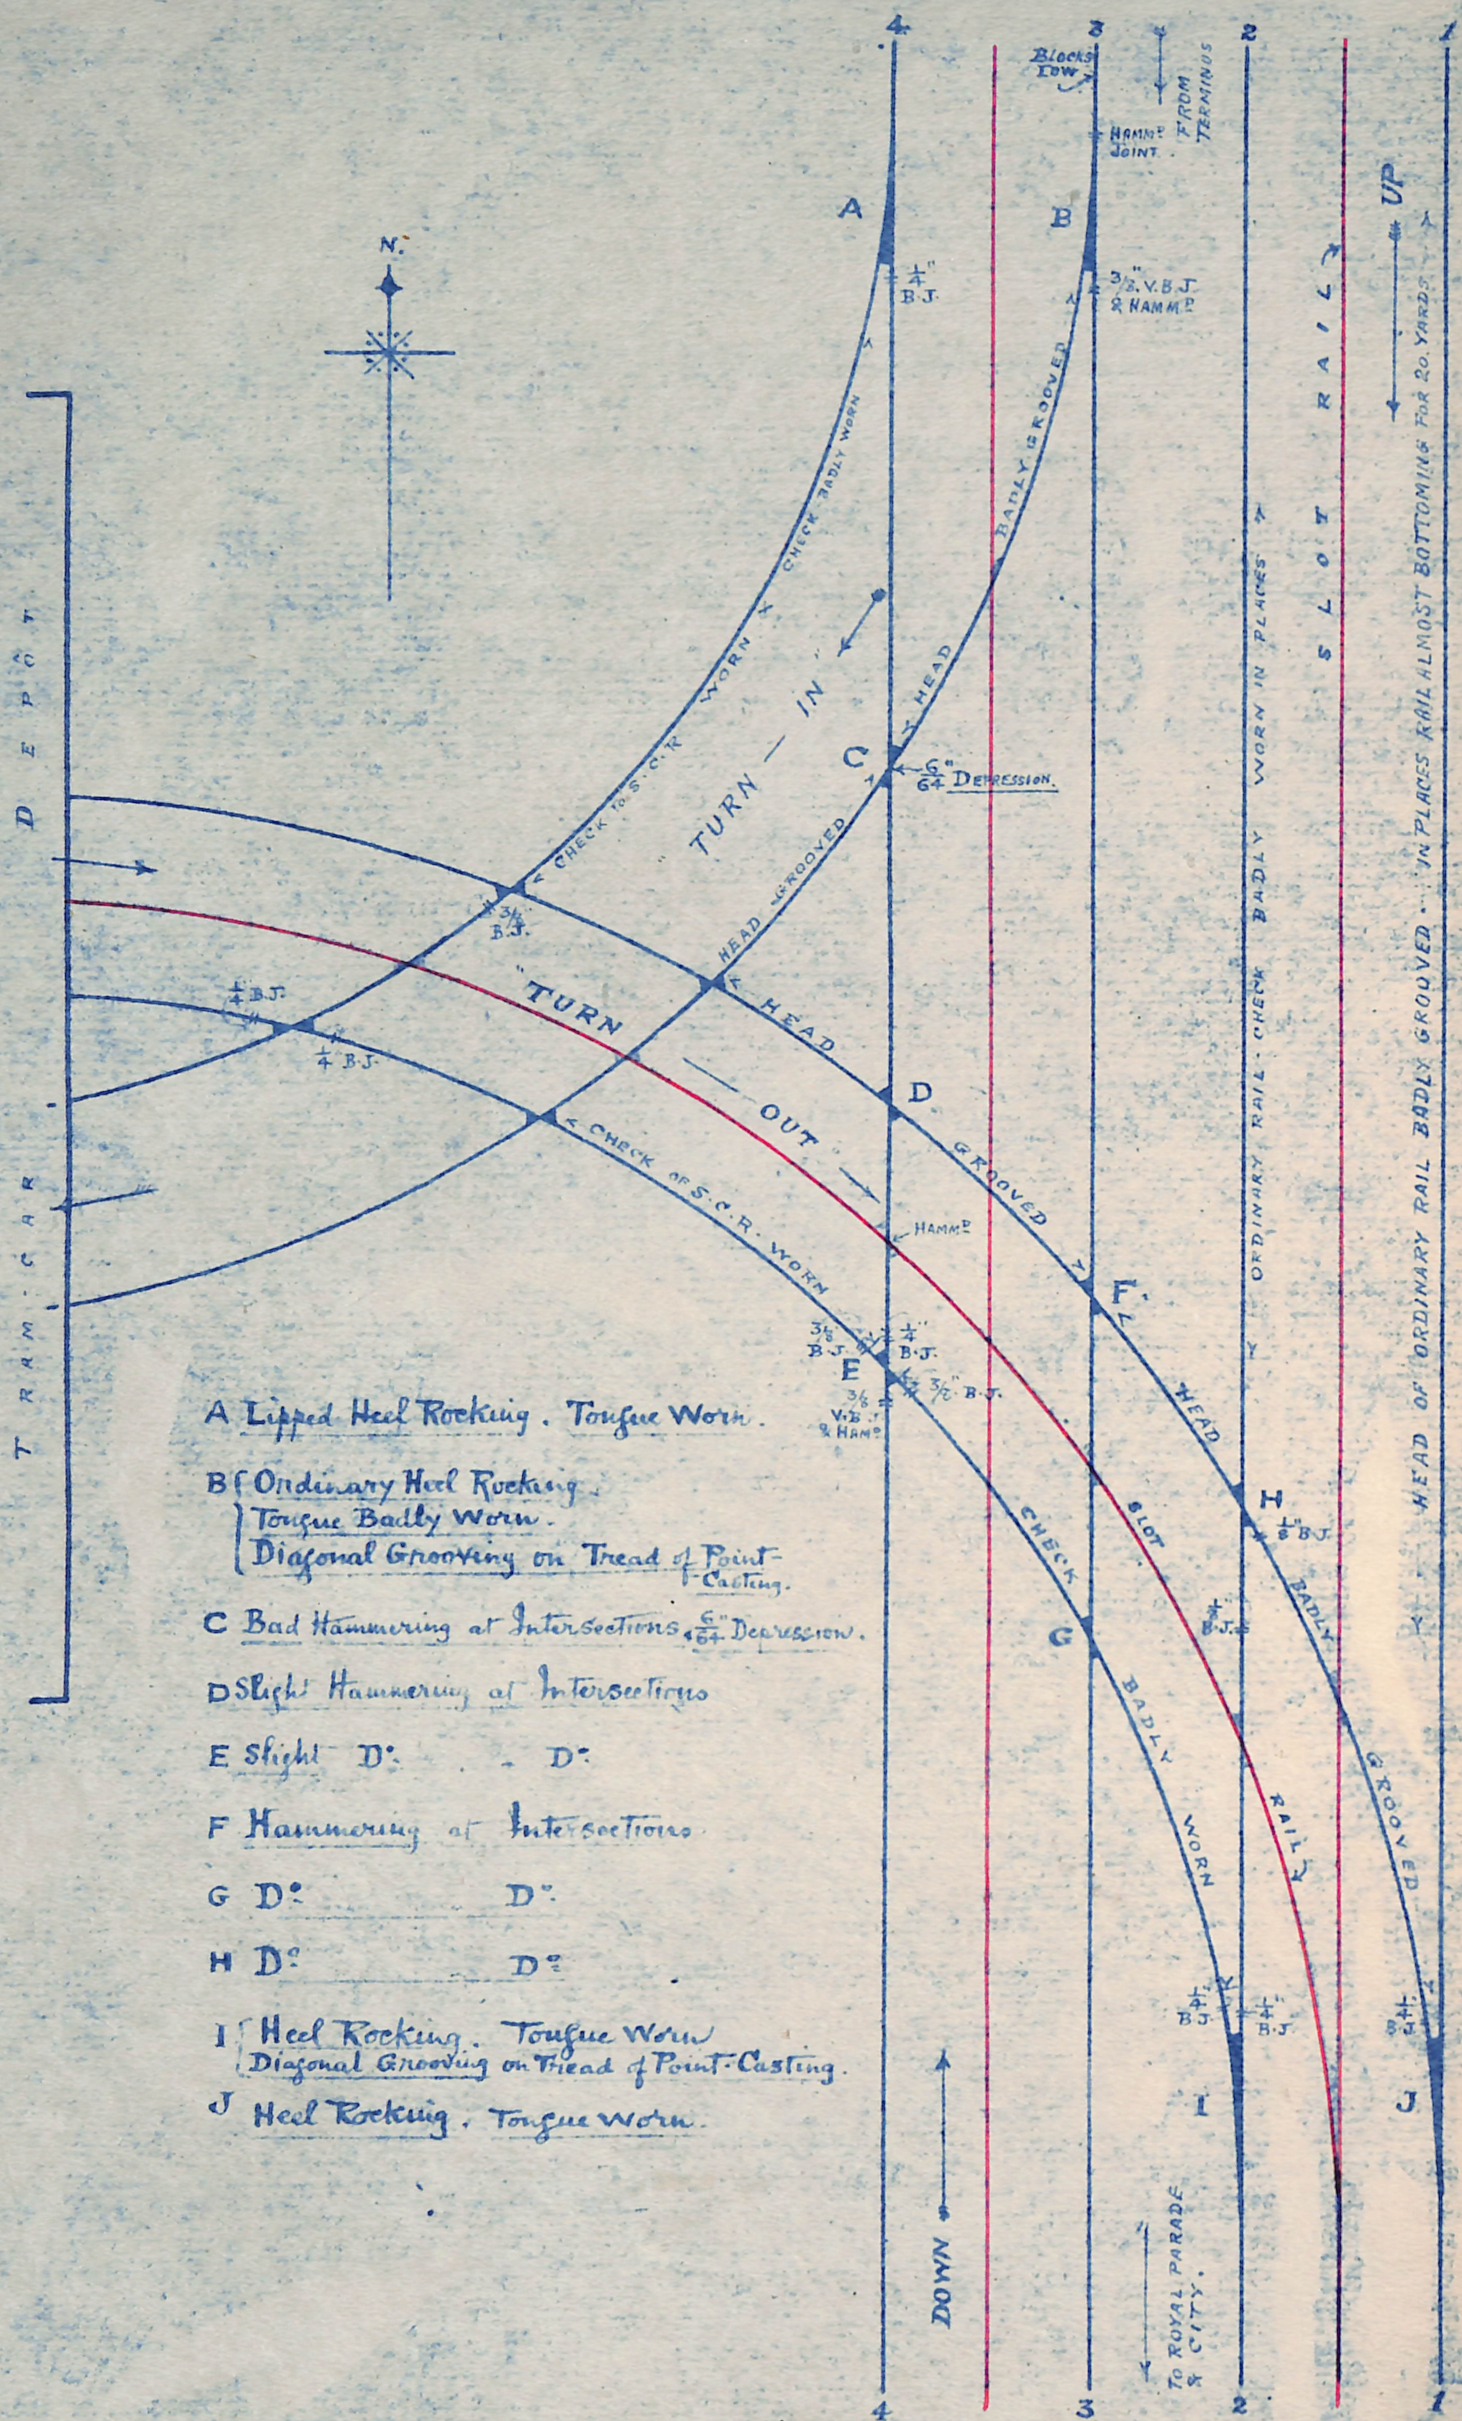
# TURN-IN AND TURN-OUT TO CAR DEPÔT

1. The checks of special check-rails on Curves leading to and from Depot are worn to varying amounts, and in places badly so. The sides of Heads of opposite rails are grooved, and in some places badly so, as a result of the above check-wear. The ordinary rail-check of No. 2 straight rail (between Curve of Turn-Out and Terminus) is badly worn in places. The side of head of No. 1 straight rail opposite the above is badly grooved in places as a result of the above check-wear, and rail is almost bottoming for about 20 yards.

2. The heels of the 4 points are of loose fit and rocking, and the Tread of two of the Point-Castings is diagonally grooved. Tongues are worn to varying amounts.

3. 14 of the Joints of Tram-rails, adjacent to rail-crossings and Points, are wide (varying from 1/8" to 3/8"), and in several cases are hammered -/some badly so -. There is also hammering of some of the joints.

4. At the Crossing intersections, also at the intersections of Slot-rails with tram rails, hammering is taking place to varying degrees.
5. Wood Paving Blocks adjacent to No. 3 Rail (North of Point of "Turn-In") are low. Blocks are loose in several other places, and tarred surface shattered.

6. The Stone-Setts, between No. 3 Rail (Down Track) and curved rail of "Turn-Out", are very loose, and some are below level of Tram-rails.

UP  
HEAD OF ORDINARY RAIL BADLY GROOVED... IN PLACES RAIL ALMOST BOTTOMING FOR 20 YARDS

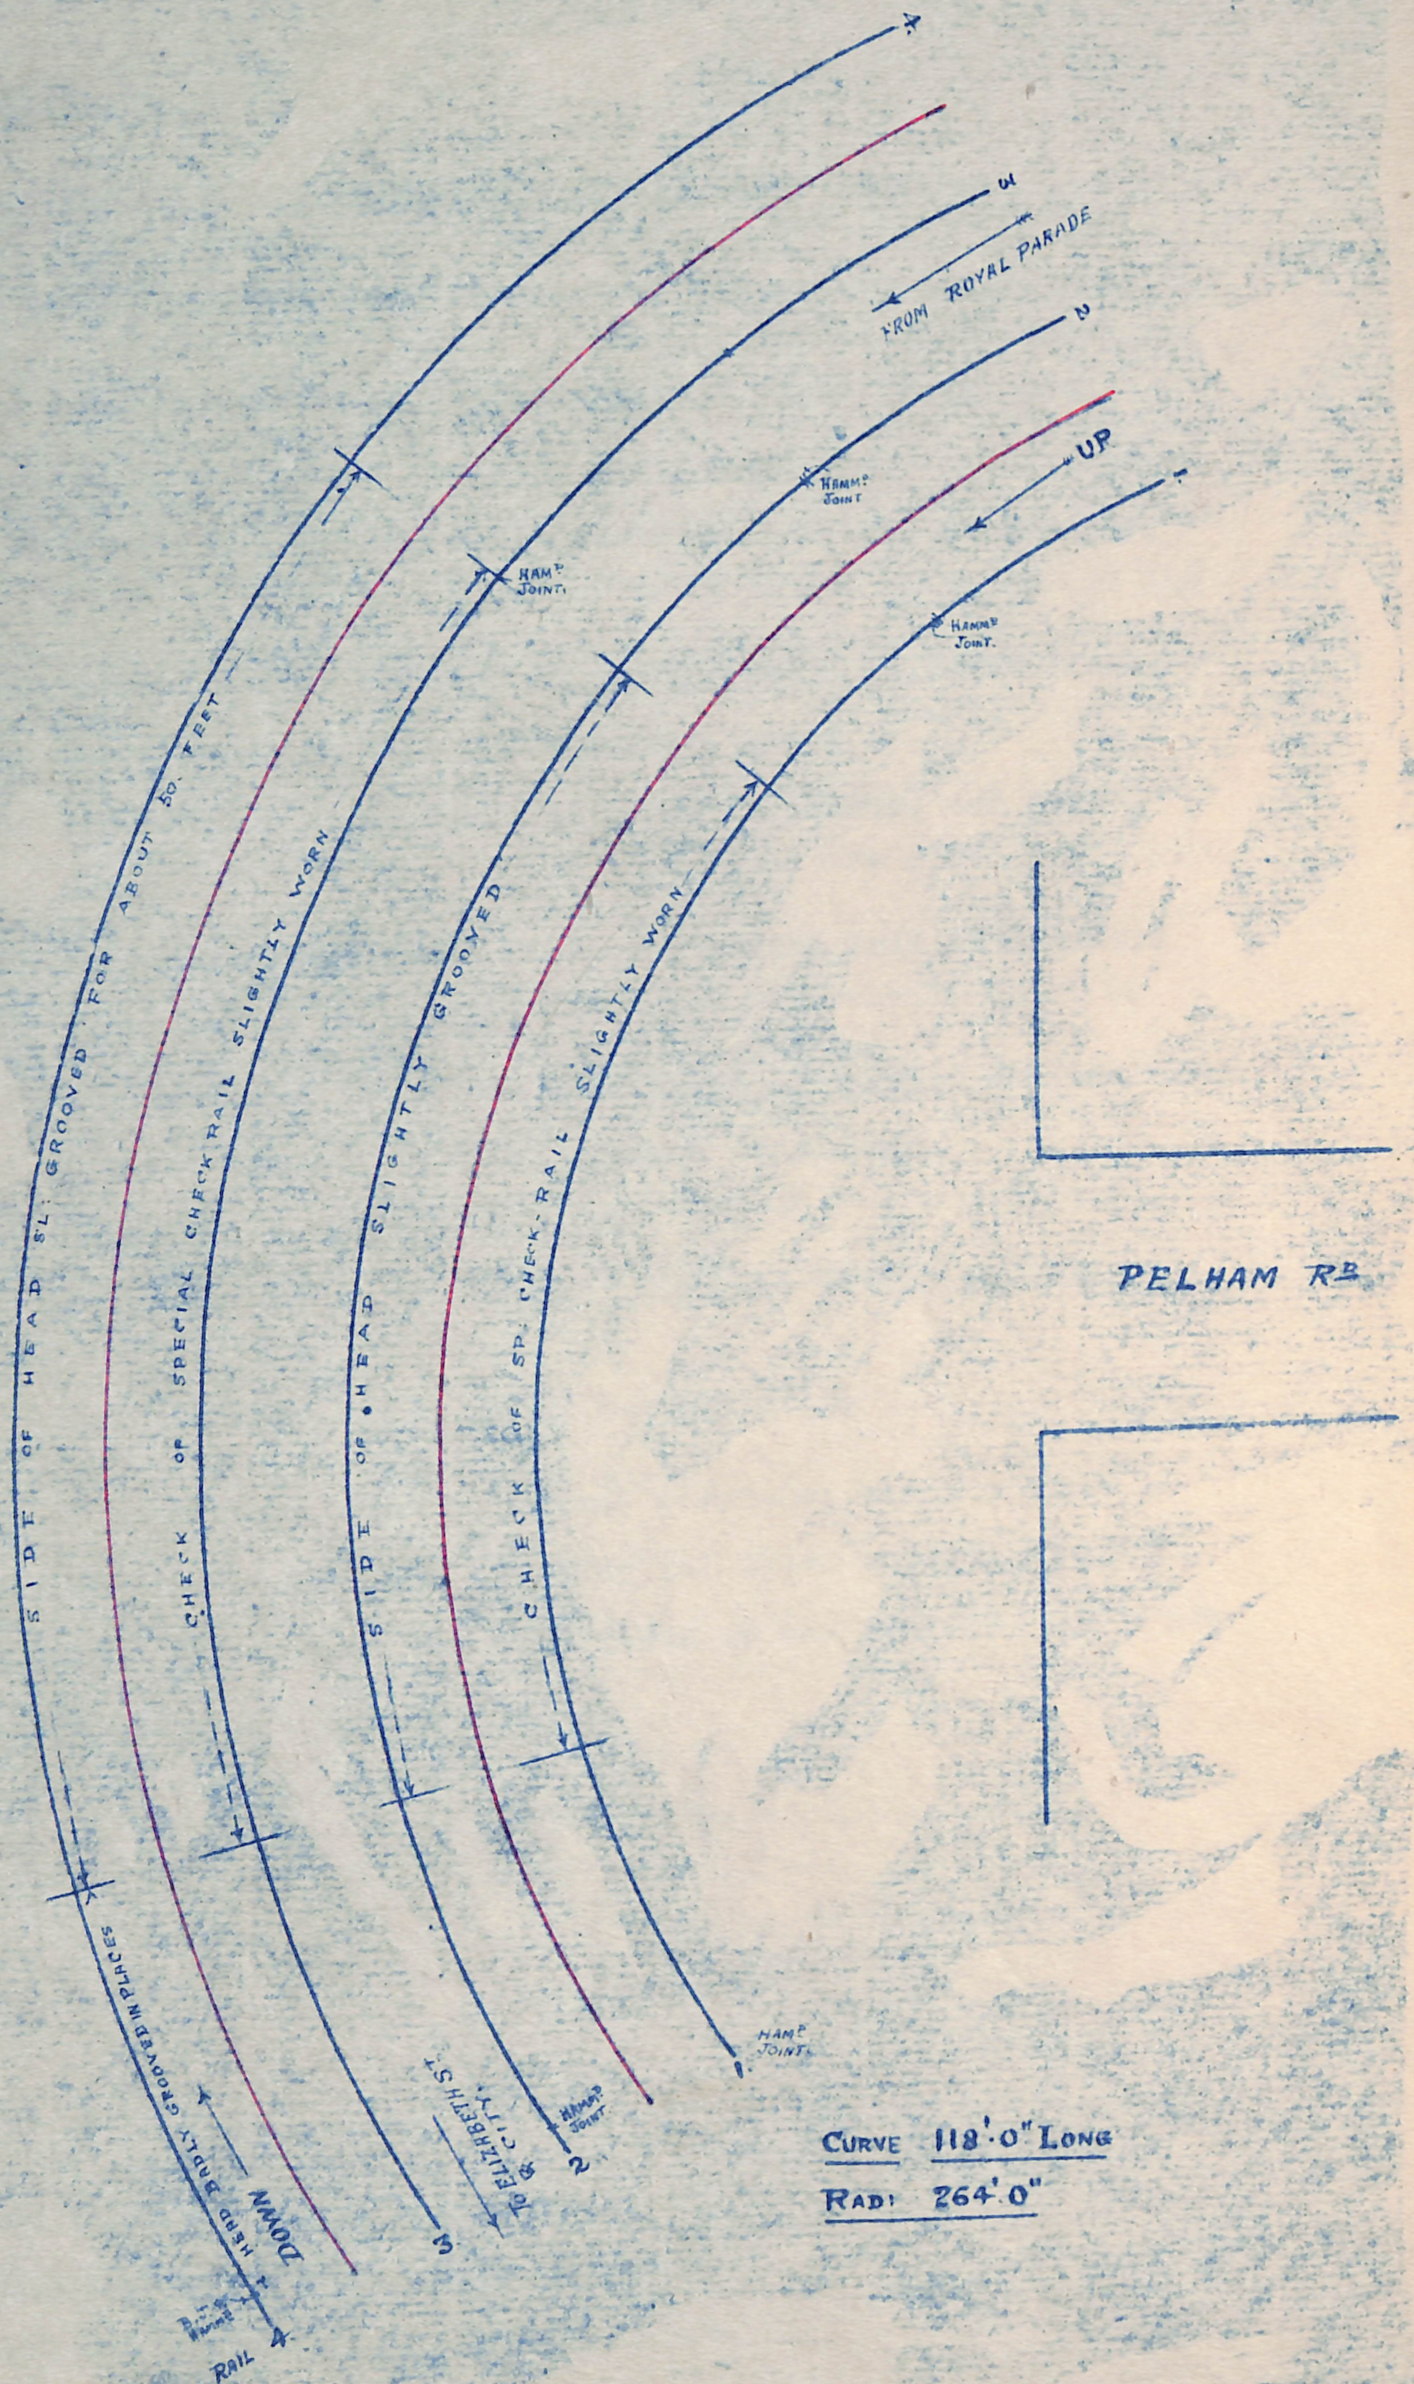
# CURVE ROYAL PARADE

1. The Checks of Special Check Rails of Nos. 1 and 3 Rails are worn slightly in centre of Curve for a length of about 50 feet.
2. The sides of heads of opposite ordinary rails (Nos. 2 and 4) are slightly grooved, as a result of the above check-wear.

Hammering is taking place at joints of rails to varying degrees.

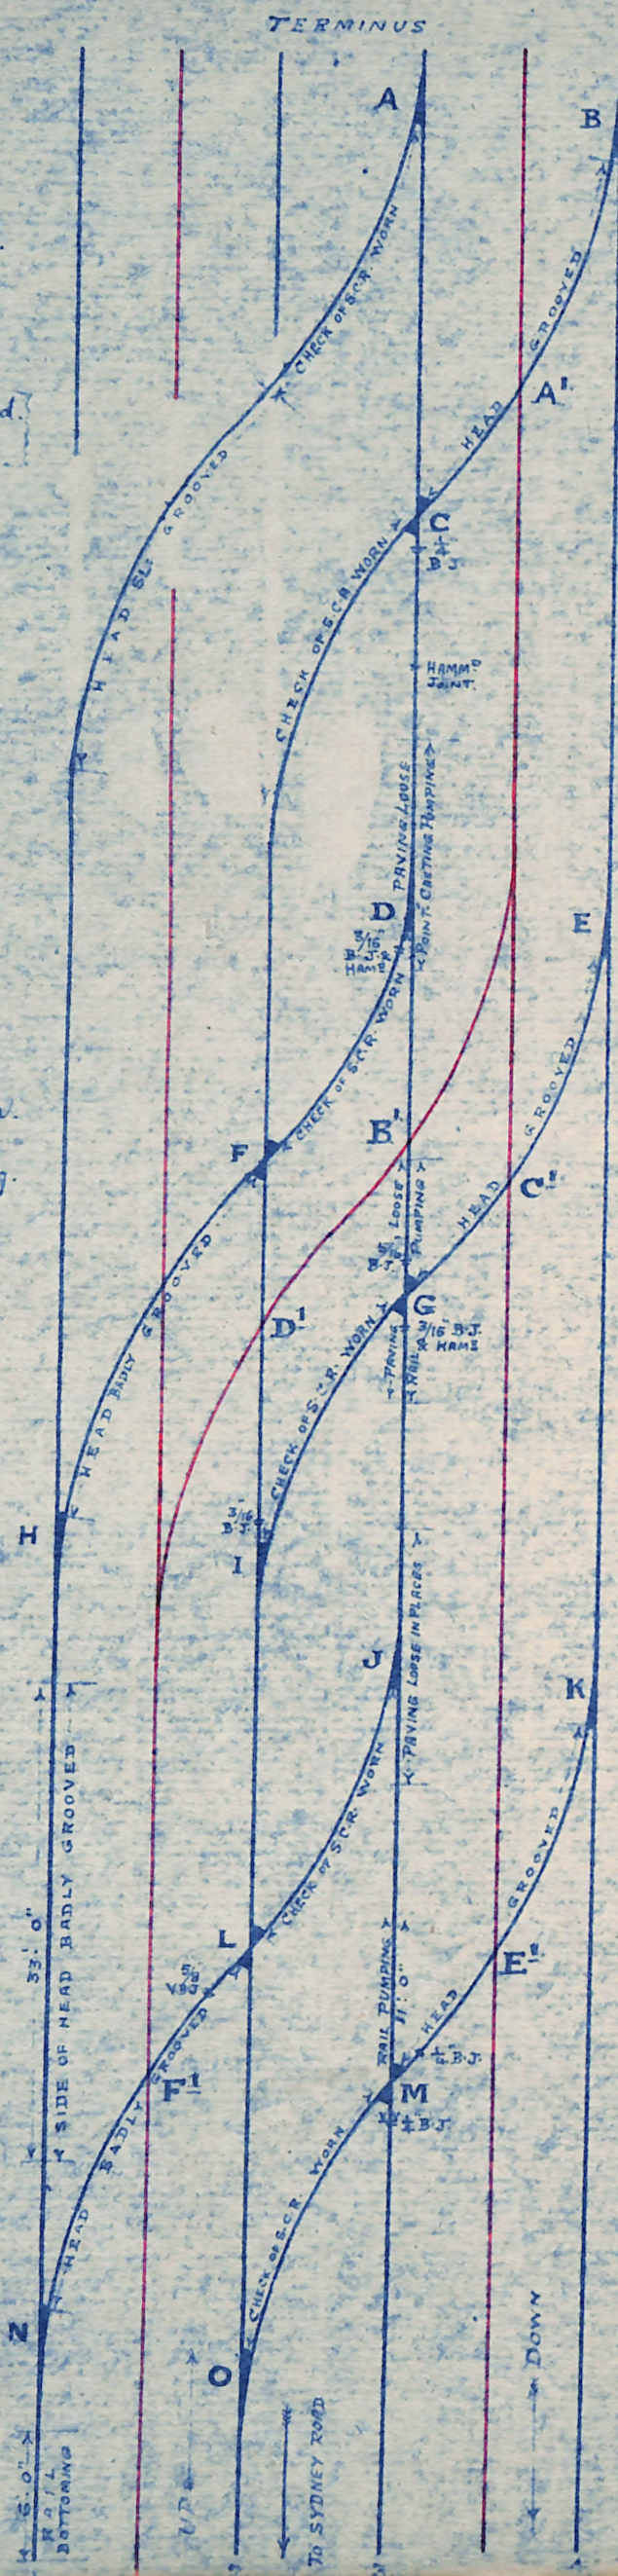
# DUMMY AND TRAILER-SHUNTS. ELIZABETH S<sup>II</sup>

1. No. 1 Rail (Up Track) - Rail between Point of Shunt and Terminus - is bottoming for about 2 yards, and tread of rails is 12 mils lower than wheel gauge. No. 1 Rail, between Dummy and Trailer Shunts, has side of head badly grooved for a length of about 11 yards.

2. On the six (6) Inner Curves of the Dummy and Trailer Shunts, the Checks of Special check-rails are worn to varying degrees. The sides of heads of the six Outer curves of Shunts are grooved to varying amounts, and in some cases badly so.

3. Three lengths of ~~xxxx~~ No. 3 Rail (Down-Track) for a distance of about 11'0" each, are pumping, and fishplates are presumably loose.
4. Paving Blocks on each side of Pumping Rails, also at several other places, are loose, and tarred surface is shattered.

5. Nine of the Heels are of loose fit, and rocking, resulting in excessive hammering. One of the heels is below level of tread. There is diagonal wear on Tread of Point-casting; in four cases Tongues are worn to varying degrees.

6. At the Crossing Intersections, also at intersections of Slot-rails with tram-rails, hammering is taking place to varying degrees, and in places it is considerable.

7. 8 of the joints of Tram-rails, adjacent to rail crossings and Points, are wide, (varying from  $3/16"$  to  $5/8"$ ), and in several cases are badly hammered.

- A { Lipped Heel Rocking  
Tongue Worn.
- B { Heel Rocking. Tongue Worn.  
Tread of Point-Casting Diagonally Worn.
- C Rail-Intersections Hammered.
- D Heel Rocking Slightly. Tongue Worn
- E { Heel Rocking. Tread Diagonally Grooved.  
Tongue Slightly Worn
- F Rail-Intersections Hammered.
- G D° D° Hammered.
- H Heel Rocking. Tongue Worn.  
Tread of Point-Casting Diagonally Worn.
- I Nil.
- J Heel Rocking. Tongue Worn.
- K Heel Rocking. Tongue Worn.
- L Rail-Intersections Badly Hammered.
- M Rail-Intersections Hammered.
- N Heel Rocking Slightly. Tongue Worn.
- O Heel below level of Tread, + Rocking.  
Tongue Worn.  
Tread of Point-Casting Diagonally Worn.

N° 1. Rail is Bottoming for about  
2. Yards (opposite N° 37 Elizabeth S<sup>I</sup>)  
and Tread is 12. Mils lower than  
gauge.

- A' Hammering at Intersections.
- B' Hammering - D°
- C' Hammering - D°
- D' Hammering - D°
- E' Hammering - D°
- F' Hammering - D°

NOTE 1 Since these Shunts were first inspected and the above particulars were noted, the two Point-Castings of Trailer-Shunt, also two short lengths of straight rails, (7'0" on No. 3 Down Track, and 9'0" on No. 4) adjacent to Point-Castings, have been taken up and removed, and New Point-Castings and two new, short lengths of straight rails, have been re-laid.

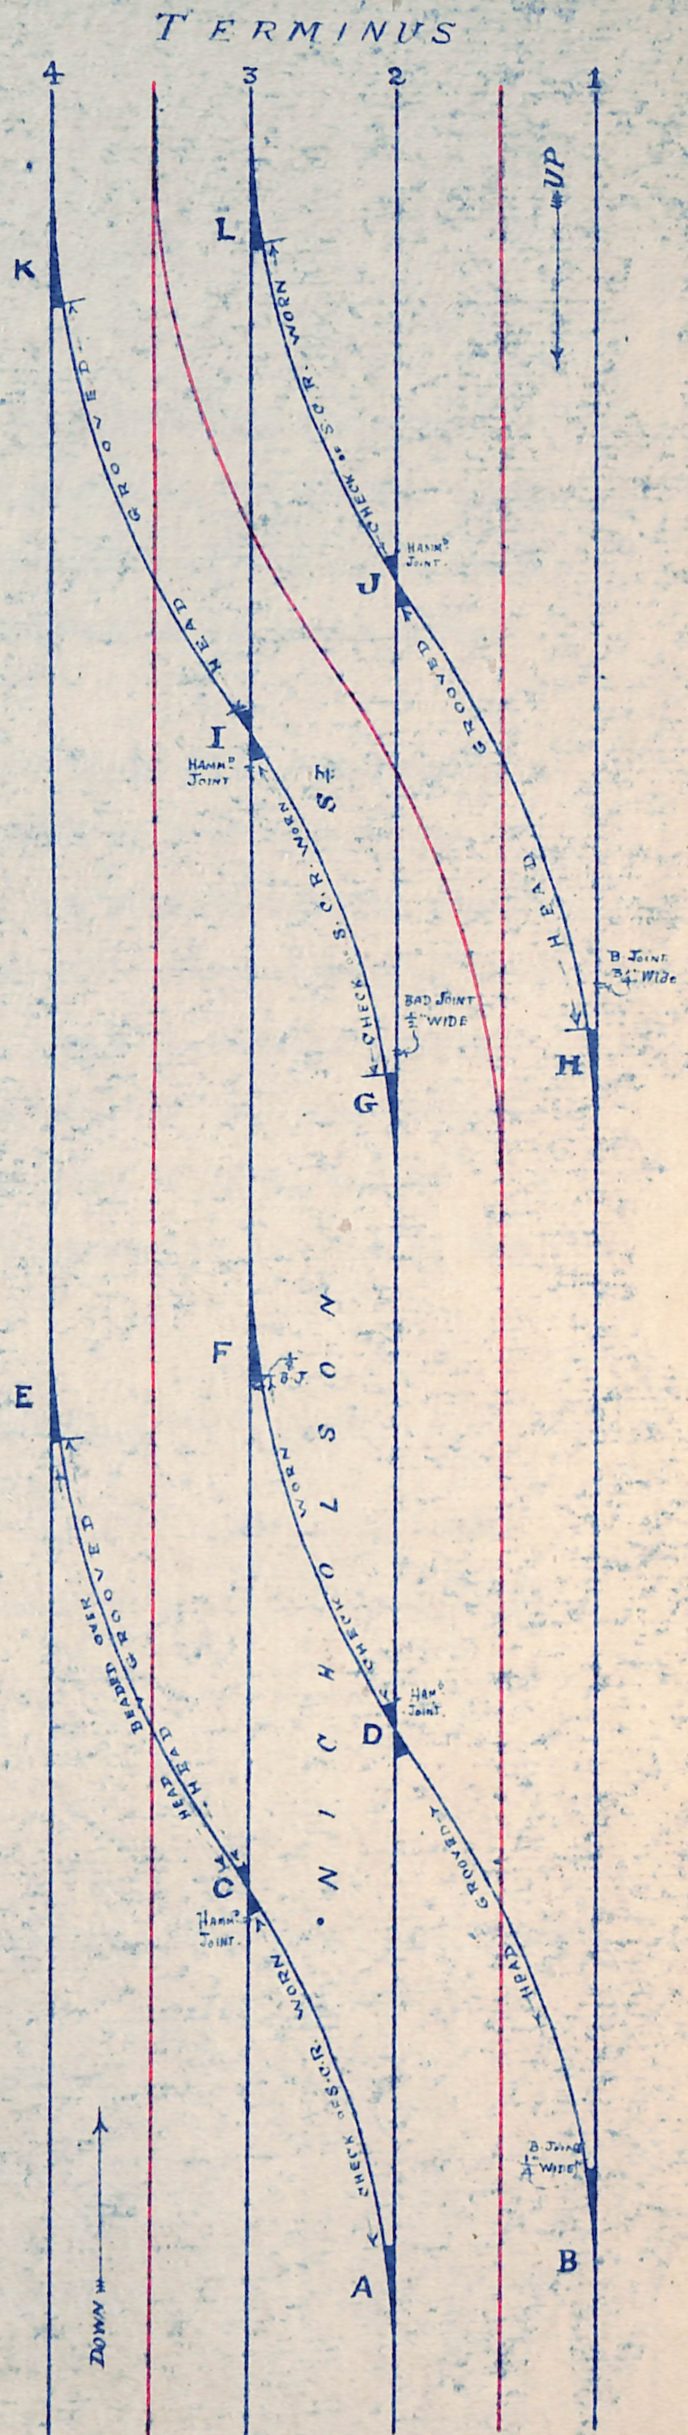
SHUNTS (2.) AT TERMINUS · NICHOLSON S<sup>E</sup>

1. The checks of Special Check Rails of the four Inner Curve rails of Dummy and Trailer Shunts are worn to varying amounts. The sides of heads of the four Outer Curve-rails are grooved to varying degrees as a result of the above check-wear. The heads of outer rails are beaded over in places.
2. Six of the heels of the 8 Points are loose and rocking. The rail-treads of 2 of the Point-Castings are diagonally grooved. Tongues are worn to varying degrees.
3. At the Crossing-intersections, also at the intersections of slot-rails with Tram-rails, hammering to varying degrees is taking place.
4. 4 of the Joints of Tram-rails, adjacent to rail intersections and Points, are wide, varying from 1/8" to 3/4", and in several cases are hammered.
5. There is also hammering taking place at some of the other joints to varying amounts.

The bearing wear has been removed from outer edge of rail-tread of Inner Curved Rail of Trailer-Shunt causing a projecting edge, which in places is very high.

- A { Heel Rocking.  
Tongue Worn.
- B. —
- C Hammering at Intersections
- D D° .. D°
- E { Heel bad Fit, and Rocking.  
Tongue Badly Worn.
- F { Heel bad Fit, and Rocking Badly. Tongue Worn.  
Tread of P<sup>E</sup> Casting Diagonally Grooved.
- G —
- H { Heel Rocking.  
Tongue Worn.
- I Hammering at Intersections.
- J Hammering - D°
- K { Heel Rocking. Tongue Slightly Worn.  
Tread of P<sup>E</sup> Casting Diagonally Grooved.
- L { Heel Bad fit, and Rocking.  
Tongue Slightly Worn.

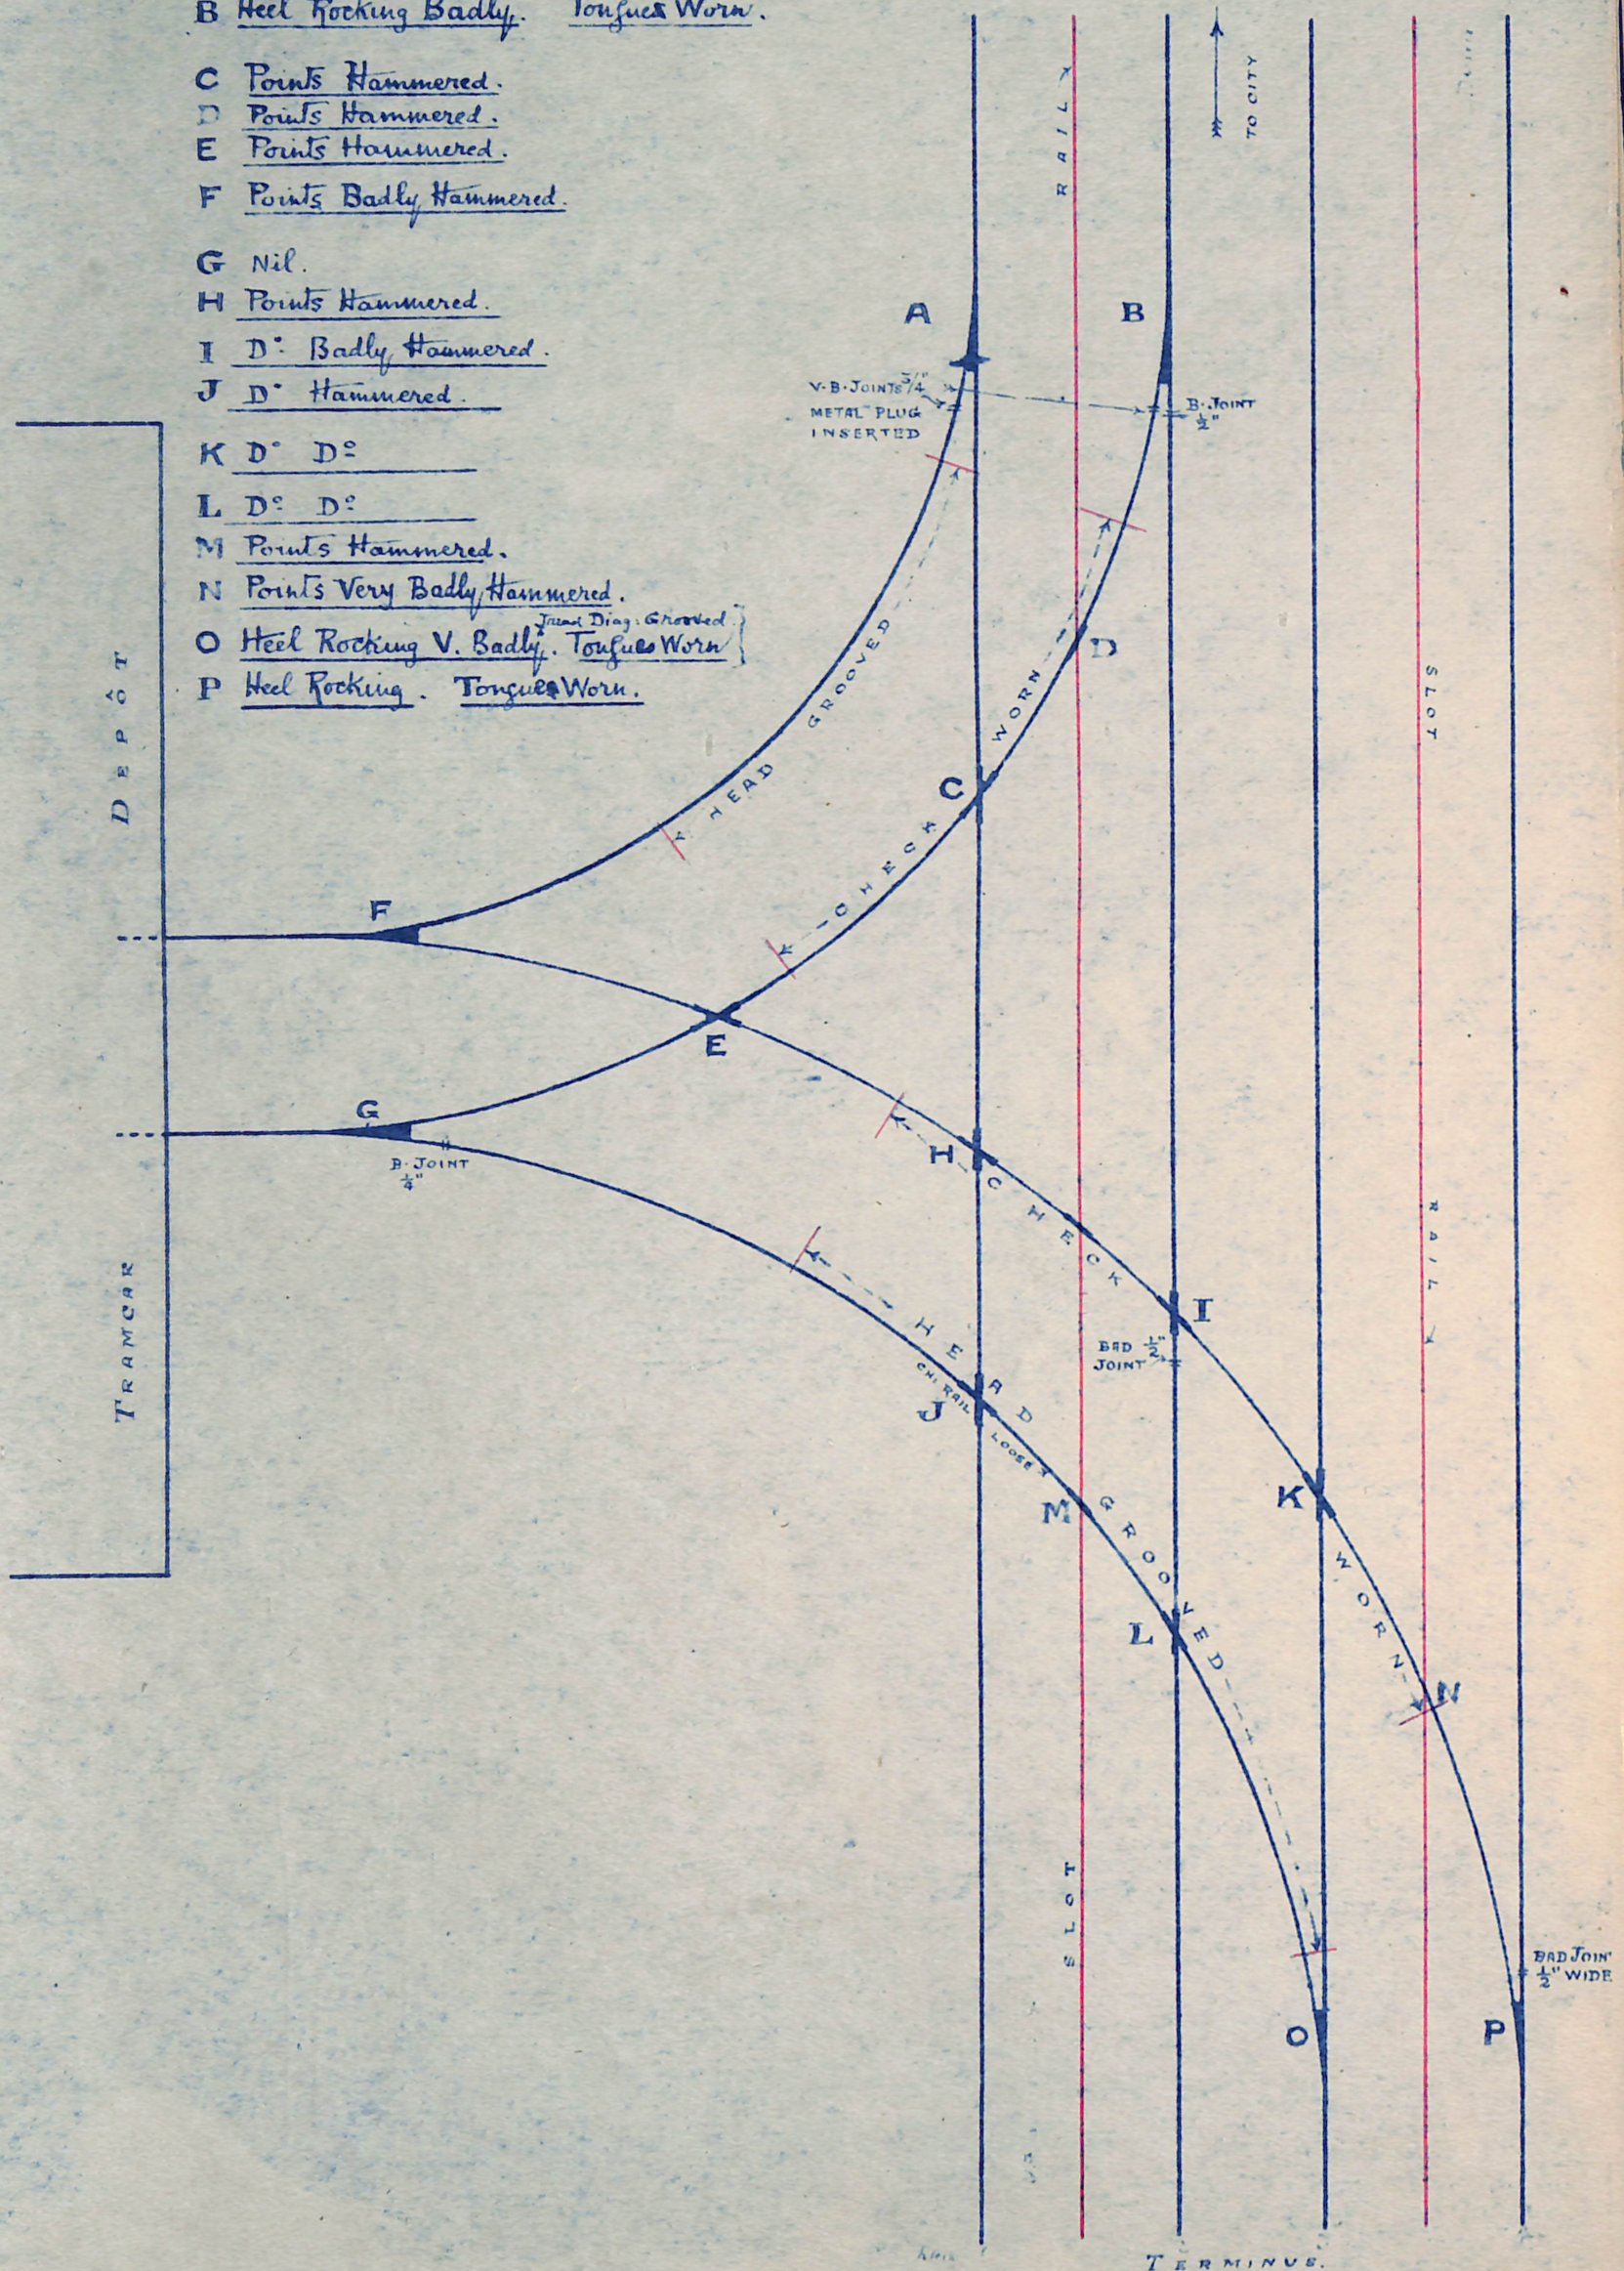
# NICHOLSON STREET

1. The special checks to Check rails of "Turn-In" and "Turn-Out" from Depot, for portions of their lengths, are worn, whilst the sides of heads of opposite rails are grooved as a result of the above check-wear. In places the special Checks to Check-rails of Inner Curves are loose and ineffective.
2. 4 of the Heels of the six Points are of loose fit, and rocking - two of them very badly so. The rail-treads of 2 of the Point-Castings are diagonally grooved. Tongues are worn to varying amounts.
3. At the Crossing-intersections, also at the intersections of slot-rails with Tram-rails, hammering is taking place to varying degrees.
4. 5 of the Joints of Tram-rails, adjacent to the Crossing-intersections and Points, are wide, varying from 1/4" to 3/4", and in several cases are hammered. There is also hammering of some of the other joints, to varying amounts.

NOTE. At joint, on No. 4 Rail is bottoming for 2 feet, and Tread is 60 mils below wheel gauge.

No. 1 Rail is bottoming for 3 yards.

- A Heel Rocking Very Badly. Tongues Worn.  
*Head Ding Grooved*
- B Heel Rocking Badly. Tongues Worn.
- C Points Hammered.
- D Points Hammered.
- E Points Hammered.
- F Points Badly Hammered.
- G Nil.
- H Points Hammered.
- I D° Badly Hammered.
- J D° Hammered.
- K D° D°
- L D° D°
- M Points Hammered.
- N Points Very Badly Hammered.
- O Heel Rocking V. Badly. Tongues Worn.  
*Joint Ding Grooved*
- P Heel Rocking. Tongues Worn.

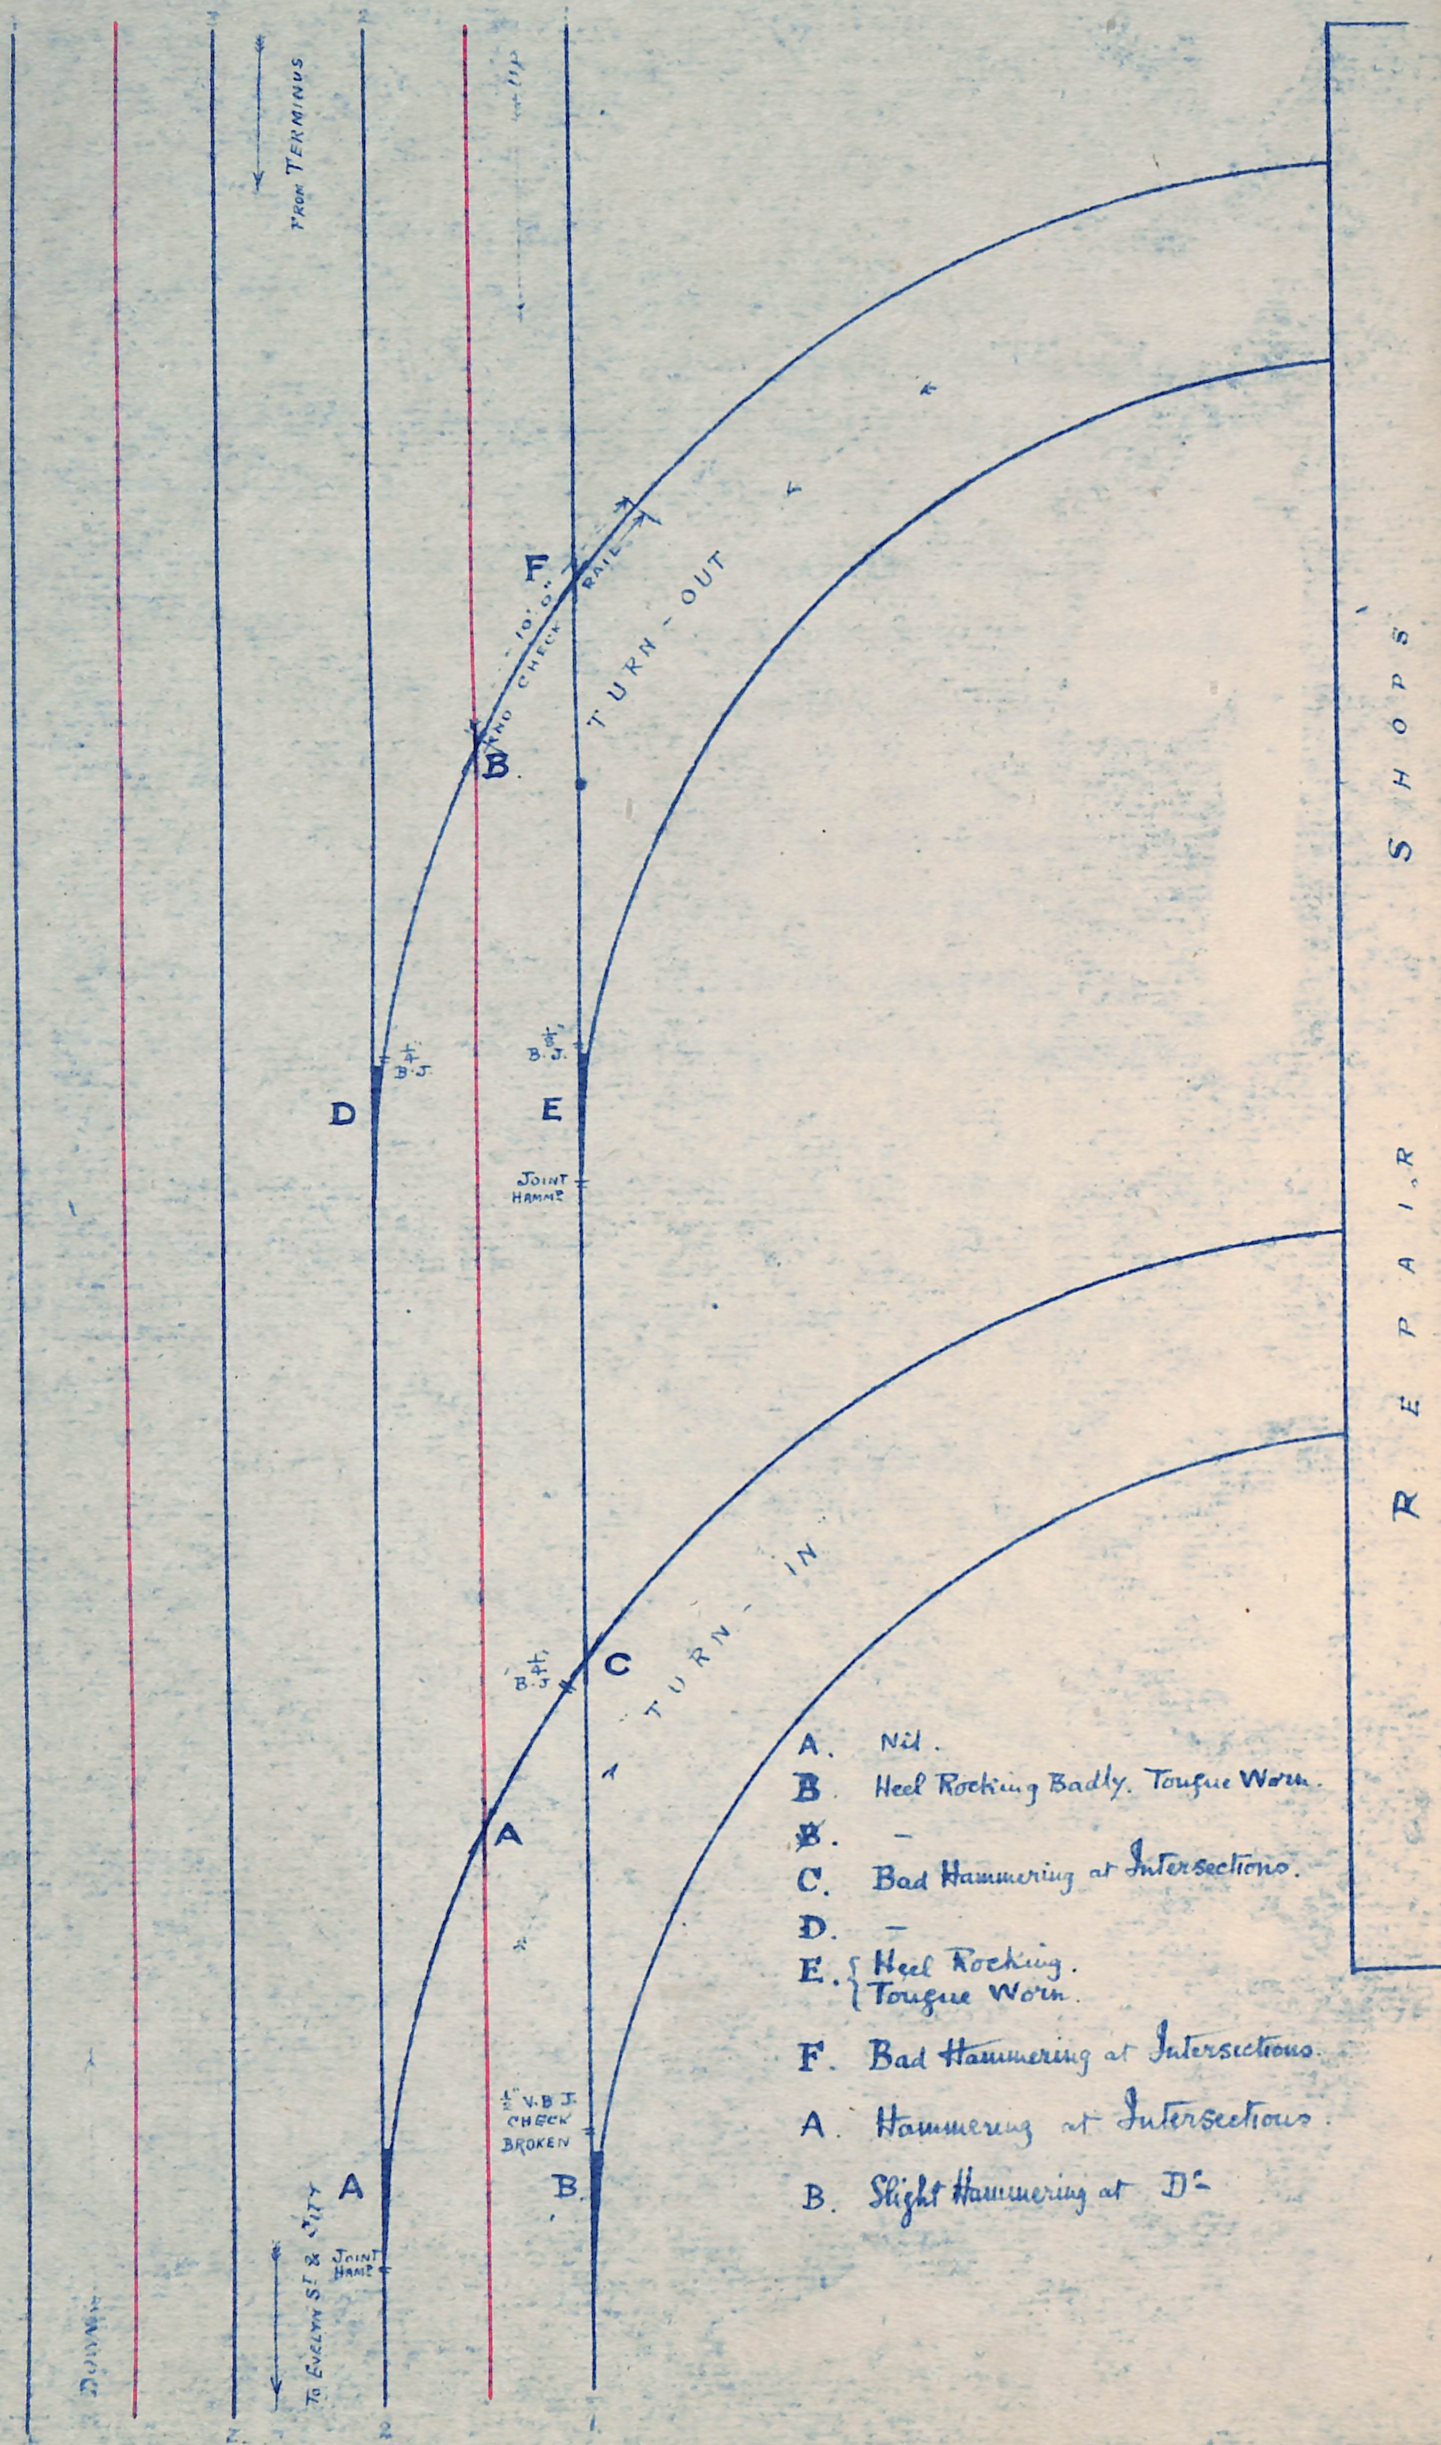
# TURN IN AND TURN OUT TO REPAIR SHOPS

1. A short length of Outer Curved rail (about 10'0") of "Turn-Out" from Repair Shops, on each side of No. 1 Rail (Up Track) has no Check to it.
2. 2 of the heels of the 4 Points are of bad fit, and rocking. Tongues are worn to varying degrees.
3. At the Crossing-intersections, also at intersections of slot-rails with Tram-rails, hammering is taking place to varying degrees.
4. 4 of the Joints of Tram-rails, adjacent to rail crossings and Points, are wide (varying from  $1/8"$  to  $1/2"$ ), and are hammered. There is also hammering of some of the other joints, to varying degrees.

- A. Nil
- B. Heel Rocking Badly. Tongue Worn
- C. Bad Hammering at Intersections
- D. -
- E. { Heel Rocking.  
Tongue Worn
- F. Bad Hammering at Intersections
- A. Hammering at Intersections
