LINE 3.

# SHUNTS AT TERMINUS SYDNEY ROAD

SHUNTS (2) AT TERMINUS - SYDNEY ROAD

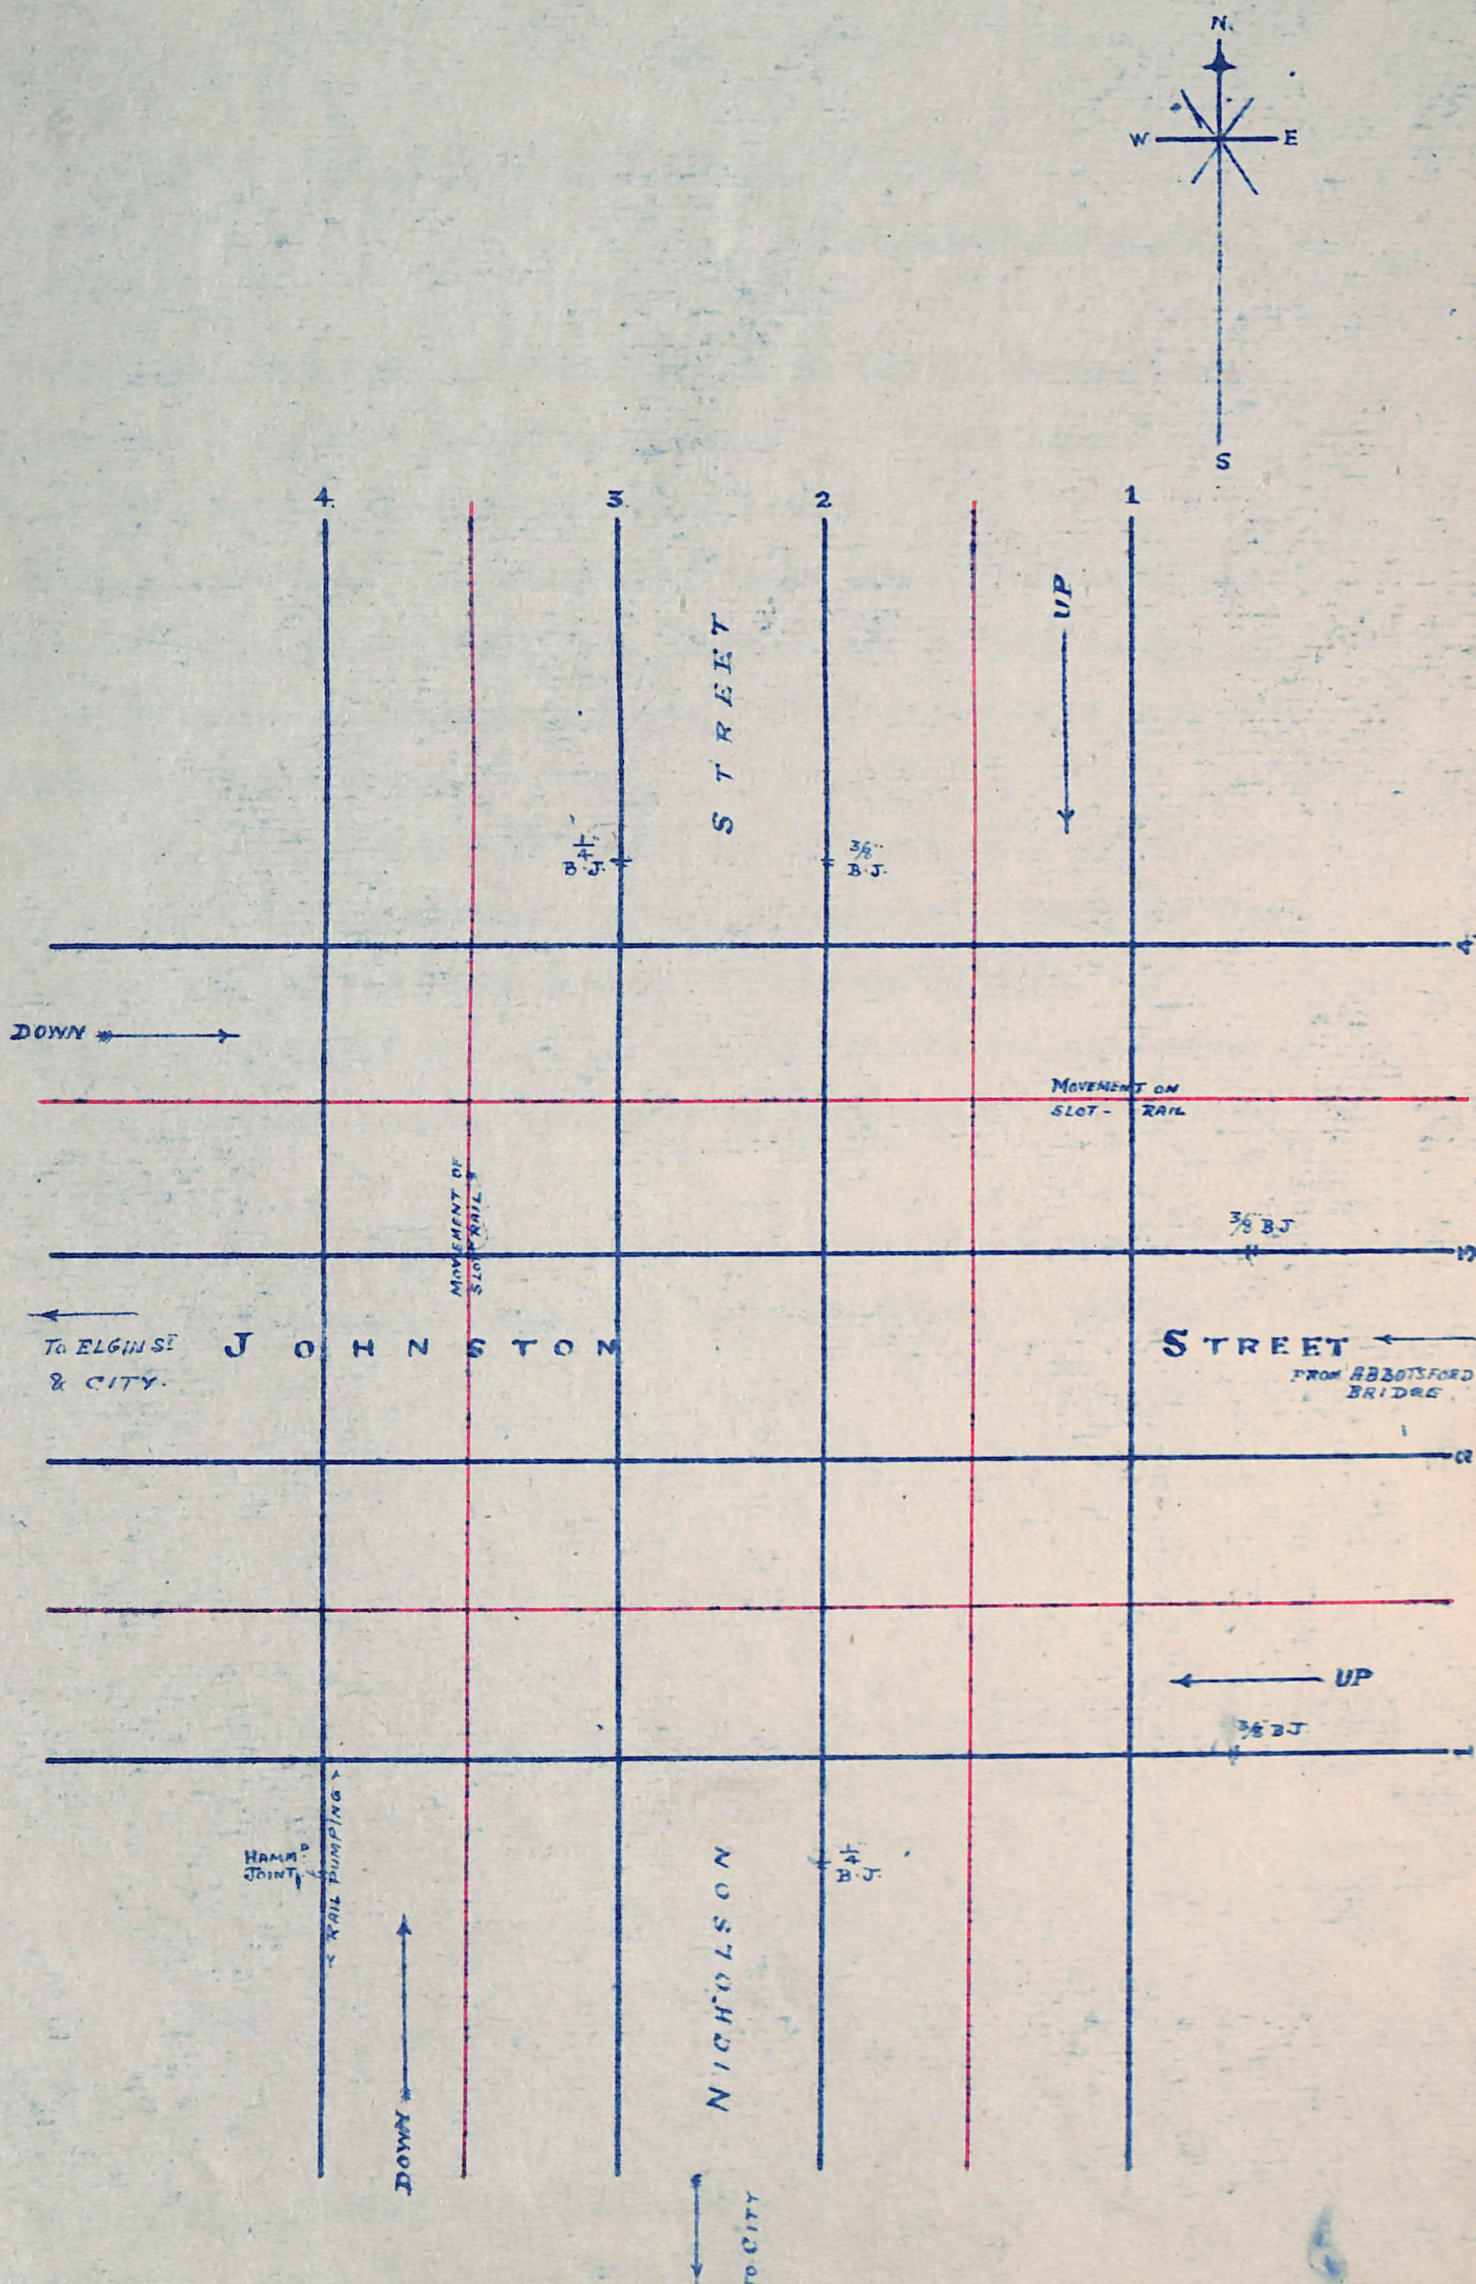
RIGHT-ANGLE CROSSING      JUNCTION OF

1. At the intersections of the tram rails, wear is taking place to varying degrees, resulting in excessive hammering.

At the Crossing-intersections, also at intersections of slot-rails with Tram rails, hammering is taking place to varying amounts, whilst a slight movement of slot-rail is apparent at several places, when cars pass over rails.

2. 5 of the Joints of Tram-rails, adjacent to rail intersections, are wide, and in several cases are hammered. There is also hammering of some of the other joints to varying degrees.

3. A short length of No. 4 rail, S. West of Crossing is pumping, and fishplates are presumably loose.

4. Paving Blocks on each side of pumping rail are loose, and tarred surface shattered in several places.
