LINE 4. PLAN A.5.

# SHUNT NICHOLSON S<sup>T</sup>

LINE 4.

EMERGENCY SHUNT - NICHOLSON STREET (OPPOSITE

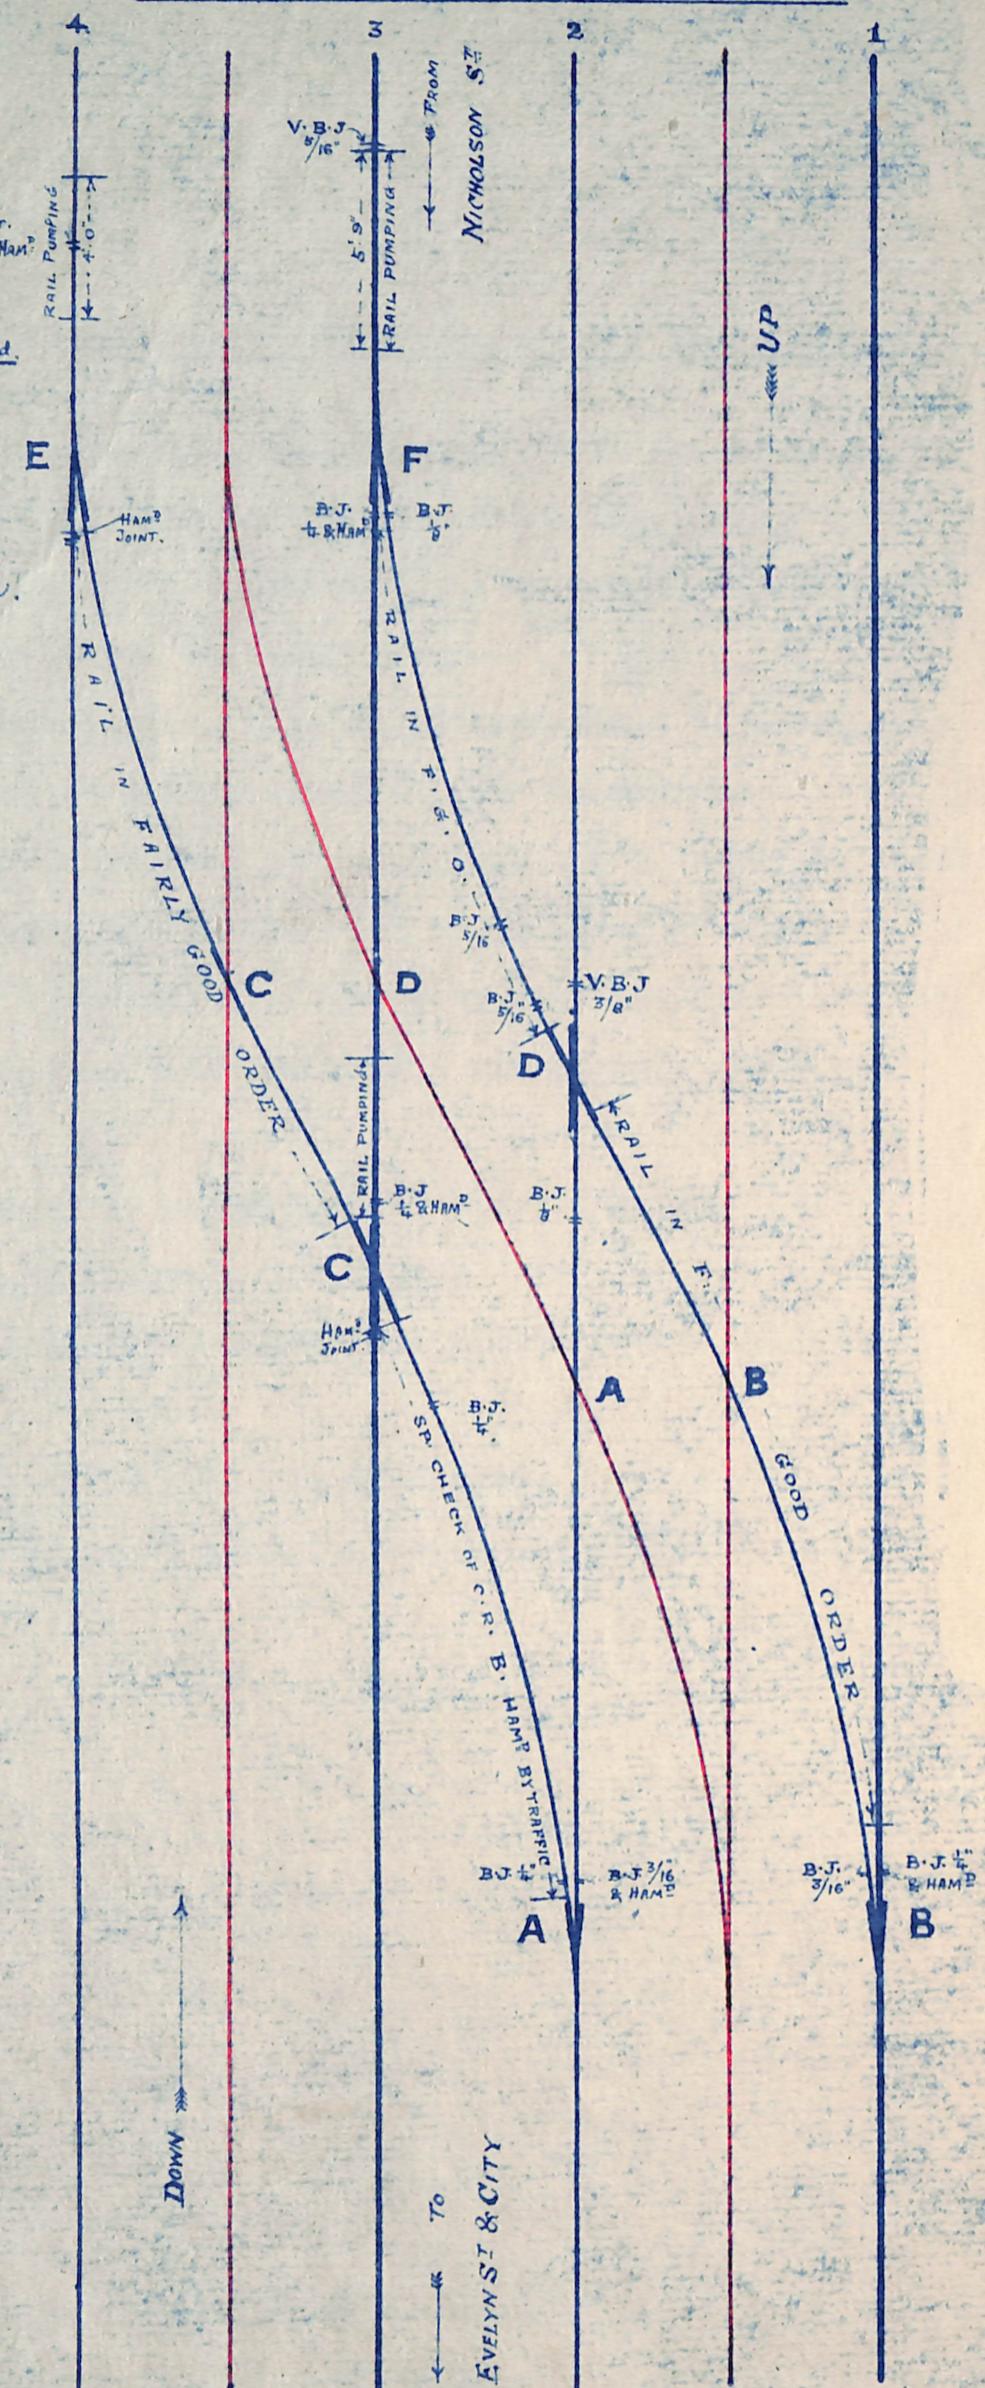
LINE 4. PLANA 5.  
**SHUNT NICHOLSON S<sup>T</sup>**

1. The special check of Check-rails of Inner Curves of Shunt are badly hammered-in places by vehicular traffic. These checks are slightly above levels of adjacent paving blocks.
2. On No. 3 Down rail, two lengths of rails (about 5'0" each) are pumping, and on No. 4 Down Track, one short length of rail is pumping, and the Fishplates are presumably loose. Paving-Blocks on each side of pumping rails are loose.
3. The heels of 2 of the four Points are of loose fit, and rocking. Tongues of the 4 Points are worn to varying amounts. There is also hammering of some of the other joints, to varying amounts.
4. 14 of the Joints of Tram rails, adjacent to the rail-crossings, and points, are wide (varying from 1/8" to 3/8") and in many cases are hammered.
5. At the Crossing-intersections, also at the intersections of slot-rails with tram-rails, hammering is taking place to varying degrees.

- A Head Bad Fit. Tongue Worn

- ## B Fixed Points Sl: Worn

- C } Points B: Hammered Found Bad  
Rails Pumping:

- D } Points B. Ham<sup>d</sup> Found? Bad  
Rails Pumping.

- ## **E** Heel Good Fit, Tongue Worn

- F } Heel Rocking. Tongue Worn**

- ## Point Hammered Bailly.

- ## A Points Hammered.

- B** D<sup>o</sup> Slightly Hand

- C** D? Slightly D?

- D** Points Hammered.

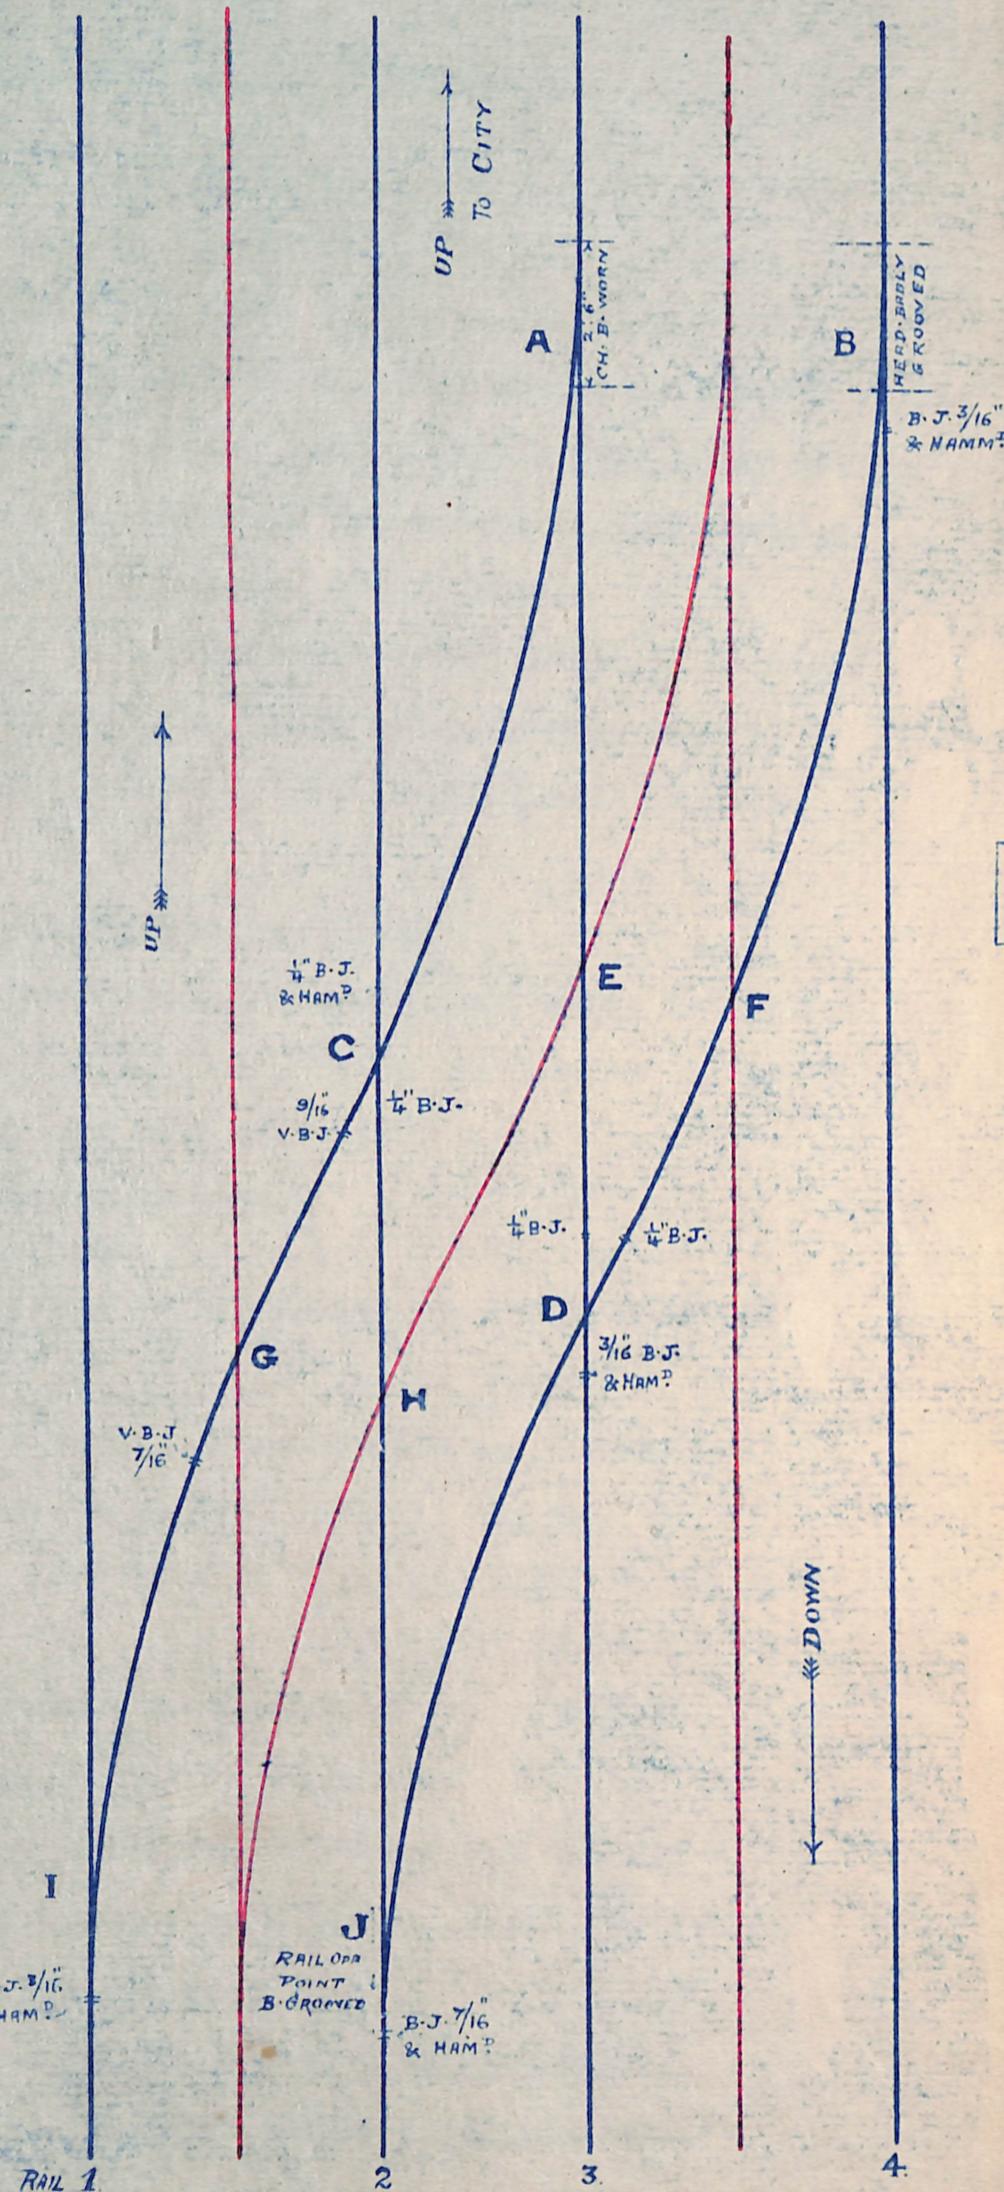
SHUNT · EVELYN S<sup>T</sup>

1. D. The rail-check of Point-Casting to No. 3 Rail (Down Track) is badly worn, whilst the ~~tread~~ tread of opposite Point-Casting (No. 4 Rail) is grooved, as a result of the above check-wear. The tread of Point-Casting to no. 2 Rail (Up Track) is badly grooved.
2. H. At the Crossing intersections, also at intersections of slot-rails with tram-rails, hammering is taking place to varying degrees.
3. J. The heel of Point of Shunt-rail (on No. 3 Rail, Down Track) is loose and rocking. Tongue is worn low. The head is hammered by heel.
4. L. Hammered by heel. 10 of the Joints of Tram-rails, adjacent to rail intersections and Points, are wide (varying from  $3/16"$  to  $9/16"$ ) and in many cases are hammered.

No. 4 Rail (Down Track) is bottoming for about 6 yards.

Depression of No. 4 rail equals 70 mils.

Nos. 1 and 2 Rails (opposite crossing of Slot-beam and No. 3 Rail) are bottoming in places.

Gauge between Nos. 1 and 2 Rails is  $1/8"$  wide.

Ordinary rail check of No. 1 rail is worn up to  $3/16"$ .

A Nil.

B Heel F. Good Fit. Tongue Sl. Worn.

C Points Badly Hammered.

D D: Hammered. Loose Joint.

E D: Badly Hammered.

F D: Hammered.

G D: Slightly Hammered.

H D: Slightly D:

I Nil.....

J Point Worn Low.

Head Grooved.

D: Hammered by Heel.

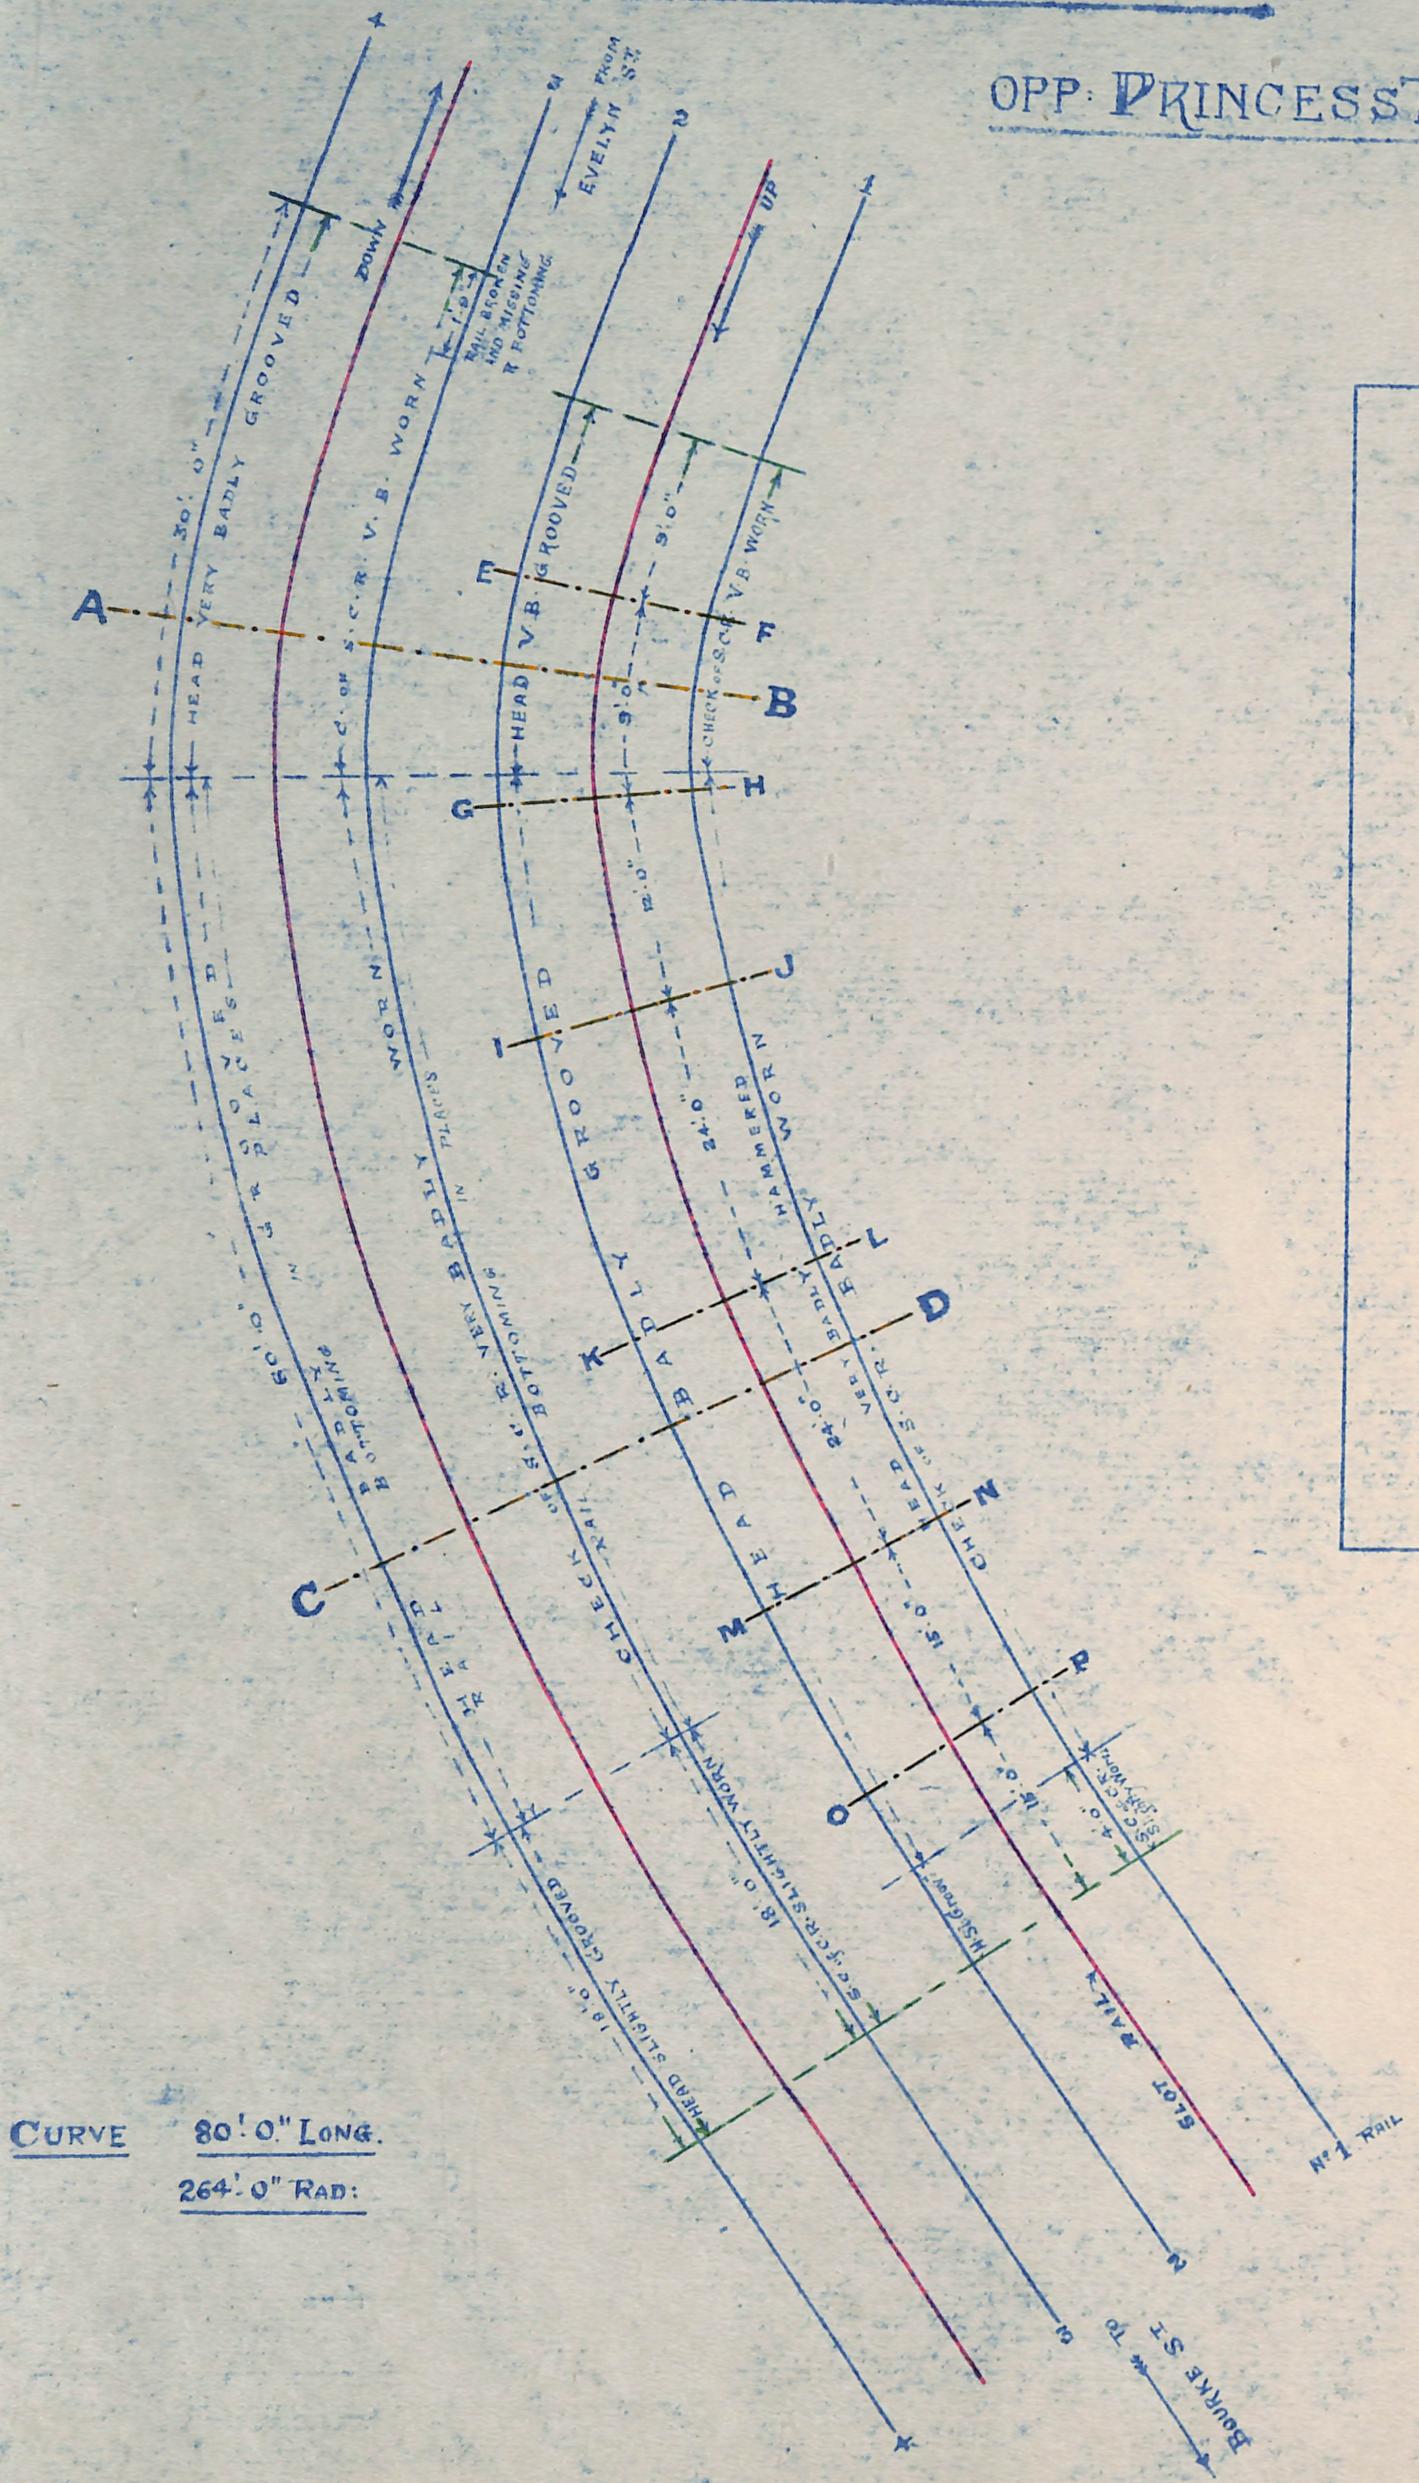
# CURVE IN EVELYN S<sup>T</sup>

1. The Checks of Special Check rails of Nos. 1 and 3 Rails are badly worn for greater portion of lengths of curves. The Check of No. 3 Rail is very badly worn in centre of curve for about 30 yards. The sides of heads of the opposite rails (Nos. 2 and 4) are badly grooved on greater portions of lengths of curves, and in places very badly so.

2. The bearing wear has been removed from outer edge of rail-tread, causing a projecting edge, which in places is very high.
3. No. 3 Rail (Down Track). A short length (about 1'9") of straight rail-check, adjacent to curved rail, on North side, is worn away at joint, whilst the ordinary rail-check of this straight rail is worn very thin.

4. Nos. 1 and 2 Rails are corrugated in places.  
No. 2 Rail is 31 Mils below Template, and is bottoming for 30 yds  
No. 4 Rail is 60 Mils " " " bottoming " 30 "  
No. 2 Rail - 1/2" is worn off side of Tread.  
No. 3 Rail - Check is worn very thin.

NOTE : Since this Curve was first inspected and the above particulars noted, and profiles taken, both tracks (Nos. 1, 2, 3 & 4 rails) have been renewed with new rails.

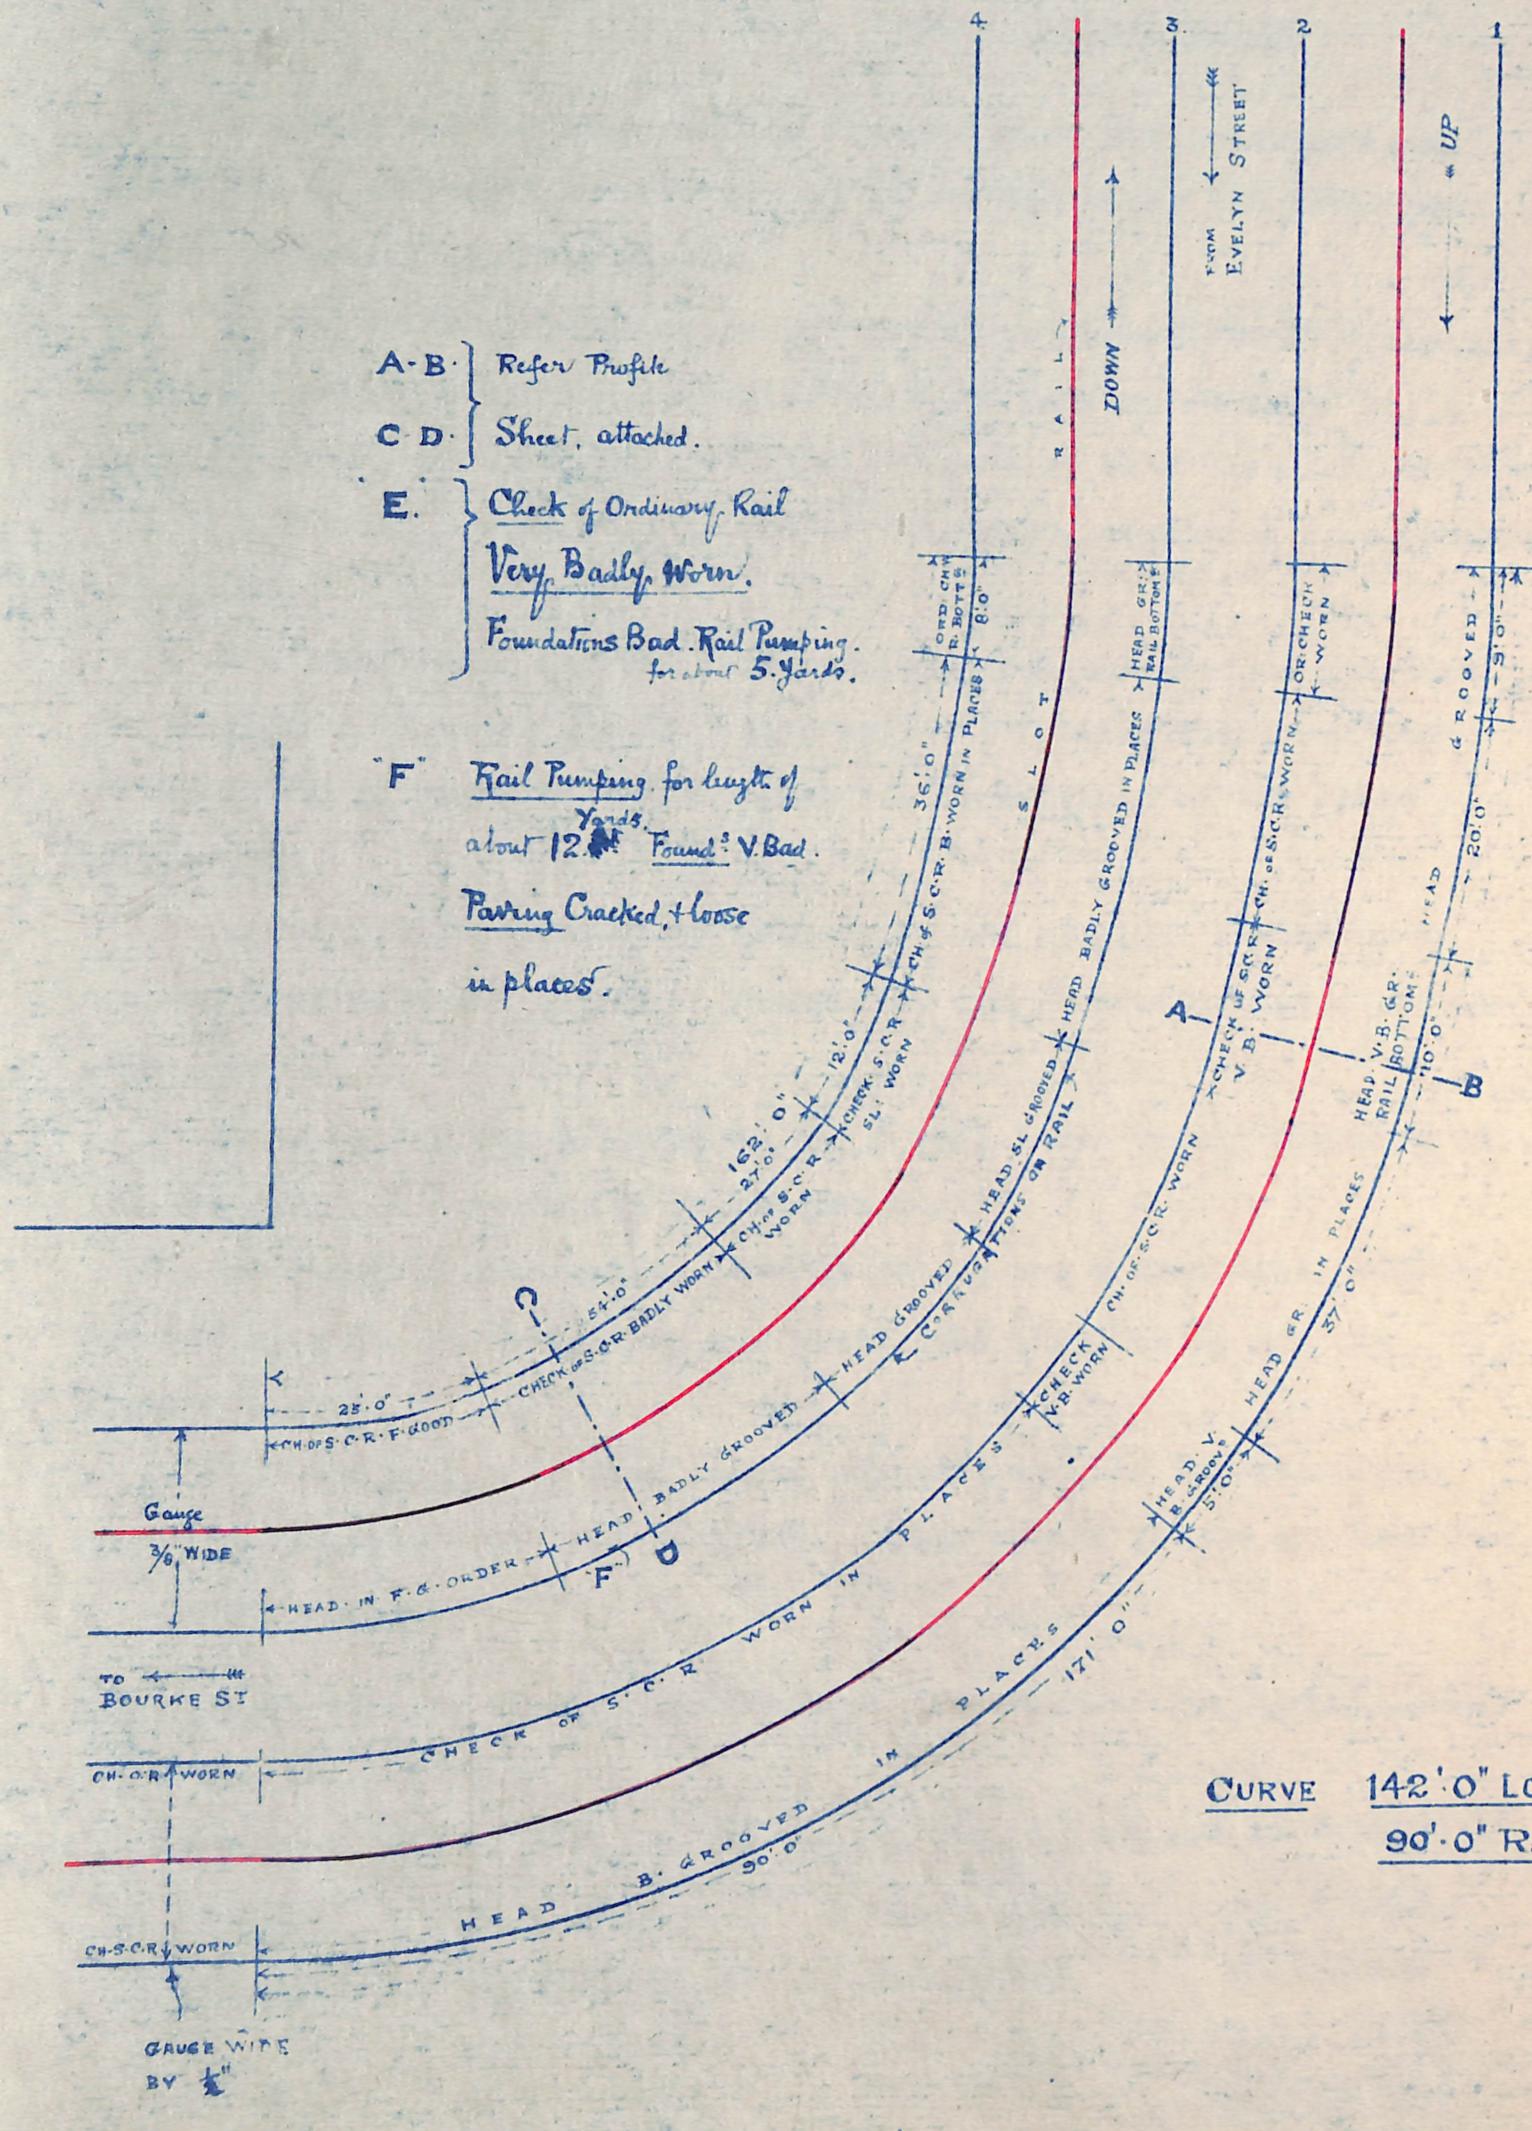
**CURVE** AT JUNCTION OF **EVELYN**  
AND **BOURKE S<sup>TS</sup>**

1. The checks of special check rails of No. 2 and 4 Rails are worn for a great portion of their length, and in places very badly so.
  2. The sides of heads of opposite rails (Nos. 1 & 3) are grooved to varying amounts, and in places very badly so, as a result of the above check wear ( $1/4"$  is worn off side of Tread of No. 1 Rail). From A-B Refer Profil 3/8" to 1/2" is worn off side of Tread of No. 3 Rail. The checks of C-D Sheet attached special check rails are loose, and ineffective in places.

3. NOS. 1 and 3 RAILS. In two places, lengths of Tram rails are pumping (for lengths of 5 yards and 12 yards respectively), and Fish-plates are presumably loose. Foundations Bad Rail Pumping. Paving-Blocks on each side of pumping rails are loose, and tarred surface at these, and at other places on Curve, is shattered.

- No. 3 Rail is 56 mils lower than gauge, and rail is bottoming for 2 yards. Paving Cracked + loose CORRUGATIONS are apparent on No. 3 Rail, along centre portion of curve, Depressions = 37 mils.

- No. 1 Rail. 1/4" is worn off side of Tread. Groove is 2" wide on No. 3 Rail.
- GAUGE of Nos. 1 and 2 Rails is 1/2" too wide, and gauge of Nos. 3 and 4 rails is 3/8" too wide.

- No. 2 Rail. Groove is  $1\frac{1}{2}$ " wide.

A-B } Refer Profile  
C-D } Sheet, attached.  
E } Checks of Ordinary Rail  
  } Very Badly Worn.  
  } Foundations Bad. Rail Pumping.  
    for about 5 Yards.

"F" Fail Pumping for length of  
Yards.  
about 12. Found: V.Bad.

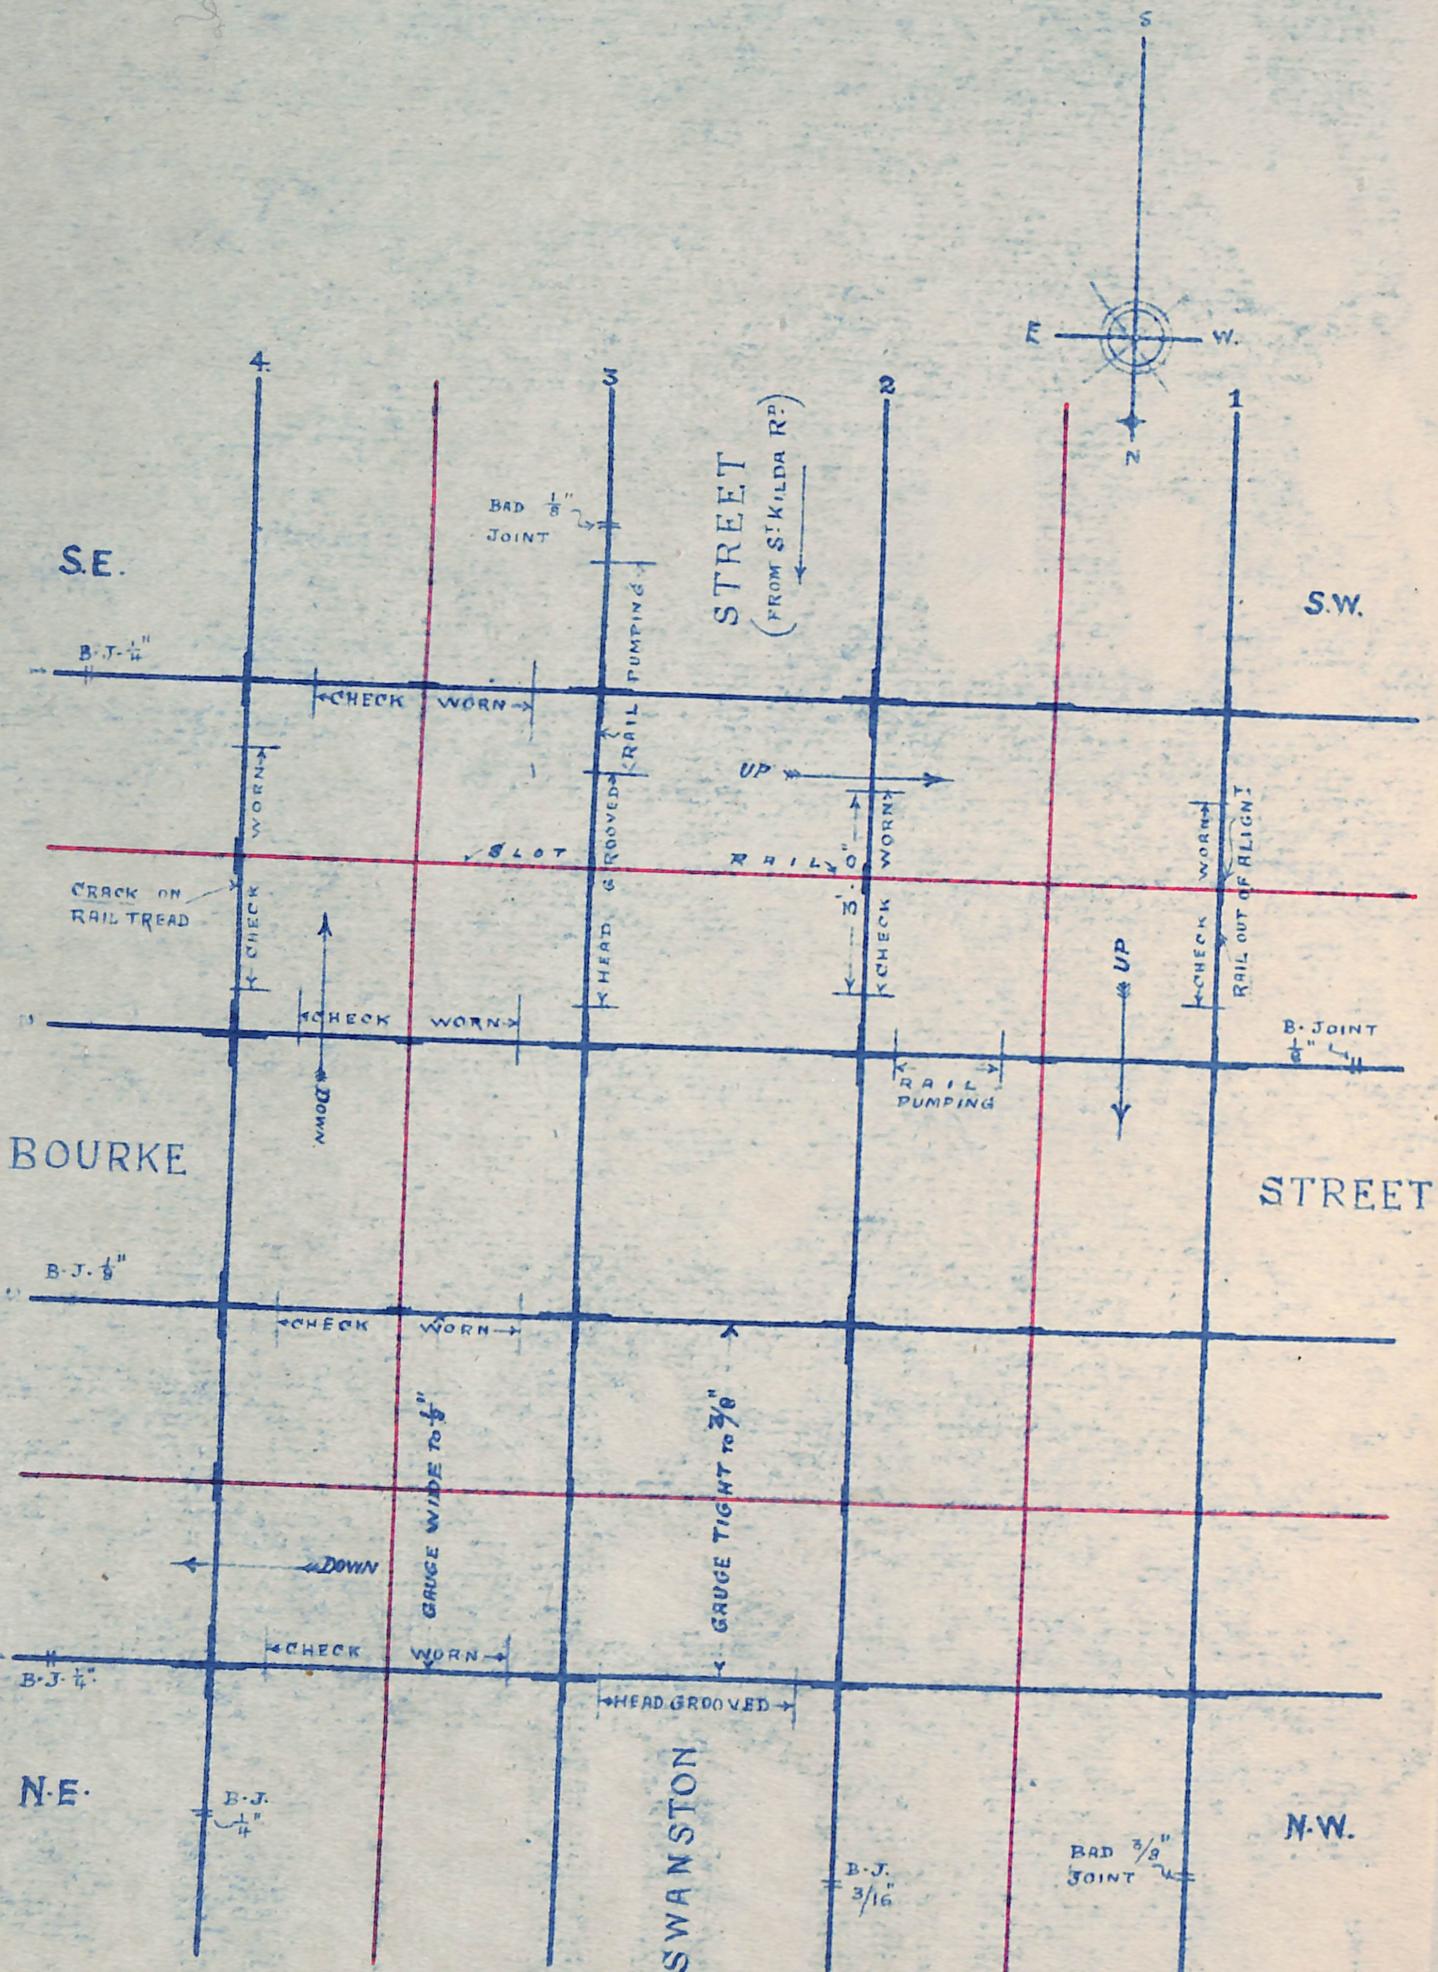
LINE 4 PLAN A.9.

1. There is considerable wear on tram-rails at the intersections, resulting in excessive hammering, and in several cases the rails are almost bottoming at these places.

At the Crossing-intersections, also at intersections of tram-rails with slot-rails, hammering is taking place to varying degrees. NO. 1 RAIL (Up Track) Swanston St., at its intersection with slot-rail (between Nos. 1 & 2 rails Bourke St.) is out of alignment, resulting in excessive hammering.

2. The Tram-rails, between intersections, and Slot-rails, are worn for a portion of their length, - the rail-check being worn, and the side of head of opposite rail is grooved, as a result of the above Check-wear.

3. In two places, lengths of tram-rails are pumping, resulting in loosening of adjacent paving. Fishplates and Foundations are, presumably, loose.

4. There is a Crack on Tread of No. 4 rail (Down Track) Swanston St., between Nos. 1 & 2 rails (Up Track) Bourke St.

5. The gauge of tram-rails, between Nos. 3 and 4 downrails (Bourke Street) is wide, up to  $1/8"$  in one place, and tight up to  $3/8"$  in another place.

8 of the joints of tram rails, adjacent to rail intersections, are wide (varying from  $1/8"$  to  $3/8"$ ). Many of the joints are hammered to varying degrees.

Tram-Rail Intersections. Evidence of Hammering at all Intersections.

Tram-Rail and Slot Rail } Intersections. D. - Hammering - D. - D.

Paving In Fairly Good Order, except where rails are pumping, where  
Paving is Bad.

Fish Plates, Generally in Fairly Good Condition, but loose in places.

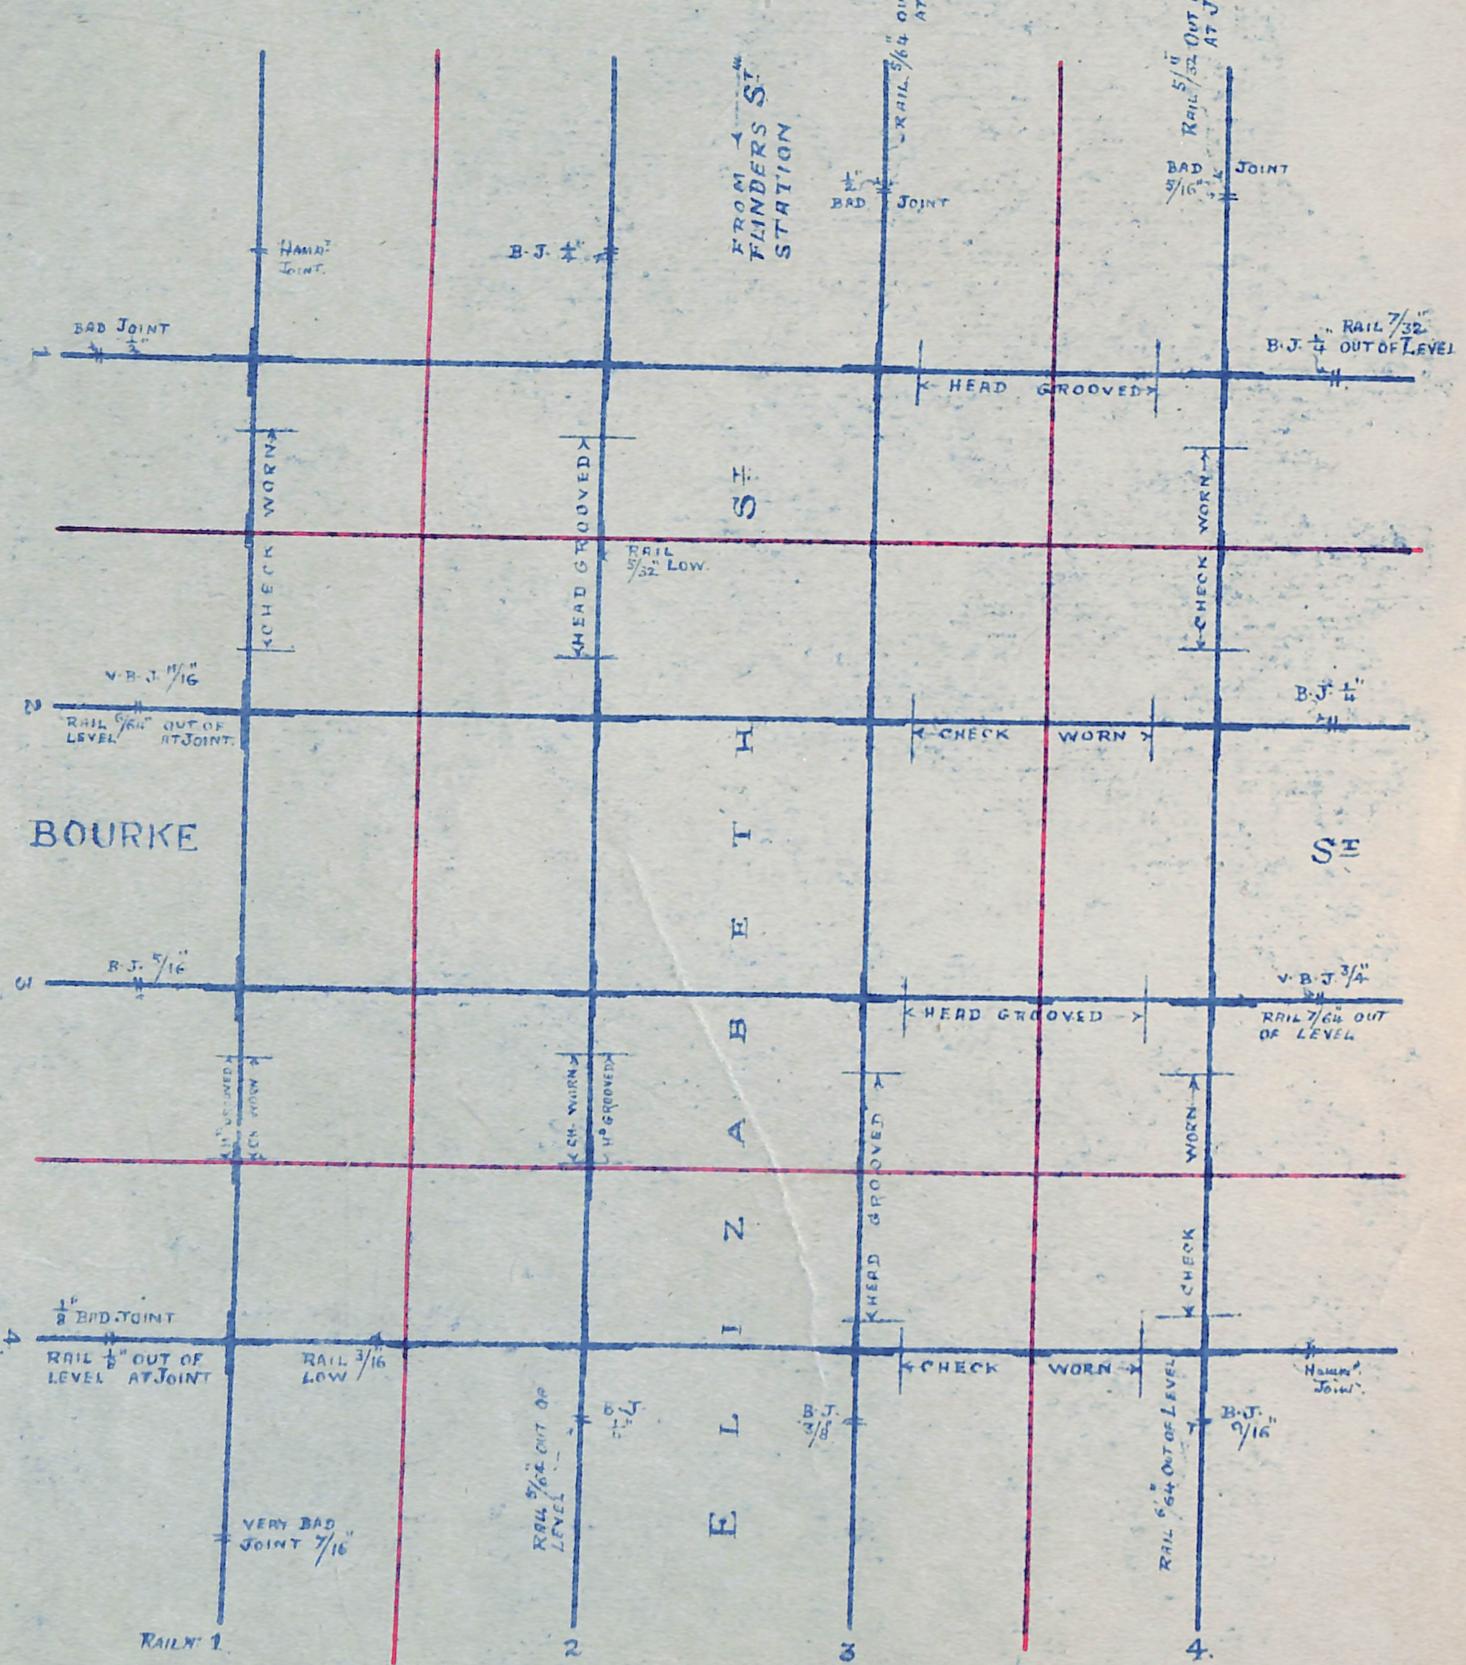
LINE 4. PLAN A-10. WITH ELIZABETH STREET.

1. There is considerable wear on rails at Crossing Intersections, resulting in excessive hammering. At the intersections of Tram rails with Slot Rails, hammering is taking place to varying degrees.
  2. The Tram-rails, between intersections and Slot-rails, are worn for a portion of their length, - the rail check being worn, and the side of head of opposite rail is grooved, as a result of the above Check wear.
  3. 14 of the Joints of Tram-rails, adjacent to rail intersections, are wide (varying from  $1/2''$  to  $3/4''$ ). Many of the Joints are hammered, to varying amounts. There is also hammering of some of the other joints, and want of lineability of the Tread Surface at ten places.
  4. Paving Blocks are loose in places, and tarred surface shattered.
- CLEARANCES between Flange and bottom of Groove, also SUPER-ELEVATIONS taken May 14th, 1916.

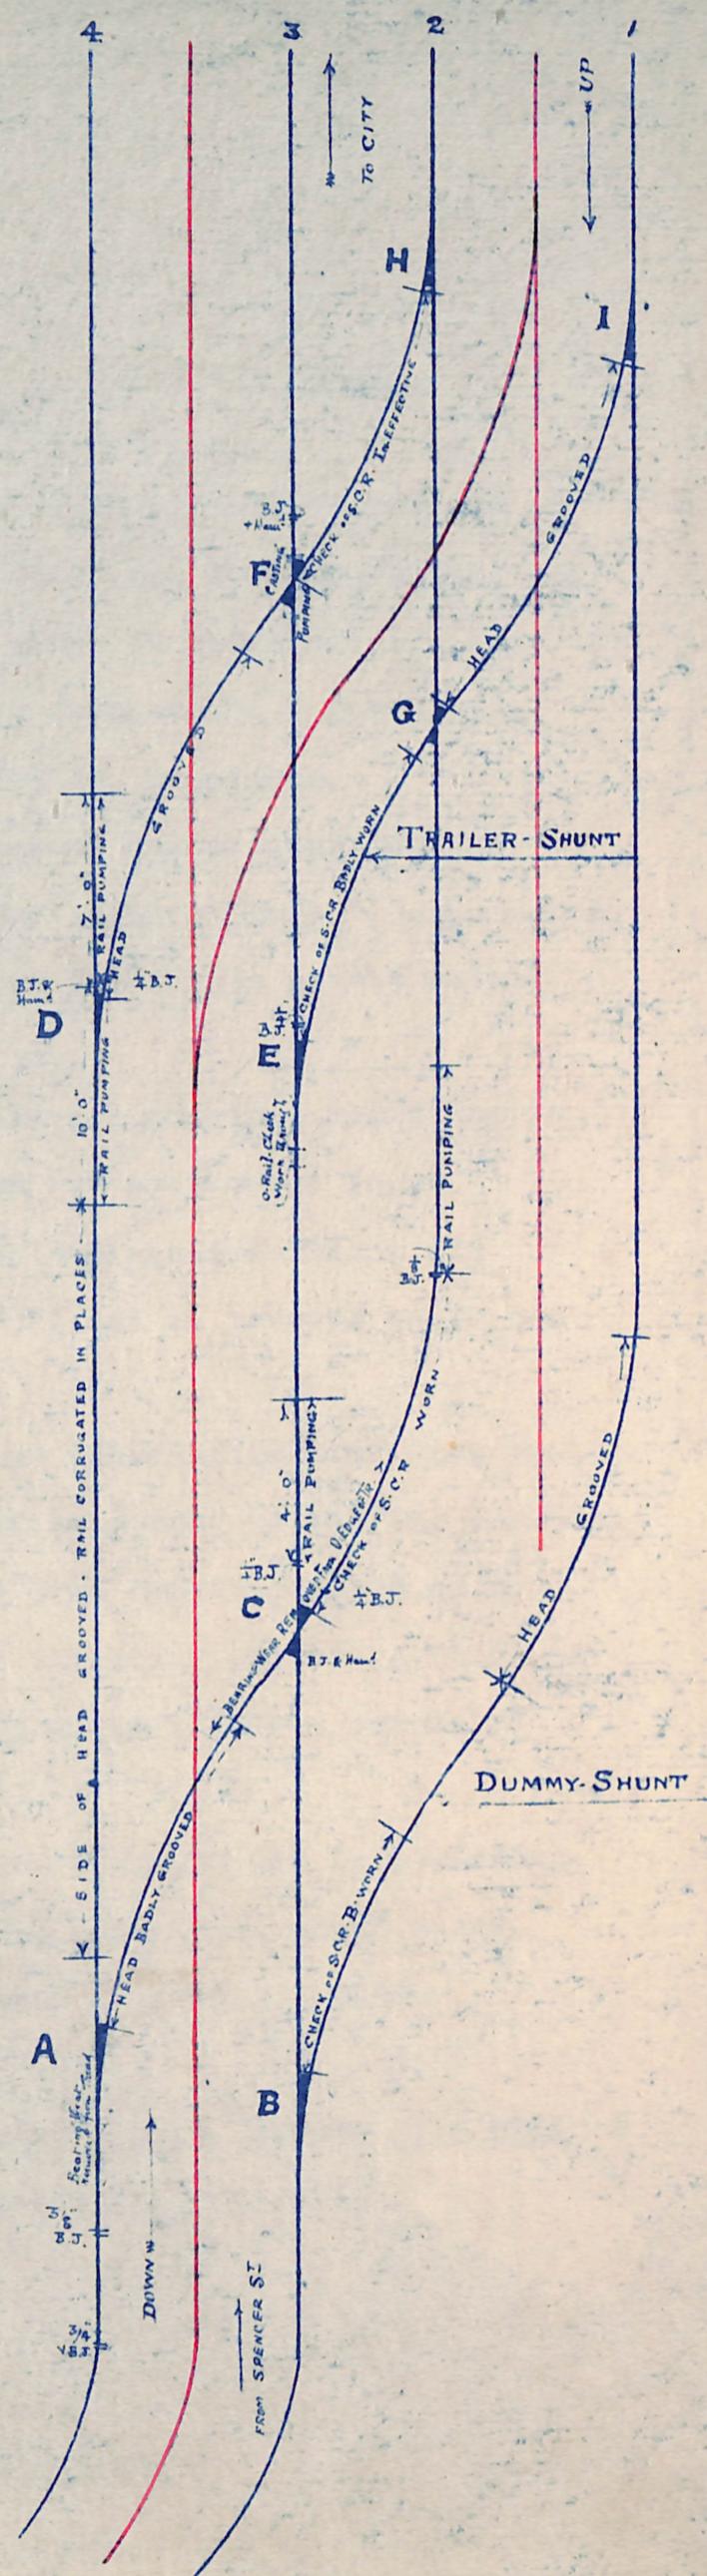
## SHUNTS (2) AT TERMINUS · BOURKE STREET

The special Checks of 3 of the four Inner Curves of Dummy and Trailer Shunts, are worn to varying amounts. In places, the special Checks are loose and ineffective.

The heads of the four Outer Curves of Dummy and Trailer Shunts are badly grooved in places as a result of the above Check wear. The Bearing wear has been removed from outer edge of tread, at several places, causing a projecting edge, which in places is high.

No. 4 RAIL (Down-Track). The side of head of Tram-rail, between Points of Dummy and Trailer Shunts, is grooved, and rail is corrugated in places.

Two short lengths of rails on each side of Point of Trailer-shunt, are pumping, and fishplates are presumably loose.

No. 3 RAIL (Down Track). A short length of rail (between end of curve of Dummy Shunt and Point of Trailer-Shunt) is pumping, and Point Castings and tongues have been fixed in lieu of same; also a fishplate is presumably loose.

The casting of Rail-crossing (intersection of Curved rail of No. 4 Rail, with No. 3 Rail Down Track), is pumping, and fishplates are presumably loose.

The check of ordinary rail, near Point of Trailer Shunt, is completely worn through.

No. 2 XXX RAIL - (UP TRACK). A short length of rail (between end of curve of Dummy Shunt and intersection of curved rail of Trailer-shunt) is pumping, and fishplates are presumably loose.

Paving is loose in several places, and tarred surface is shattered. At the Crossing intersections, also at intersections of Slot-Rails with Tram-rails, hammering to varying degrees is taking place.

Five of the 6 heels of Points are of loose fit and rocking, and several of these are below level of rails, resulting in excessive hammering. There is also diagonal wear on Treads, in several cases. Tongues are worn to varying amounts.

7 of the Joints of Tram-rails, adjacent to the rail-intersections and joints, are wide, varying from  $1/4"$  to  $3/4"$ , and in several cases are hammered.

- A. Heel bad fit and Rocking.  
Tongue Worm.
  - B. Heel below level of Rail, and Rocking.  
Tongue Worm.
  - C. Bad Hammering at Rail Intersections.
  - D. Heel below level of Rail, and Rocking.  
Tongue Worm.      Diagonal Wear  
on Tread of Point-Casting.
  - E. Heel bad fit and Rocking.  
Tongue V. Badly Worm.
  - F. Bad Hammering at Rail Intersections.  
Casting of Rail-Crossing Pumping.
  - G. Hammering at Rail Intersections.
  - H. Heel Bad fit, and Rocking.  
Tongue Worm.
  - I. Tongue Slightly Worm.

Since the above Track was first inspected, and particulars noted, the two Point-Castings of Trailler-shunt (on Nos. 3 and 4 Rails), also a 7'0" length of rail, have been taken up and New Point Castings and Tongues have been fixed in lieu of same; also a 7'0" length of second-hand rail has been laid adjacent to Point-Casting work (No. 4 Rail). This was carried out on May 23rd. 1916.
