LINE 4. PLAN A.5.

# SHUNT NICHOLSON S<sup>T</sup>

LINE 4.

EMERGENCY SHUNT - NICHOLSON STREET (OPPOSITE

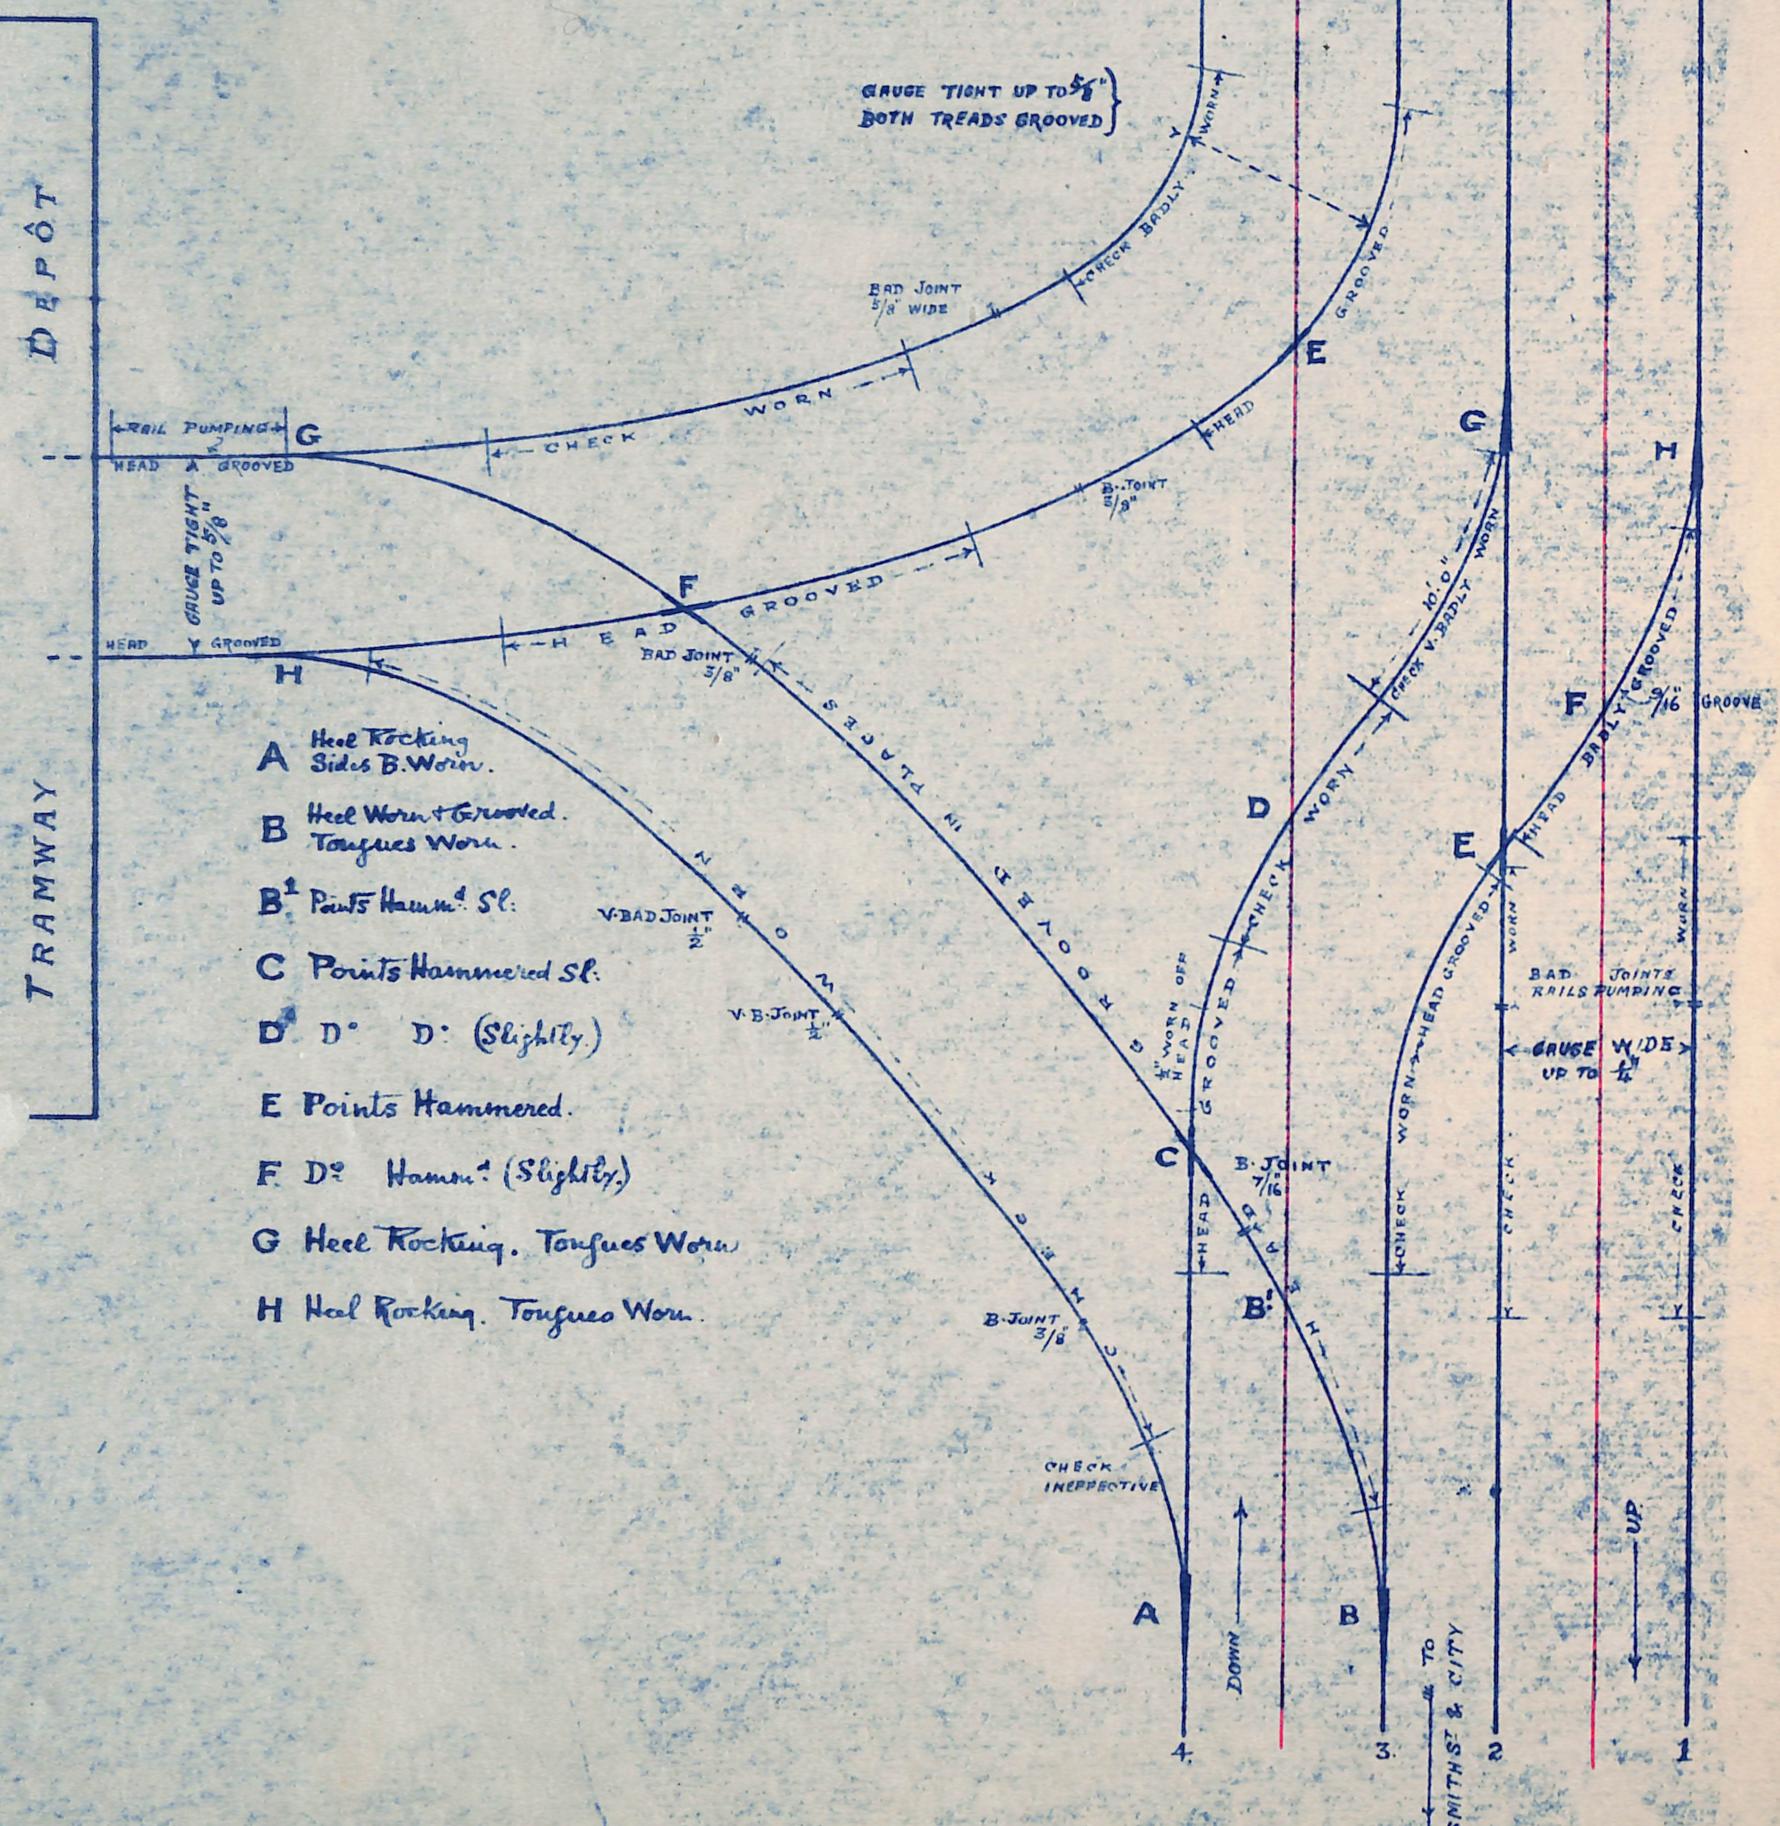
LINE 4. PLAN B.1.

1. H. D: ~~Heel Tread Slight~~ Foot Wear.  
 The Checks of Special check-rails to "Turn-In" and "Turn-Out" of Car Depot, also 3 of the Inner Curves of Dummy and Trailer Shunts, are worn, and in places very badly so. The sides of heads of opposite rail are grooved, as a result of the above check-wear. Checks to special check-rails are loose, and ineffective, in places.

2. The heels of 7 of the eight Points are of bad fit and rocking. In several cases the heel is below level of adjacent rail. Tongues are worn to varying degrees. In several cases the treads of the Point-Castings are diagonally worn.

3. In three places, lengths of Tram-rails are pumping, resulting in loosening of adjacent paving. Fishplates are presumably loose.
4. 10 of the Joints of rails adjacent to rail-intersections and Points, are wide (varying from  $3/8"$  to  $5/8"$ ) and in several cases are hammered.

5. At the Crossing-intersections, also at intersections of Slot-rails with tram-rails, hammering and wear is taking place, to varying degrees.
6. The gauge of Tram rails on "Run-Out", from Depot is tight up to  $5/8"$  in two places, and sides of heads of rails are grooved. Gauge on straight rails (opposite "Run-In") is wide up to  $1/4"$  and checks of both rails are worn.

E Points Hammered.  
 No. 4 rail at Terminus (opp. 464 Heidelberg Road) is bottoming for about 3 yards. Rail-Tread is 125 mils lower than wheel gauge.

**A** Heel Tread Low. Heel Rocking.  
Pointe Worn Badly. Tongue Worn.  
Heel Rocking.  
**B** Point Worn Badly. Tongue Worn.

## C Points Badly Hammered. Loose Fish-Plates.

D<sup>2</sup> Points Hammered.

**E** D<sup>o</sup>: Slightly Hammered.

## F Rail Crossing Badly Hammered.

**G** Heel Rocking. Point worn away.

H D: Rocking Slightly. Point Work.
