RATHDOWN STREET

SCHEDULE OF SHUNTS.

NORTH CARLTON LINE.

T
R
A
M
C
A
R
D
E
P
O
T

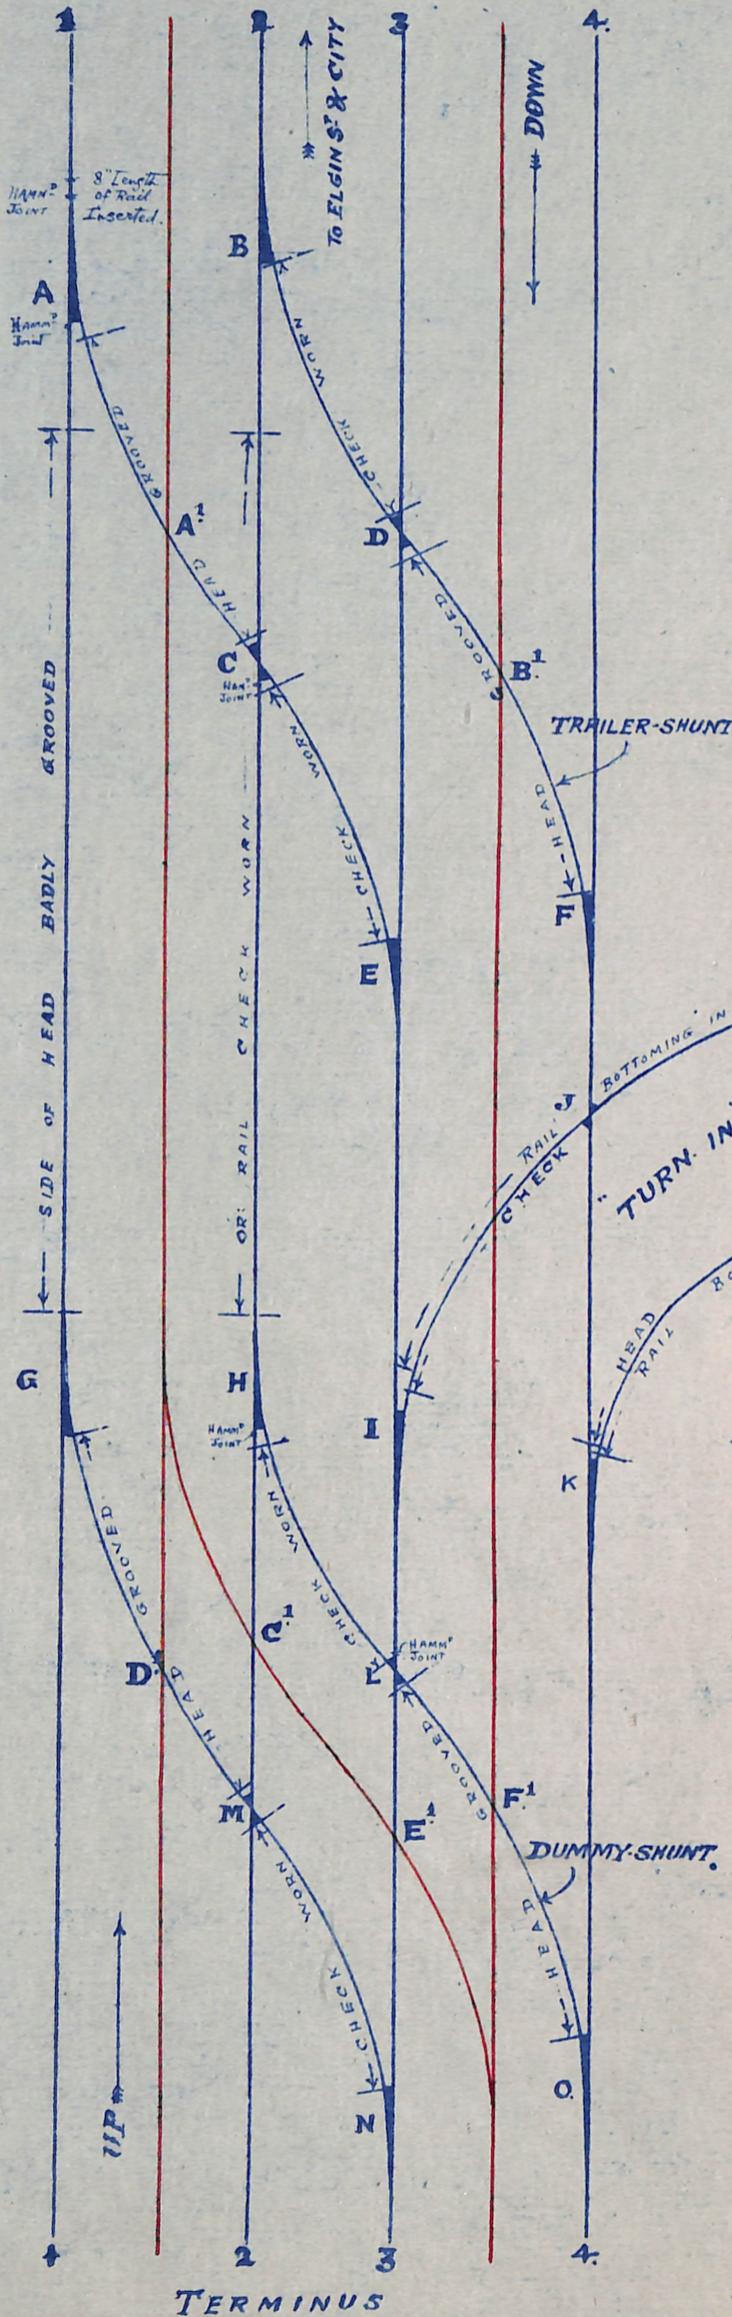
SHUNTS & TURN-IN TO DEPÔT.

1. The checks of Special Check-Rails of the four Inner Curves of Dummy and Trailer Shunts, also check of Outer Curve of "Turn-In" to Car Depot, are worn to varying amounts. *Heel Rocking Badly, A Tongue Badly Worn, Heel loose fit, & Rocking.*

2. The sides of heads of the four Outer Curves of Dummy and Trailer Shunts, also side of head of Inner Curve of "Turn-In" to Car Depot, are grooved as a result of the above check-wear. *D, E Heel Rocking, Tongue Worn, F D. Rocking, Tongue Worn, G Point Badly Worn, H B.*

3. 8 of the ten heels of Points to Shunts and "Turn-In", are loose, of bad fit, and rocking. Tongues are worn to varying degrees, and in some cases badly so. *J Hammering at Intersections, K Heel Rocking, Tongue Worn, L Slight Hammering at Intersections.*

4. The ordinary rail-check of No. 2 Straight-rail (between Dummy and Trailer Shunts) is worn, whilst the side of head of opposite (No. 1) Rail is badly grooved, as a result of the above check-wear. *M Hammering at Intersections, N Heel Rocking, Tongue Worn, O Grooved in places.*

5. At the Crossing intersections, also at intersections of slot-rails with tram-rails, hammering is taking place to varying amounts, and at some places it is very considerable.

6. Hammering is taking place, to varying degrees, at joints of Tram-rails, adjacent to Crossing-intersections, and Points.
7. Gauge, between Nos. 3 and 4 Rails, Down Track, (opposite Car-House Door) is 1/8" tight. *A Slight Hammering at Intersections, B, C.*

8. The two rails of "Turn-In" to Car Depot are bottoming in places, and Inner-rail tread is 40 mils lower than wheel gauge. *D Bad Hammering at Intersections, E.*

- Heel Rocking Badly
 - A Tongue Badly Worn.
 - Heel loose fit, + Rocking.
 - B. Tongue Worn.
 - C Bad Hammering at Intersections.
 - D -
 - E Heel Rocking - Tongue Worn.
 - F D. Rocking. Tongue Worn.
 - G Point Badly Worn
 - H D. D. D
 - I Heel Rocking. Tongue Worn.
 - J Hammering at Intersections.
 - K Heel Rocking. Tongue Worn
 - L Slight Hammering at Intersections.
 - M Hammering at Intersections.
 - N Heel Rocking. Tongue Worn.
 - O Heel Rocking Badly.
 - Tongue B. Worn.
-
- A¹ Slight Hammering at Intersections.
 - B¹ -
 - C¹ -
 - D¹ Bad Hammering at Intersections
 - E¹ -
 - F¹ Hammering at Intersections.

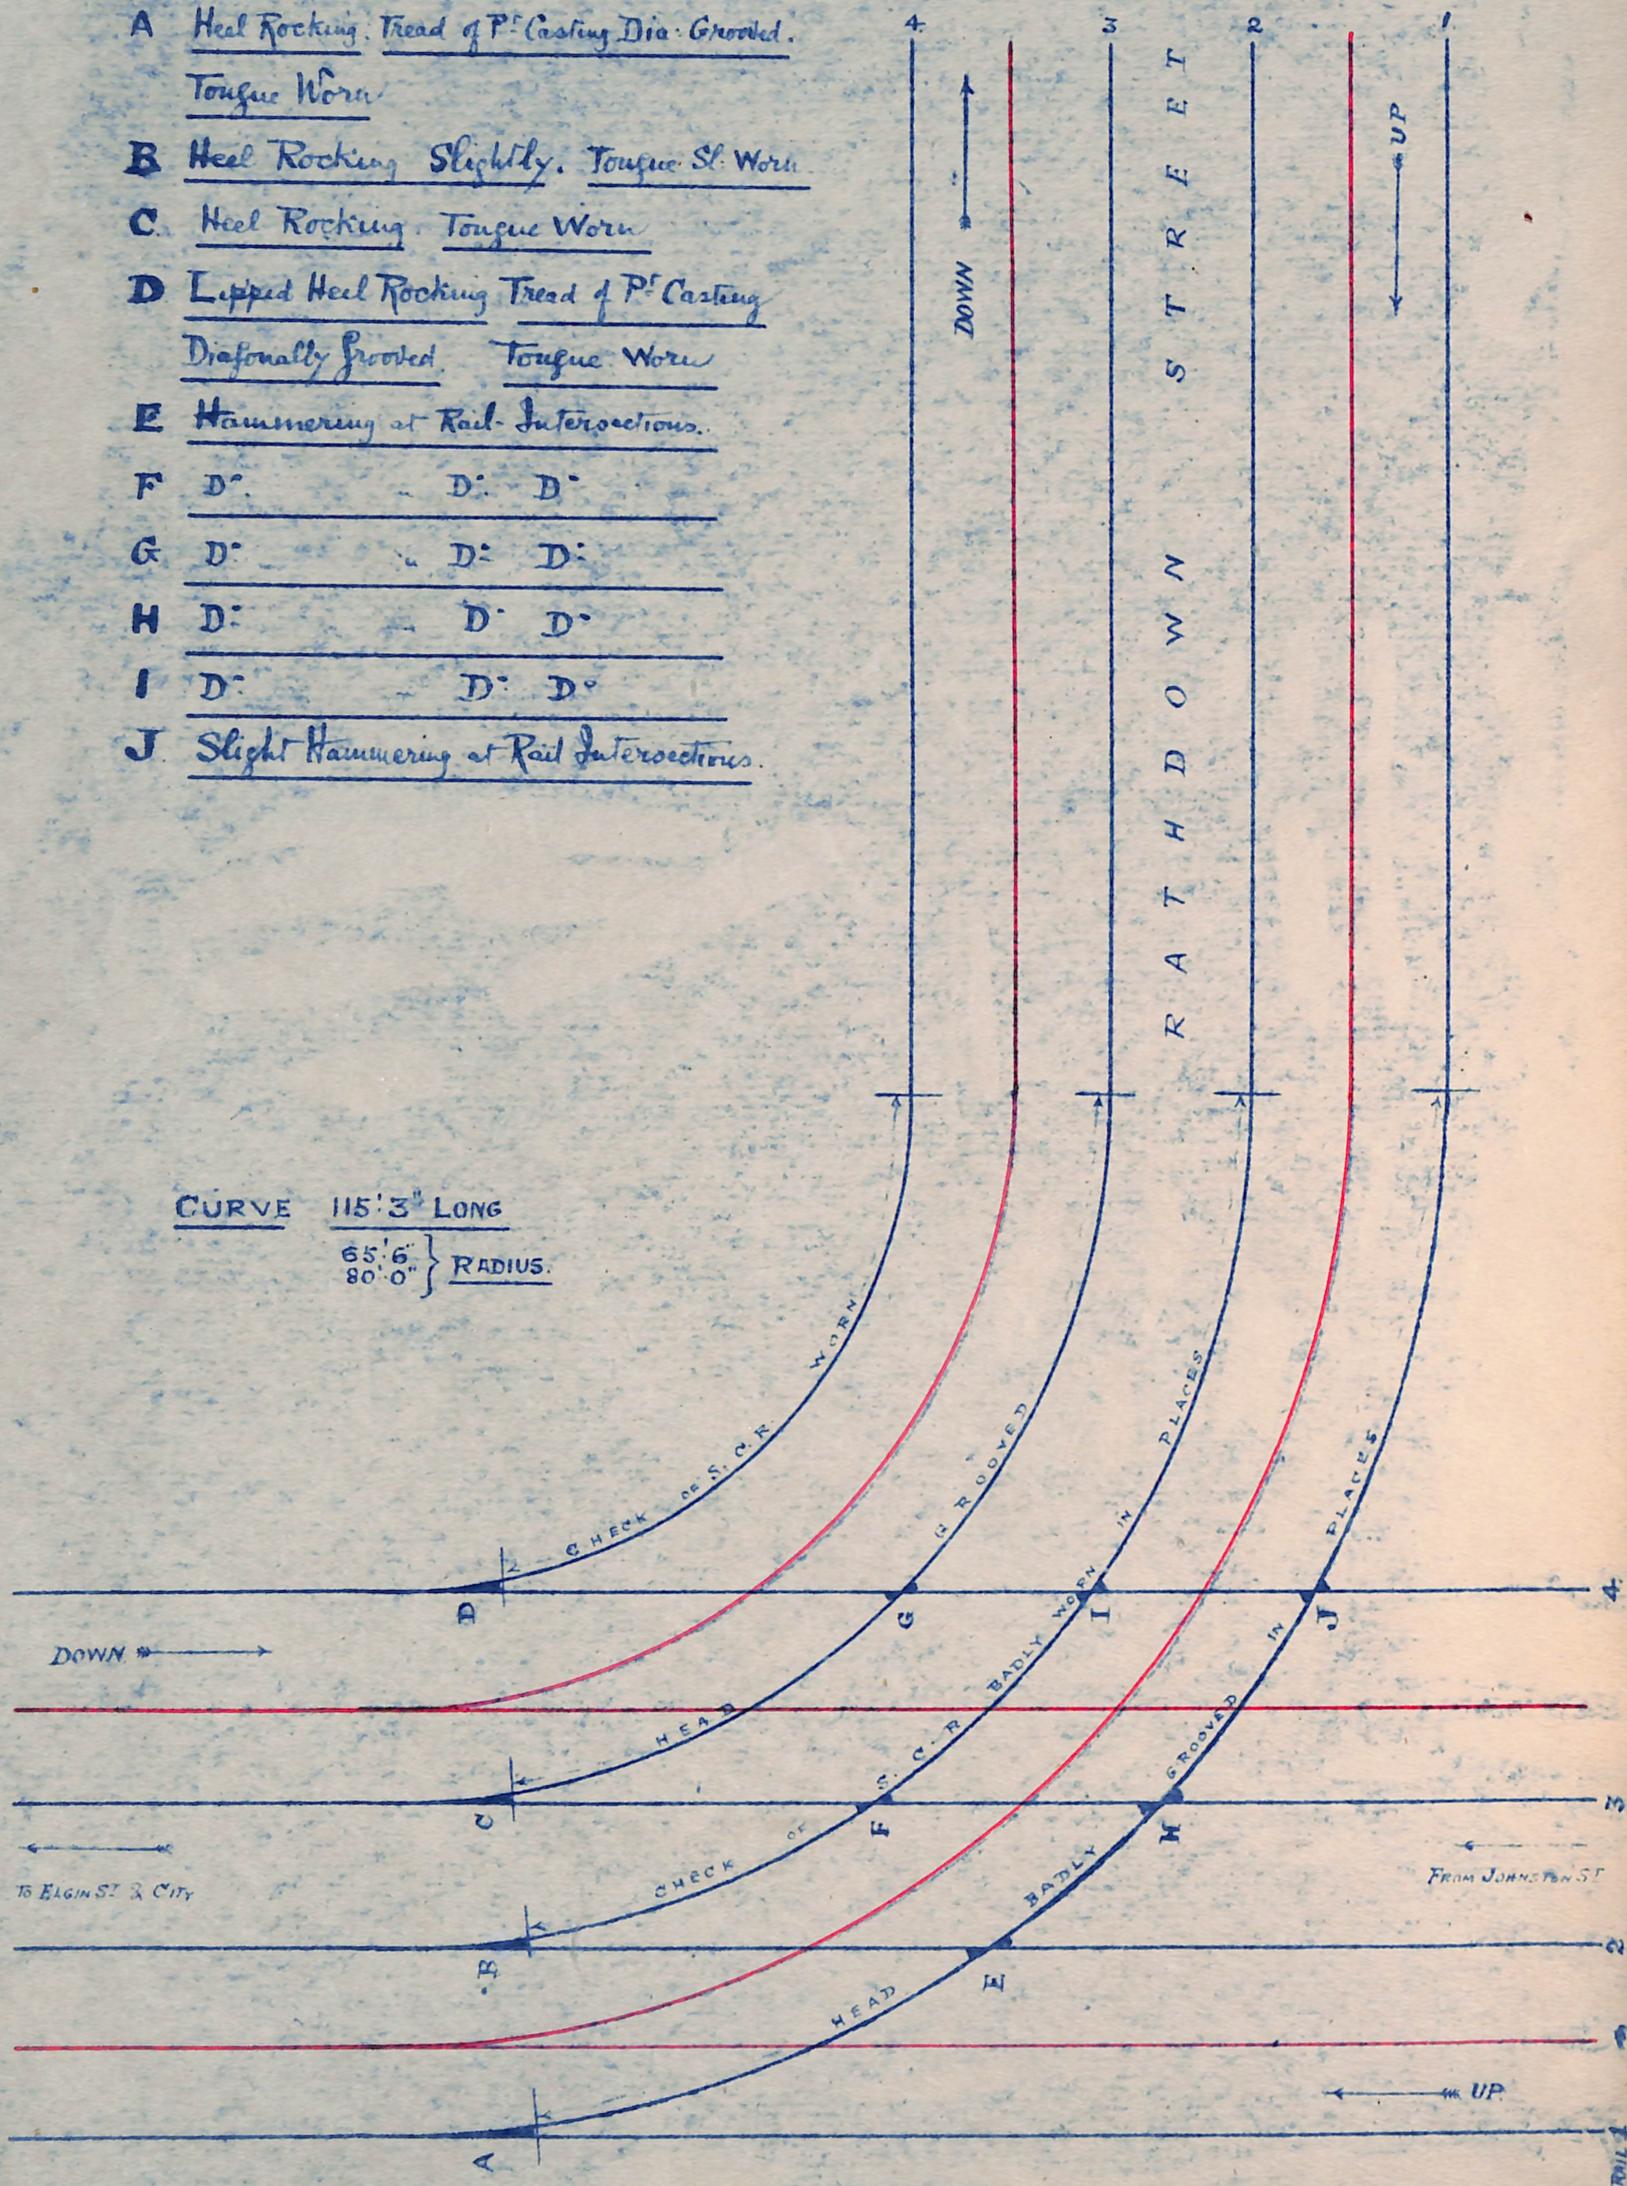
CURVE AND JUNCTION AT JUNCTION OF RATHDOWN

1. *Lippis Heel Rocking. Head of P. Casting*
 D The Checks of Special Check-rails of Nos. 2 and 4 Rails, are worn to varying amounts, and badly so in places. Check to No. 2 Check-rail requires renewing.

2. *Hammering at Rail Intersections*
 F The sides of heads of opposite rails (Nos. 1 and 3) are badly grooved in places as a result of the above check wear.

3. *Super Hammering at Rail Intersections*
 H Three of the 4 heels of Points are of loose fit, and rocking. There is also diagonal wear on two of the treads of Point-Castings. Tongues are worn to varying degrees.

4. At the Crossing-Intersections, also at intersections of slot-rails with tram-rails, hammering to varying amounts is taking place.
5. There is also hammering at joints of Tram-rails, adjacent to Rail-crossings and Points.

- A Heel Rocking. Tread of P^c Casting Dia. Grooved. Tongue Worn
- B Heel Rocking Slightly. Tongue Sl. Worn
- C Heel Rocking. Tongue Worn
- D Lipped Heel Rocking Tread of P^c Casting Diagonally Grooved. Tongue Worn
- E Hammering at Rail Intersections.
- F D° D° D°
- G D° D° D°
- H D° D° D°
- I D° D° D°
- J Slight Hammering at Rail Intersections.

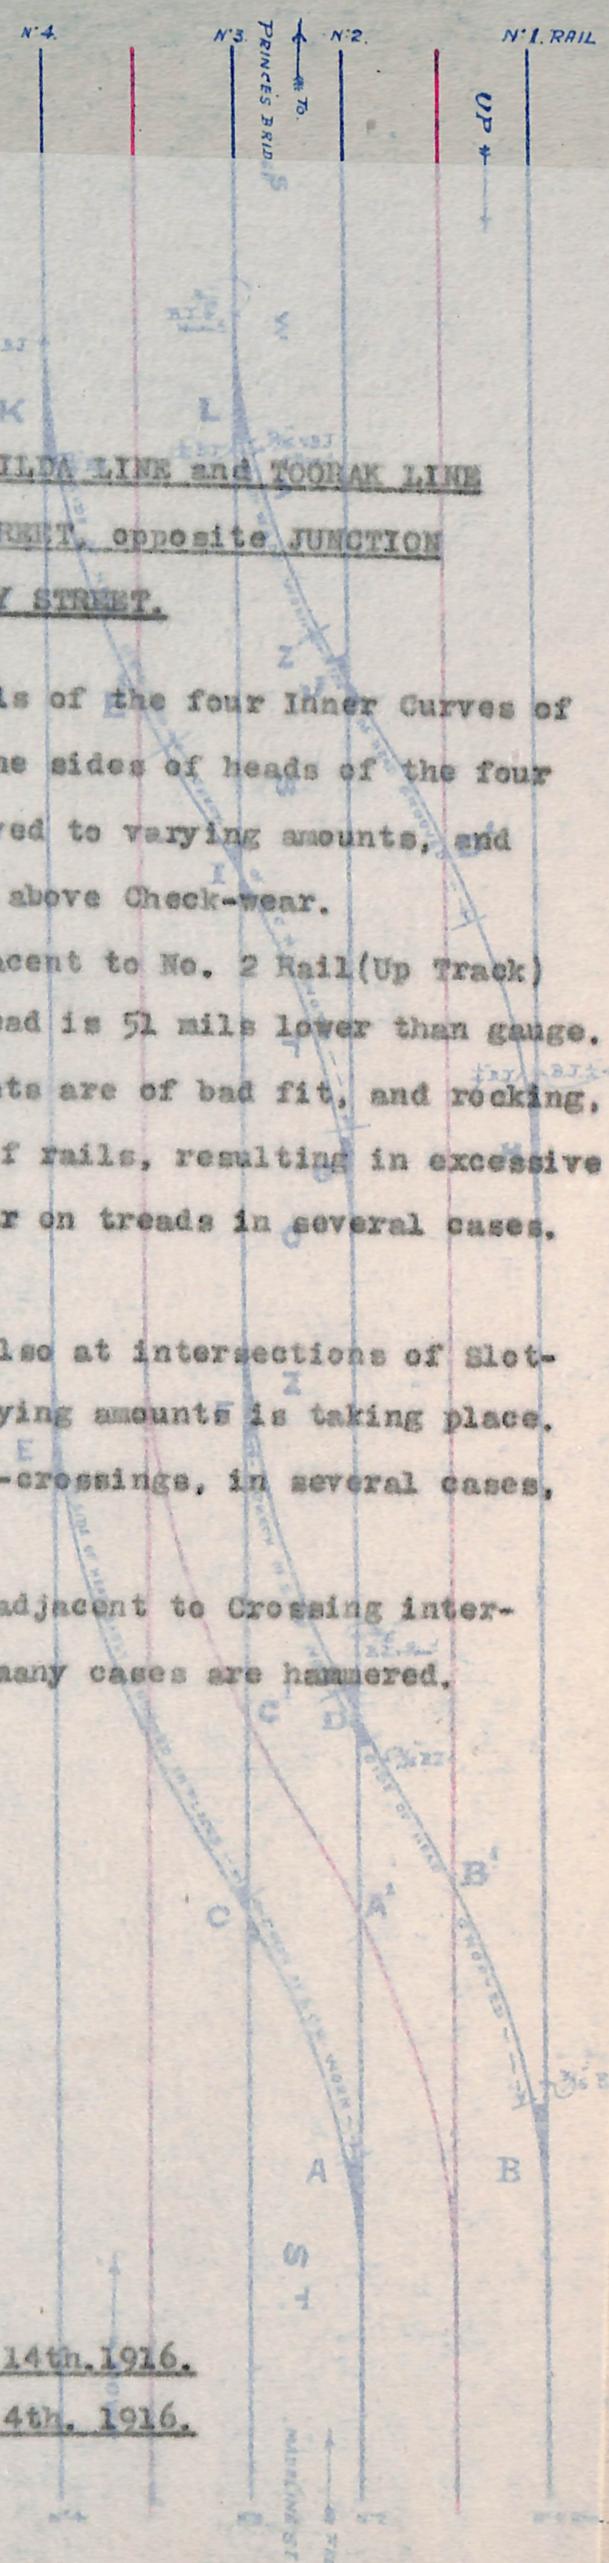
SWANSTON STREET · NEAR JUNCTION WITH
QUEENSBERRY STREET

1. E The Checks of Special Check-rails of the four Inner Curves of
 Dummy and Trailer Shunts are worn. The sides of heads of the four
 opposite Rails (Outer Curves) are grooved to varying amounts, and
 badly so in places, as a result of the above Check-wear.

2. G The Cross-over(Outer) rail, adjacent to No. 2 Rail(Up Track)
 is bottoming for about 5 yards, and Tread is 5/16 mile lower than gauge.

3.7- H 7 of the heels of the Eight Points are of bad fit, and rocking,
 and several of these are below levels of rails, resulting in excessive
 hammering. There is also diagonal wear on treads in several cases.
 I Tongues are worn to varying degrees.

4. K At the Crossing-intersections, also at intersections of Slot-
 rails with Tram-rails, hammering to varying amounts is taking place.
 L The sides of Treads of castings of rail-crossings, in several cases,
 are grooved.

5. A 10 of the Joints of tram-rails, adjacent to Crossing inter-
 sections, and Points, are wide, and in many cases are hammered.

- A { Heel Rocking . Tongue Worn
Tread of Point-Casting Badly Worn.
- B { Heel Rocking . Tongue Worn.
Tread of Point-Casting Badly Worn.
- C Hammering at Rail Intersections.
- D Bad Hammering at D° D°
- E { Heel Rocking . Tongue Worn.
Point-Casting Worn
- F Heel Rocking . Tongue Worn
- G { Heel Rocking . Tongue Worn.
Tread of Point-Casting Badly Worn.
- H { Heel Rocking . Tongue Worn, and High at Heel.
Tread of Point-Casting Worn.
- I
- J
- K { Heel below level of Rail, and Rocking.
Tongue Worn.
- L
- A¹ Hammering at Rail and Slot Intersection.
- B¹ { Hammering - D° - D° D°
Side of Tread of Rail Grooved.
- C¹ Hammering at Rail Intersections.
- D¹
- E¹

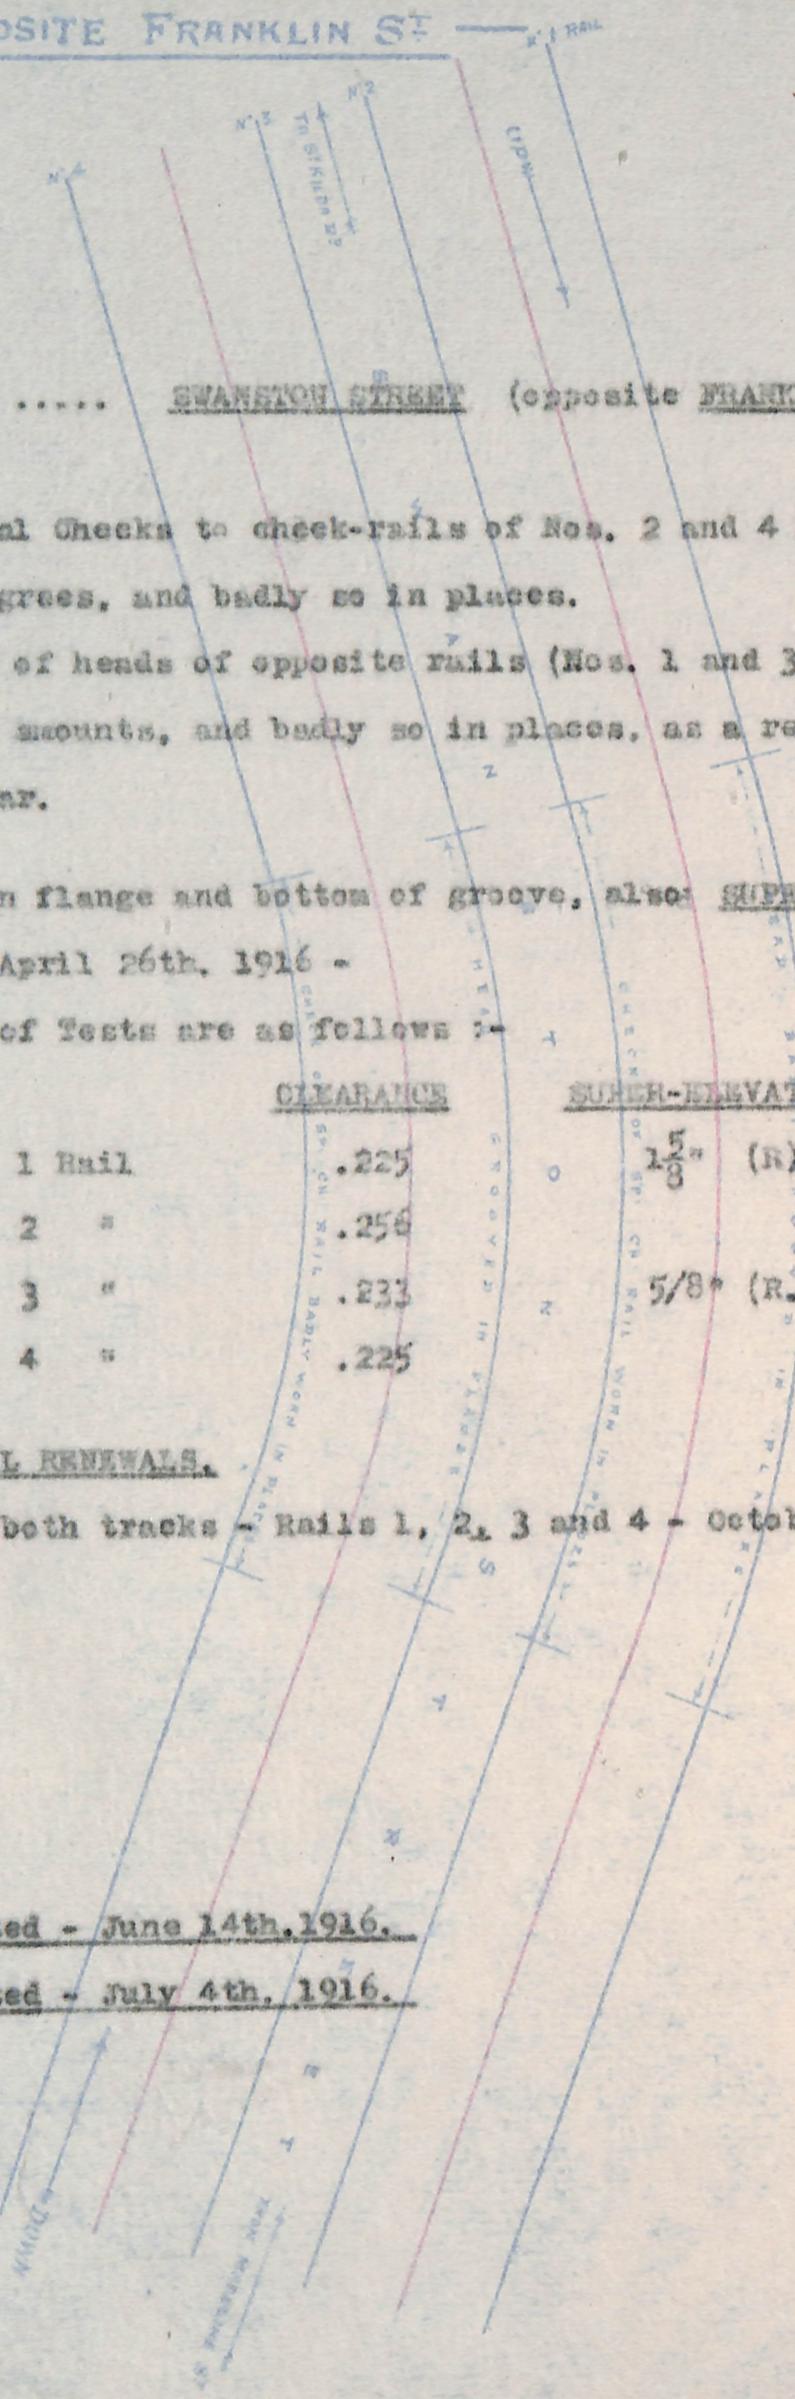
CURVE SWANSTON STREET

1. The Special Checks to check-rails of Nos. 2 and 4 Rails are worn to varying degrees, and badly so in places.
2. The sides of heads of opposite rails (Nos. 1 and 3) are grooved to varying amounts, and badly so in places, as a result of the above check wear.

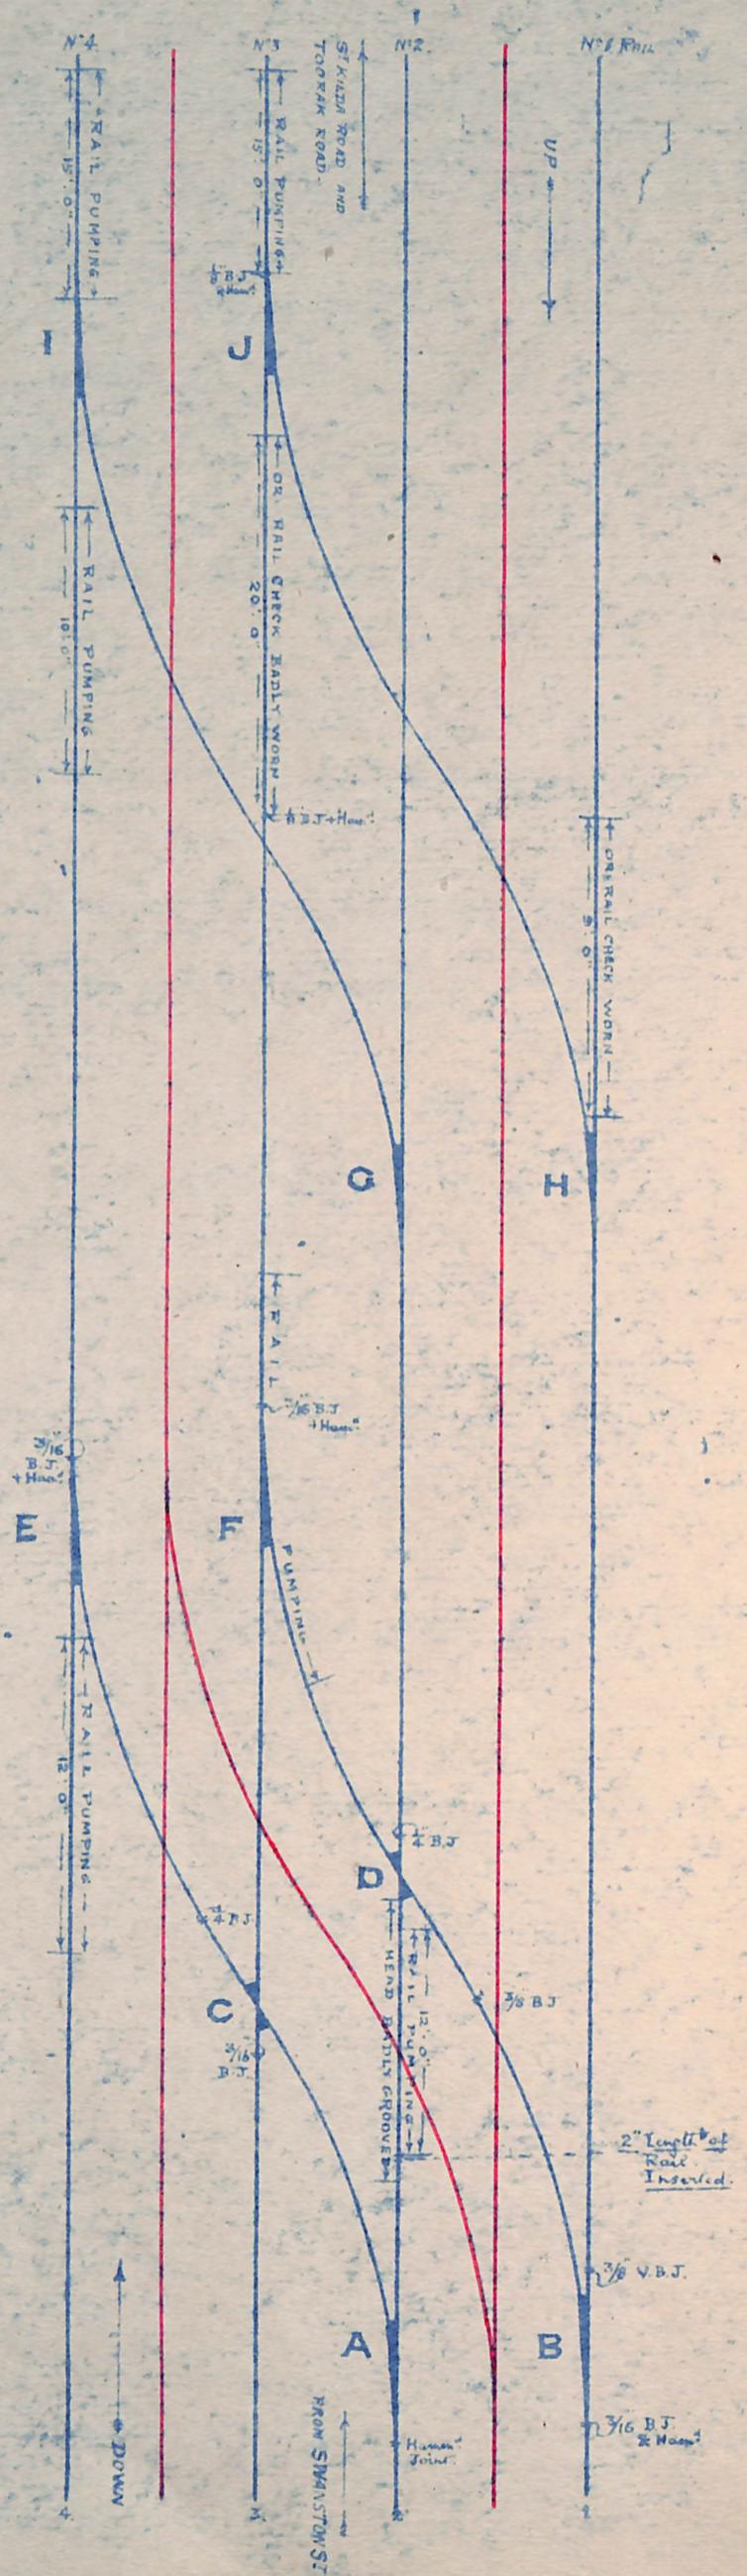
EMERGENCY SHUNTS

1. The ordinary rail-checks of No. 1 (Up-Track) adjacent to Point of Dummy-Shunt, are worn for about 9 feet. The ordinary rail-check of No. 3 (Down Track) between Point and Rail-crossing of Dummy-Shunt is badly worn for about 20 feet.

2. A short length of No. 2 Rail, between Point and rail-crossing of Trailer-Shunt, has the side of head badly grooved.
3. Nos. 1, 2, 3 and 4 Rails. These rails, also a length of Curved rail of Trailer-Shunt (adjacent to Point on No. 3 Rail) are pumping in six places. Paving Blocks on each side of pumping rails are loose, and tarred surface shattered.

4. At the Crossing-intersections, also at intersections of xxx slot-rails with tram-rails, hammering to varying amounts is taking place, and in places it is considerable.

5. There is diagonal wear on the Treads of Point Castings in several cases, whilst in places the sides of Treads are grooved to varying amounts. Tongues are worn to varying degrees, and in most cases badly so.

6. 10 of the Joints of Tram-rails, adjacent to Crossing-intersections and Points, are wide, (varying from 3/16" to 3/8"), and in many cases, are hammered. There is also hammering taking place at some of the other joints.

No. 4 Rail is bottoming for 6 yards.

A { Side of Head of Point-Casting Diagonally Grooved.
Tread Very Badly Hammered.

B Tongue Badly Worn

C Bad Hammering at Rail Intersections

D Bad Hammering at D° D°

E { Side of Tread of Point-Casting Grooved
Tongue Very Badly Worn.

F { Rail Tread Diagonally Grooved.
Tongue Badly Worn

H Tongue Badly Worn.

I Tongue Badly Worn.

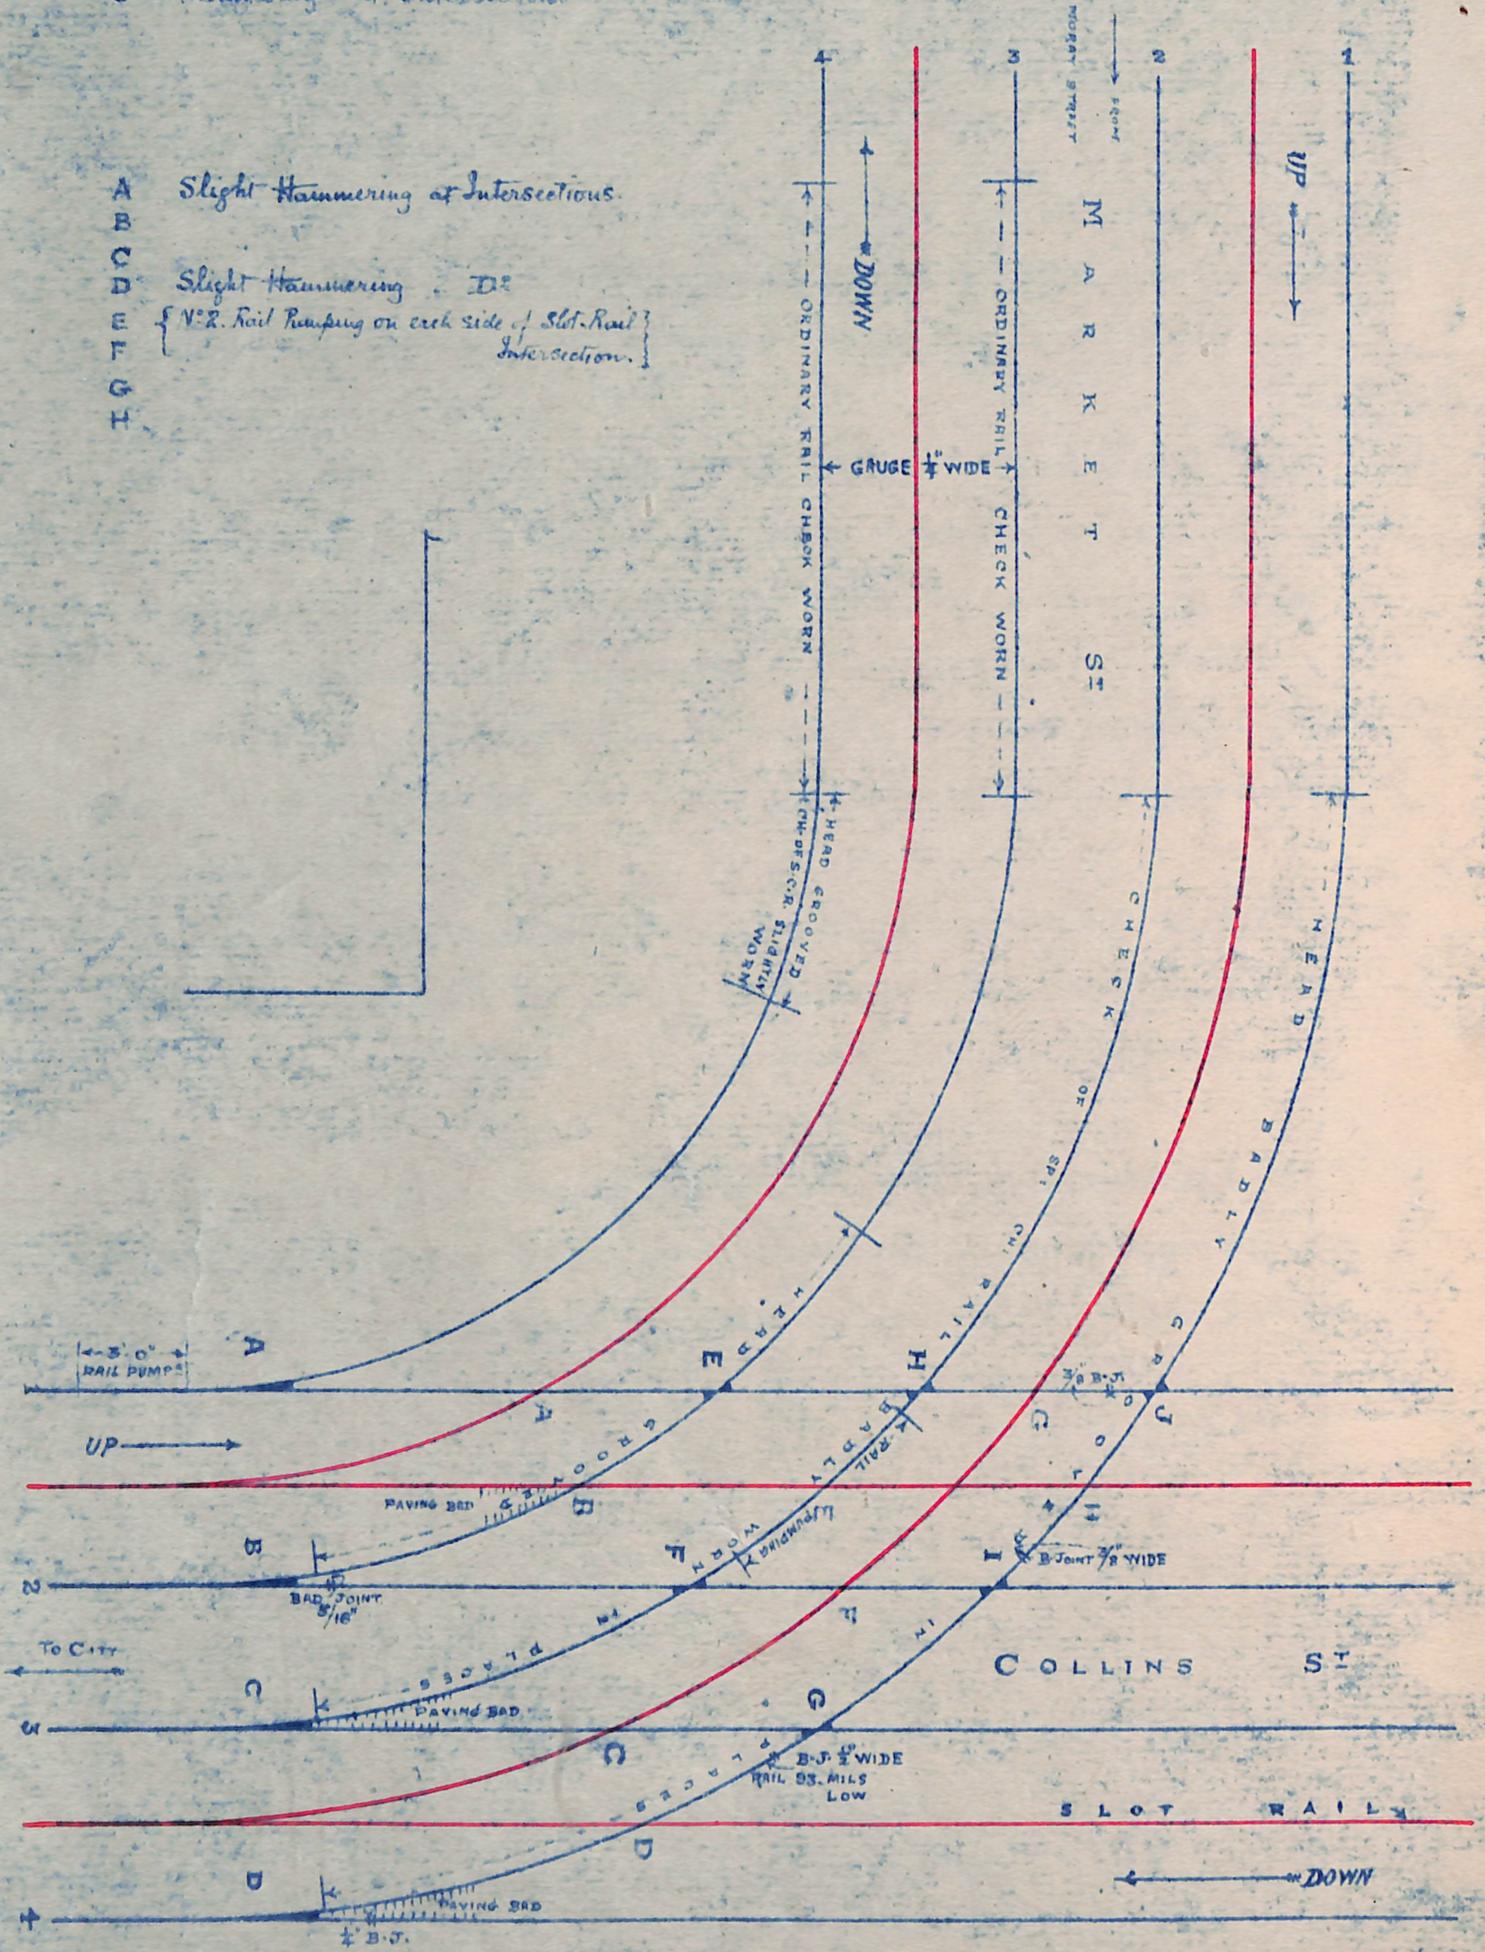
CURVE AT JUNCTION WITH COLLINS ST

1. The checks of special check-rails of Nos. 2 and 4 Rails, are worn to varying degrees, and badly so in places.
 2. The sides of heads of opposite rails (Nos. 1 and 3) are grooved to varying amounts, and badly so in places, as a result of the above check-wear.

3. Three of the 4 heels of Points are of loose fit, and rocking. There is also diagonal wear on treads of Point-Castings. Tongues are worn to varying degrees.

4. At the Crossing-intersections, also at intersections of slot-rails with tram-rails, hammering is taking place, to varying amounts, and in places it is considerable.

5. 5 of the joints of tram-rails adjacent to rail-crossings and Points are wide, varying from 1/4" to 1/2", and in several cases are badly hammered.
 6. Paving is loose in places, and tarred surface shattered.

- Gauge between Nos. 3 and 4 straight rails (Down Track) Market Street, adjacent to curve, is 1/4" wide. Ordinary rail-checks of these rails are worn.

A short length of No. 2 rail, near centre of Curve (between Nos. 1 and 2 Rails), Collins St. Line, also a short length of No. 1 Rail (Up Track) Collins St. Line, adjacent to Point, are each pumping, and fishplates are presumably loose.

- A Lipped Heel F.G. Fit. Tongue Worn
- B Heel Rocking. Tongue Worn
- C Heel Rocking Slightly. Tongue Worn
- D Heel D° Slightly. Tongue Worn
- E Hammering at Intersections.
- F Hammering at Intersections
- G Slight Hammering at Intersections.
- H Bad Hammering at Intersections.
- I Bad Hammering. D°
- J Hammering at Intersections

- A Slight Hammering at Intersections.
- B Slight Hammering. D°
- C V.R. Rail Pumping on each side of Slot-Rail Intersection.
- D
- E
- F
- G
- H
- I
- J

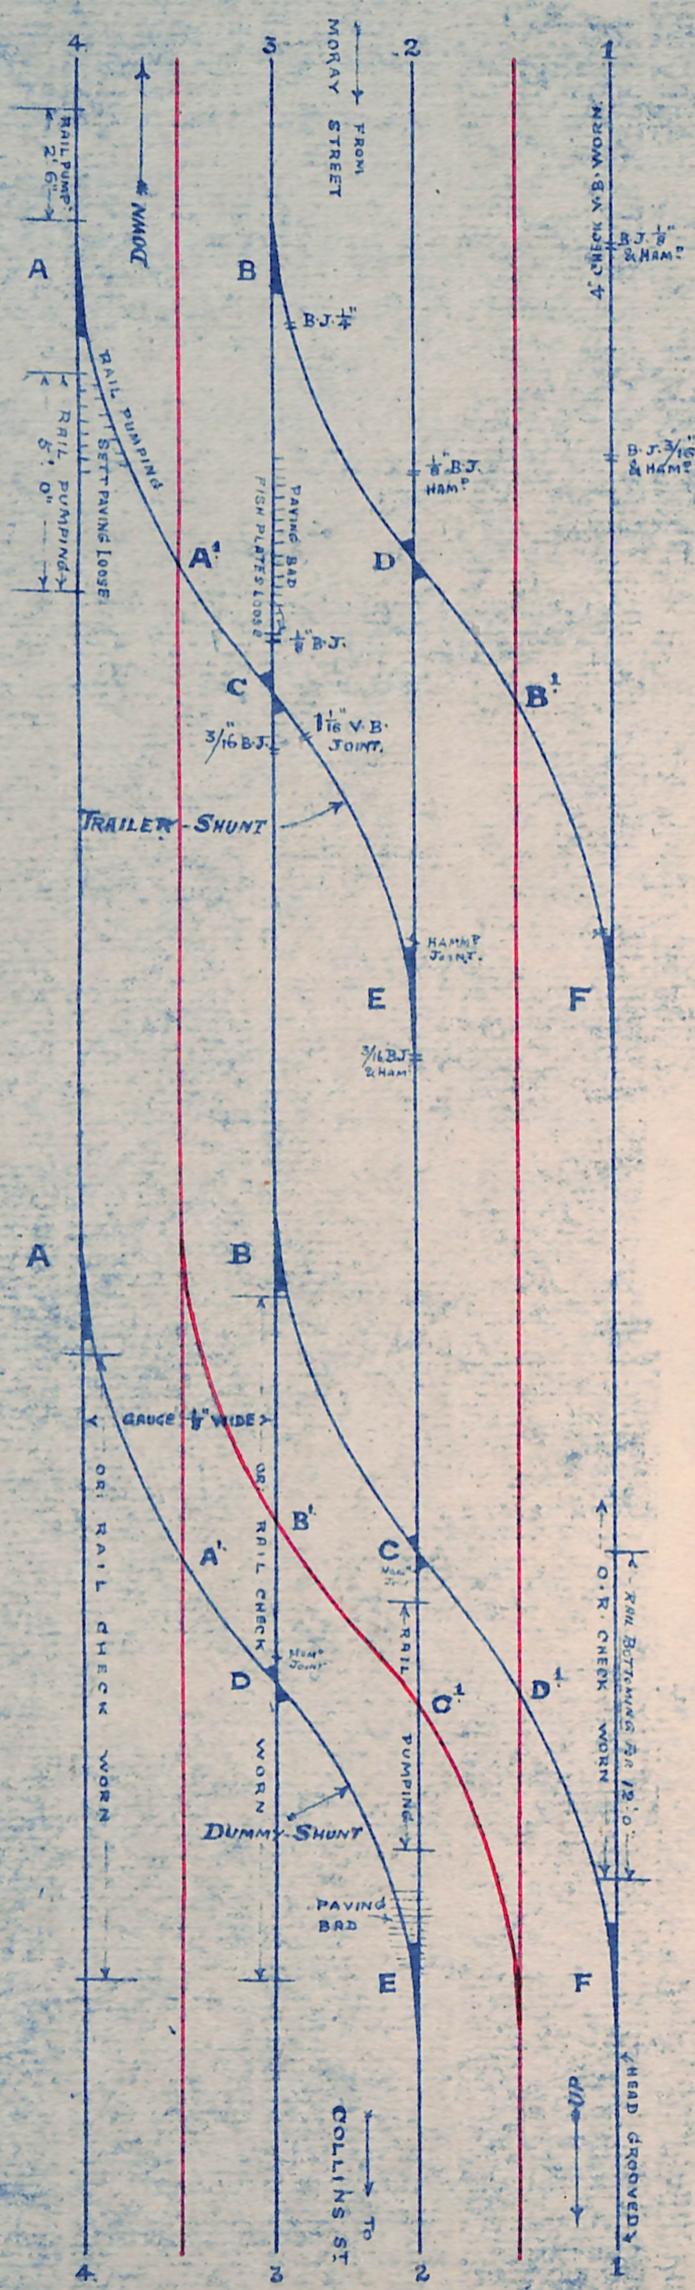
MARKET ST SHUNTS

1. The Gauge of Nos. 3 and 4 (straight) rails, adjacent to Points of Dummy Shunt, is $1/8"$ too wide, resulting in the ordinary checks of these rails being worn.

2. The ordinary rail-check of No. 1 Rail, for about 15 feet, is worn, and this rail is bottoming for about 12 feet. The side of head of No. 1 Rail, adjacent to Point of Dummy Shunt, (on North Side) is grooved.

3. Nos. 2, 3 and 4 Rails. Lengths of rails, in five places, are pumping, and fishplates are presumably loose. Paving on each side of pumping rails is loose, and in places the Stone Setts have very wide joints, and Tarred surface is shattered.

4. 5 of the heels of Points are of bad fit, and are rocking. There is diagonal wear on tread of one of the Point-Castings. Tongues are worn to varying amounts.

5. At the Crossing-intersections, also at intersections of slot-rails with tram-rails, hammering is taking place to varying degrees, and in places badly so. No. 2 Rail, at its intersection with slot-rail, is cracked.

6. 8 of the Joints of Tram-rails, adjacent to rail-crossings and Points, are wide, varying from $1/8"$ to $1\frac{1}{16}"$, and in several cases, are badly hammered. There is also hammering of some of the other joints, to varying degrees.

- A Heel Rocking Slightly.
- B No Points.
- C
- D
- E Heel Rocking. Tongue Worn
- F Heel Rocking Sl. Tongue Low, and Badly Worn.
- A' Points Slightly Hammered.
- B' D: D: D:

- A Heel Bad Fit, and Canted.
- B
- C
- D Points Hammered.
- E { Heels Badly made. Tongue Worn
Diagonal wear on Head.
- F Heel Bad Fit.

- A
- B
- C { Points Badly Hammered. Rail at
Intersection with Slot Rail, Cracked.
- D { Stone Sets. Very Wide Joints. Surface Bad

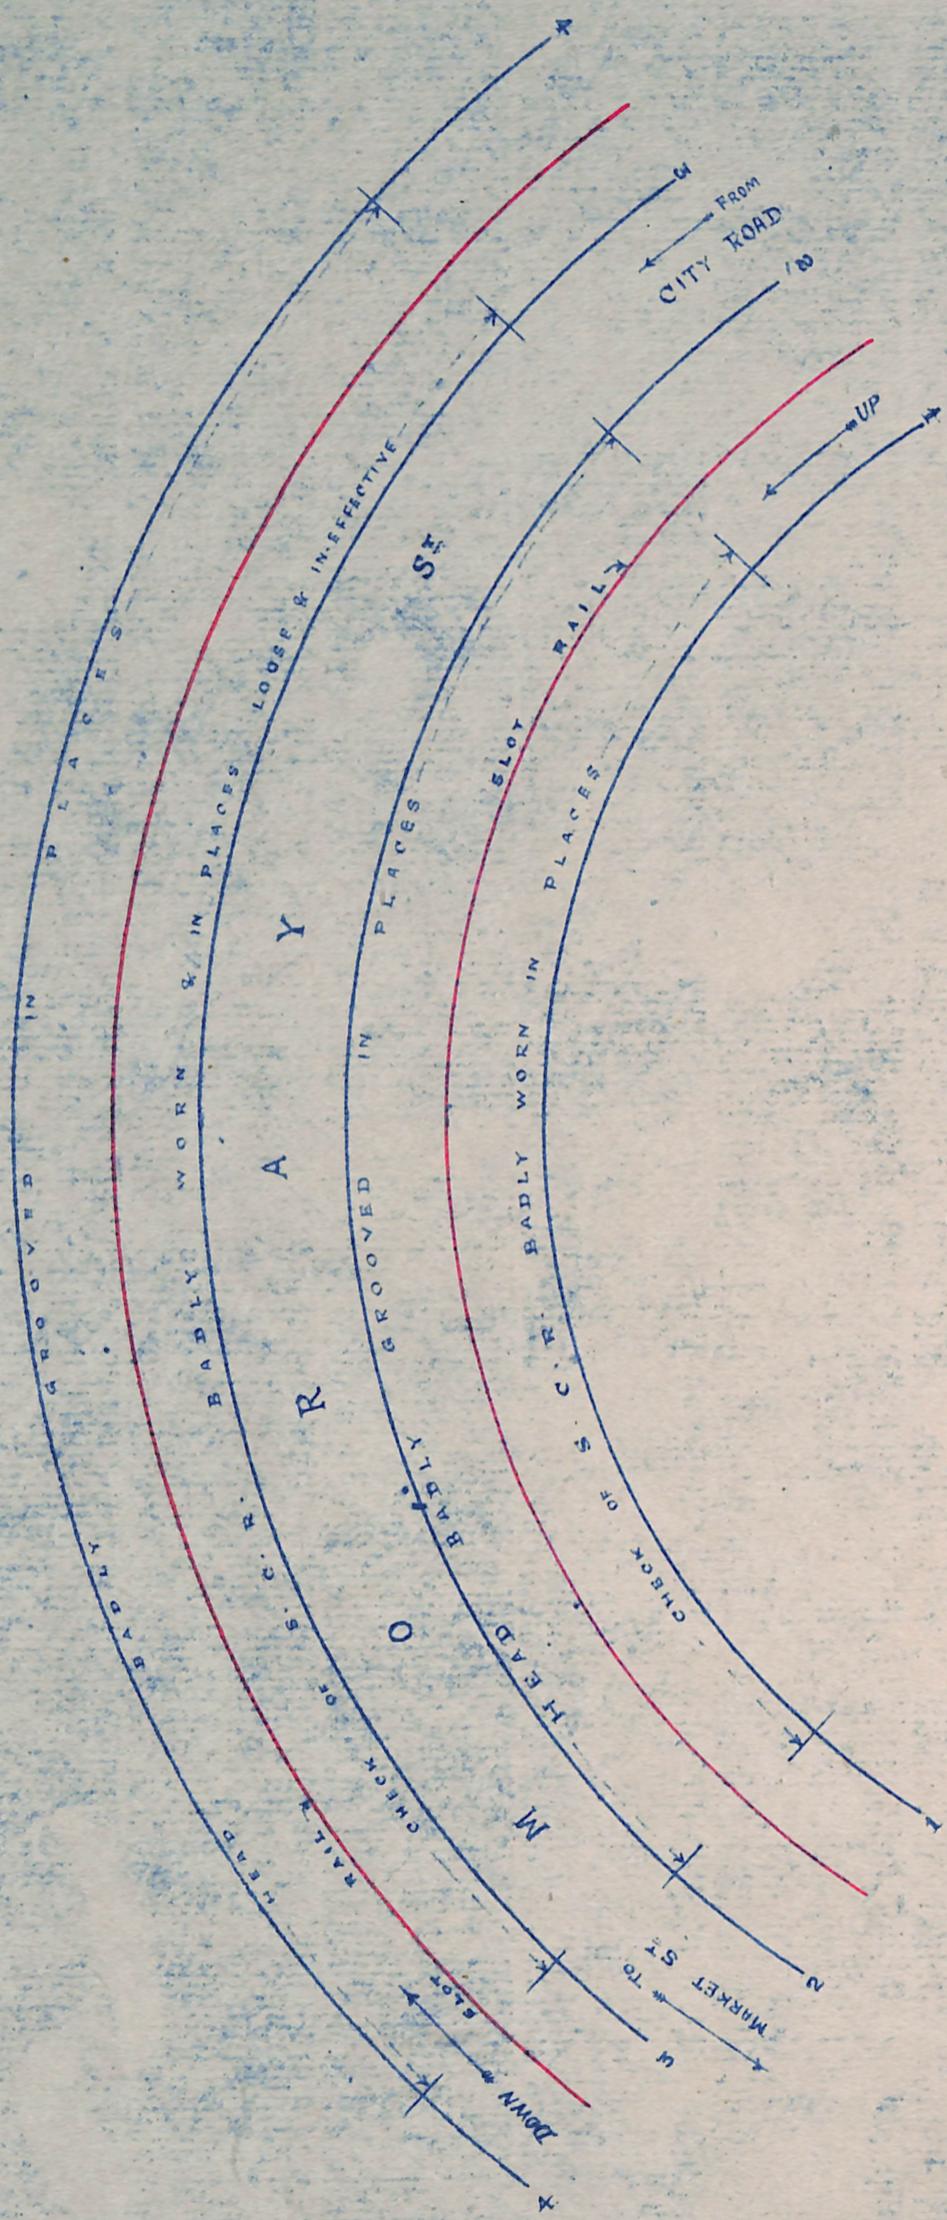
CURVE MORAY ST

1. The Checks of Special check-rails of Nos. 1 and 3 Rails are badly worn over the greater portion of length of curve. Special checks are loose and ineffective in places.
2. The sides of heads of opposite rails (Nos. 2 and 4) are badly grooved in places, as a result of the above check-wear.
