BALLARAT TRAMWAYS

TRAMWAYS - TAIL LIGHTS

WIRING DIAGRAM
TRAMCAR TAIL LAMP AND
BATTERY CHARGING ARRANGEMENT.

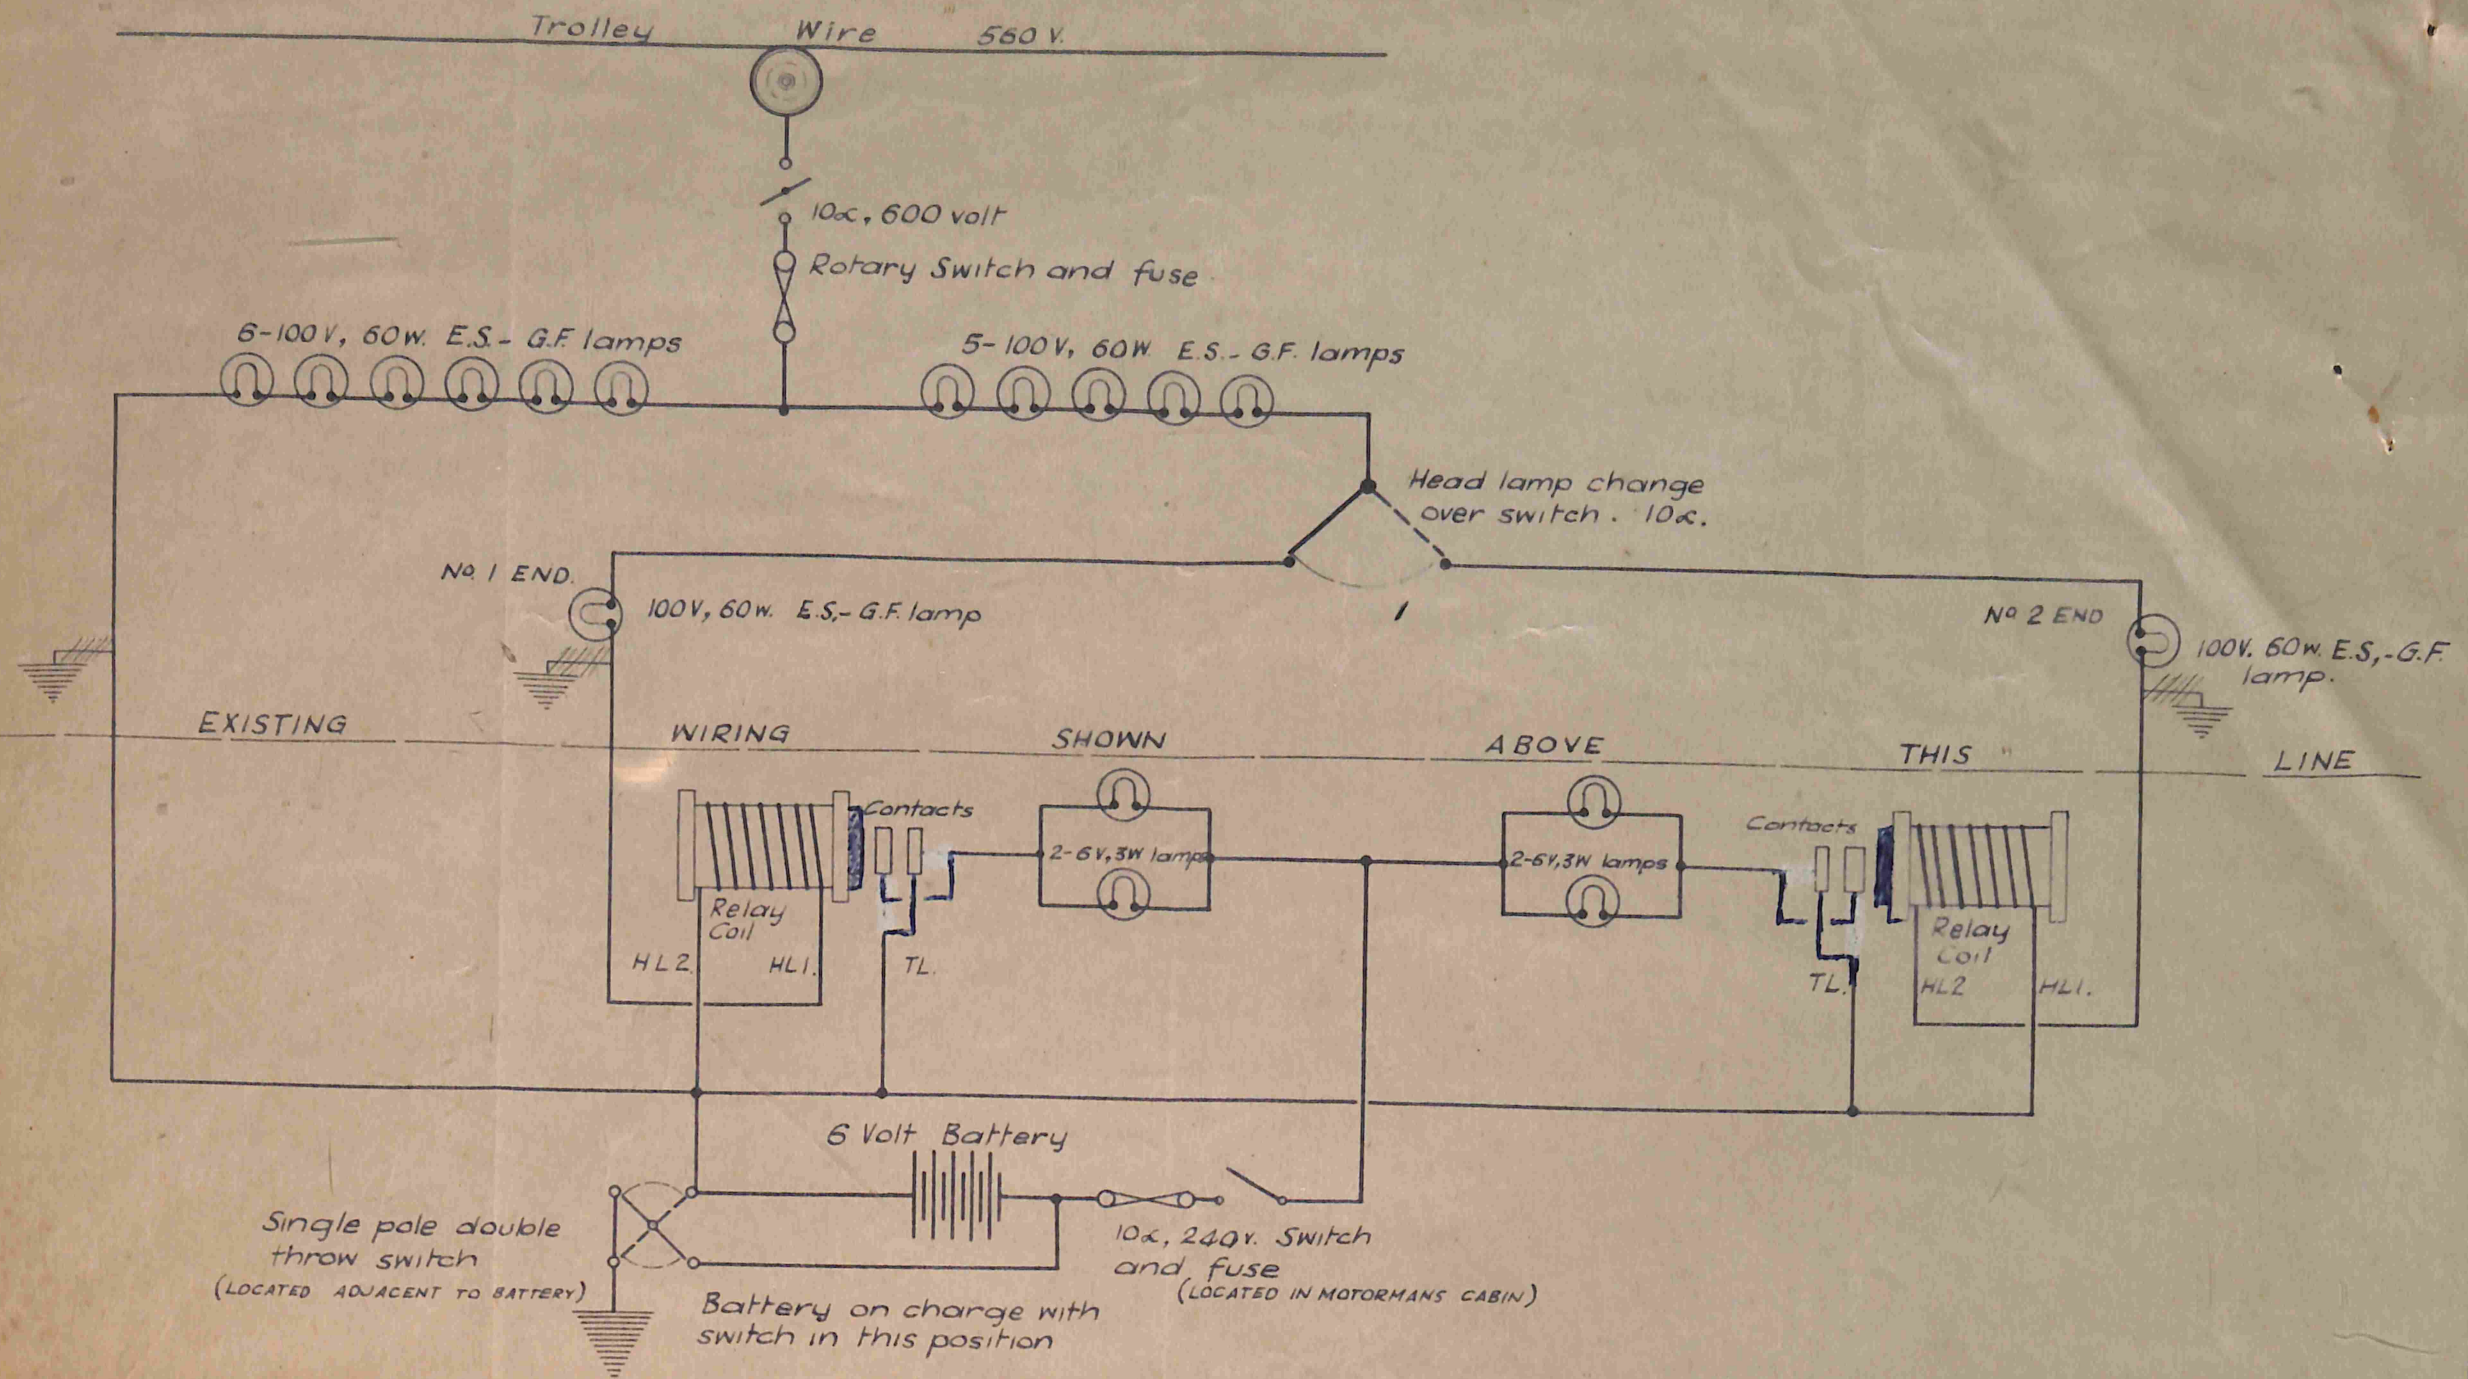
DRG.BA-T8-8100.

Experimental tram No. 26 has accordingly been fitted at one end with tail lamps under this scheme, and they also have operated satisfactorily during the three weeks of the tests. It was found that the battery charging rate through the lamp circuits is 1.05 to 1.10 amps. Using twin tail lights of 6-volt 3-watt auto type, the consumption is 1.00 amp. The net result, therefore, of the battery being under charge when the tail lamps are in use is a charge condition of only from 0.05 to 0.10 amp.

The maximum discharge rate with tail lights at both ends would be only 2.00 amps. when power is off or pole removed from the overhead wire. An advantage of the use of twin tail lights would be in the event of a lamp failure, the lamps being wired in parallel. The parts used were obtained from Auto Services, the tail lamps at 6/- each and horn relays at 5/6d. each. The cost of the necessary parts, therefore, would be nominally less than 35/- per tram. No alteration is required to existing fittings, and the wiring is simplified by the reversing of the usual operation of the relay.

- (A) Use of separate tail lamps for greater efficiency and use of low wattage lamps.
- (B) Reduction of battery drain would permit battery charging through lamp circuits, and eliminate both the use of resistance units and any increase in power consumption.
- (C) Use of relays in headlight circuits to automatically operate the tail lamps.

Details of the car lighting and the alteration to wiring necessary for this system are shown on the accompanying sketch.
