**VILLA ALBA MUSEUM LANDSCAPE RECONSTRUCTION**

**ARCHAEOLOGICAL TEST EXCAVATIONS PHASE 2**

**A report to Villa Alba Museum Inc and Heritage Victoria**

**October 2002**

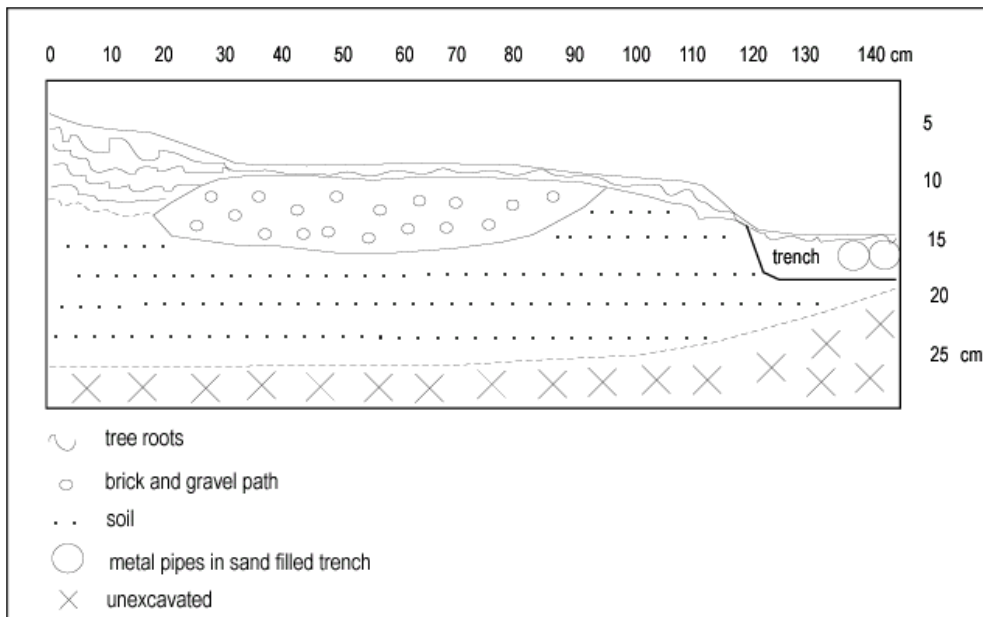
Figure 4.1. Area 2A Trench B, south section.

A section of concrete adjacent to the east side of Trench A was removed and a slit trench dug across the underlying path (trench B). A layer of gravel embedded in a pink/orange matrix (context 11) consistent with a path was noted in the southern section approximately 2cm beneath the concrete. See Figure 4.1 for section drawing.

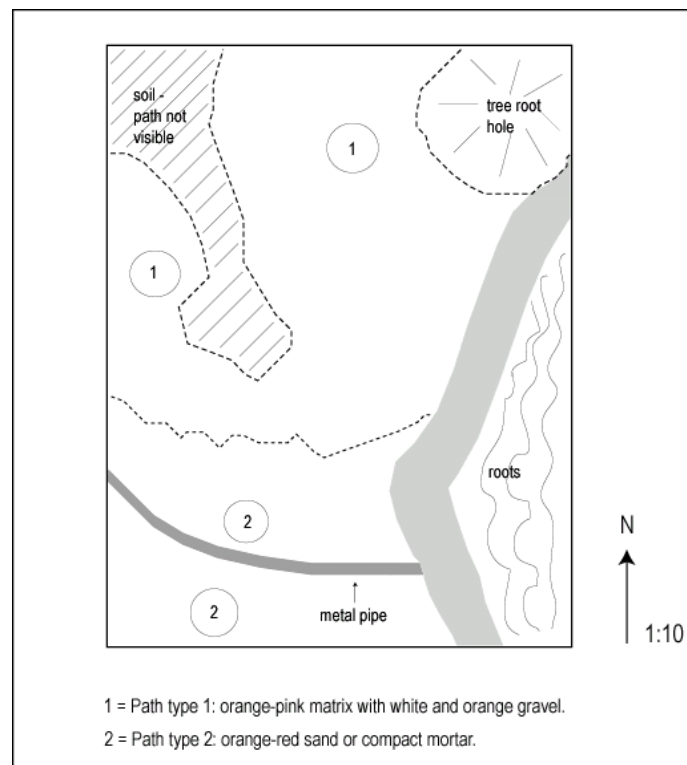
Figure 4.2. Area 2A Trench C, plan view.

Another section of concrete was removed in the vicinity of the junction of two historically known paths further to the south and the deposits excavated by hand. A similar layer of gravel in a pink/orange matrix was exposed (contexts 21, ?22). The layer had been disturbed by tree roots, bioturbation and the laying of a water pipe (context 23), and it was not possible to determine its original width or orientation. The path was located 5.38 metres due east of the existing metal fence, and 15.5 centimetres below the surface of the existing concrete path to the north. See Figure 4.2 for plan.

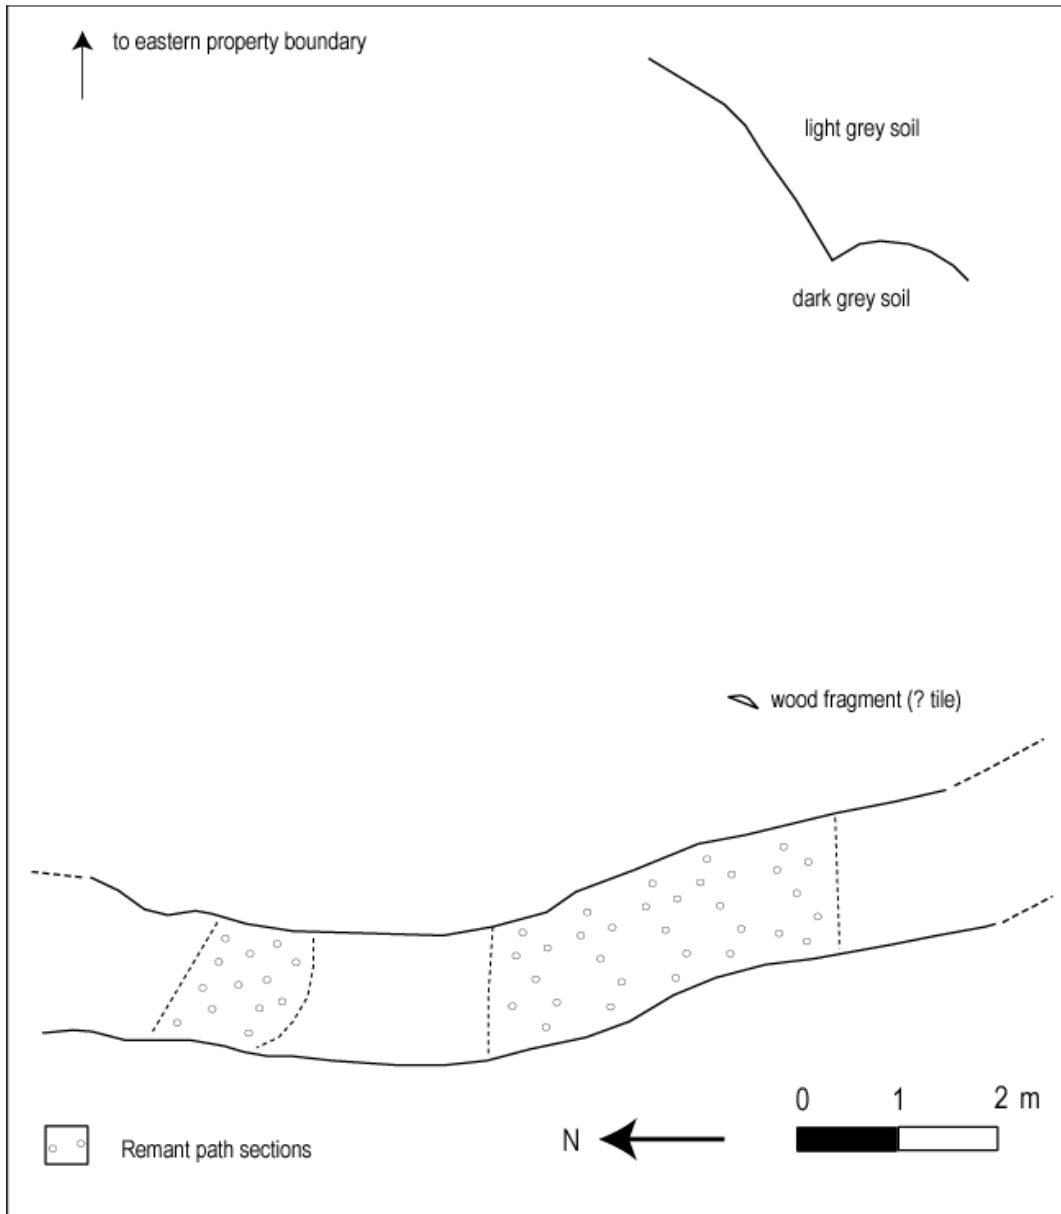
Figure 4.3. Area 3 Trench D. Wood-lined garden paths.

Mechanical scraping across the area to the south east of the Villa Alba mansion indicated that the north, east, south and parts of the centre and west had been subject to considerable disturbance and no evidence of the former parterre was observable in these areas. However a substantial north-south section of wood-lined path was recovered, in addition to a small section of wood-lined path near the eastern boundary (see Figure 4.3). The surface of the path consisted of extremely fine white gravel embedded in a pink-orange matrix (context 31) lined with the remains of vertically placed wooden edging tiles (context 32) of which only the cross-section is now visible due to previous disturbance of the site. The paths were recovered between 3 and 5 centimetres below the current ground surface and were between 1.2 and 1.3 metres wide. The locations of the paths were recorded in relation to the mansion and the original looped-wire fence along the southern boundary, and preserved *in situ* by tracing the outline with blue rope and fixing it in place with staples. The area was then backfilled.

- Two substantial sections of garden paths and the remains of edging tiles were located between 3 and 5 cm below the current ground surface to the southeast of the Villa Alba mansion. The paths were between 120 and 130 cm wide. The remainder of the area was highly disturbed.
- An area of soil consistent with a garden bed was located in the centre of the area immediately south of the Villa Alba mansion, and an intact wooden edging tile was recovered from the northern edge. The remainder of the area was highly disturbed and no garden paths or borders were observed.
- No evidence relating to former structures or gate features was recovered in the vicinity of the western boundary.

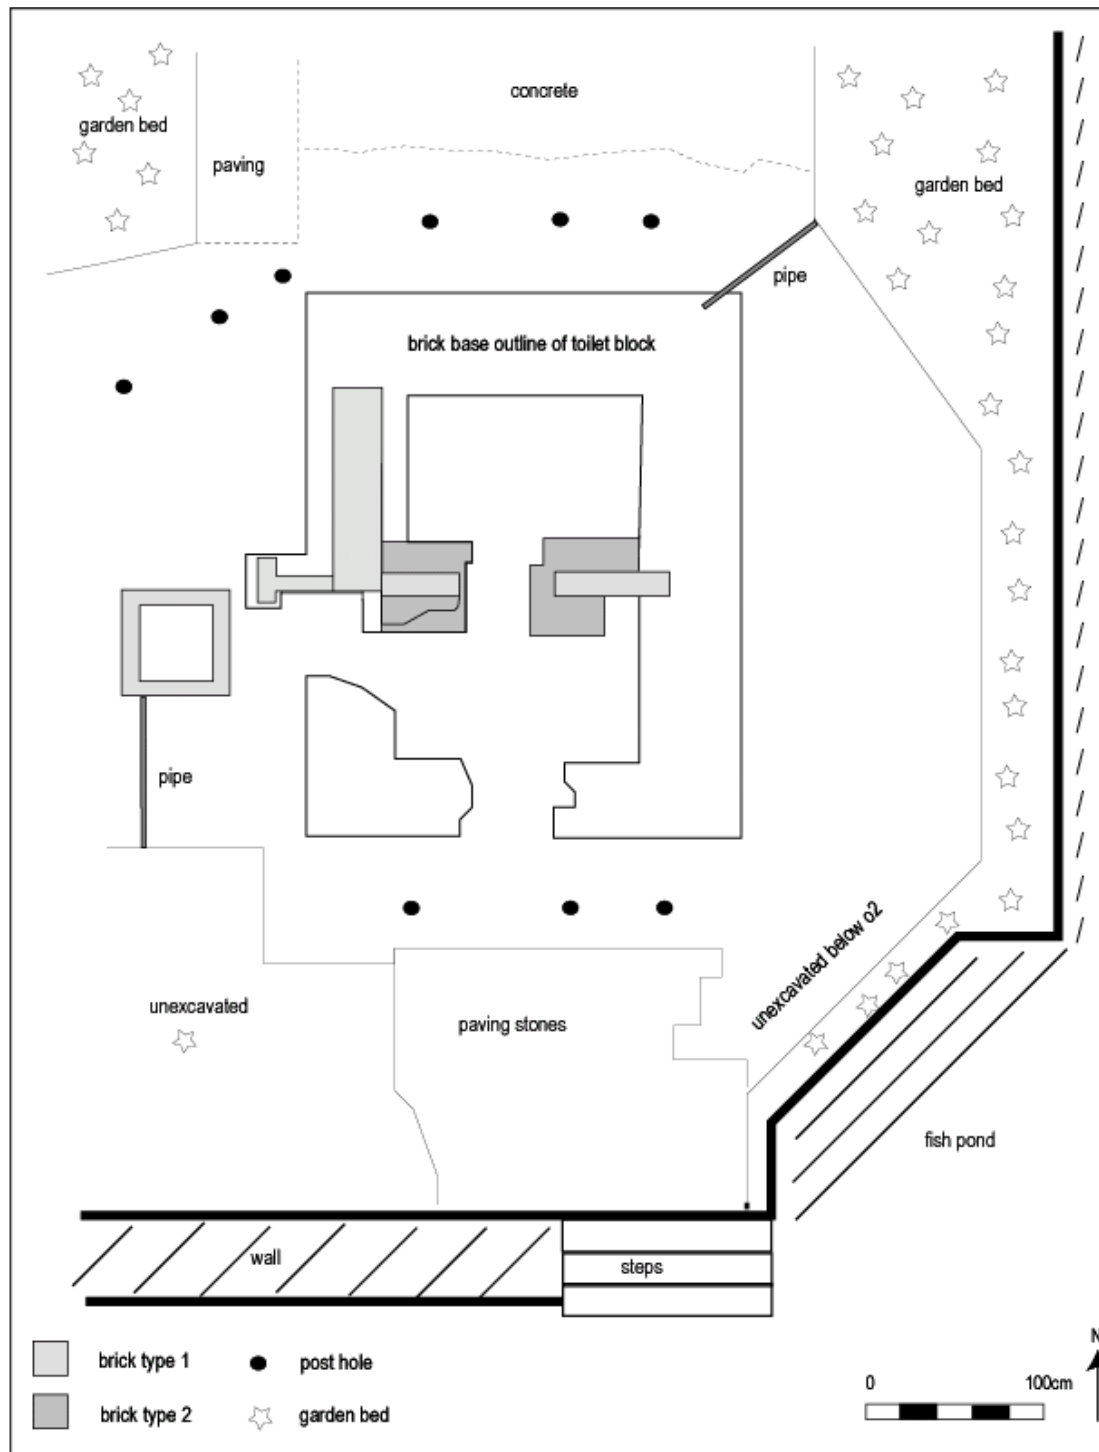
Figure 4.4. Area 7A Trench H. Toilet block, plan view.

Trench H refers to the excavation of an area measuring 6 x 5 m in the vicinity of a historically known toilet block (see Figure 4.4).

The existing surface between the western fence and a retaining wall in the east consisted of concrete tiles (context 70) bordered by garden beds. The removal of these tiles revealed a level surface consisting of an octagonal outline of red tiles (context 72) with a rectangle of concrete in the centre (context 73). The red tiles appeared to be similar to those dating to the period of site use as a hospital. The area between the concrete rectangle and red tiles was covered in 'crazy paving', or irregularly shaped pieces of concrete laid in random fashion and bonded with cement mortar (context 74). A number of large triangular and rectangular pieces of marble (context 130) were recovered at this level from around the perimeter of the tiled and concreted area. These paving layers were also removed.

Approximately 15 cm below the modern surface, nine postholes relating to the remains of an octagonal structure were recovered in the north, northwest and south (context 79). Postholes were spaced at intervals of approximately 50 and 70 cm. No postholes were visible along the projected east or west boundaries of the octagon. In the centre of the octagonal outline were the remains of a possible brick structure. A substantial rectangular brick outline (three brick widths across) appeared to be divided into two chambers (context 82) filled with a clay deposit, the odour of which suggested that it contained contents of a human biological origin (context 77). Deposits within the rectangular outline were not excavated as this task was beyond the conditions of the Heritage Victoria permit and the scope of the brief. However, artefacts from the fill lying under the concrete paving blocks and overlying the brick outline (context 80) were retained for analysis should the structure be subject to archaeological investigation in the future. Additional bricks (context 81) postdating those found in the rectangular foundations were located adjacent to and on top of the foundations, including a gully trap on the western border (context 75). These bricks probably represent modifications or repairs carried out on the structure in years following its original construction. A small section of gravel embedded in a compact surface was recovered outside the southeast corner of the octagonal structure, consistent with a path (context 84). No evidence of a threshold path was recovered at the north entry of the octagonal structure.

- Brick foundations consistent with the remains of a two-seater toilet block were located under two layers of concrete paving.
- Nine postholes consistent with an octagonally-shaped structure were located at the same level as toilet block foundations in the north, northwest and south.
- A small section of white gravel located outside the projected boundary of the octagonal structure may indicate a path or type of surface treatment.
- No evidence of a threshold path was recovered at the north entry of the octagonal structure.

The large fragments of marble (context 130) removed from Trench H in Area 7A were set aside and not replaced during backfilling. As it is possible that the marble pre-dates the period during which the site was occupied by the hospital, it has been retained for possible incorporation into the final design of the landscape reconstruction.

The clay deposits (context 77) in Area 7A Trench H were located in the area of former toilets and were left *in situ* and backfilled. It is recommended that these deposits be archaeologically tested as potential cess pit fill before undertaking any disturbance or removal of the deposits. This recommendation may be implemented as a separate program of archaeological excavation or in the form of archaeological monitoring during works. If archaeological remains are identified during monitoring, the archaeologist will have the authority to suspend further subsurface disturbance until the remains have been adequately assessed. Structural features and any artefacts recovered during archaeological monitoring (or excavation) should be fully documented, catalogued and analysed in accordance with Heritage Victoria guidelines. On completion of monitoring, a report should be prepared describing the results and any historical or management implications. A permit from Heritage Victoria will be required prior to commencing works.

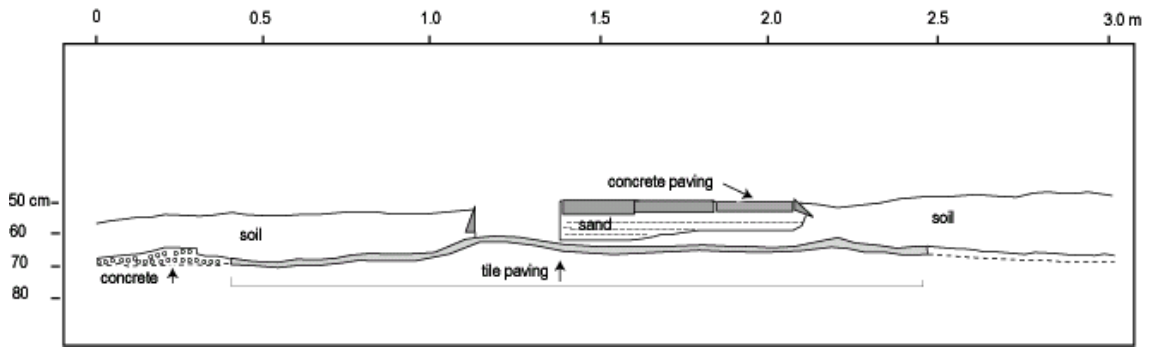
Figure 4.5. Area 7B Trench I, south section.

A slit trench was dug from the west face of the mansion to the western property boundary (see Figure 4.5). The base of the centre and west of the trench was lined with alternating reddish and pale yellow tiles (context 95) consistent in materials and patterning with original tiles found on the east side of the mansion. A section of tiling appeared to have been patched with more modern red tiles similar to those found in 7A (context 72). The tiles were located between 13 and 18 cm below the current ground surface and were in reasonable condition although lying on an undulating surface due to the action of nearby tree roots. In the west the tiles were overlaid by topsoil (context 92); in the centre, by sand and concrete paving tiles (contexts 90, 91); and in the east by two layers of concrete underlying topsoil (contexts 93, 94). It was not clear whether the tiles continued under the concrete layers to the west face of the mansion.

- Alternating red and yellow tiles consistent with those found on the east side of the mansion were recovered 13 to 18 cm below the current ground surface.

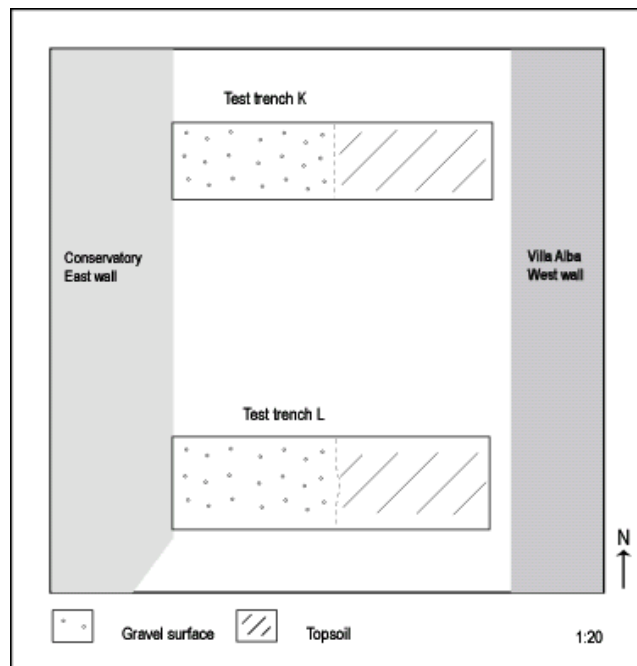
Figure 4.6. Area 7D Trenches K and L, plan view.

Two east-west slit trenches were dug between the former conservatory and the west wall of the Villa Alba mansion, 1.10 m apart. The stratigraphy in each trench was the same. Beneath a layer of vegetation and topsoil (contexts 110, 111) a loose layer of soil containing white gravel (context 112) overlying a layer of white gravel in a compact surface (context 113) was recovered at the west end of each trench adjacent to the east face of the conservatory wall. These gravel layers are consistent with the remains of a path running north-south adjacent to the conservatory wall. The path fragments were 68 and 72 centimetres wide respectively, located 8 cm below the current ground surface. They did not extend to the west face of the mansion. See Figure 4.6.

- A gravel surface consistent with a path was located adjacent to the east face of the conservatory at a depth of 8 cm below the current ground surface. The gravel section was 68 to 72 cm in width. The area between the gravel and the west face of the Villa Alba mansion appeared to have no treatment apart from topsoil.
- The path located in trenches K and L appears to continue further south.
- Two circular holes were located in an east-west line 35 cm north of the southwest corner of the Villa Alba mansion, however additional evidence would be required to support an interpretation of these as the remains of a hedge.

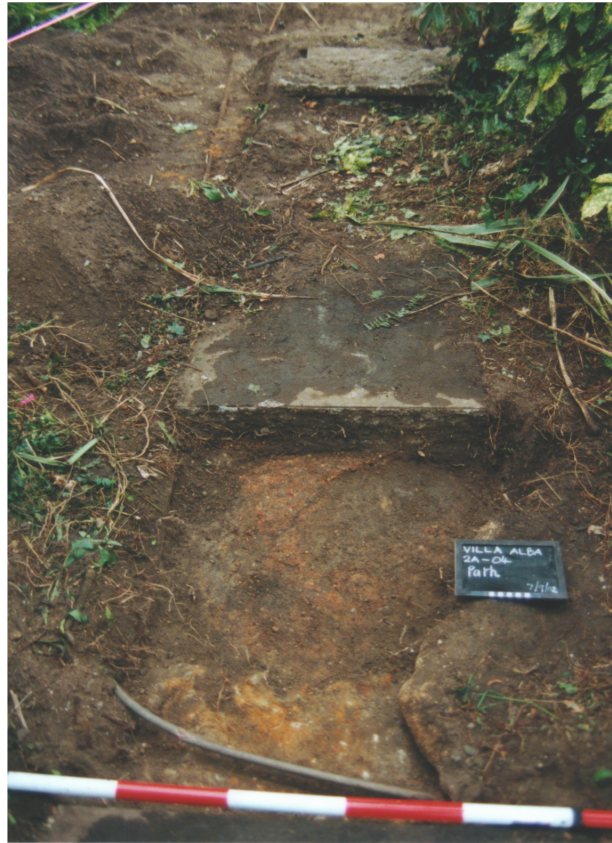
Plate 1. Area 2A Trench C, looking north.

Archaeological evidence of earlier paths was recovered in two places in Area 2A. While it was not possible to determine the junction of a north-south and east-west path due to disturbance, the evidence indicates that the north-south section of path lies almost directly under the concrete path on the current ground surface. The path treatment of white gravel in a pink-orange matrix was similar to that observed in Area 3 (Plate 1).

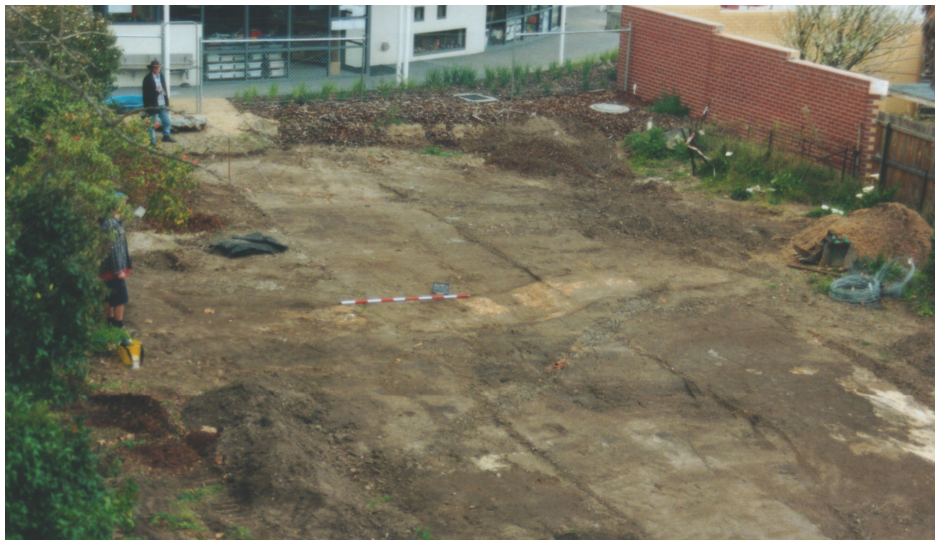
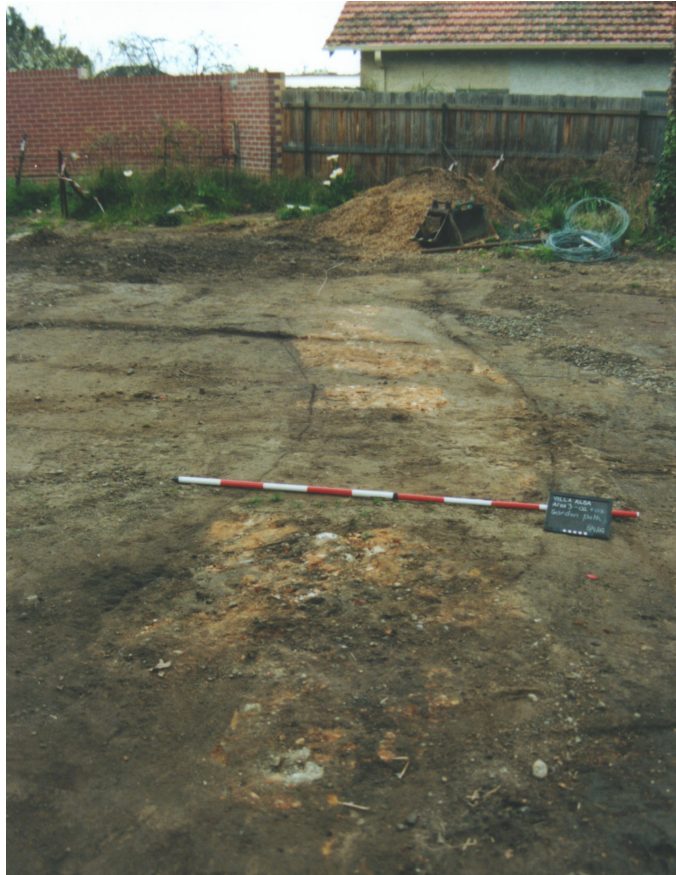
The recovery of sections of wood-lined path in Area 3 was particularly useful as the 19<sup>th</sup> century design of the parterre in this area is not well documented in historical records. In Figure 5.1 the archaeological evidence has been overlaid onto a c1945 aerial photograph as a tentative "test of fit" (the placement is conjectural only and should be reviewed by the Villa Alba landscape architect). The recovery of these landscape features provides an indication of surface treatment, evidence of wooden edging tiles, and an original surface level for future garden reconstruction (Plates 2, 3).

Plate 2. Area 3 garden path, looking southeast.

Plate 3. Area 3 garden path detail, looking south.

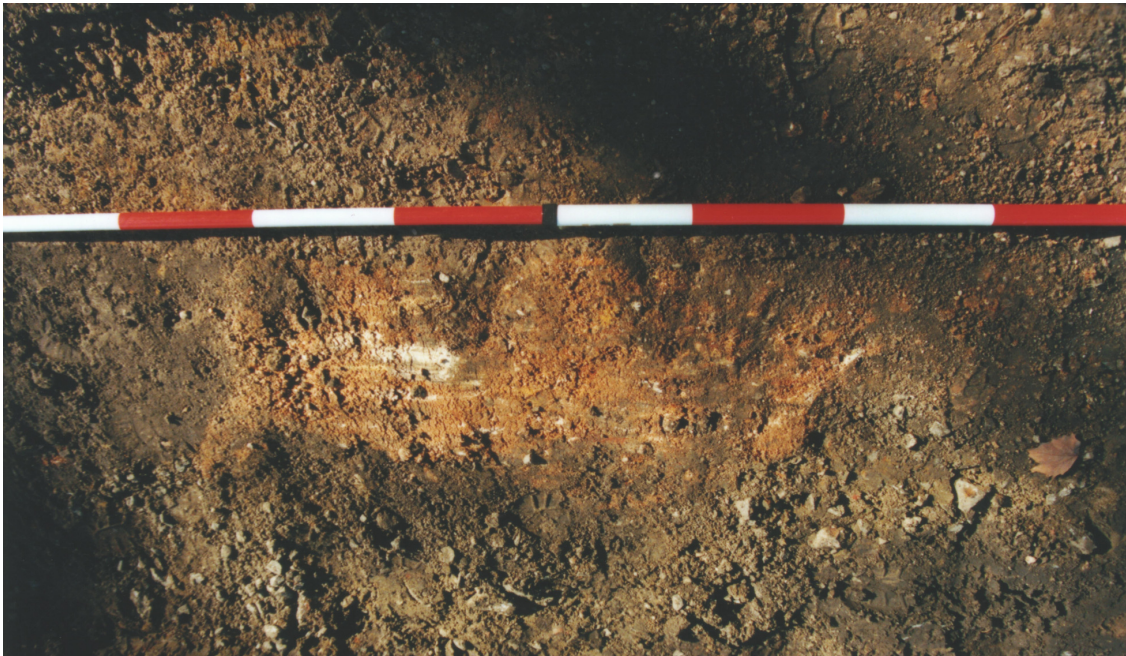
A trench dug across the south face of the mansion tower (Figure 3.1) revealed a small remnant patch of path. The location and width of the path were consistent with plans of the former parterre (Broadbent pers.comm). The path consisted of fine white gravel embedded in a pink-orange matrix of crushed rock (context 51).

Plate 4. Area 3 Trench F path treatment detail.

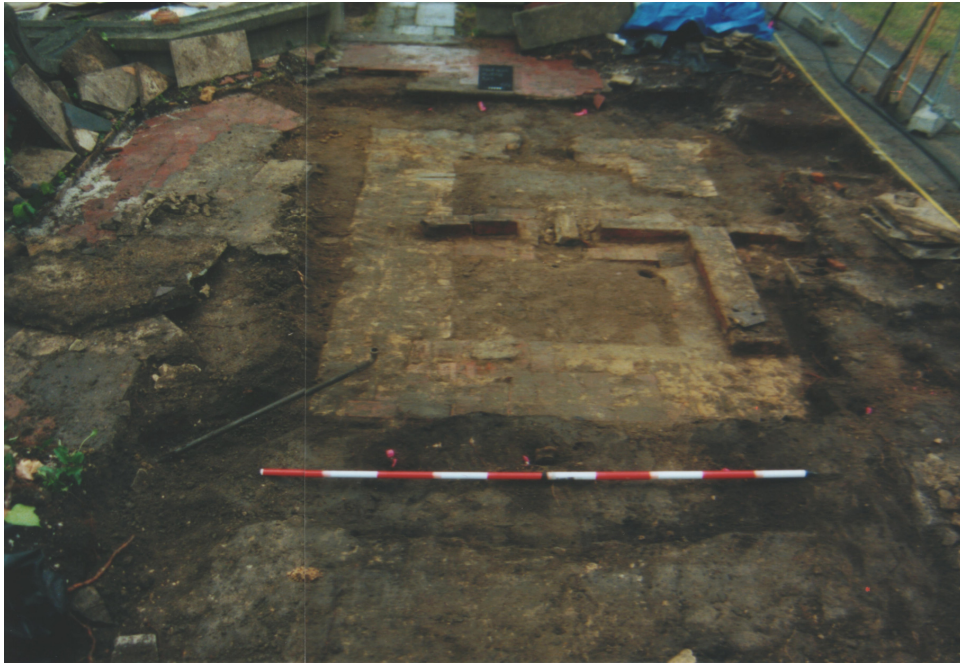
Plate 5. Area 7A Trench H toilet block foundations, looking south.

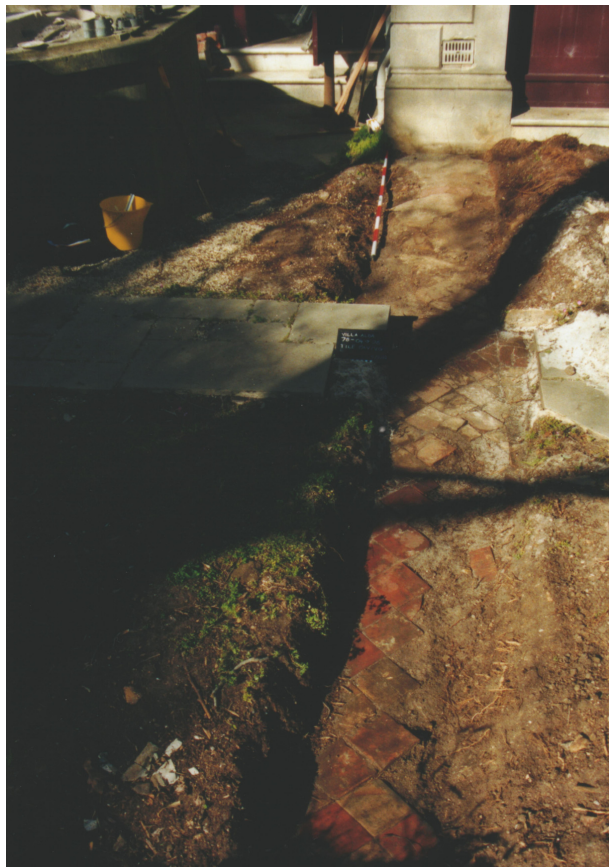
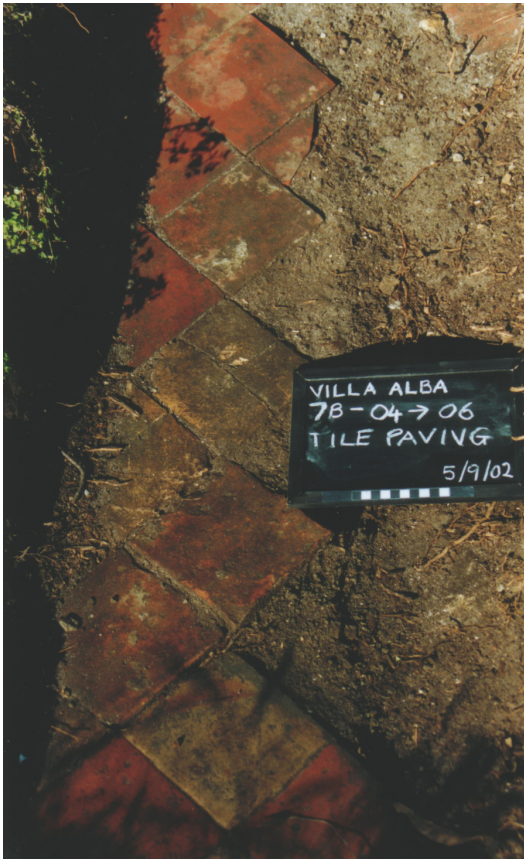
Plate 6. Area 7B Trench I, looking east.

Plate 7. Area 7B Trench I, tile paving detail, looking east.
