A GOLDFIELDS PALACE

Bendigo Town Hall has been described as one of the most remarkable boom time buildings in Victoria. It has a stunning interior featuring elaborate plasterwork and extensive hand painted decoration. But by the late 20th century the building was tired and under-used. In 2000 the City of Greater Bendigo embarked on a major restoration program. On 14 January 2000 the Minister for Planning, John Thwaites, announced a grant of \$940,000 for internal restoration works and render repairs from the Department of Infrastructure's Public Heritage Program, administered by Heritage Victoria. The total cost of the restoration is \$3 million with the City of Greater Bendigo providing \$2,030,000 and a further \$30,000 from private sponsorship.

CONSERVATION WORKS

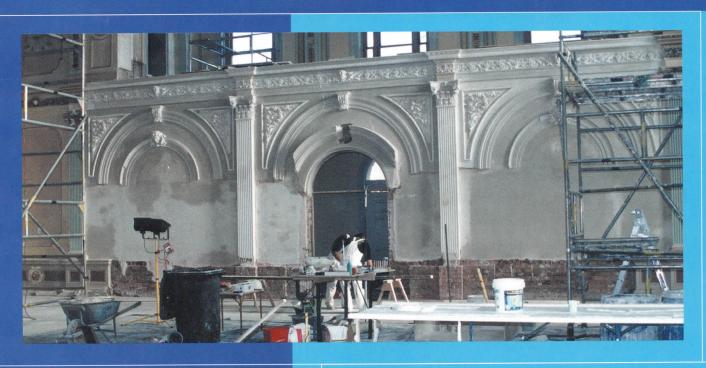
The major conservation works began with the reinstatement of the Hargreaves Street entrance, foyer and balcony, involving demolition of the 1926 stage and proscenium arch.

The reinstatement of the original balcony involved the erection of the supporting brick wall removed in 1926. The wall was modelled on photographic evidence.
