ROYAL VICTORIAN INSTITUTE FOR THE BLIND

555-557 ST KILDA ROAD
MELBOURNE

CONSERVATION MANAGEMENT PLAN

February 2002

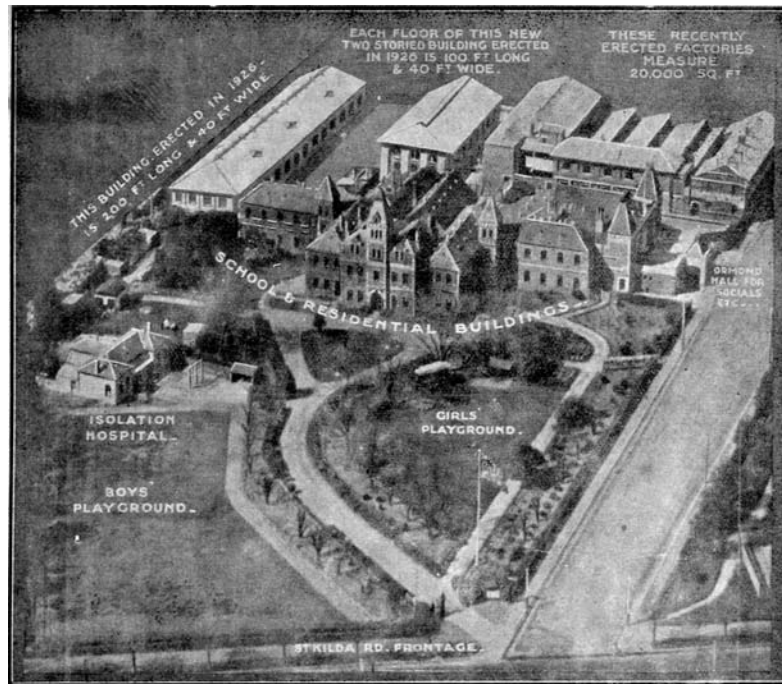
Figure 8 *Aerial view of the RVIB site showing the single storey former stables which have been widened on the south side, located on the north-east boundary .*
 Source: RVIB Annual Report 1927

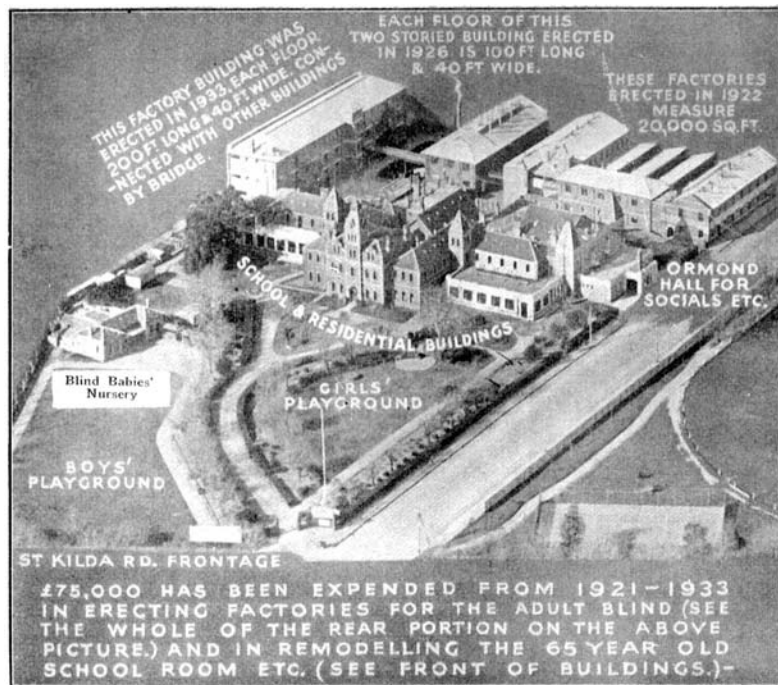
Figure 9 *Aerial view of the RVIB site showing the two-storey addition to the former stables, and the bridge connection to the factories to the south.*
 Source: RVIB Annual Report 1947

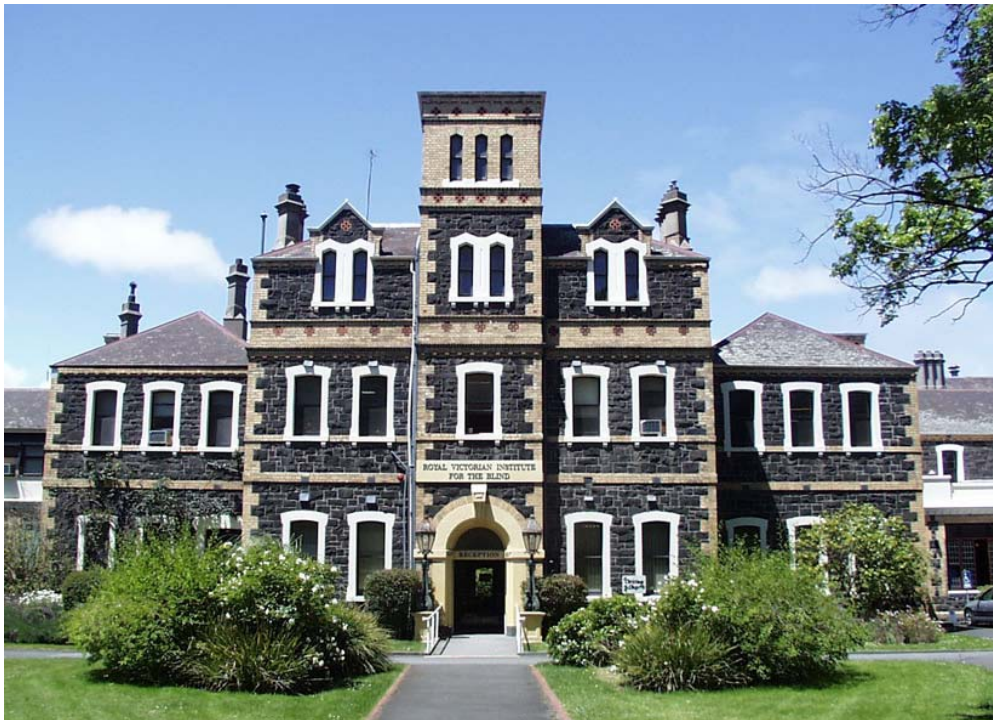
Figure 19 *RVIB west façade facing St Kilda Road*

The west elevation of the central administration building, which addresses the front garden and driveway, is divided into three bays. It comprises rock-faced coursed squared random rubble, delineated horizontally into floor levels by cream brick stringcourses. The four-storey central tower is break-fronted, flanked either side by three-storey bays, and contains the entrance porch at ground level. Cream brick quoining highlights the vertical divisions of the facade. The arched entry opening, located in the central bay has a painted rendered dressing with a moulded keystone and cream brick segmental arch over.

A slated turret, which has since been removed, originally capped the central tower; while the original entry steps have been replaced by a paved ramp, which slopes up to ground floor level. The decorative lamps with glazed lanterns either side were donated to the RVIB in 1880 by the Prahran City Council.

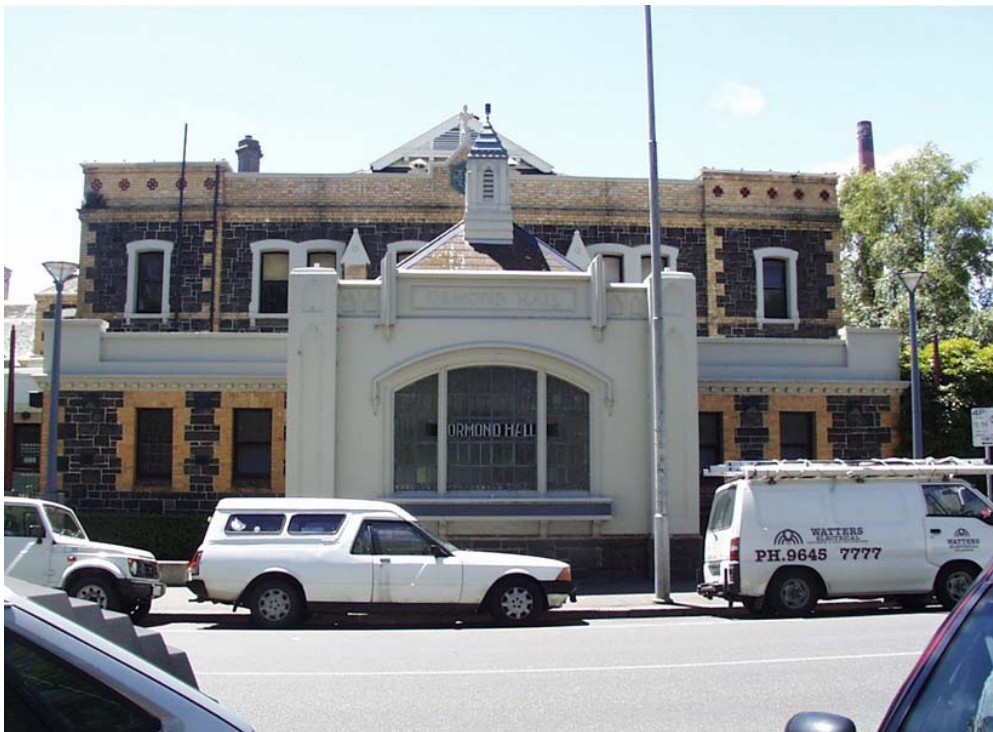
Figure 20 *South façade showing Ormond Hall, Moubray Street*

The two-storey music hall has two end bays which are articulated by cream brick quoining at the corners and red brick lozenges at the parapet. The central bay has grouped window openings with dressed surrounds. The cream face brick is ornamented by a centrally positioned crown supporting a pressed cement crucifix, below which is a wall-mounted metal crest. The entry portico by contrast, has a bluestone masonry base with painted render over. The arched stained glass window, which is symmetrically located between corner piers, has a moulded hood and corbelled sill and features the lettering '*Ormond Hall*'. The parapet is ornamented and features the lettering '*Ormond Hall*'. The hipped roof is clad with slate and surmounted by a small flèche with a pyramidal capping.

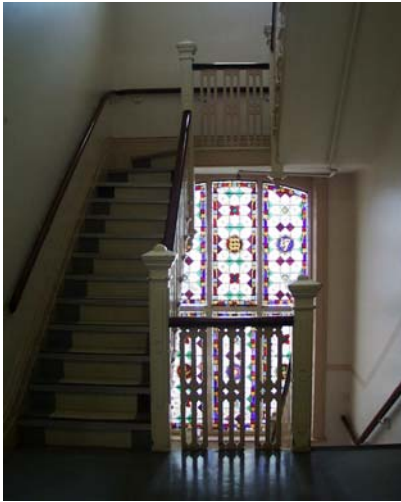
1. Main stairwell and window

The main stair is timber-framed, painted, and has vinyl tile treads and risers with aluminium safety nosings. At ground level, the stairwell is in-filled with moulded timber panelling, providing a small cupboard space. Other original features of the stair include the painted timber balusters which have rose-shaped cut-outs, and turned newel posts which support a varnished timber handrail. The arched opening in the east wall at the level of the stair landing comprises six panels of stained glass, divided by timber mullions and transoms. The design of each panel has a geometric border and distinctive floral and diamond patterned infill. Various heraldic iconography are located at the centre of each panel symbolising Ireland (three-leaf clover, angel with harp), Scotland (a thistle, a lion rampant) and England (three lions couchant, rose). The stair continues to the first and second floor levels in similar detail. The original ceiling, at the top level, is painted hard plaster and has raked perimeter edges.

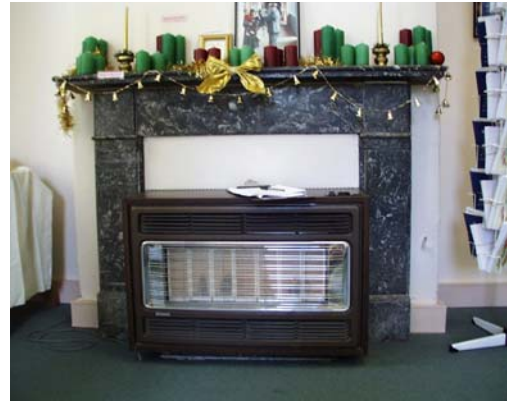
2. RVIB shop fireplace

Original fabric which has been modified includes the black marble mantel and fireplace surround in the RVIB shop, which has a gas heater installed. Whilst the rooms generally contain loose furniture and workstations, the computer room has built-in benches in the south-east corner. In addition, the original door opening to the south turret has been closed off and the wall cavity used for electrical and cable ducting.

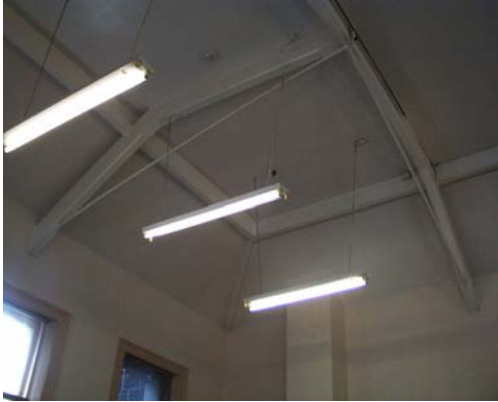
1. Original form and fabric of the ceiling

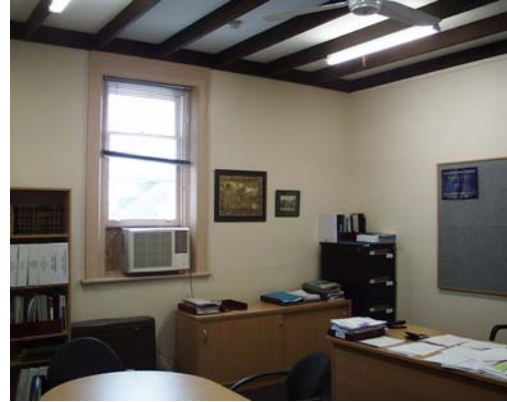
2. Typical false ceiling over

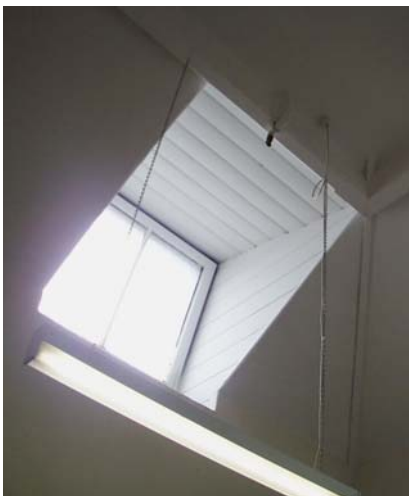
5. Timber-lined skylight in stairwell

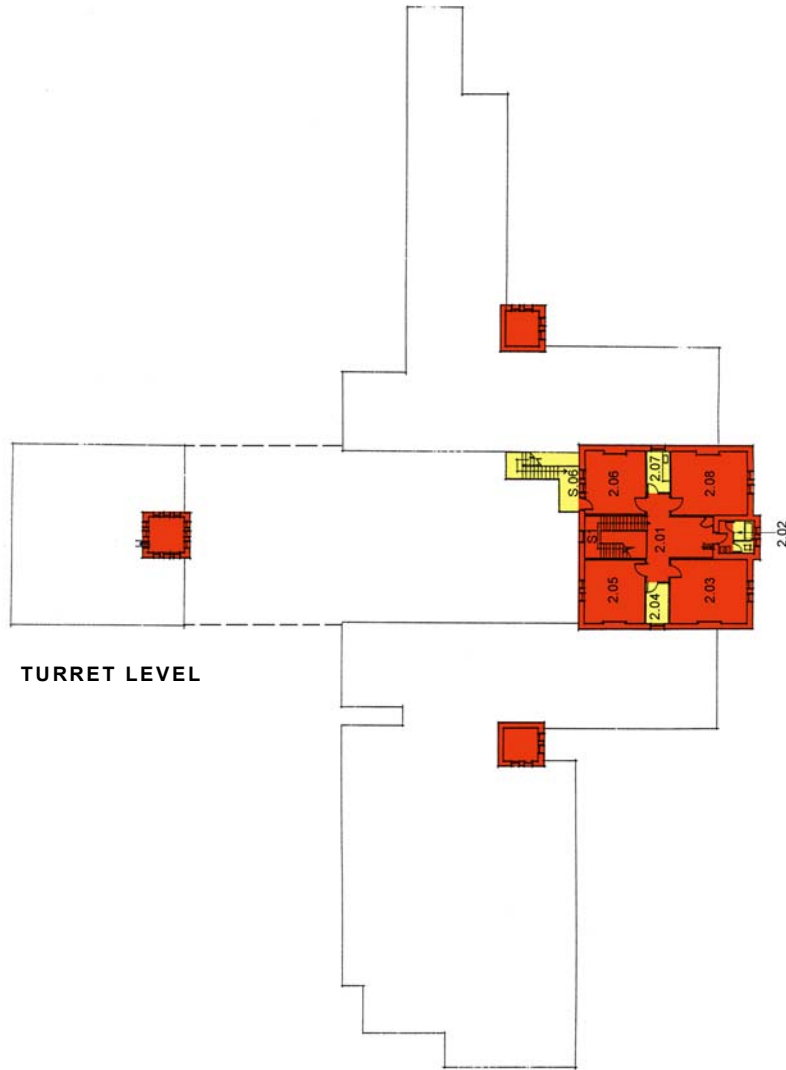
Figure 46 Second Floor Plan & Turret, Levels of Significance
