# **Assignment 2 – Conservation Management Plan**

# The Tramway Signal Cabin, Waiting Shelter and Conveniences at Swanston Street & Victoria Street, Melbourne

*FEBRUARY 2017*

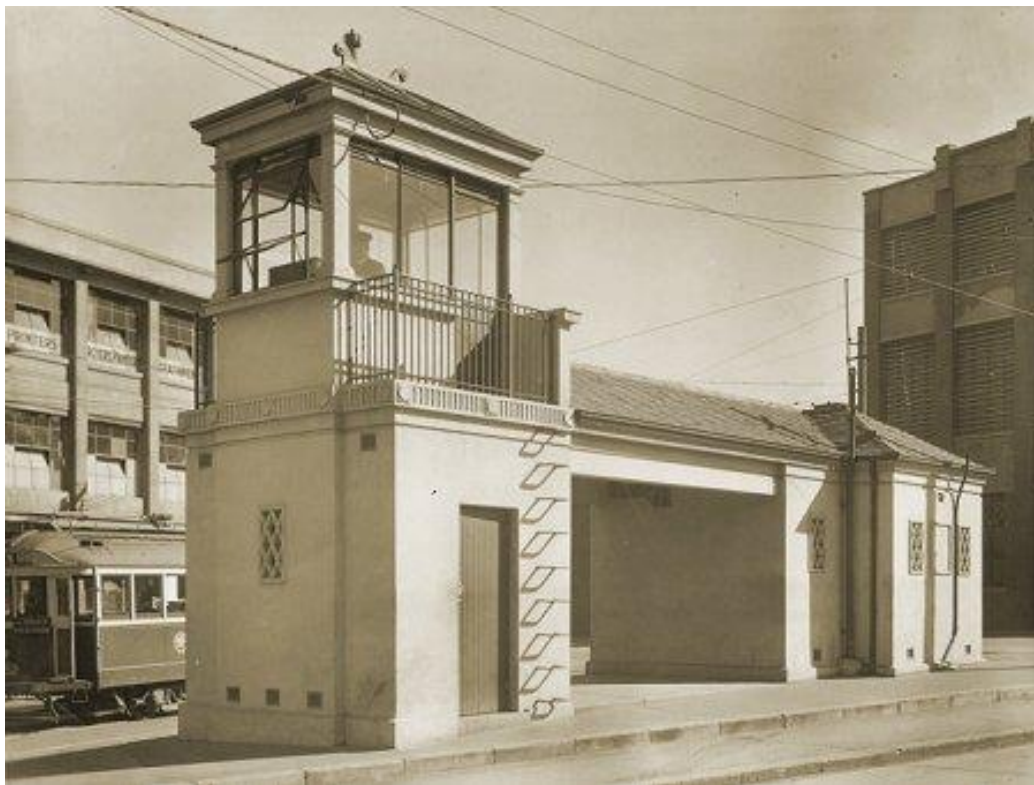
The Tramway Shelter (see Figure 1) was designed by Alan Gordon Monsborough. Monsborough headed the Architect's Department of the M&MTB during the rapid expansion of Melbourne's electrical tram network through the 1920s and 1930s (Jones 2014). He used what is considered a "stripped Greek Revival style" for his designs during this period and is responsible for numerous tram-related structures across the city besides the Tramway Shelter, including depots, substations and shelters (Jones 2014).

**Figure 1:** An official M&MTB photograph of the Tramway Shelter from the late 1920s.

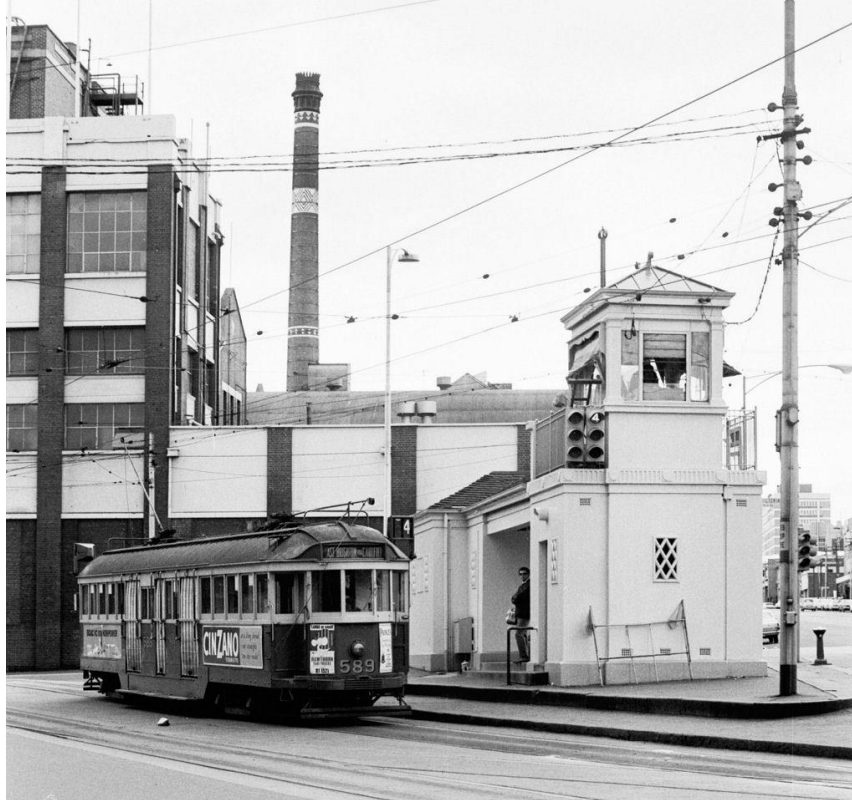
Signal boxes help traffic flow and allow trams to cross busy intersections. The controls were manually operated by a signalman and indicated to tram drivers by coloured lights and small semaphores (Bailey 1966). This equipment was manufactured in the United States for the M&MTB. On the Tramway Shelter itself, six lights numbered 1-6 were used to indicate to drivers which crossover a terminating car was to use (see Figure 2). The year 1946 saw the introduction of vehicular traffic signals and modifications to the original signals of the building (Breydon 1972). Later, considered a "recent addition" by 1972, a 'Q' was added to direct cars to the Queensberry

Street shunt (Breydon 1972). A buzzer mounted to the signal cabin gave the departure signal. The job of signalman was considered vital and busy, particularly in peak periods.

**Figure 2:** A photograph dating from December 1969 showing the six numbered lights (with the '4' illuminated) and a person waiting at the shelter. Note that the structure is not majorly different from its earlier days shown in Figure 1.

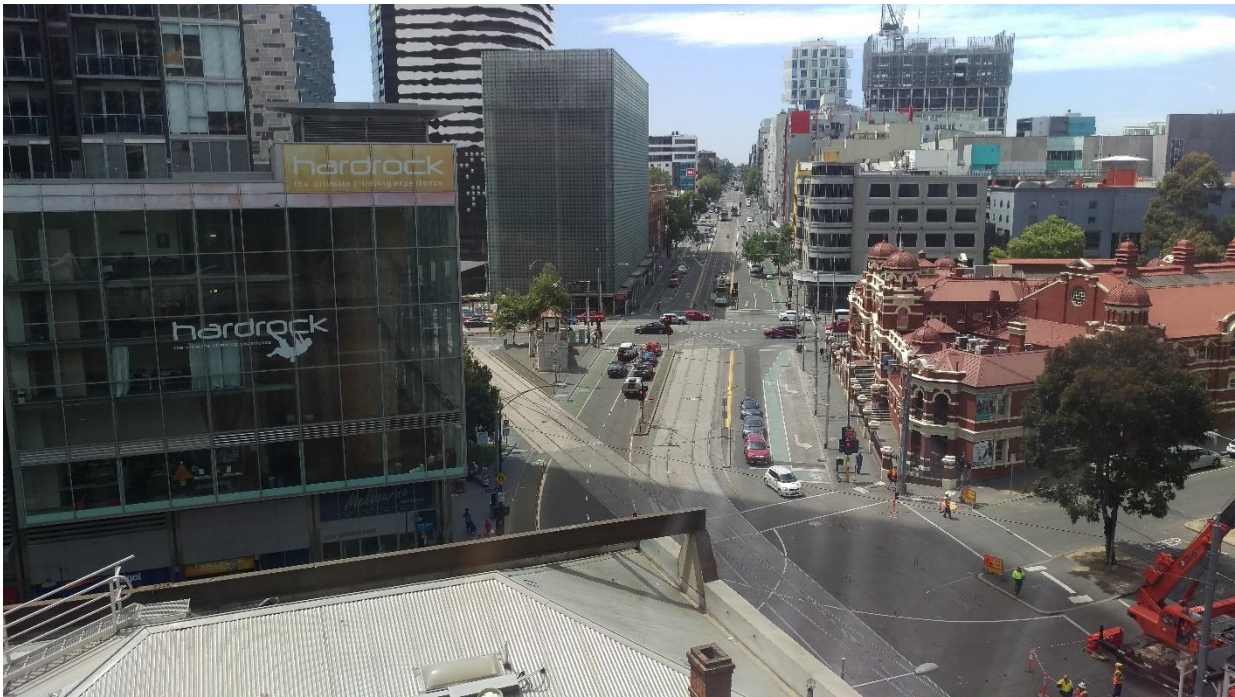
**Figure 3:** The Tramway Shelter shown in front of RMIT's Design Hub, in its once crucial position at the top of Swanston Street.

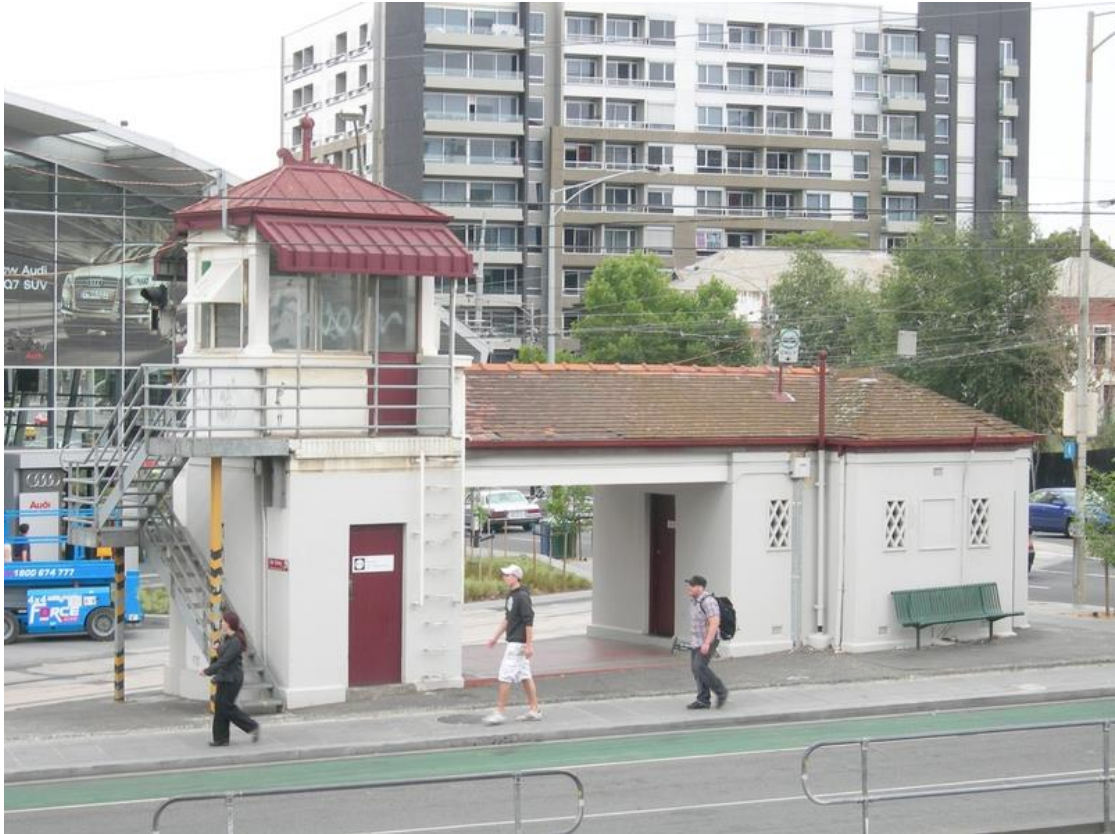
and became redundant in 1991 (Jones 2006; M Larsson [Heritage Victoria] 2016, pers. comm., 14 December 2016). Nevertheless, the addition of a steel staircase after 1991 (see Figure 4) suggests the signal box may still have been used following its supposed redundancy (W Doubleday [Friends of Hawthorn Depot Inc.] 2016, pers. comm., 16 December 2016). This staircase remained until at least 2008, after which it was removed. Modern technology has meant that combined tram signal box/shelter buildings are no longer necessary (Jones 2006). Public toilets for women have been provided since construction of the Tramway Shelter, with public toilets for men only added ten years later in 1938 (M Larsson [Heritage Victoria] 2016, pers. comm., 14 December 2016). These facilities are still available to the public and are listed as Toilet No. 146 by the City of Melbourne.

**Figure 4:** The Tramway Shelter pictured in 2008 showing the added steel staircase.

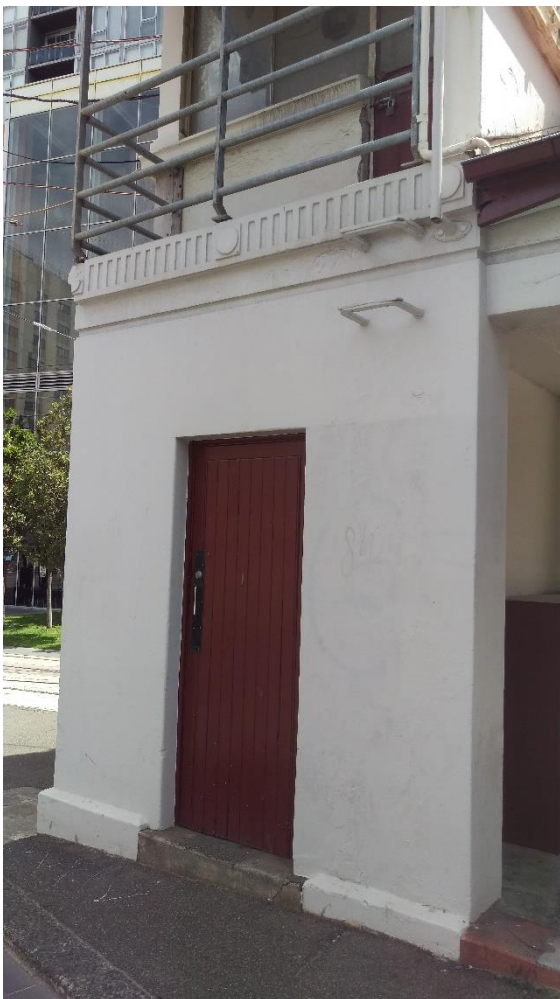
**Figure 6:** The eastern face of the building at the southern end, showing the remaining step rungs.  
*Source: Y Gaouil, taken 3 December 2016*

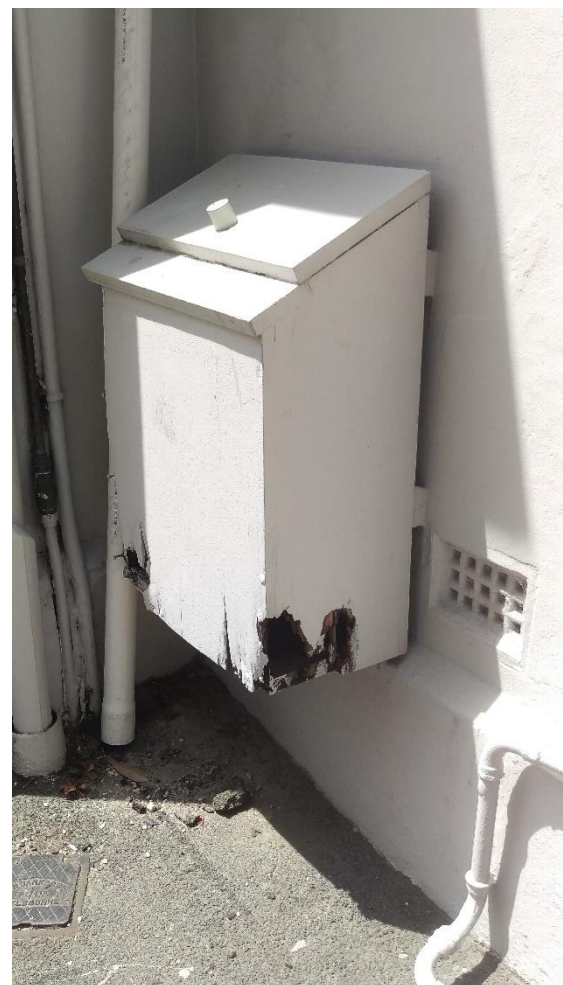
The structure of the Tramway Shelter appears sound and of reasonable condition. There is damage to a wooden box attached to the western face of the structure (see Figure 7). The paintwork on the structure has minor wear, but is largely consistent. The structure suffers from notable graffiti.

**Figure 7:** The damaged wooden box.  
*Source: Y Gaouil, taken 3 December 2016*

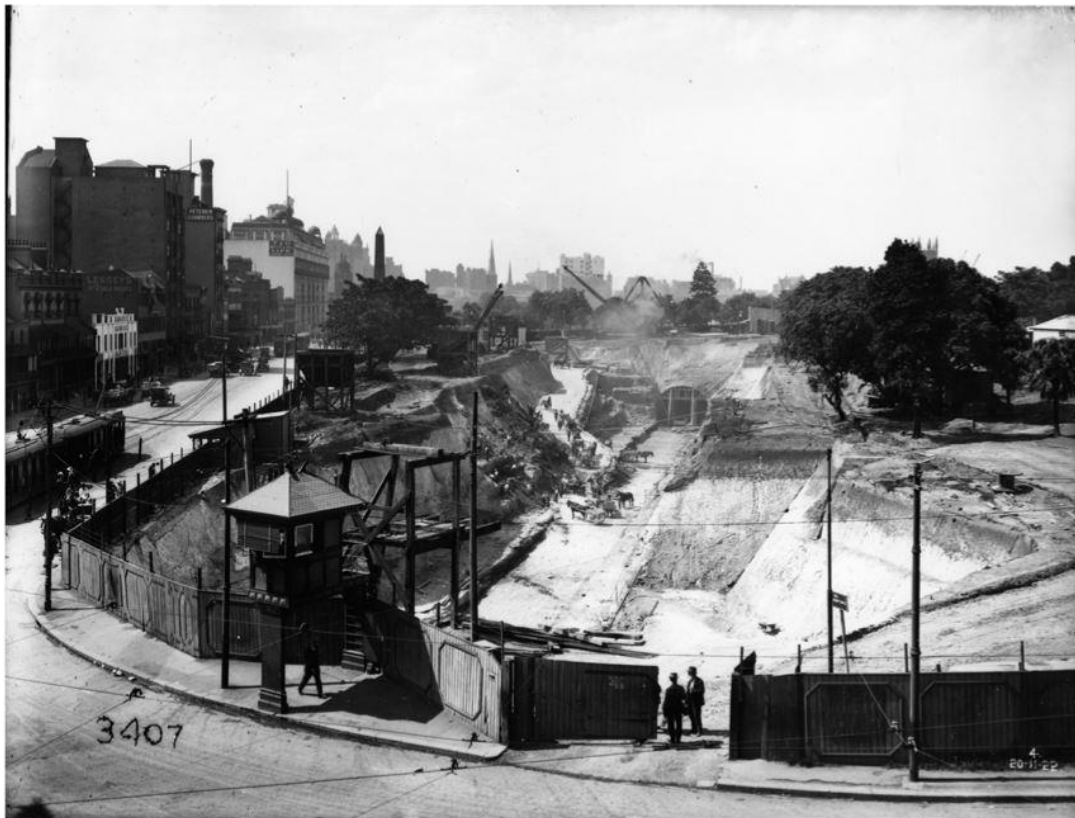
**Figure 8:** The signal box at Elizabeth and Liverpool Streets (foreground) during the construction of Museum Station in Sydney.

The Tramway Shelter is one of only three major signal boxes to ever be built for Melbourne's tramway network, and of these is the only one still standing. The others were located at St Kilda Junction and Batman Avenue. The St Kilda Junction signal box was demolished in the late 1960s following the reconstruction of the junction and a shift to automatic signals (Bailey 1966). The Batman Avenue signal box, like the signal box at Swanston and Victoria Streets, was also combined with a shelter but was demolished as a result of the Federation Square development (Jones 2006). Signal boxes were more prevalent in Australia's other tramway cities, however most of these have been removed since the closure of tram services in these cities. Of those constructed in Sydney only one remains, though relocated from its original position at the intersection of Elizabeth and Liverpool Streets (see Figure 8) to the Sydney Tramway Museum (Sydney Tramway Museum 2016). Similarly, Brisbane's Valley Junction signal cabin, as the lone surviving box in the city, was transported to the Brisbane Tramway Museum in 1969 and

subsequently reused as the museum's ticket office (West 2017). Neither structure resembles the one subject to this plan, nor do they combine multiple functions into a single complex.

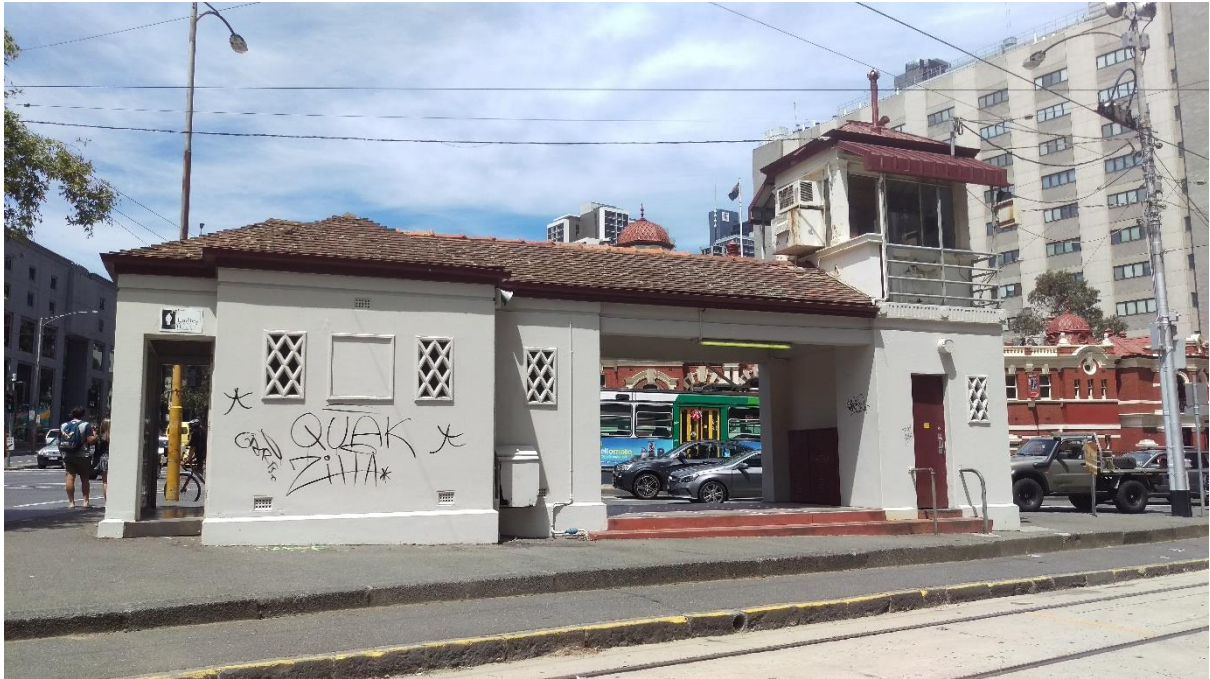
The site's urban location also brings challenges. As an exposed and open building in a busy area, the Tramway Shelter is easily accessible to the public. The disadvantage of this is made most clear by the graffiti found on the walls and windows of the structure (see Figure 9). Another potential threat to the site is weather, which has potential to damage or diminish the appearance of the building. Construction, whether directly associated to the Tramway Shelter or otherwise indirectly relevant, could pose a threat if procedures are not followed correctly.

**Figure 9:** Graffiti on the face of the Tramway Shelter.  
*Source: Y Gaoulii, taken 3 December 2016*

Mechanisms should be implemented to prevent and manage graffiti at the site.

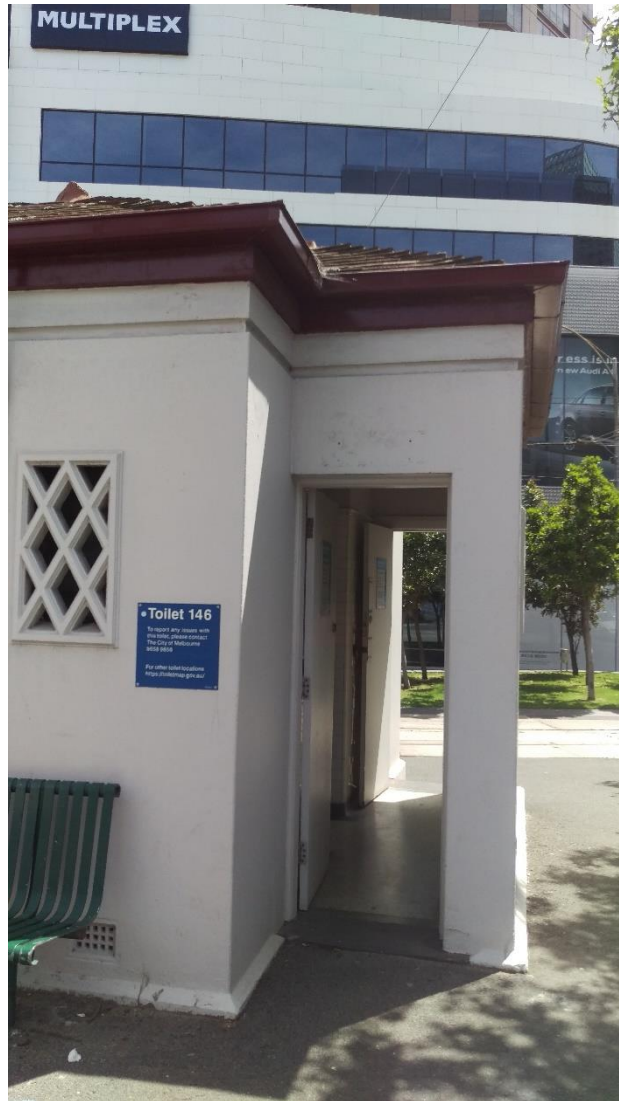
The Tramway Shelter is currently used for its public toilet facilities at its northern end (see Figure 10). This is considered an acceptable use given it fulfils one of the original purposes of the site and, in any case, provides a useful function.

**Figure 10:** The eastern entrance to toilet facilities.  
*Source: Y Gaouilil, taken 3 December 2016*

However, toilet facilities should be assessed for whether they require upgrades and be monitored periodically.

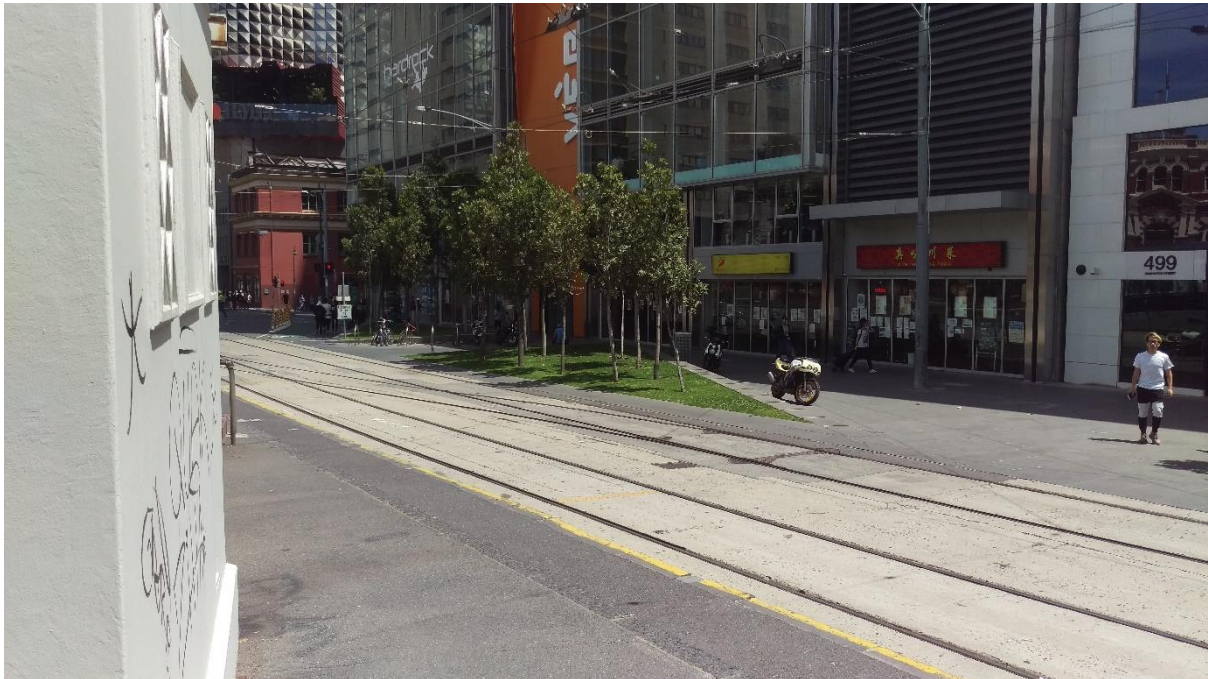
**Figure 11:** The area surrounding the Tramway Shelter, facing southwest.

Opportunities to better integrate the area surrounding the site (see Figure 11) with the site itself should also be investigated.

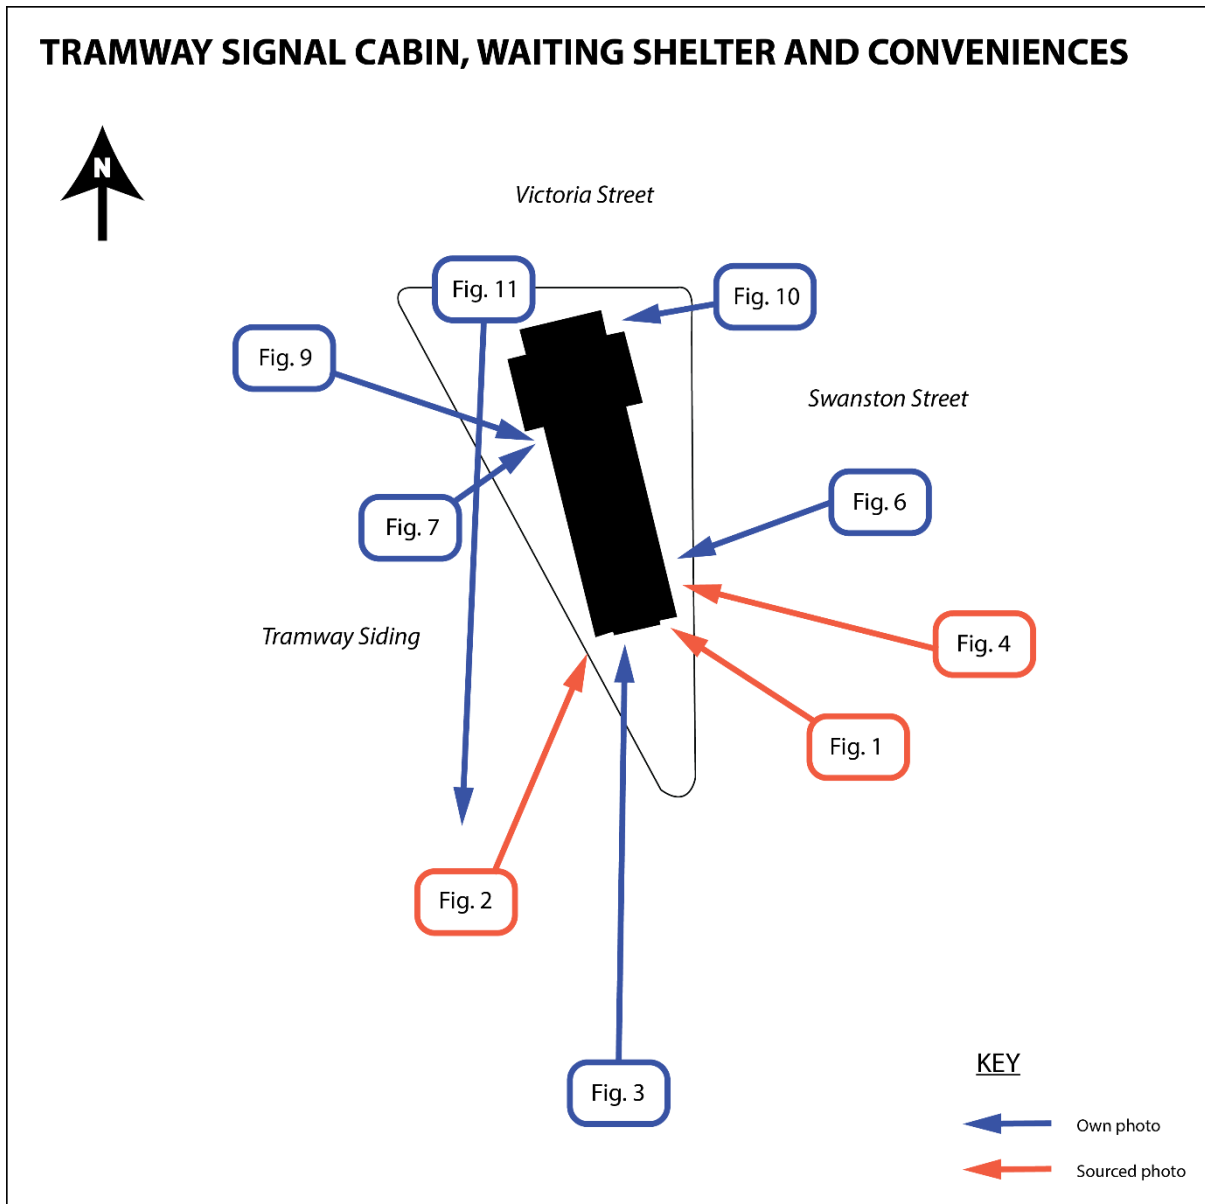
**Appendix A:** A 'mud map' showing the layout of the Tramway Shelter and perspectives of photos used in the document (both own and sourced).
