**NOMINATION OF THE PRESERVATION AND RESTORATION OF
MELBOURNE & METROPOLITAN TRAMWAYS BOARD
L CLASS TRAM No. 103
FOR THE COTMA ACHIEVEMENT AWARD**

The Committee of Management of the Melbourne Tramcar Preservation Association Inc. would like to nominate the preservation and restoration of Melbourne & Metropolitan Tramways Board L Class tram No. 103 for the 2008 COTMA Achievement Award.

Preservation and Restoration

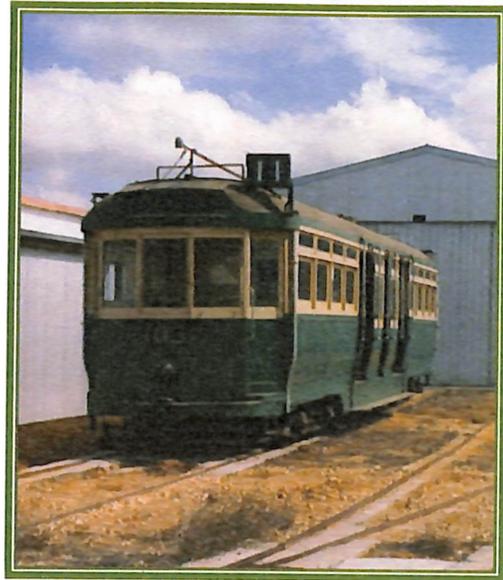
When acquired from Melbourne the GE247 motors and the DH 16 compressor from L class No. 103 were retained by the MMTB as spares for W class trams in its fleet, rendering it inoperable. As such, the priority for the initial refurbishment of trams at Haddon centred on trams which were complete and nominally operable.

*L 103 after arrival at Haddon.
Photo – Anthony Smith*

Some early work was carried out on L 103, scraping off old paint and filling and priming the surfaces for eventual painting. Most of this work was carried out as fill-in work while work was being undertaken on other trams and on other projects at the Museum.

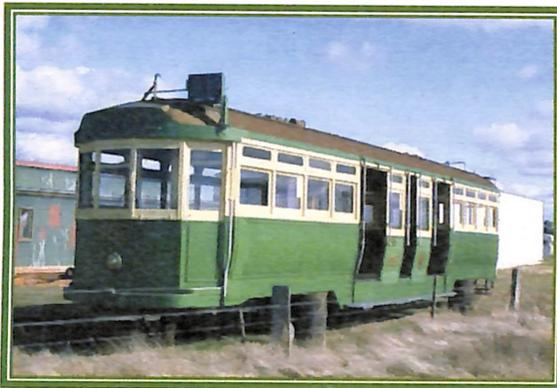
Sister car L 105 awaiting dismantling at Haddon. Photo – Anthony Smith

An important part of works that contributed to L 103's restoration involved the careful dismantling of the body of sister car L 105 to provide usable components to assist in the restoration of L 103. Other mechanical components from L 105 assisted in the eventual restoration of VR 41.

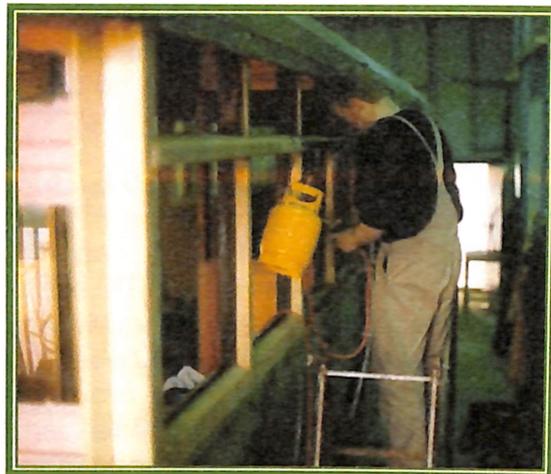
*Richard Gipps burns and scrapes the old paint from the exterior of L 103.
Photo – Anthony Smith*

Works on L 103 were still impacted by other construction works at the Museum site, so its progression was a lot slower than the previous two trams. Initially work concentrated on completing the scraping and filling of the exterior, and repairs to windows and doors.

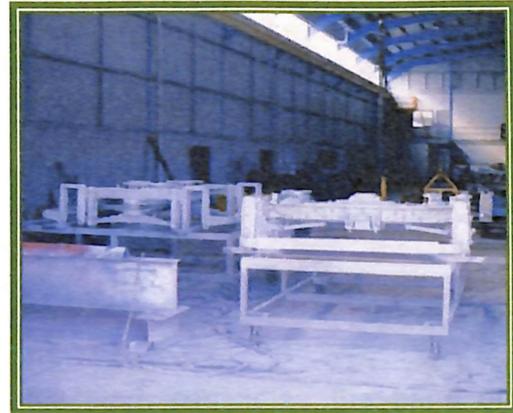
*The truck frames from L 103 after being sandblasted and primed.
Photo – Anthony Smith*

L 103 from the time of its arrival had sat on the trucks from sister car L 105, leaving L 103's trucks free for working on. Initially the truck frames were completely dismantled, cleaned, worn components rebuilt, and then reassembled using the wheelsets from 222.

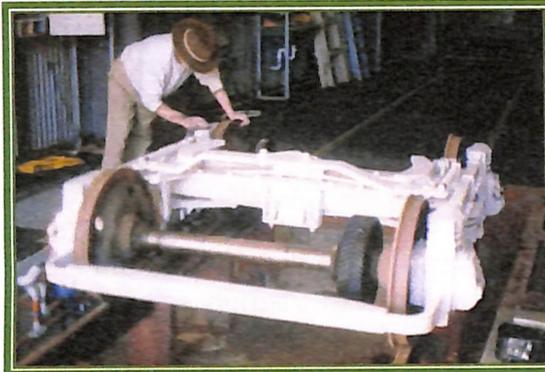
*John Withers cleans the truck frames after fitting of the wheelsets for the MV101 motors.
Photo – Anthony Smith*

The task of fitting the MV101 motors required some additional engineering work to be carried out on the truck frames to allow them to fit, but eventually all four motors were reunited with their respective wheelsets.

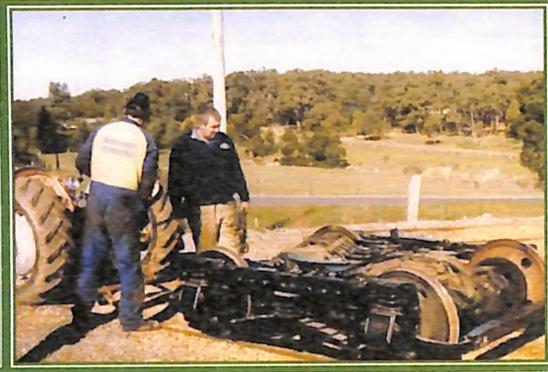
*Anthony Smith and Kym Smith carrying out non-live testing of the 77E trucks for L 103 after fitting of the MV101 motors.
Photo – Jacqui Smith*

As the GE247 motors were still unobtainable in the late 1990's the Museum set about modifying L 103's Brill 77E trucks to accommodate MV101 motors from W2 class tram 222.

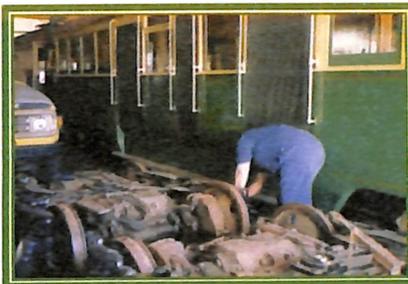
*Kym Smith making final adjustments and lubricating the trucks for L 103 prior to their reinstallation.
Photo – Anthony Smith*

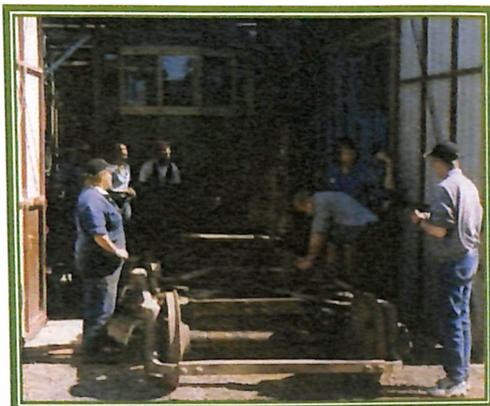
The Bendigo crew removing the temporary trucks from under L 103 prior to reinstalling the overhauled trucks.

Within the space of a few hours L 103 had been lifted, the trucks exchanged, compressor installed, and the tram lowered onto its original and now refurbished trucks.

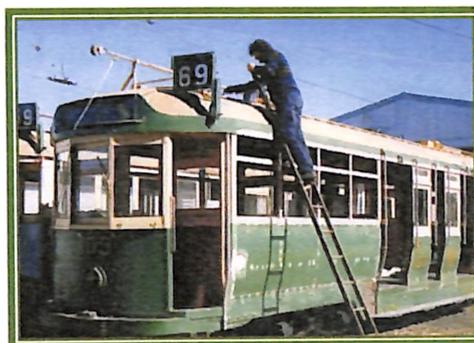
Anthony Smith sealing and painting the roof of L 103. Photo – Jacqui Smith

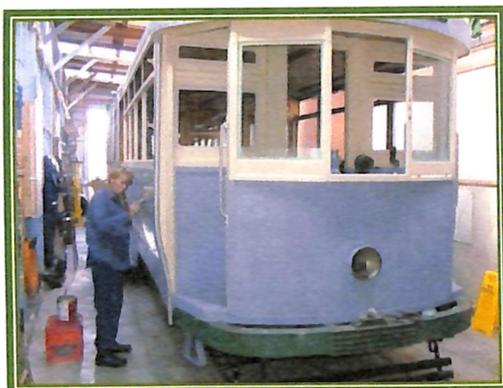
Jacqui Smith undercoating the side panels of L 103. Photo – Anthony Smith

With the mechanical work now completed, work concentrated on completing the scraping and filling of the external surfaces, followed by priming, undercoating, and gloss coating the exterior.

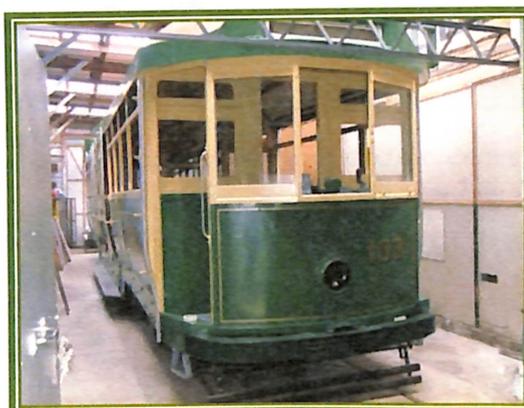
L 103 after completion of the pinstriping and numbers. The cab front numbers were later replaced with the correct height numbers.

During 2005 and 2006 work continued on the exterior and interior of the tram until late 2006 when the gold pinstriping, numbers and MMTB crests were applied.

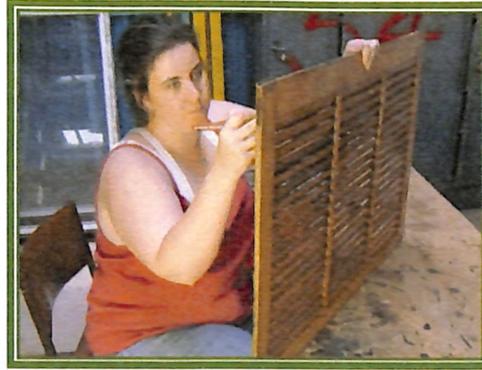
Cindy Tassie varnishing the timber louvres from L 103. Photo – Anthony Smith

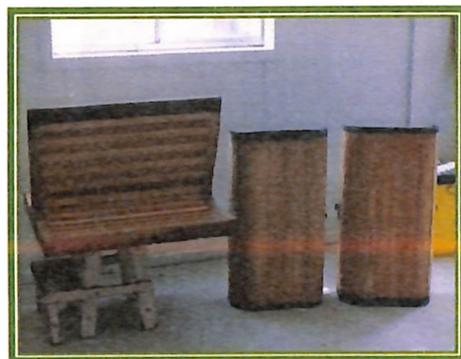
Restored and re-varnished dropcentre seat and controller covers for L 103. Photo – Anthony Smith

The majority of L 103 is original components restored for reuse. Where the original components have been unserviceable, in the first instance they have been sourced from the salvaged body of components of sister car L 105, in the second instance like components have been sourced from other trams, in the third instance components have been sourced from similar era trams, and in the fourth instance new replacement components have been used.

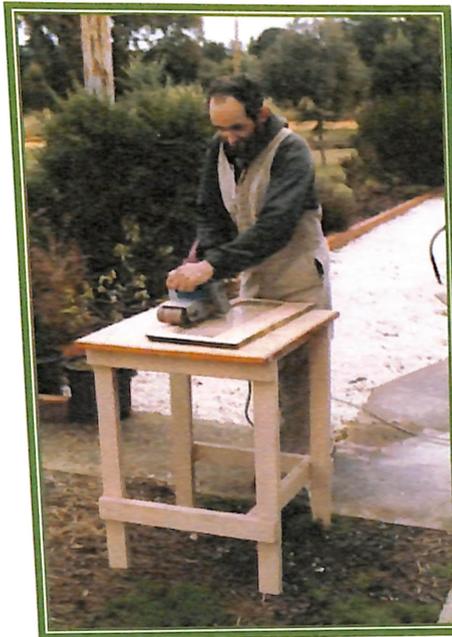
*Arthur Ireland sands down a hopper window from L 103.
Photo – Anthony Smith*

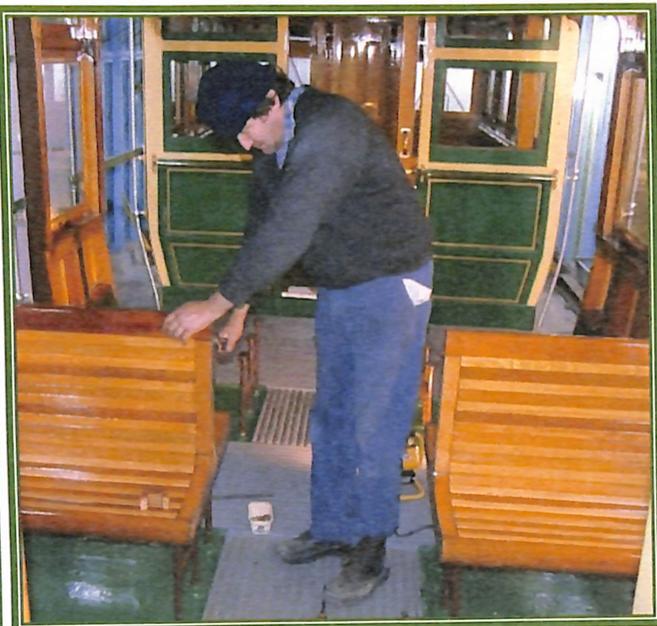
*Anthony Smith installing the freshly varnished dropcentre seats in L 103.
Photo – Jacqui Smith*

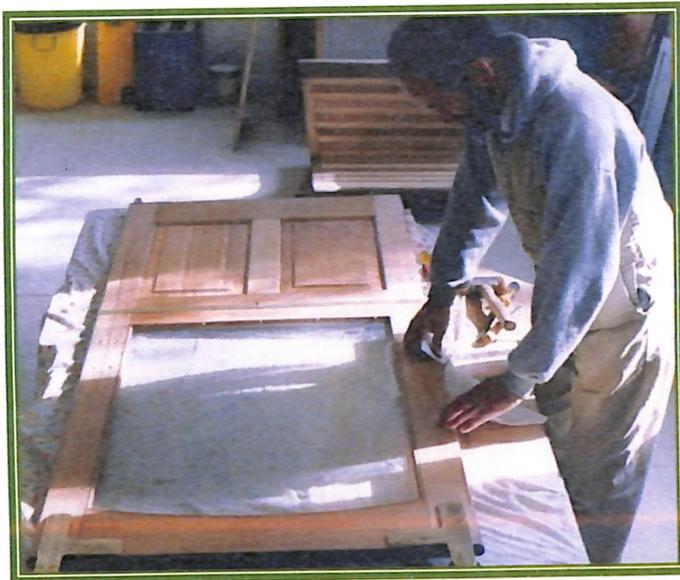
Arthur Ireland sanding down a saloon door from L 103. Photo – Anthony Smith

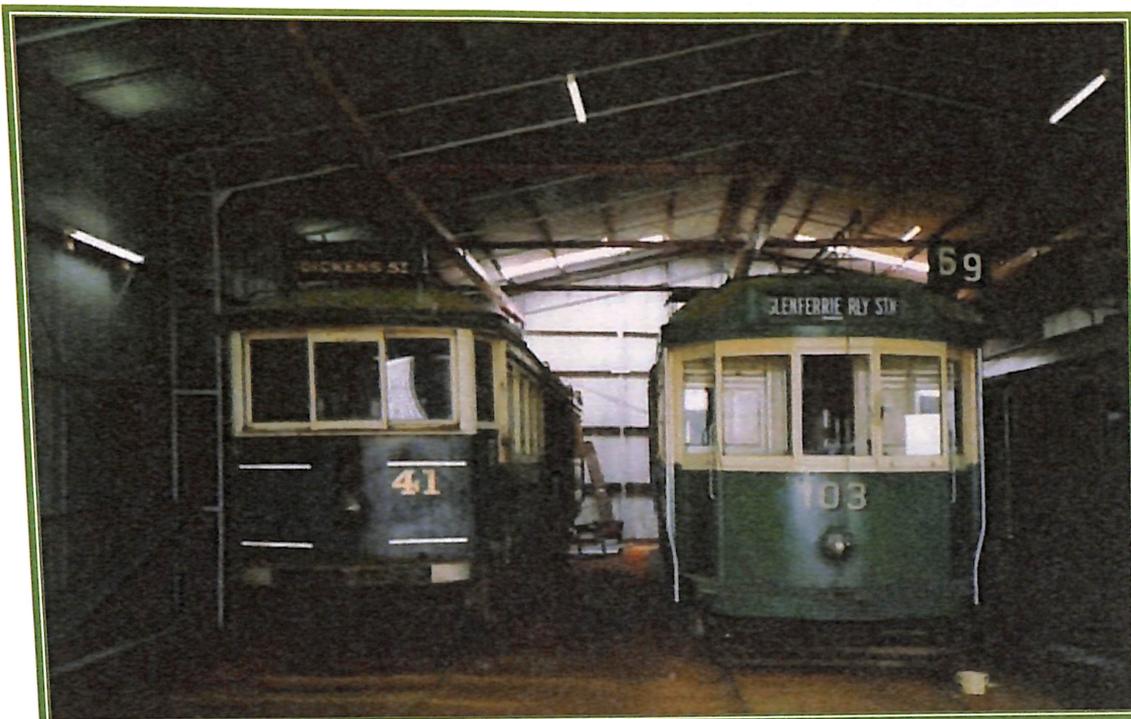
Upper Photo – VR 41 and L 103 await their restorations, November 1991.
Photo courtesy Bob Pearce.

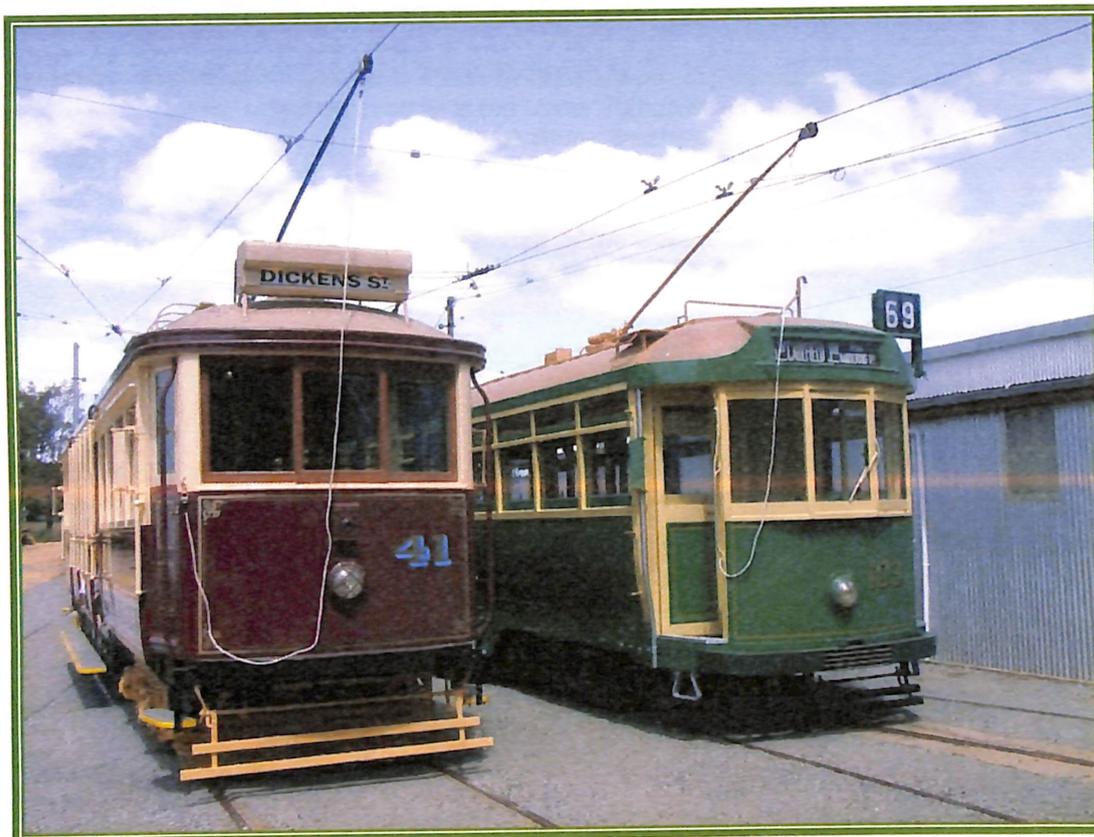
VR 41 and L 103 on the Carbarn fan at Haddon, April 2008.
Photo – Anthony Smith

L 103 has been returned to its late 1950's/early 1960's appearance featuring green window pillars, gold pinstriping, numbers to the sides of the headlights, and numbers and logos on the saloon panels.
