CURVE JUNCTION OF COLLINS STREET

WITH SPRING ST.

LINE 2.
PLAN A.4.

DESCRIPTION A.4.

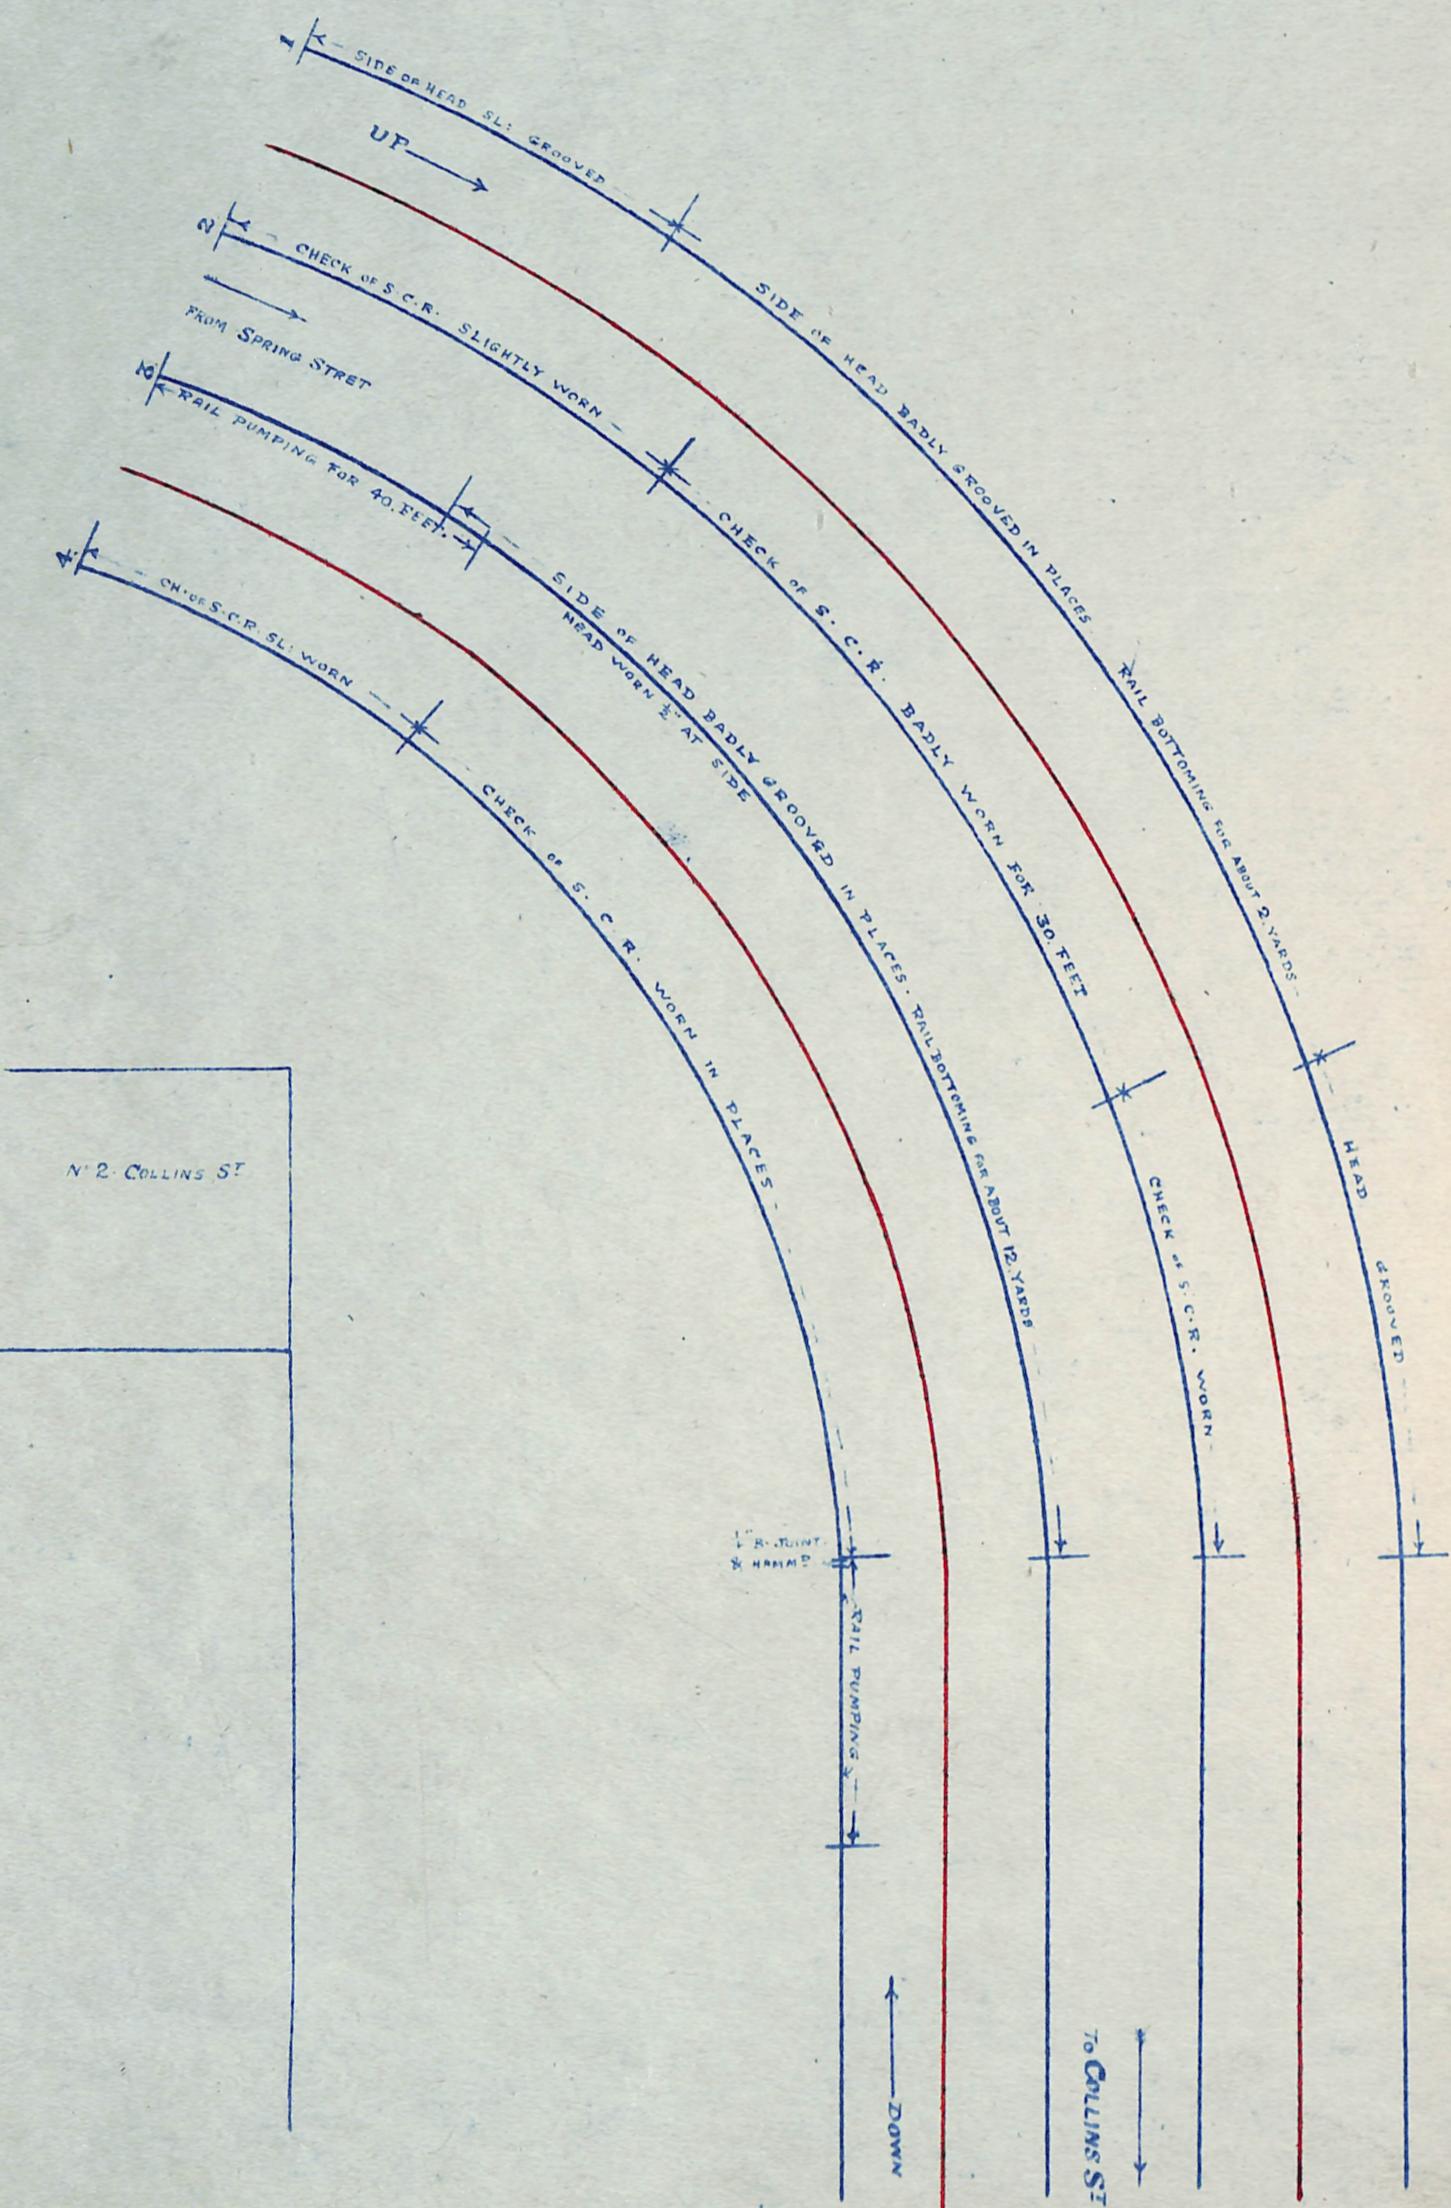
LINE 2.
PLAN A.4.

1. The Checks of Special Check-rails of Nos. 2 and 4 rails are worn to varying amounts. The centre of Curve of No. 2 rail, the check is badly worn for a length of about 30 feet. The Checks to Nos. 2 and 4 rails are in places loose and ineffective. Sides of Heads of opposite rails (Nos. 1 and 3) are grooved to varying degrees, and in the centre of each curve are badly grooved, and on No. 3 rail is worn $1\frac{1}{2}$ " at side, as a result of above check-wear.

2. No. 1 Rail is bottoming for about 2 yards, near centre of curve. No. 3 Rail is bottoming for about 12 yds., near (Collins St.) end of curve.
3. A length of No. 3 rail (about 40 ft.) is pumping and fishplates are presumably loose. A short length of straight rail adjoining No. 4 Curved rail, on West side, is pumping, and fishplates are presumably loose.

4. Paving Blocks on each side of pumping rails are loose.
5. The Joint between end of curved No. 4 rail and straight rail is $\frac{1}{4}$ " wide, and hammered.

<u>Clearance</u>		<u>Super-Elevation</u>
No. 1 Rail	.186	No. 1 Rail $2\frac{1}{2}$ " (Rolling Place)
No. 2 "	.233	" 3 " $3\frac{3}{4}$ " (Rolling Place)
No. 3 "	0	
No. 4 "	.171

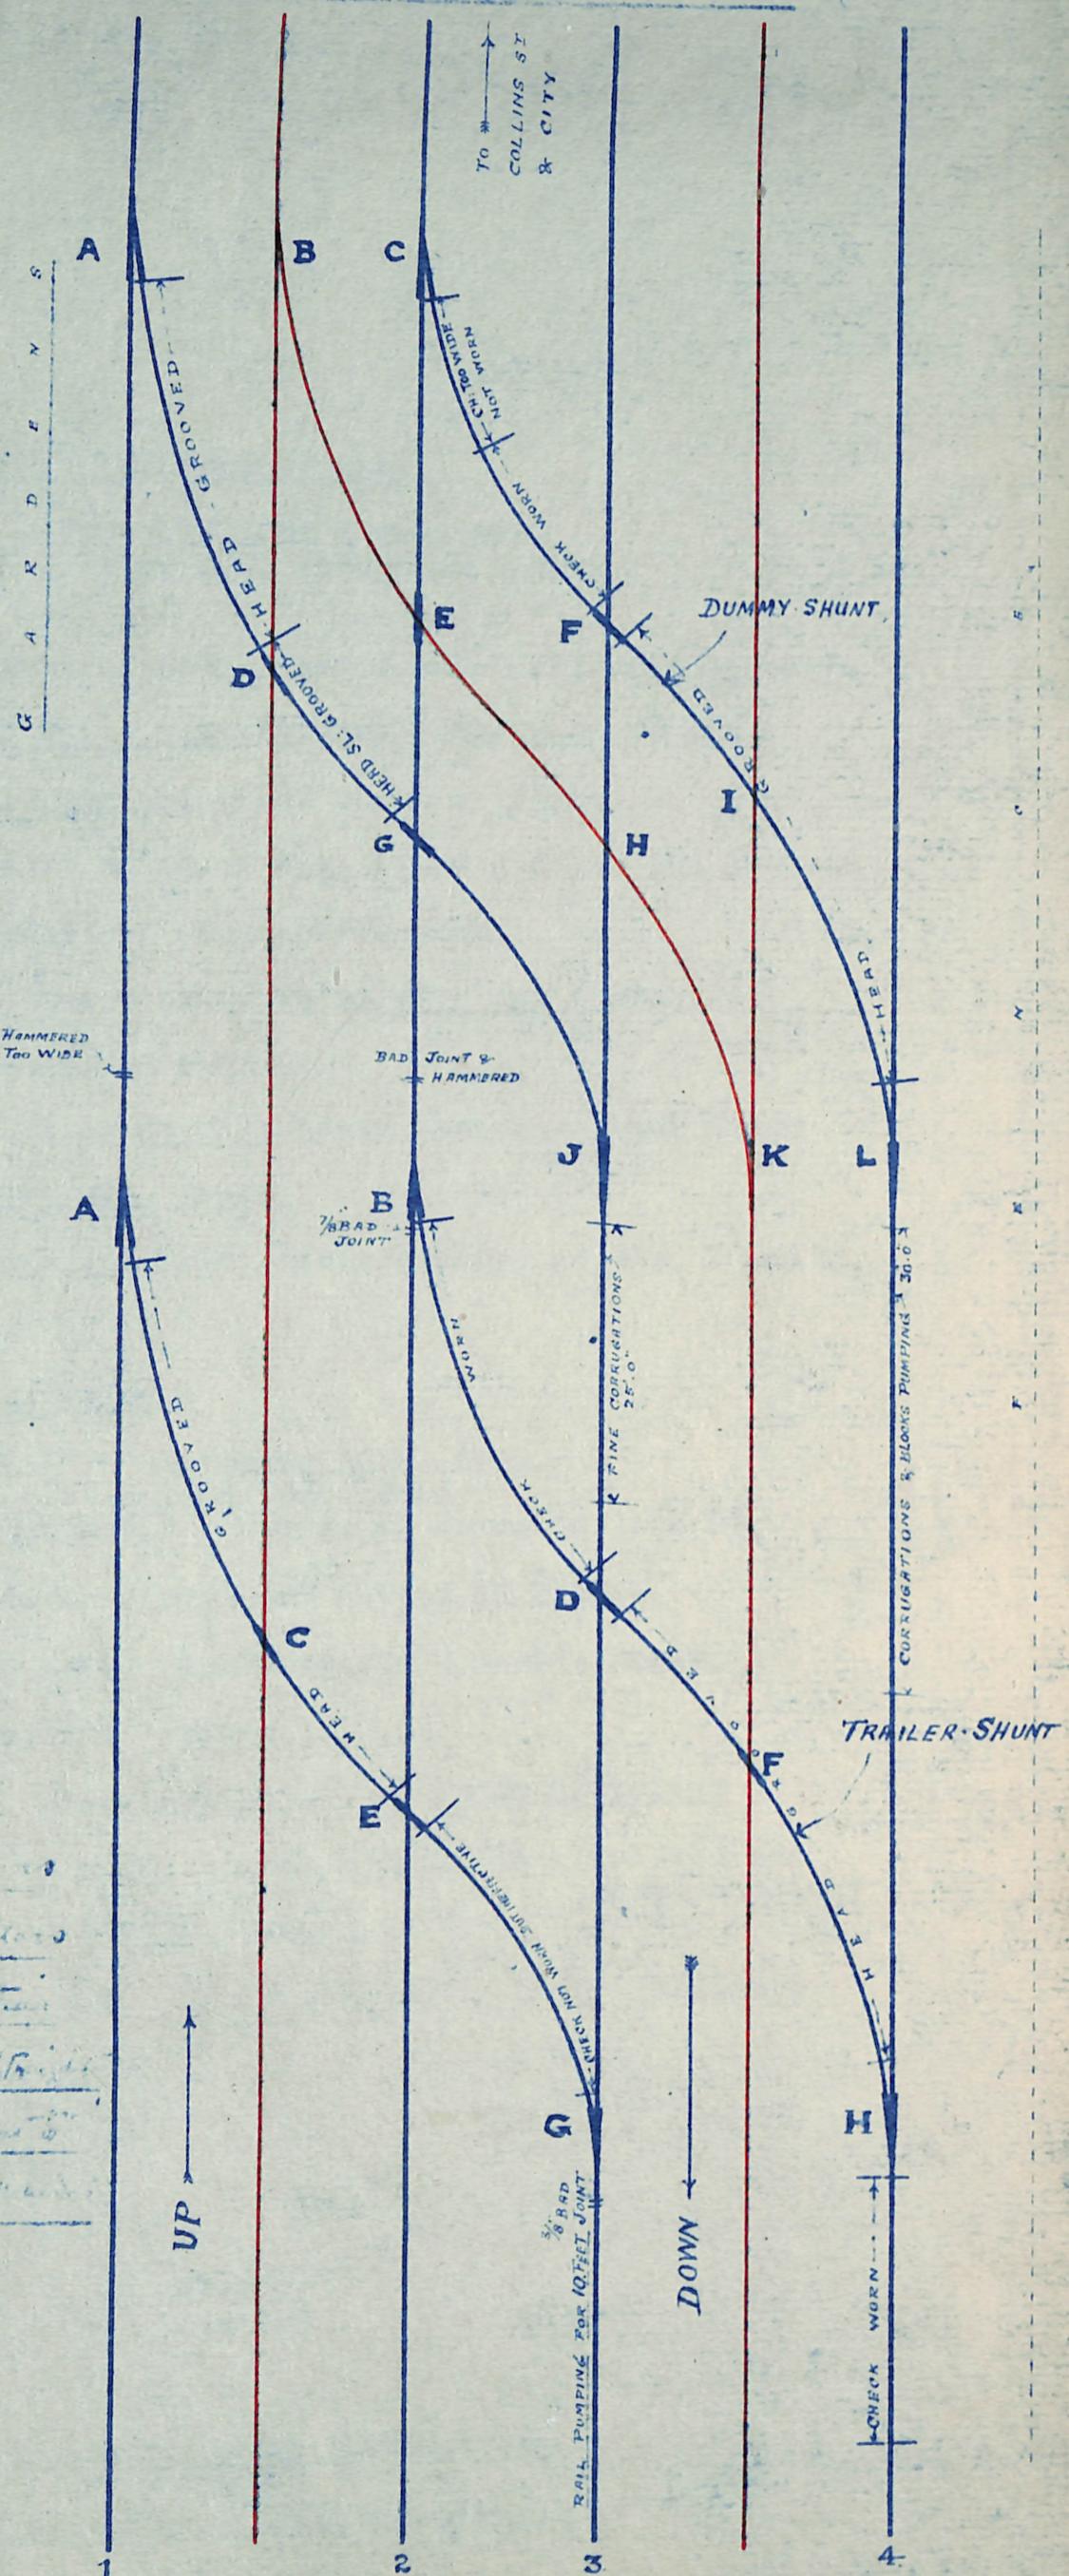
LINE 2
PLAN. A. 5.

1. On two of the four Inner Curves of the Dummy and Trailer-Shunts the checks of Special Check-rails are worn. On one of the Inner Curves of Trailer-Shunt, the Special check is loose and ineffective in places. *Heel Rocking*

Kid
The sides of heads of the four Outer Curves are grooved, as a result of the above check-wear.

2. Seven of the heels of the eight Points are of loose fit and rocking, resulting in excessive hammering. Tongues are worn to varying degrees, and in two cases are below level of Point-Casting.

3. A length of No. 3 Rail (Down Track) adjacent to point of Trailer-Shunt for about 10 feet is pumping and fishplates are presumably loose.
4. The adjacent paving-blocks are loose at several places on each side of Nos. 3 and 4 rails, and tarred surface is shattered.

5. Fine corrugations are apparent, on No. 4 Rail (Down-Track) North of Point of Trailer-Shunt, for a distance of about 30 feet, and on No. 3 Rail, North of intersection of Trailer-Shunt rail, for a length of about 25 feet.

6. At the crossing intersections, also at intersections of slot-rails with Tram-rails, there is hammering to varying degrees.
7. Two of the Joints of Tram-rails, adjacent to Points are wide ($3/8"$ and $7/8"$) and these joints are hammered. There is also hammering of some of the other joints, and want of lineability of tread-surfaces.

- A Heel Rocking
 - B Nil.
 - C Heel Rocking
 - D Points Hammered.
 - E Points Badly Hammered
 - F D: Hammered.
 - G D: Hammered.
 - H D: Slightly Hammered
 - I D: Hammered.
 - J Heel Rocking
 - K Nil.
 - L Heel Rocking Badly.

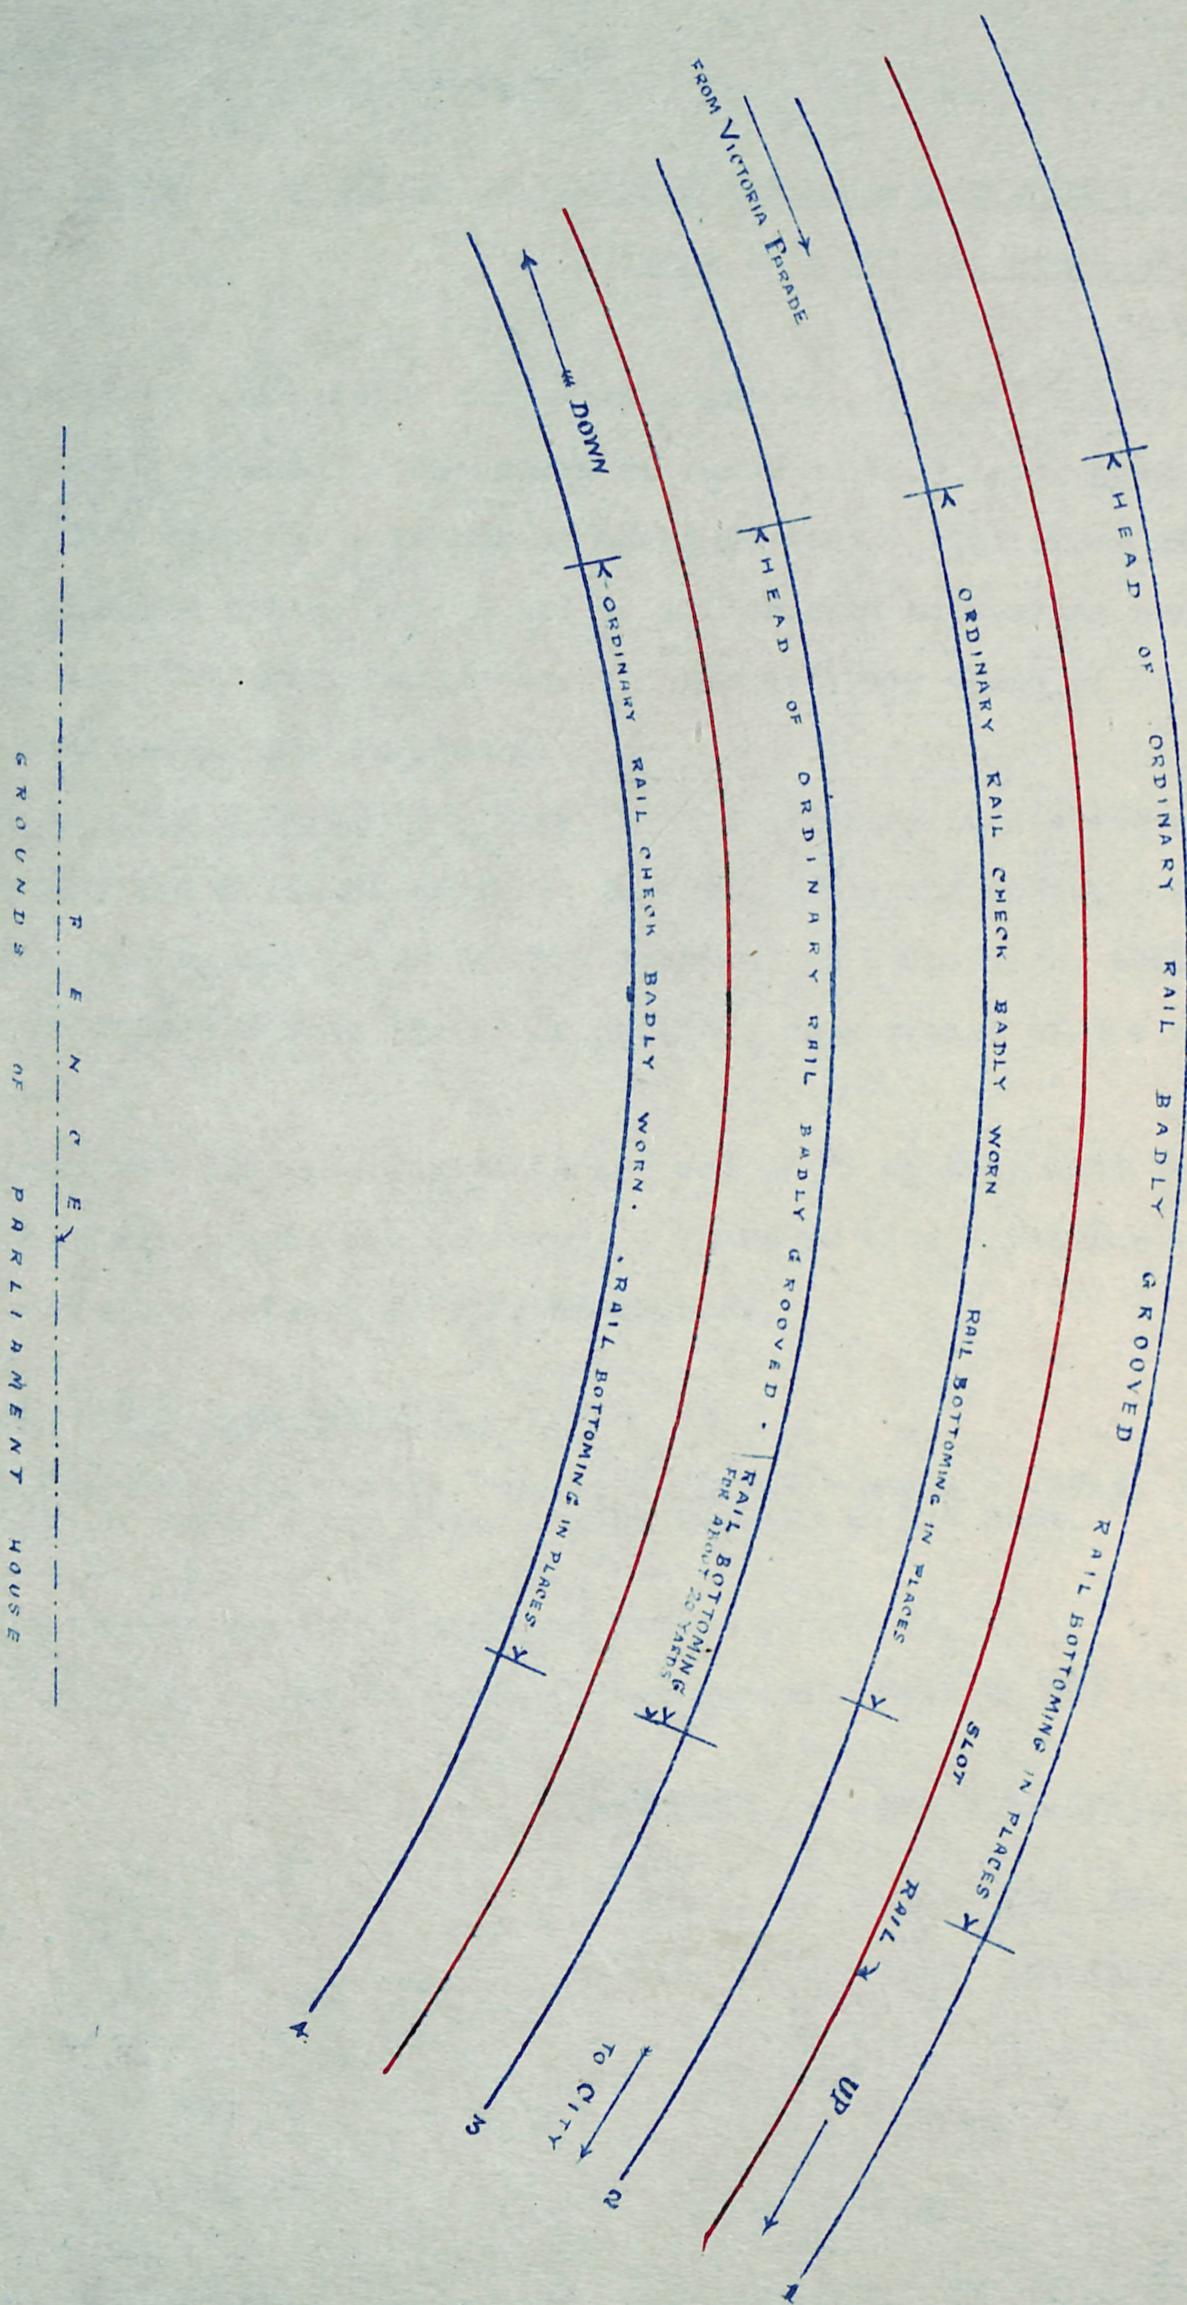
LINE 2.
PLAN A.6.

1. The ordinary rail-checks of Nos. 2 and 4 Rails are worn to varying amounts. The check of No. 4 rail is very badly worn in the centre of curve, and rail is bottoming for about 15 yards. The sides of heads of Ordinary Rails of Nos. 1 and 3 Rails are grooved to varying amounts, as a result of above check-wear. The head of No. 3 rail in centre of curve is very badly grooved, and rail is bottoming for about 20 yards.
2. The Tread of No. 3 rail is 60 Mils lower than the Wheel Gauge and Tread of No. 4 rail is 45 Mils lower.
3. There is a slight down-gradient (towards City) on Nos. 1 and 2 Rails.

<u>Clearance</u>	<u>Super-Elevation</u>
No. 1 Rail	.250	No. 1 Rail 1" (Rolling and Light Braking)
No. 2 "	.279"	No. 2 "
No. 3 "	0	" 3 " 1 $\frac{1}{8}$ " (Rolling)
No. 4 "	0	" 4 "

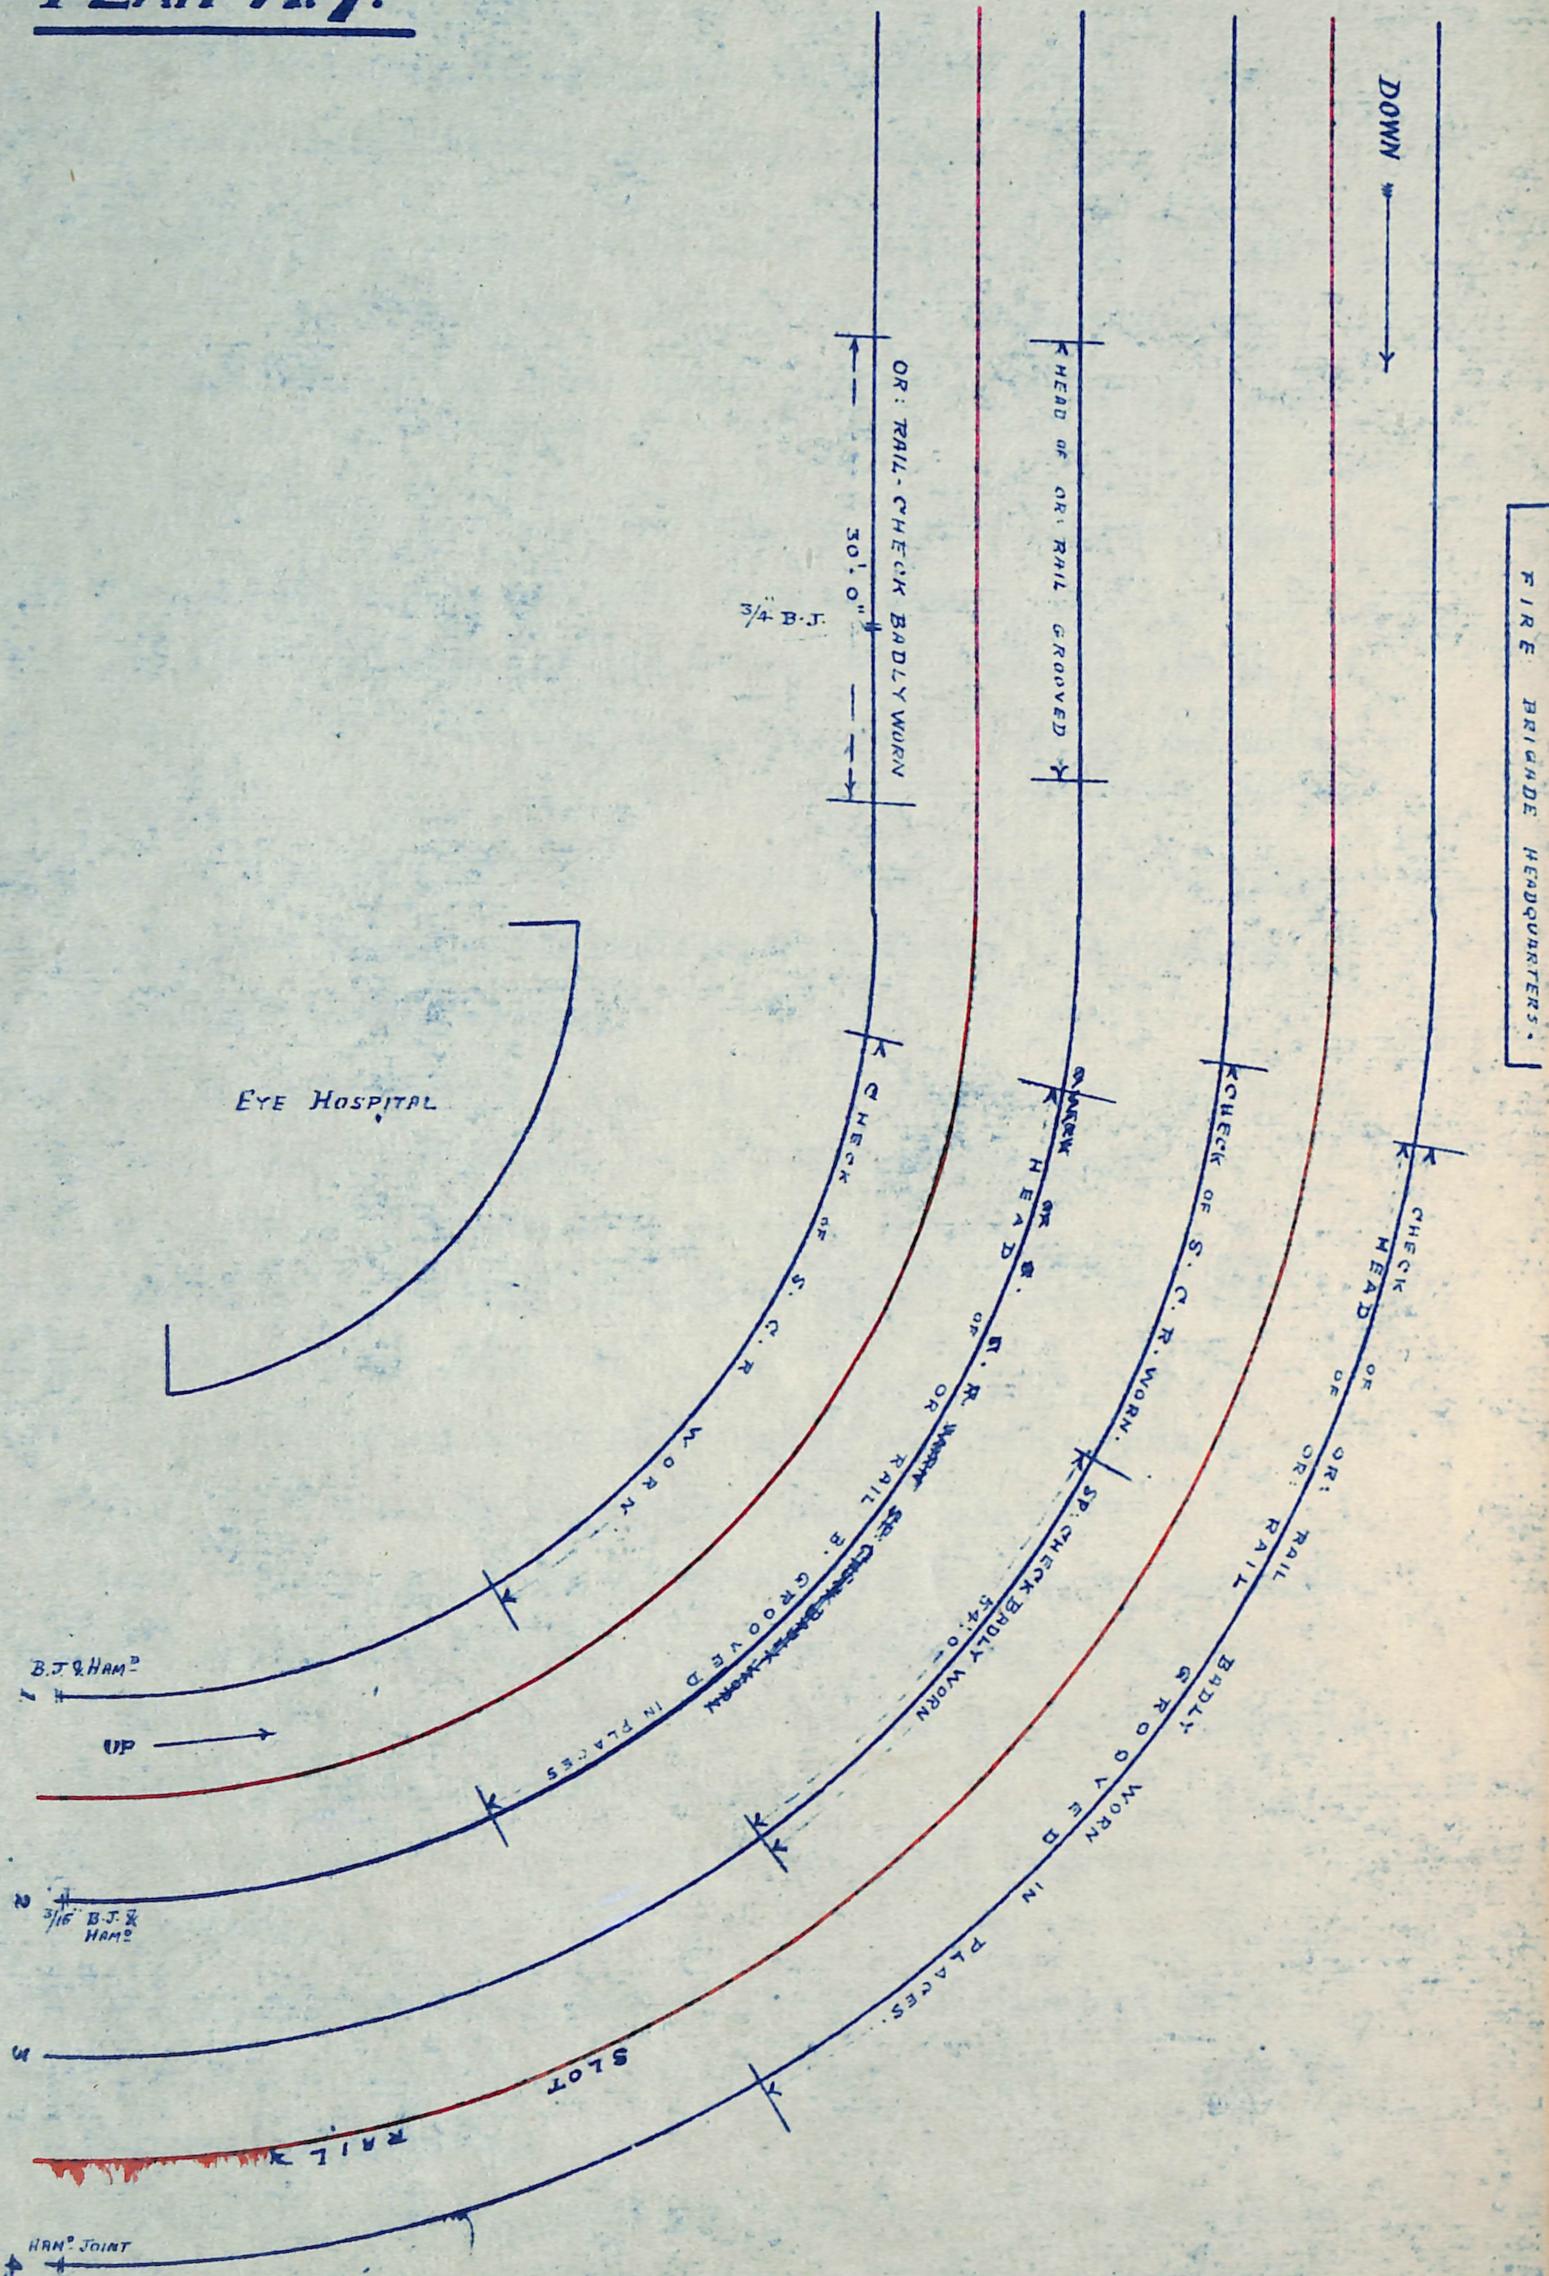
PLAN A.7.

1. The Checks of Special Check-rails (of Nos. 1 and 2 Rails) are worn to varying amounts. In centre of Curve on No. 3 Rail, special check is badly worn for a length of about 54 feet. The sides of heads of opposite rails (Nos. 2 and 4) are grooved to varying amounts, as a result of the above check-wear. The ordinary check of No. 4 Rail is also badly worn in places.
2. Nos. 1 and 2 Rails (Up-Track). The ordinary rail-check of No. 1 straight rail for a length of about 30 feet, adjoining curve, (on South side, and nearly opposite Fire station) is badly worn, whilst the head of opposite rail (No. 2) is grooved, as a result of the above check-wear.
3. There are two wide joints ($3/16"$ and $3/4"$) on Nos. 1 and 2 rails, and these joints are hammered. There is also hammering of some of the other joints, to varying degrees.

Clearance	Super-Elevation
No. 1 Rail	.250	
No. 2 "	.233	$3\frac{1}{2}$ " (Rolling Place)
No. 3 "	.345	
No. 4 "	.270	$1\frac{1}{2}$ " (Rolling Place)

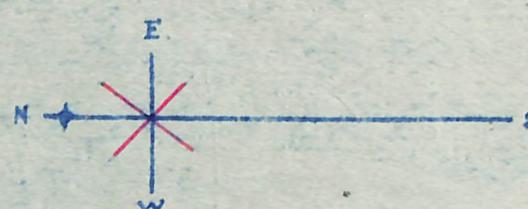
LINE 2 · PLAN B.1.

1. On the four (4) Inner Curves of the Dummy and Trailer Shunts, the Checks of Special Check Rails are worn, and in some cases badly so; The sides of heads of the two Inner Curves of Trailer Shunt are badly grooved.

An 8" length of check is broken and missing from Casting of Intersection of No. 3 Rail with curved rail of Dummy Shunt.

2. The sides of heads of three of the 4 Outer Curves are grooved to varying amounts, and in places very badly so, as a result of the above check wear.

A length of No. 1 rail (about $2\frac{1}{2}$ yards) is bottoming, and rail tread is 60 mils lower than wheel gauge. A length of No. 3 rail is bottoming in places for a length of 12 yards.

4. A short length of No. 3 rail, for about 4 yards, is pumping, and Fishplates are presumably loose.

5. The rails adjacent to Points of Dummy Shunt, and Trailer Shunt, on No. 4 Rail, are $3/16"$ and $1/8"$ respectively out of alignment.

7. Four of the 6 heels are of loose fit and rocking, and one of these is higher than level of tread of Point-Casting.

8. At the Crossing intersections, also at the intersections of slot-rails with tram rails, hammering is taking place to varying degrees, and in some cases it is considerable.

9. 9 of the Joints of Tram-rails, adjacent to rail-crossings and Points are wide, (varying from $1/4"$ to $3/8"$), and in several cases are badly hammered. There is also hammering of some of the other joints, and

10. GAUGE of Nos. 1 and 2 Rails is $1/4"$ too wide, and No. 2 Rail Check is worn.

11. PAVING BLOCKS on each side of pumping rails are loose, and Tarred surface is shattered.

- A Heel loose Fit and Rocking.
Tongue Wear
- B Heel loose Fit and Rocking. Point Badly worn.
Diagonal Grooving on Tread of Point-Casting.
- C Bad Hammering at Intersections.
8" length of Check of Point-Casting
Broken and Missing.
- D Heel loose fit, and slightly higher than adjacent Tread. Tongue Wear. Diagonal Wear on Tread of Point-Casting.
- E Tongue Slightly worn.
- F Bad Hammering at Intersections.
- G Hammering at Intersections.
- H Tongue Wear (Slightly.)
- I Heel loose fit and Rocking.
Tongue Wear
- A .
- B Bad Hammering at Intersections.
- C Hammering at Intersections.
- D .
- E Bad Hammering at Intersections
Slot-Rail loose and Moving when Cars pass over.
- F Hammering at Intersections.

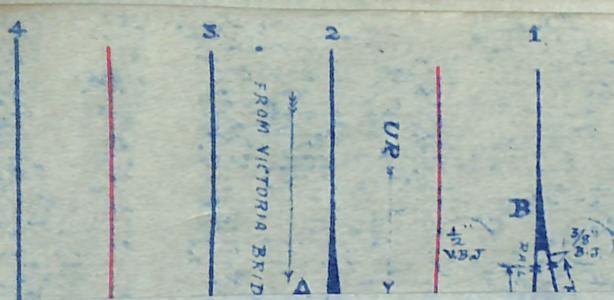
TRANSCAR DEPOT VICTORIA G.T.

1. The ordinary and Special Checks to the rails of "Turn-In" and "Turn-out" to Car Depot are worn to varying amounts, and the sides of Heads of opposite rail grooved, as a result of the above check wear. The check-rail to Turn-Out is ineffective in places.

2. Three of the four heads of Points are of loose fit and rocking Tongues are worn, to varying degrees. Super-Elevation
3. A length of No. 1 Up-rail (adjacent to Point of "Turn-In") also a length of curved rail of "Turn-In" (adjacent to the same Point) are both pumping, and the fish-plates are presumably loose. Clearances

4. Faving blocks adjacent to the abovenamed rails, are loose and paved surface is shattered.
5. At the intersections of the Tran-rails also at intersections of slot-rails with Tran-rails there is hammering to varying degrees.

- A. Tongue Slightly worn.
- B. Heel loose Fit, and Rocking.
- C. -
- D. Hammering at Intersections.

- E. Nil.
- F. Heel loose Fit and Rocking.
- G. Slight Hammering at Intersections.
- H. Hammering at Intersections.

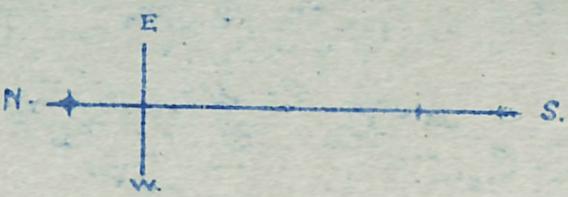
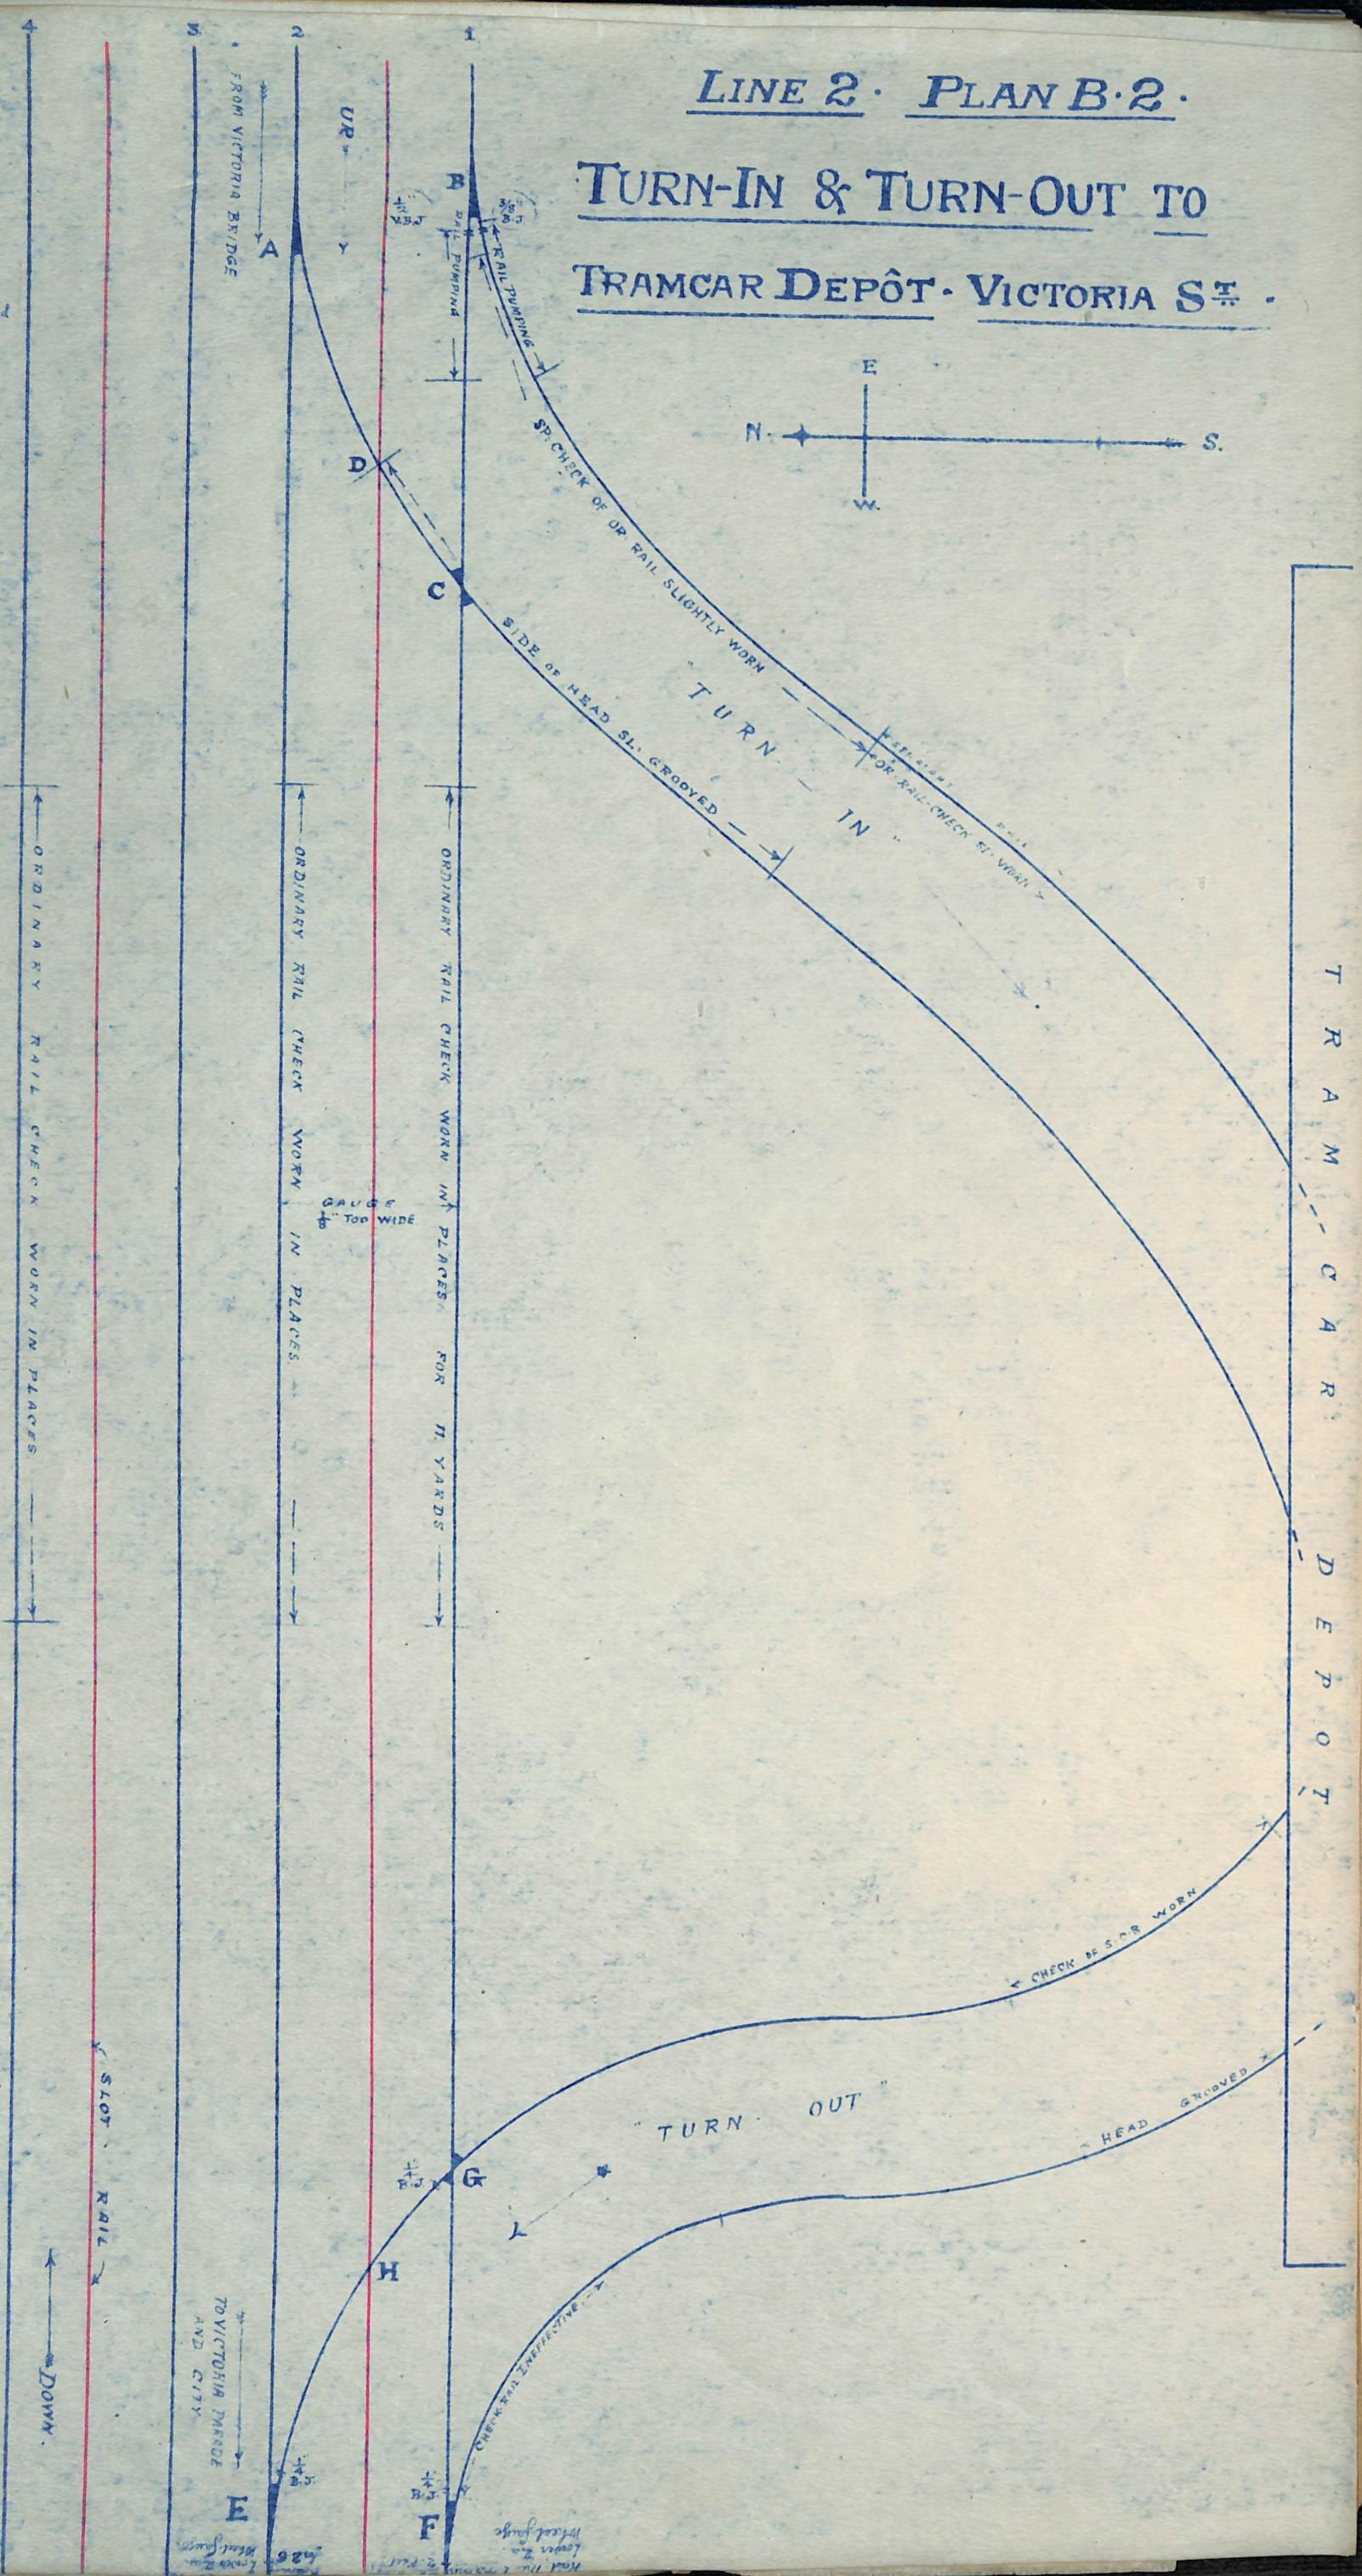
LINE 2. PLAN B.2.

6. Five of the joints of Tran-rails, adjacent to the rail-crossings and Points, are wide, varying from $1/4"$ to $3/8"$ and, in several cases, are hammered. There is also hammering of some of the other joints, to varying degrees.

7. Nos. 1 & 2 Rails West of Points of Turn-Out from Trancar Depot are bottoming for 2 feet and 2 feet 6 inches respectively CLEARANCES taken May 10th 1916 between flange and bottom of groove.

The lengths of straight rails (Nos. 1, 2 & 4) of Main Track for a length of about 11 yards, between "Turn-In" and "Turn-Out" have their ordinary rail-checks worn to varying amounts.

Gauge between Nos. 1 and 2 Rails is $1/8"$ too wide.

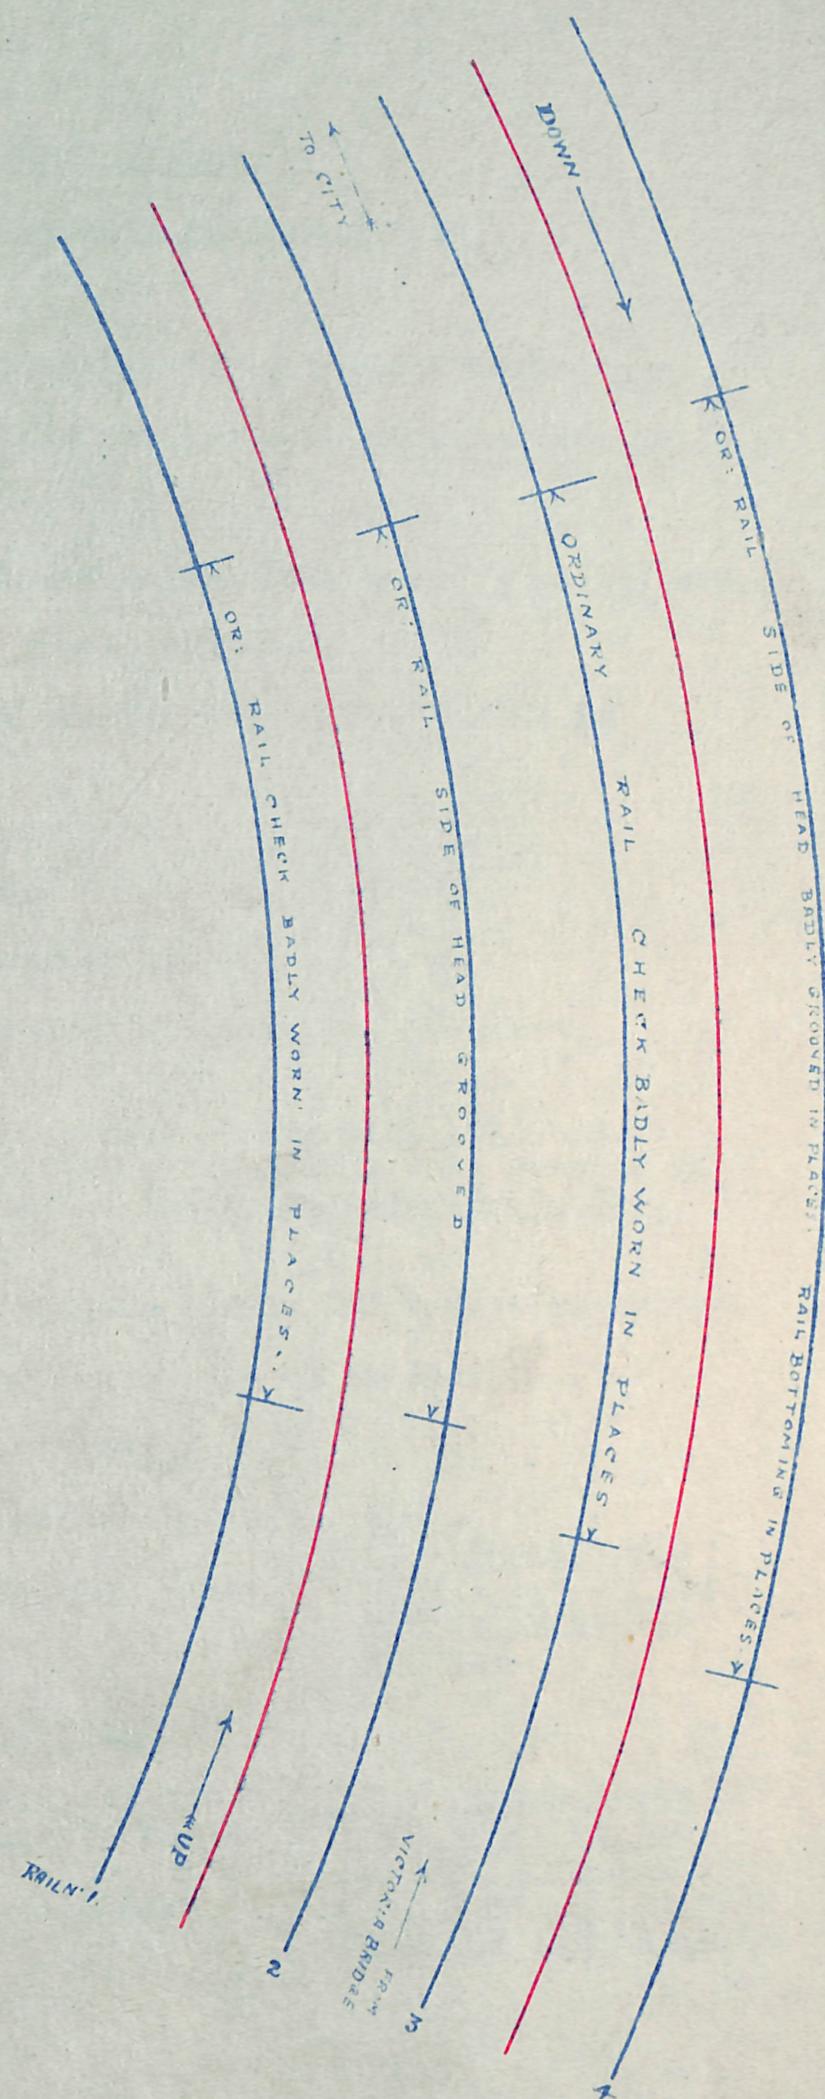
LINE 2.
PLAN B.3.

1. The Ordinary rail-checks of Nos. 1 and 3 Rails are worn to varying amounts. In the centres of curves checks are badly worn.
2. The sides of heads of ordinary rails are badly grooved in places, as a result of the above check-wear.
3. No. 4 rail (Down-Track) is bottoming in places.
