CURVE JUNCTION OF COLLINS STREET

WITH SPRING ST.

LINE 2.
PLAN A.4.

DESCRIPTION A.4.

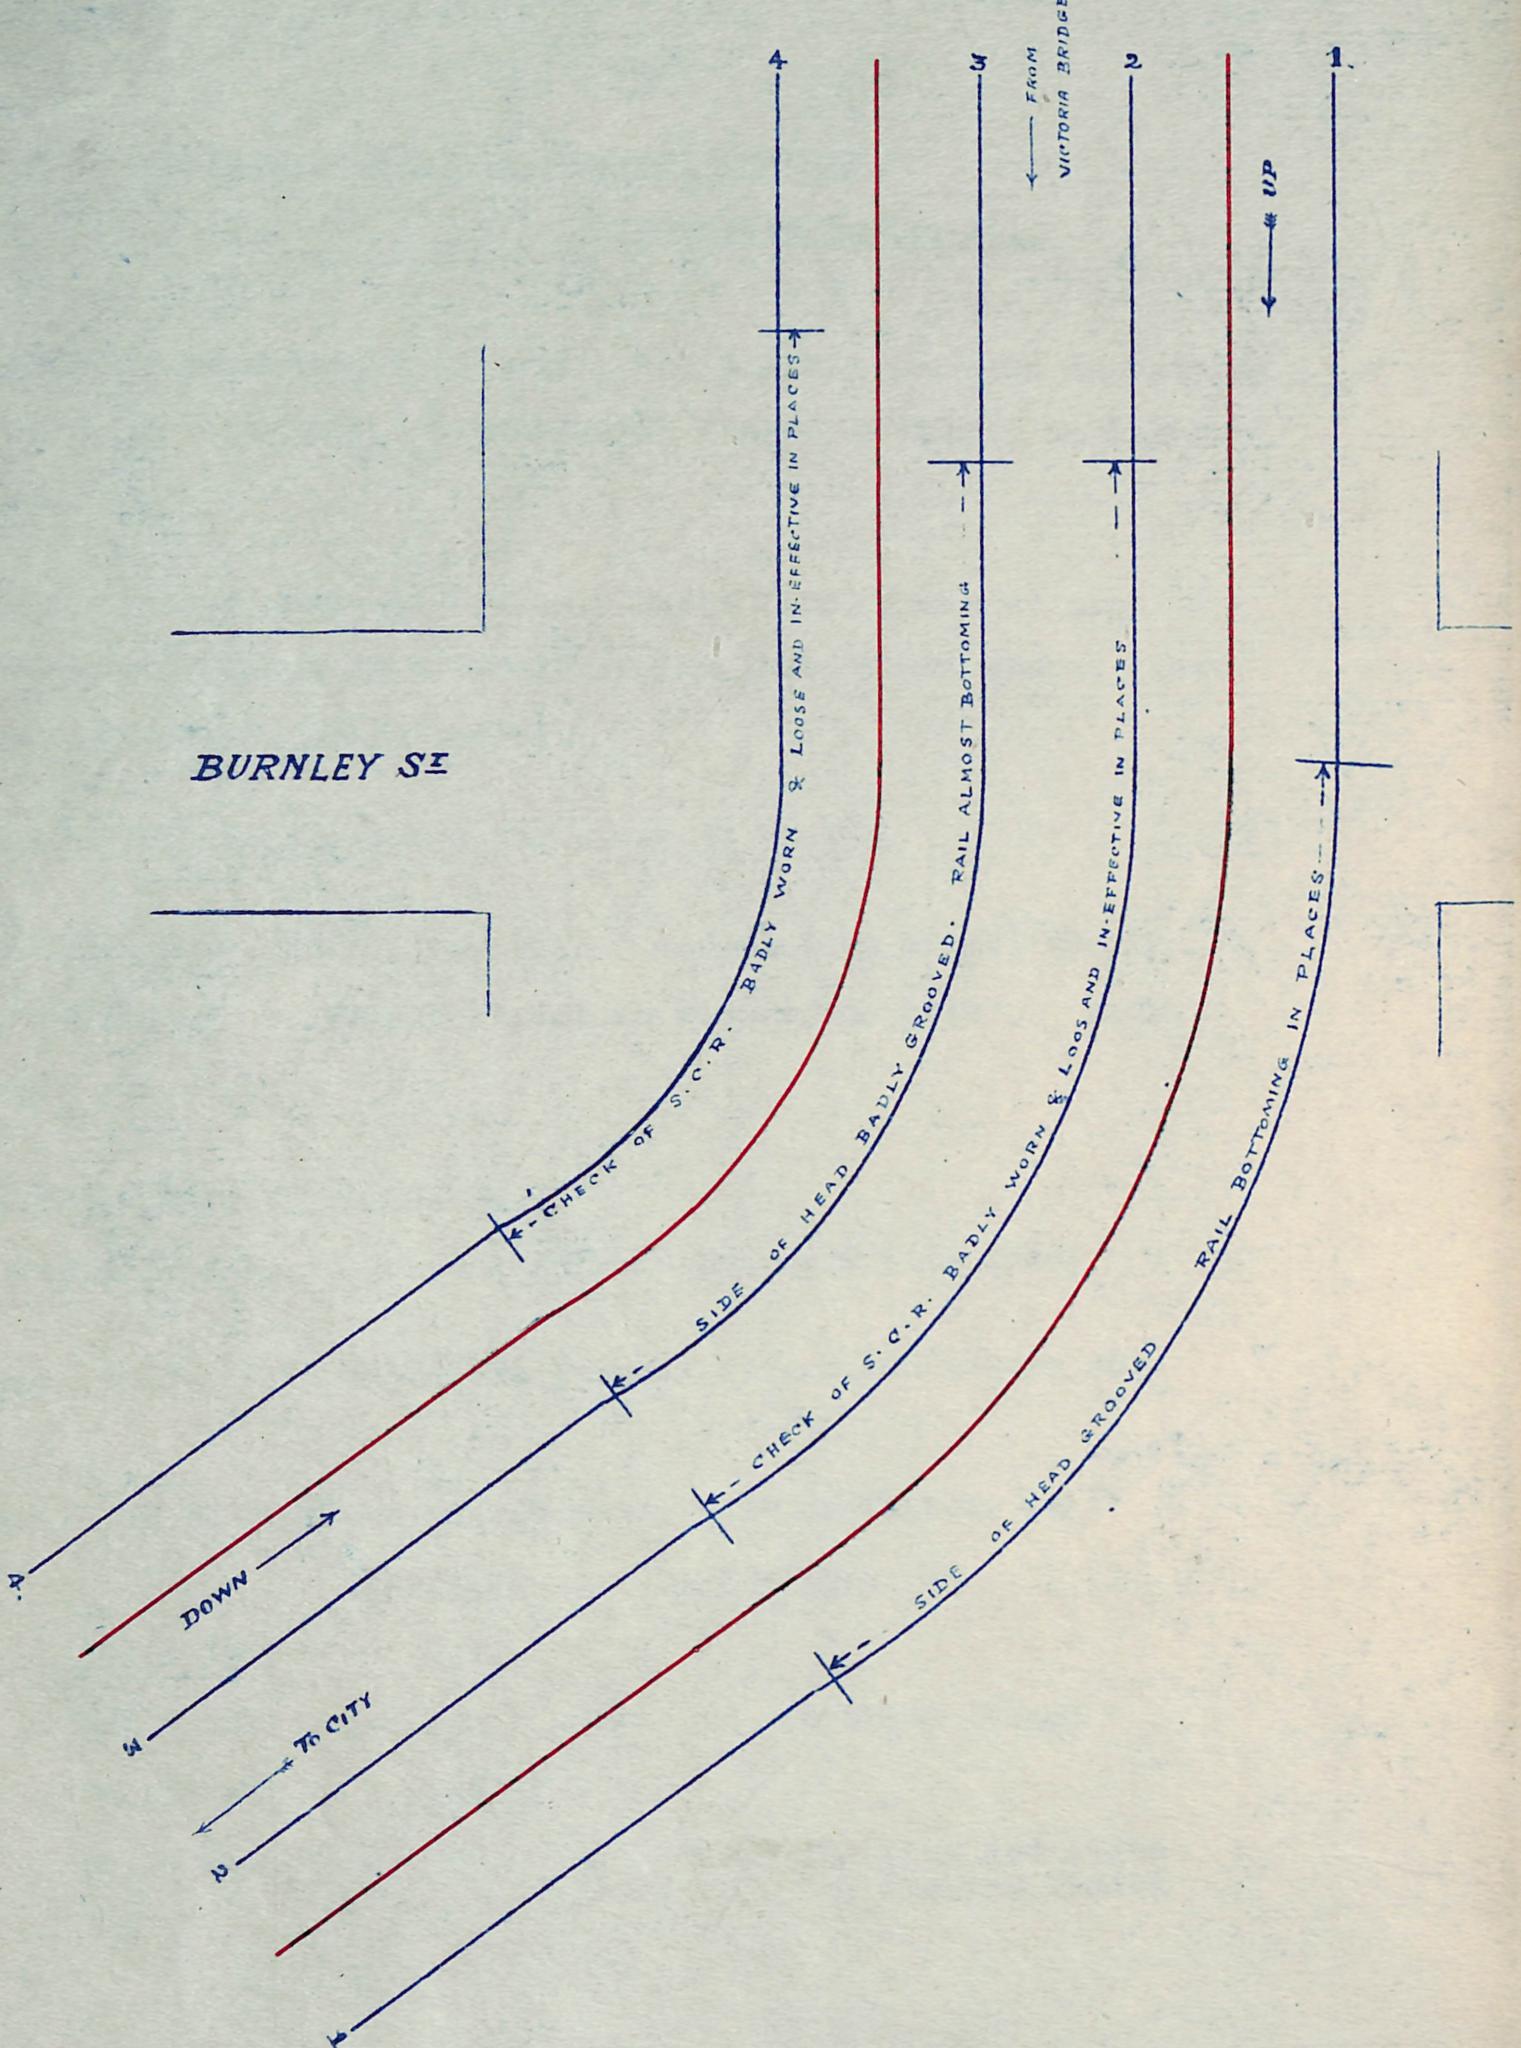
LINE 2.
PLAN B.4.

1. The Checks of Special Check-Rails (Nos. 2 and 4 Rails) are badly worn in places. These Checks are loose and ineffective in places.
2. The sides of heads of Ordinary rails (Nos. 1 and 3 rails) are badly grooved as a result of the above check-wear.
3. No. 1 Rail is bottoming in places, whilst No. 3 rail is almost bottoming. BURNLEY ST.

<u>Clearance</u>	<u>Super-Elevation</u>	
No. 1 Rail	0	$1\frac{3}{8}$ " Rolling Place	
No. 2 Rail	.225"	$1\frac{1}{4}$ " Rolling Place	
No. 3 Rail	.062"	$1\frac{1}{4}$ " Rolling Place	
No. 4 Rail	.171"

<u>Clearance</u>	<u>Super-Elevation</u>	
No. 1 Rail	.326"	$1\frac{1}{8}$ " Rolling and Light Braking	
No. 2 Rail	.380"	$1\frac{1}{8}$ " (Rolling)	
No. 3 Rail	.372"		
No. 4 Rail	.310"

NOTE. - Since Track was first inspected on May 11th. 1916 and above particulars noted, there has been a full renewal of both tracks (Nos. 1, 2, 3 and 4 rails) on June 18-19, 1916.

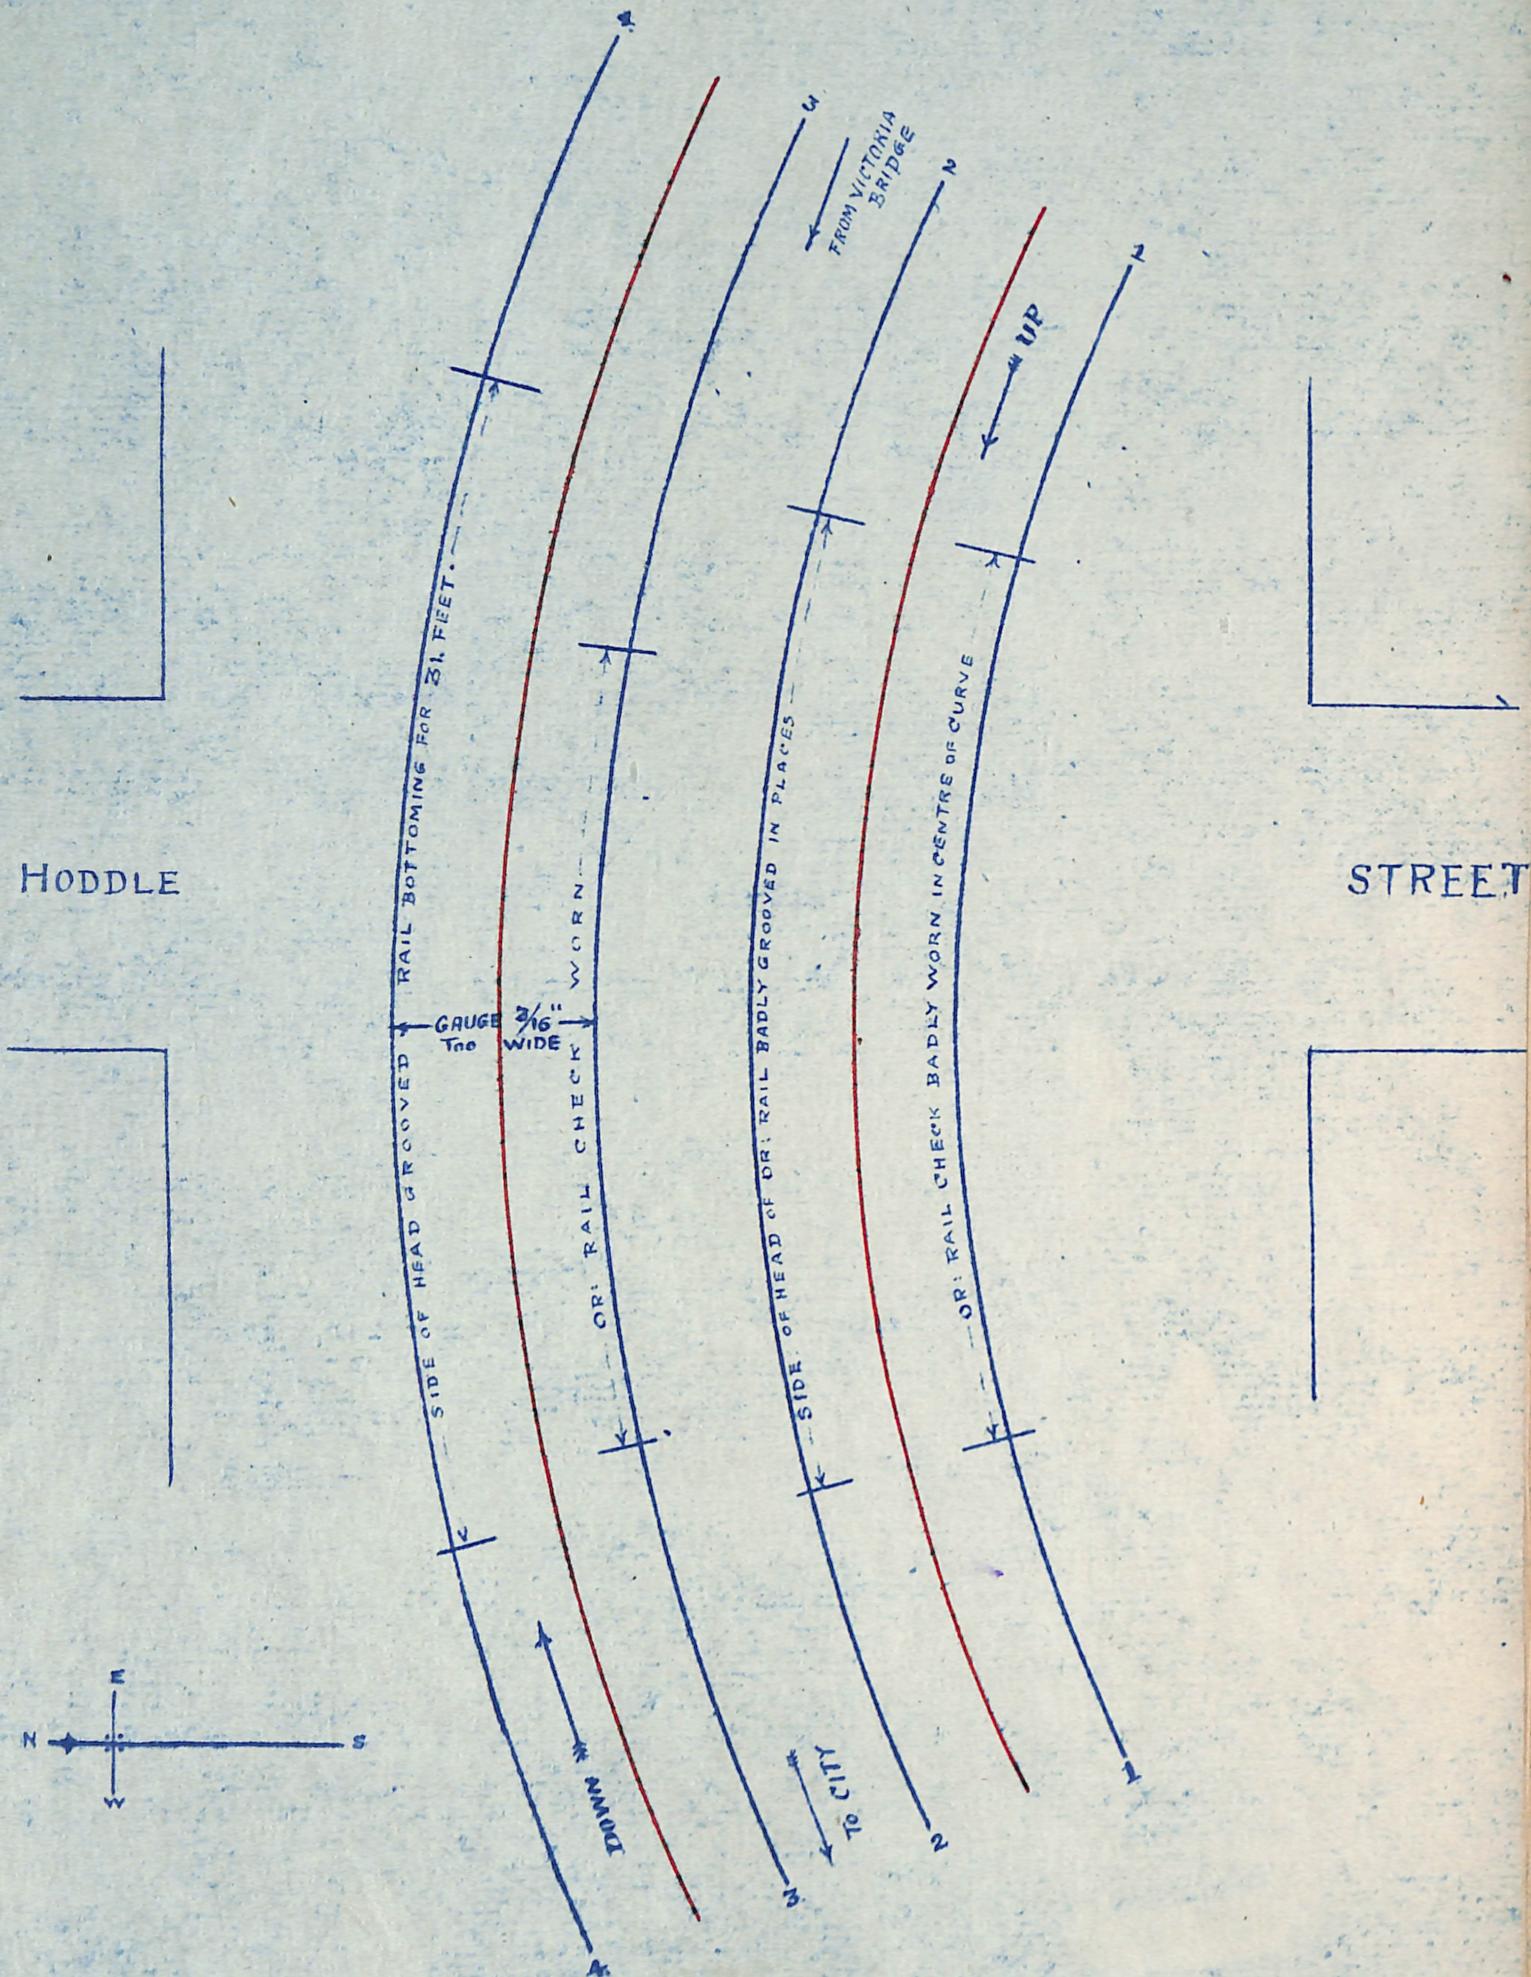
LINE 2.
PLAN B.5.

1. Ordinary rail-checks of Nos. 1 and 3 Rails are worn to varying amounts, and on No. 1 Rail, the check, in centre of curve, is badly worn.
2. The sides of Heads of Ordinary Rails (Nos. 2 and 4) are grooved badly in places as a result of the above check wear. The treads of these rails are hammered.
3. No. 4 rail is bottoming for about 31 feet.
4. The gauge of Tram-rails, Nos. 3 and 4 (Down Track) nearly opposite N.W. Corner of Hoddle Street is wide up to $\frac{3}{16}$ ". Both rail-checks are worn.

<u>Clearance</u>	<u>Super-Elevation</u>
No. 1 Rail	.031	
No. 2 Rail	.135	1° (Rolling Place)
No. 3 Rail	.171	
No. 4 Rail	0	7/8° (Rolling and Light Braking Place)
