CORROSION PREVENTION PROGRAM

BOEING COMMERCIAL AIRPLANE GROUP ■ 707/727/737 DIVISION

D6-40719
AUGUST 1972

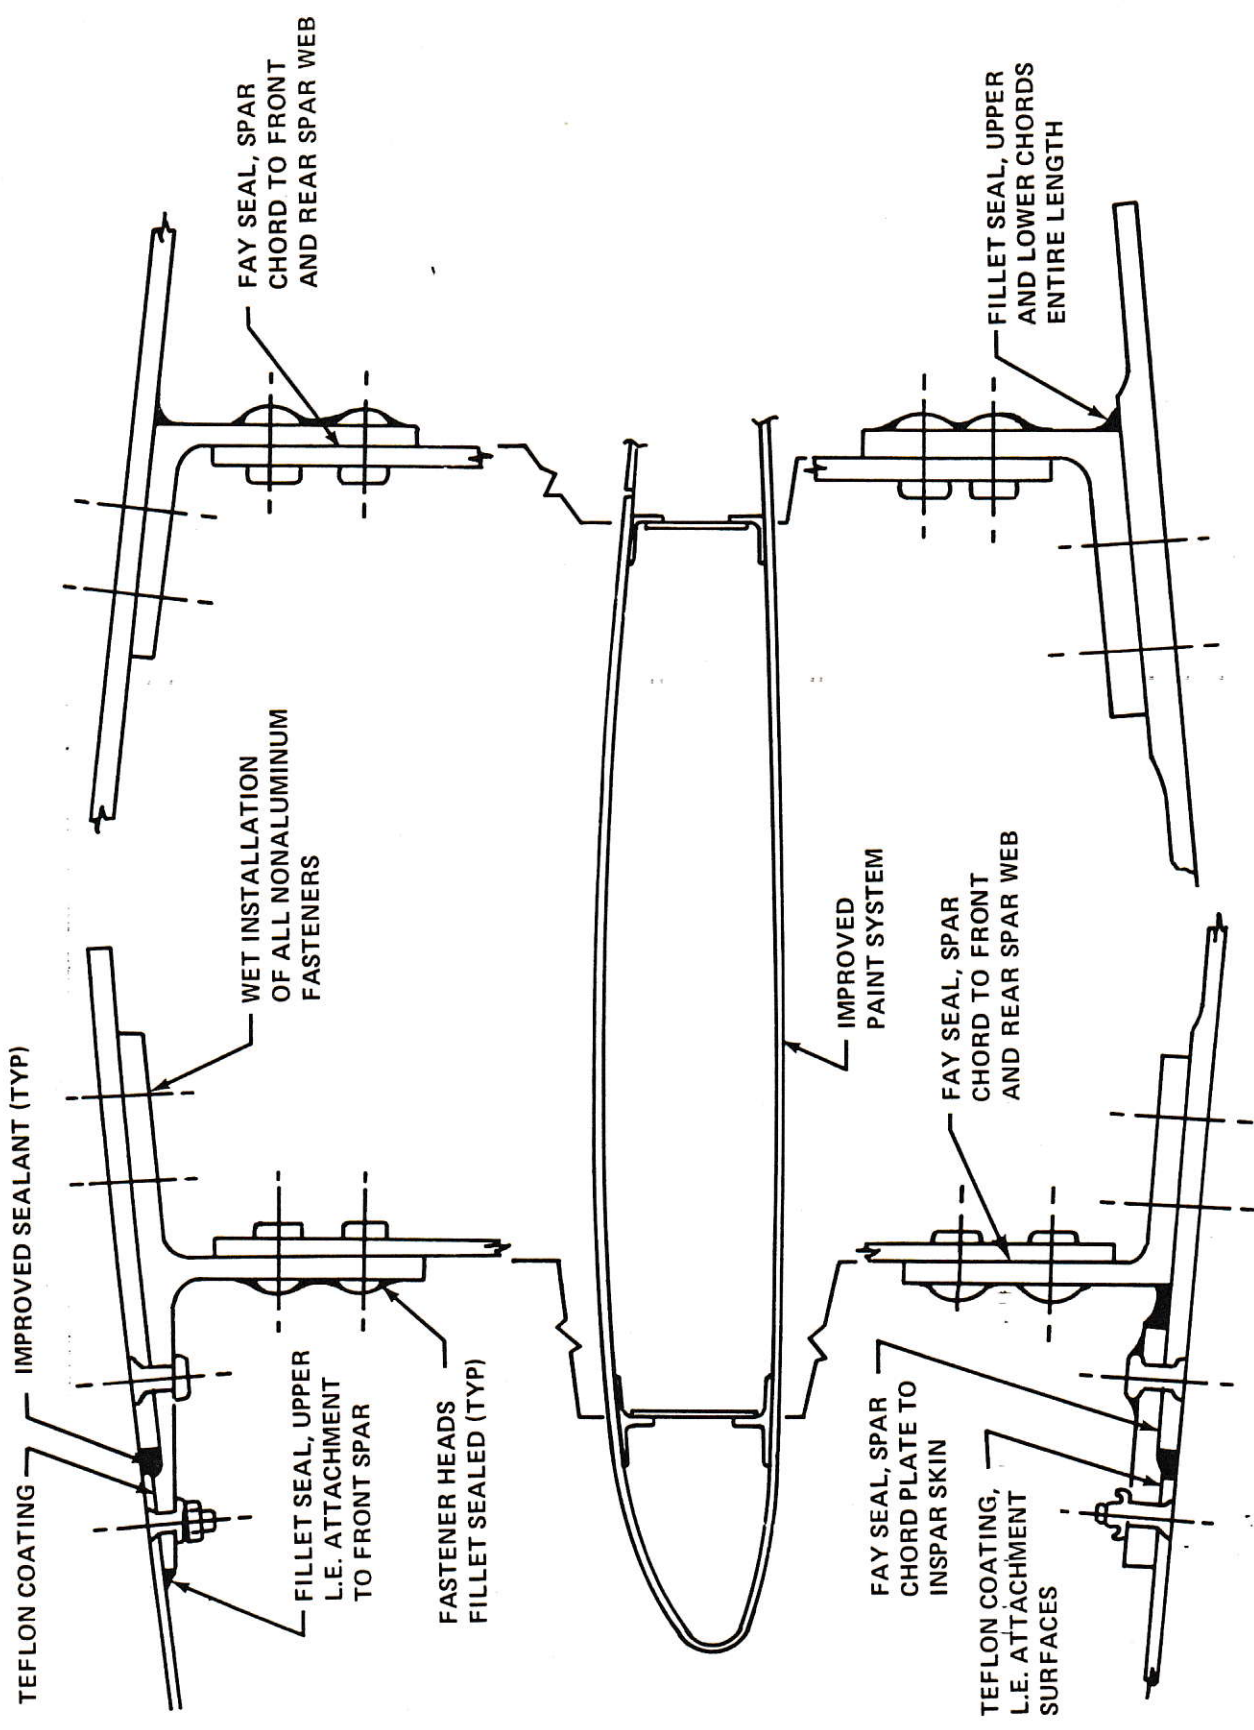
Figure 1.

Figure 1 illustrates the following product improvement changes that have been incorporated into the 727 wing:

- Fillet seal fasteners at spar chords
- Faying surface seal spar chord to spar web joint
- Fillet seal spar chord to inspar skin joint
- Apply teflon coating at leading-edge panel attachment surfaces to front spar
- Install all nonaluminum fasteners in primary structure with wet primer or sealant
- Faying surface seal front spar chord plate to inspar skin joint
- Change upper front and rear spar chord material from 7178-T6 to 7075-T73
- Apply improved (polyurethane) paint system on wing lower surface
- Fillet seal front spar upper chord to fixed leading-edge skin joint
- Faying surface seal all fittings and stiffeners to spar chords

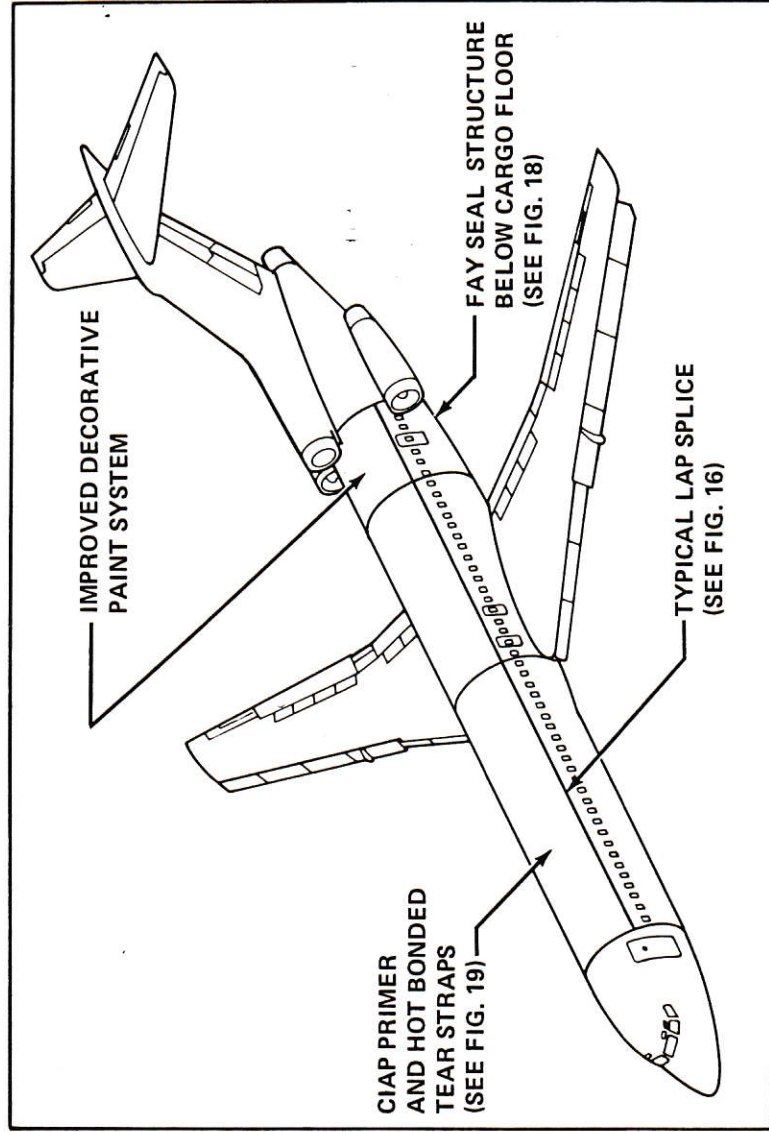
The fuselage corrosion preventative measures incorporated on the 727 are listed below and are generally illustrated in Figure 12.

- Apply improved decorative paint system with greater resistance to filiform corrosion
- Add corrosion inhibiting adhesive primer (CIAP) to hot bonded skin panels and doublers
- Faying surface seal lap splices
- Faying surface seal all structures below cargo floor common to interior of body skin

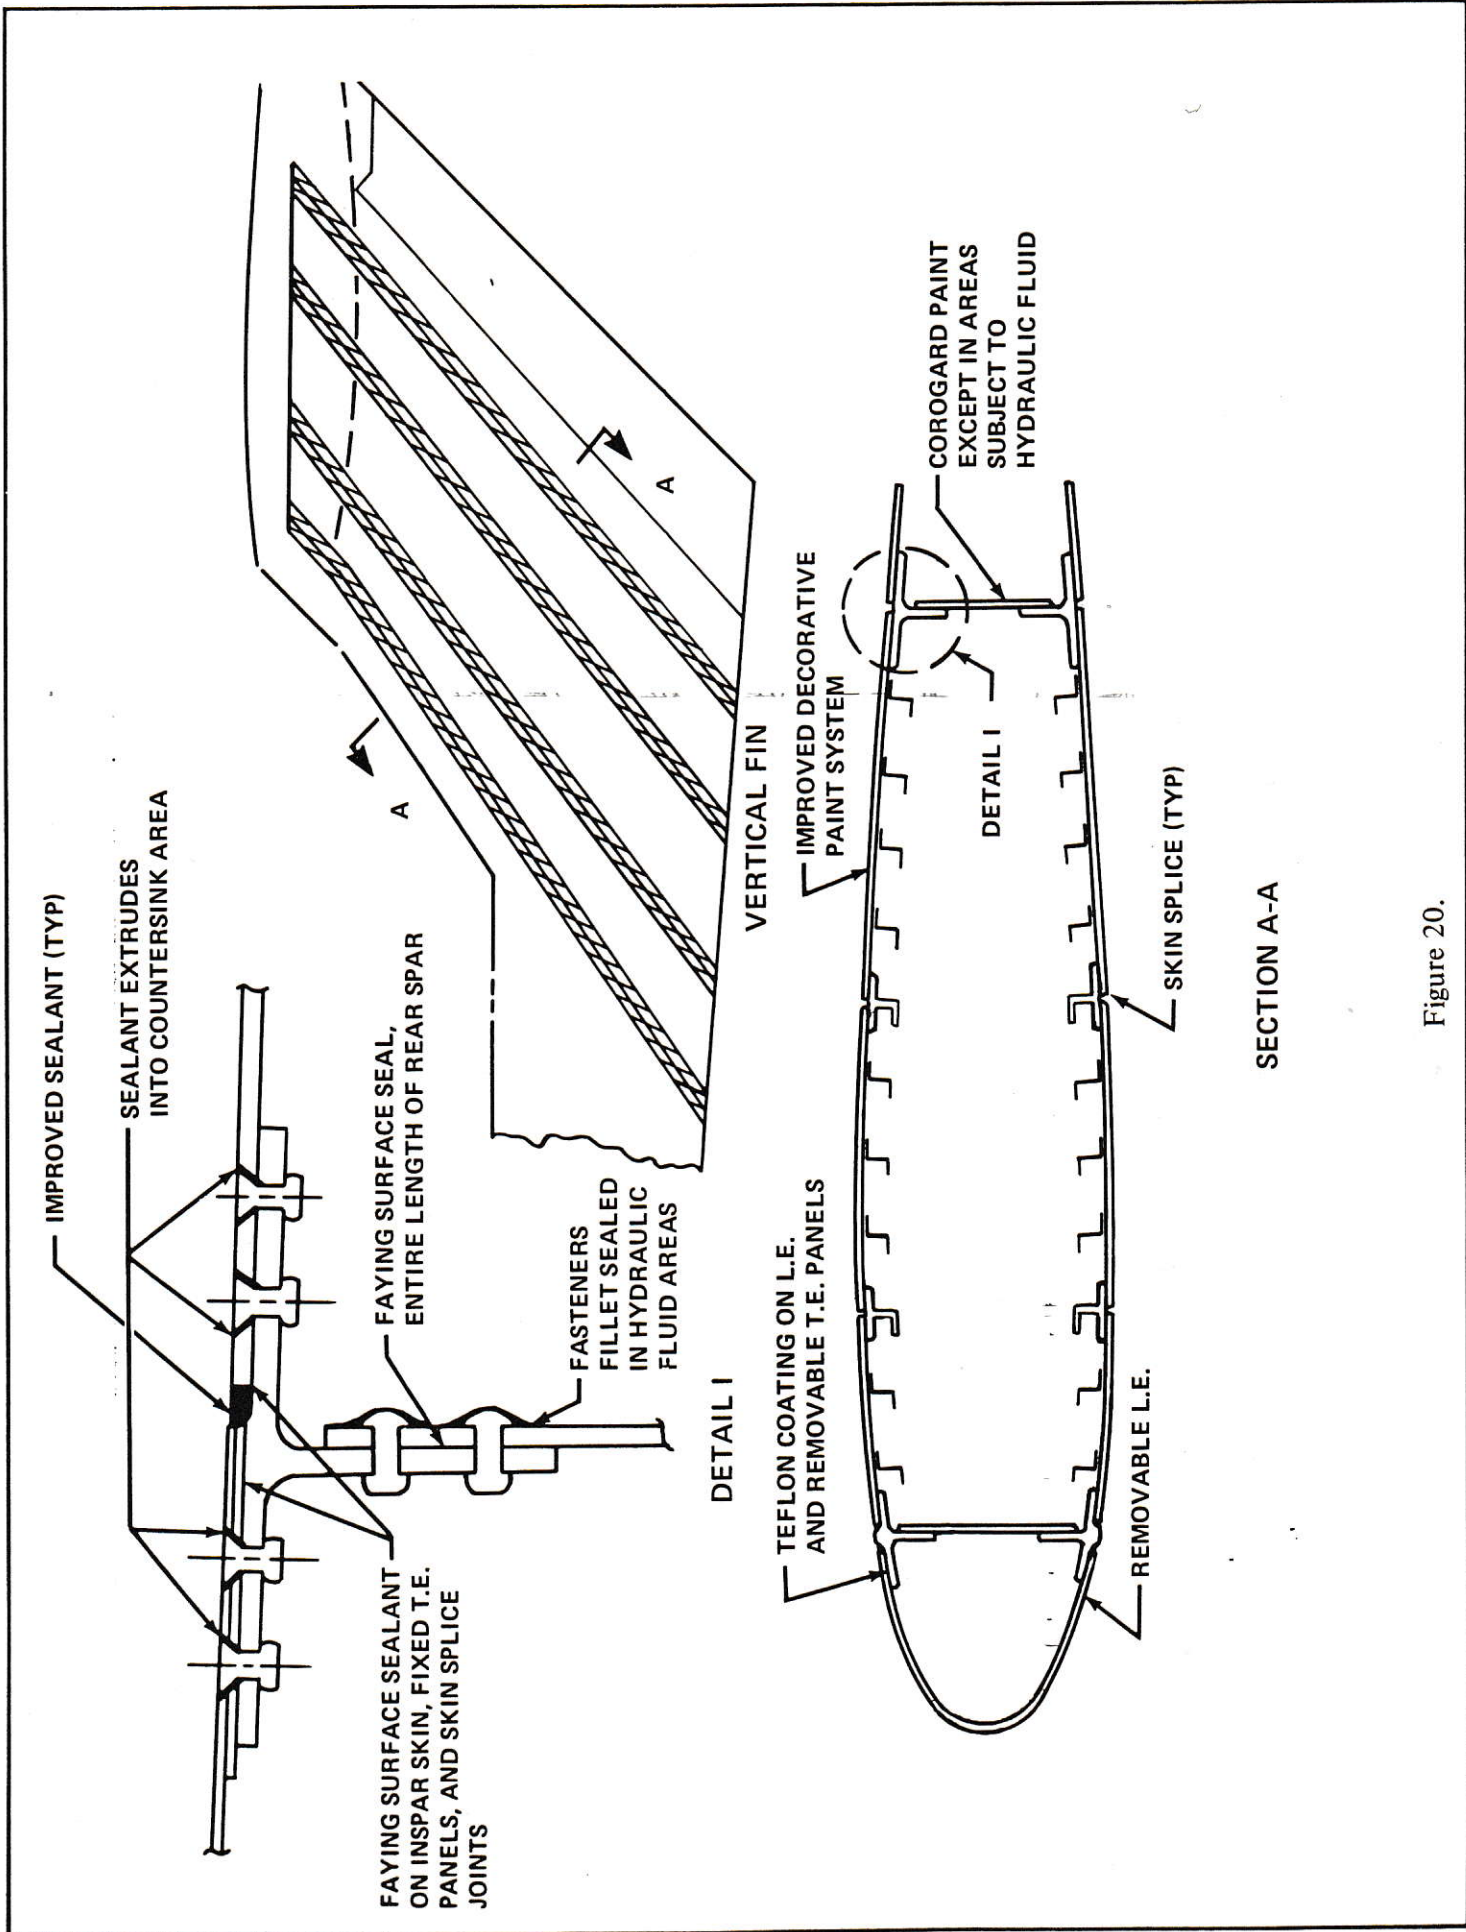
Figure 20.

Product improvement changes to prevent corrosion in the empennage areas are illustrated in Figure 20 (Vertical Stabilizer) and Figure 21 (Horizontal Stabilizer). Specific improvements follow, with details on subsequent pages.

- Faying surface seal inspar skins to spar chords and splice stiffeners
- Faying surface seal rear spar chords to spar web
- Apply an improved decorative paint system with greater resistance to filiform corrosion
- Apply Corogard paint on aft surface of rear spar in areas not subject to hydraulic fluid
- Fillet seal fasteners on rear spar chord in areas subject to hydraulic fluid
- Teflon coat removable leading- and trailing-edge panels and faying surface seal permanent panels at trailing-edge attachment surfaces to spar chords

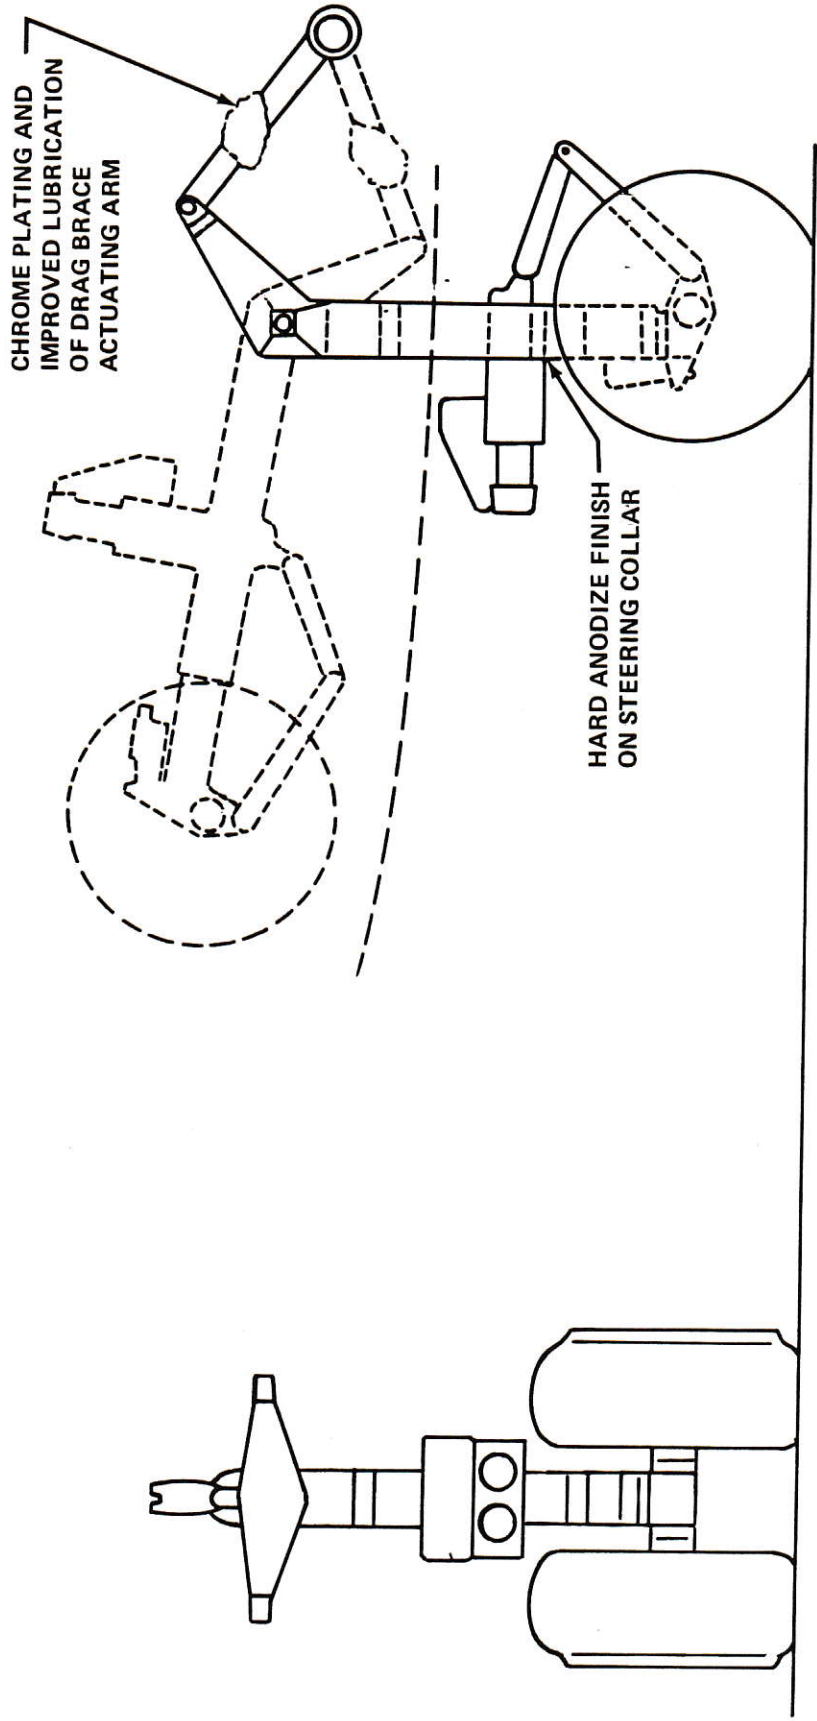
Product improvement changes to prevent corrosion in the landing gear area are: (1) the addition of a hard anodize finish to the nose gear steering collar and (2) the addition of chrome plating to the nose gear drag brace actuating arm. These changes are illustrated in Figure 24.
