Office of the Chief Investigator
Transport and Marine Safety Investigations

**Rail Investigation
Report No 2009/03**

Fire on Tram
W Class Tram 946
La Trobe Street
15 January 2009

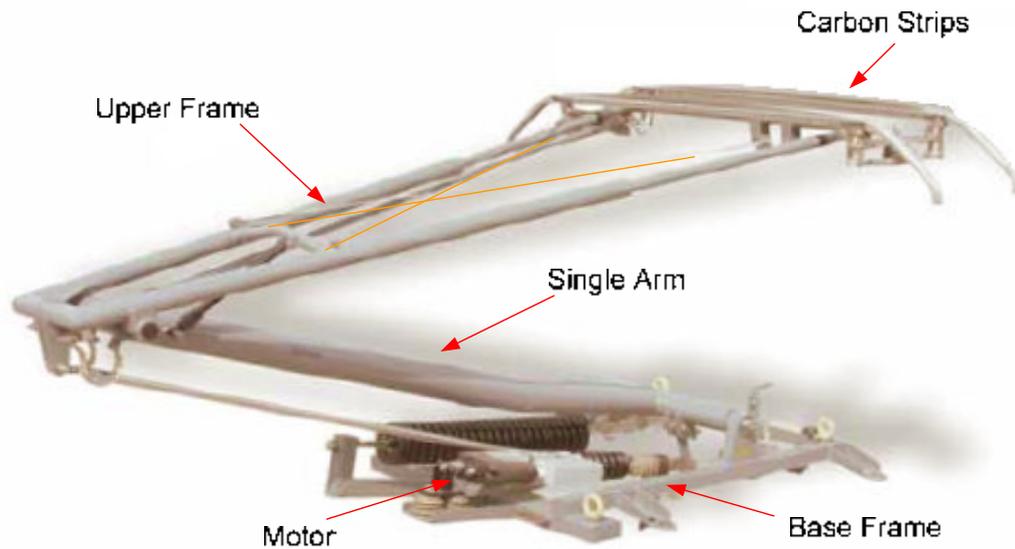
Figure 4 – Type of Pantograph on Tram 946

The 'current collection system' of Tram 946 consisted of a pantograph model SBE 992 manufactured by Schunk Bahntechnik GmbH (Figure 4). It is of the single-arm design with an electrically insulated drive motor integrated into the base frame of the pantograph. The motor is driven by a 24 volt battery supply and is utilised to raise or lower the pantograph from the drivers console in the tram. The pantograph is designed to handle a nominal current of 1,000 Amps and a peak current of 1,800 Amps. The pantograph can be manually raised or lowered by the use of a crank handle.

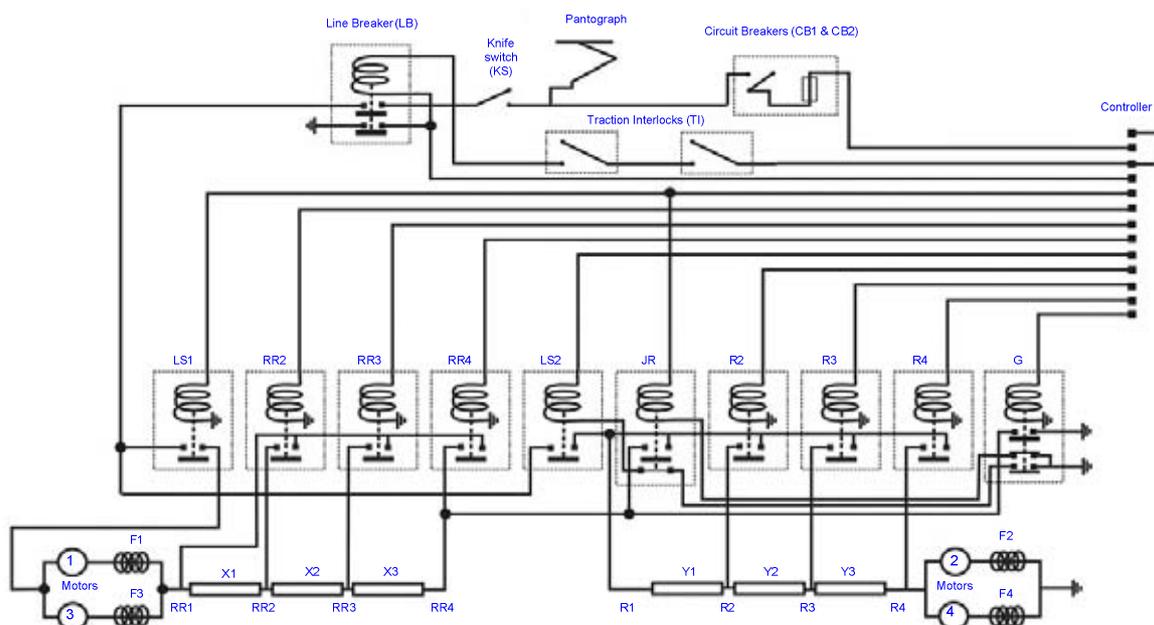
Figure 8 – Traction system circuit diagram

As shown in the electrical schematic in Appendix A and Figure 8, when the pantograph of the tram is in contact with the overhead cable, the current flows to Circuit Breakers (CB1 & CB2) through a Knife Switch (KS) in the driver's cabin to the Line Breaker (LB). The line voltage is approximately 600 volts DC.

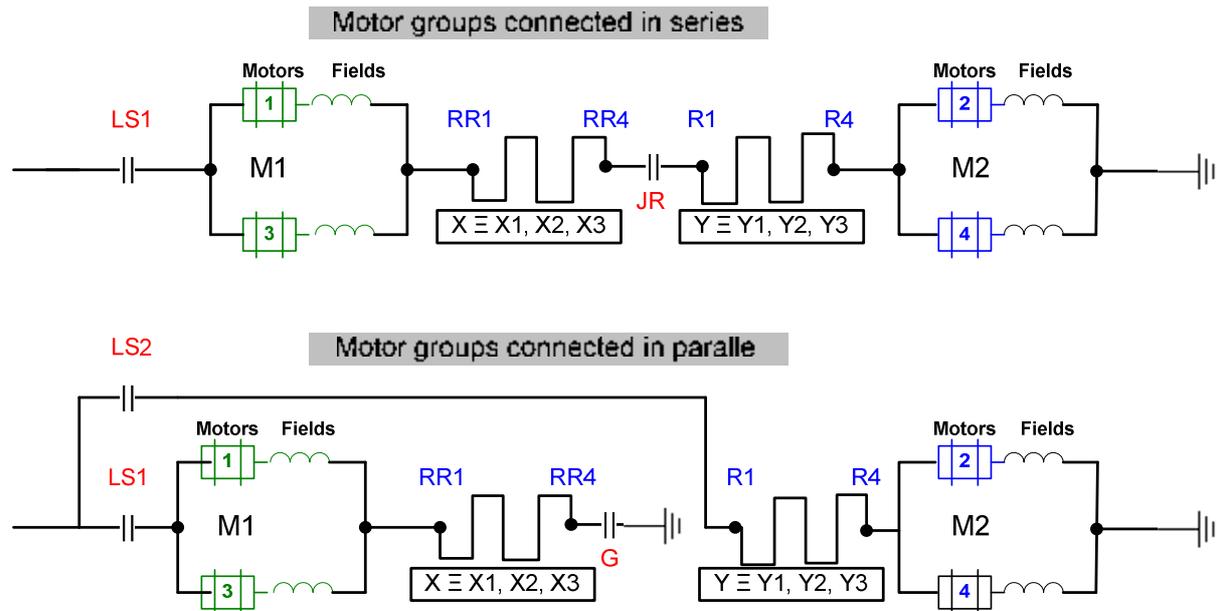
Figure 9 – Motor groups connected in series and parallel

Figure 9 shows motors No.1 and No.3 (Motor group M1) permanently connected in parallel and motors No.2 and No.4 (Motor group M2) connected in parallel. Motor groups M1 and M2 can be configured to operate in series or in parallel by opening or closing Grouping Contactors LS1 and LS2.

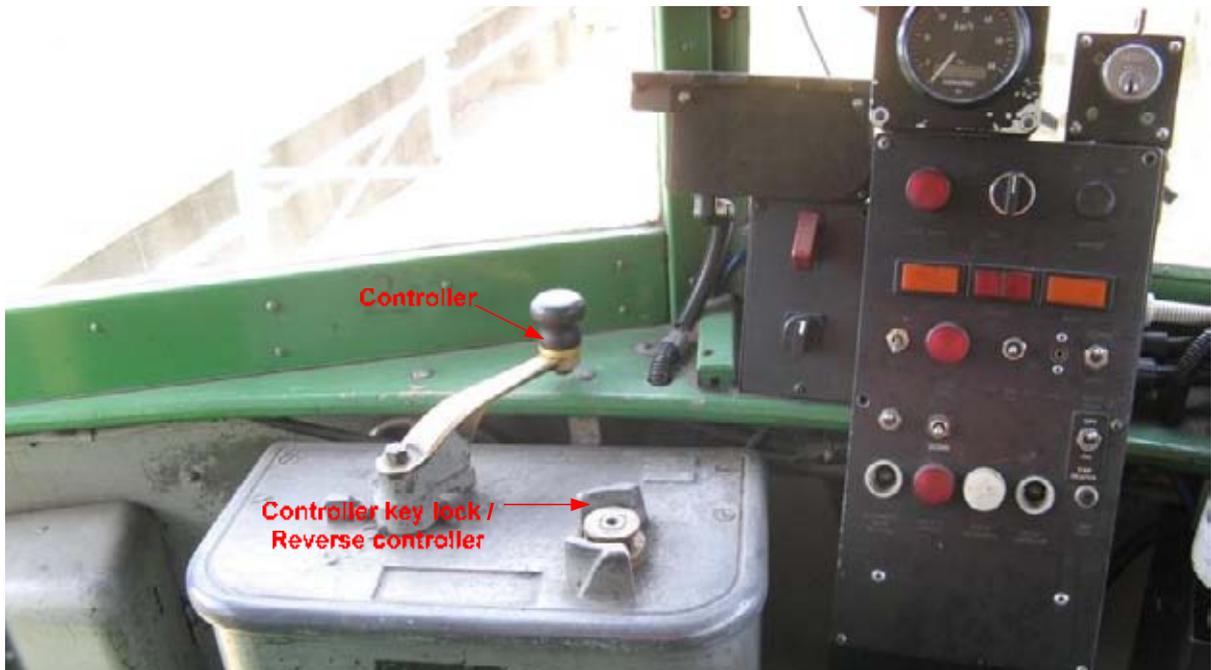
Figure 10 – Traction system controller

A speed controller is located in both No.1 and No.2 drive positions. The controller can only be operated when the 'key' is placed in the 'key lock' and in the forward or reverse position (Figure 10). The Line Breaker and the step-up contactors are engaged by the tram driver operating the controller. As each step up contactor is engaged the corresponding resistor (X1, X2, X3, Y1, Y2 & Y3) is by-passed increasing the current to the traction motors and in turn increasing the power output from the motors.
