Arboricultural Report

Tree Management Plan

Ballarat Tram Museum, 100 Gillies St Nth, Ballarat, Victoria

Inspections commenced on Thursday 7th March 2019

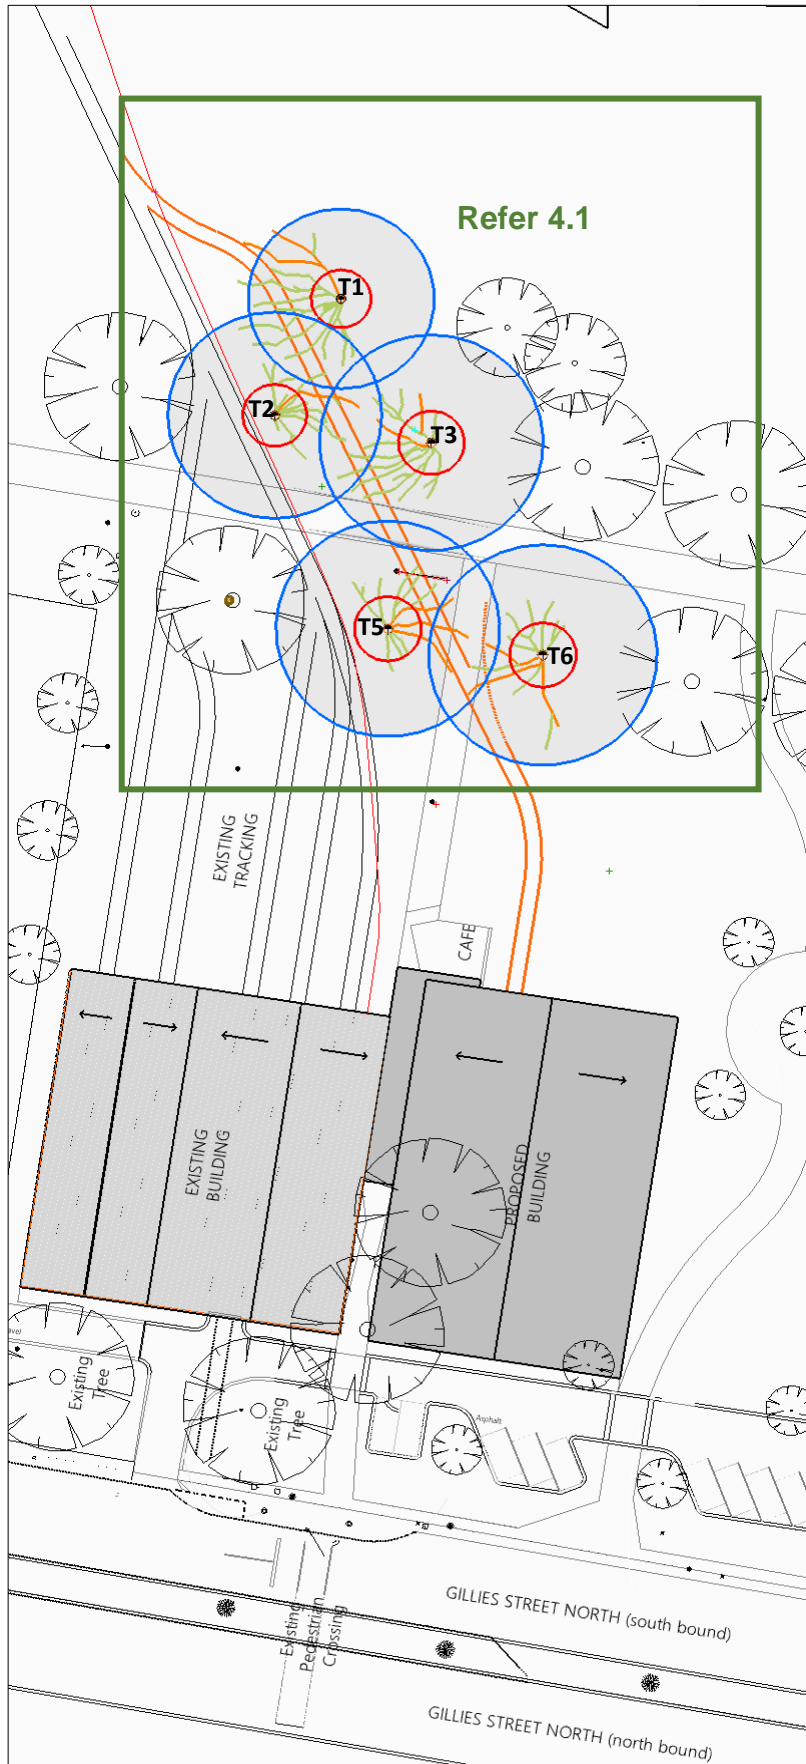
3.Site Map – Geoscan – Root Mapping

- Excavation is outside the Structural Root Zone
- No significant roots are severed within the Tree Protection Zone (in orange on plan)
- Only minimal undefined roots are severed (in green on plan)

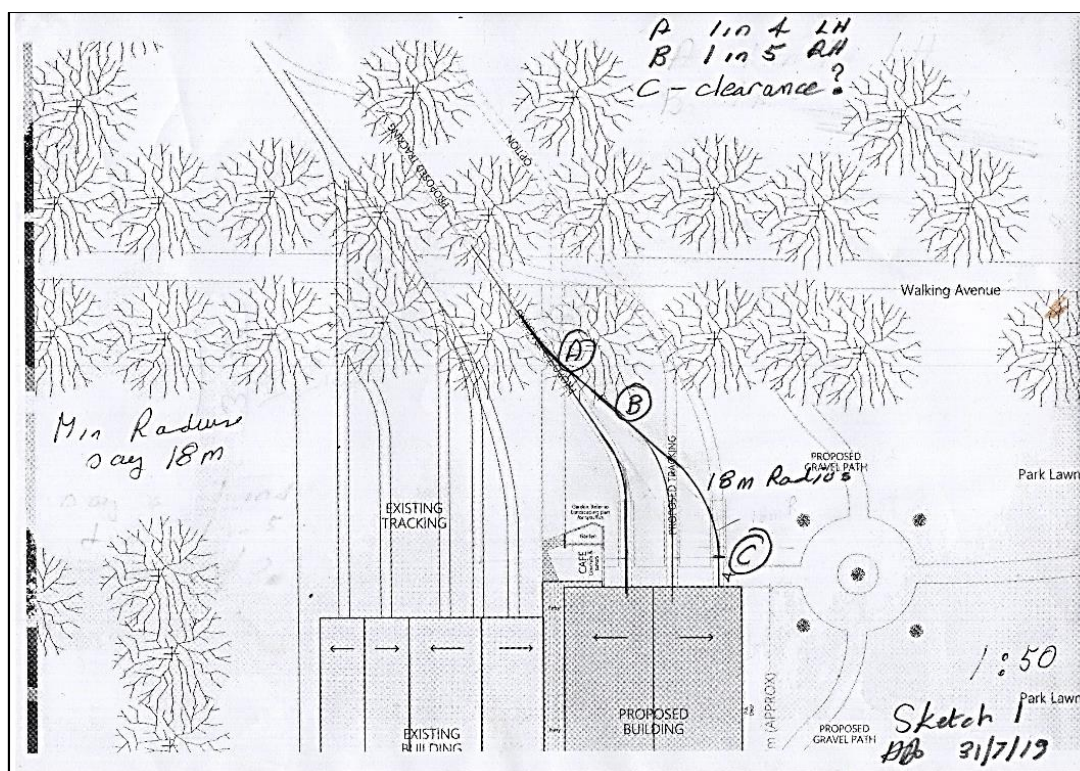
It is understood that the track placement between tree #6 and the proposed new tram shed may differ from the plans. It is proposed that the track branch off at this stage into 2 tracks and then again into another track enabling three separate tracks to access the proposed new tram shed.

When looking at the Geoscan findings there appears to be minimal root activity on the area that is required for the tracks to divide. Provided the appropriate care is taken it is likely that this proposed track construction will cause minimal damage to the retained trees.

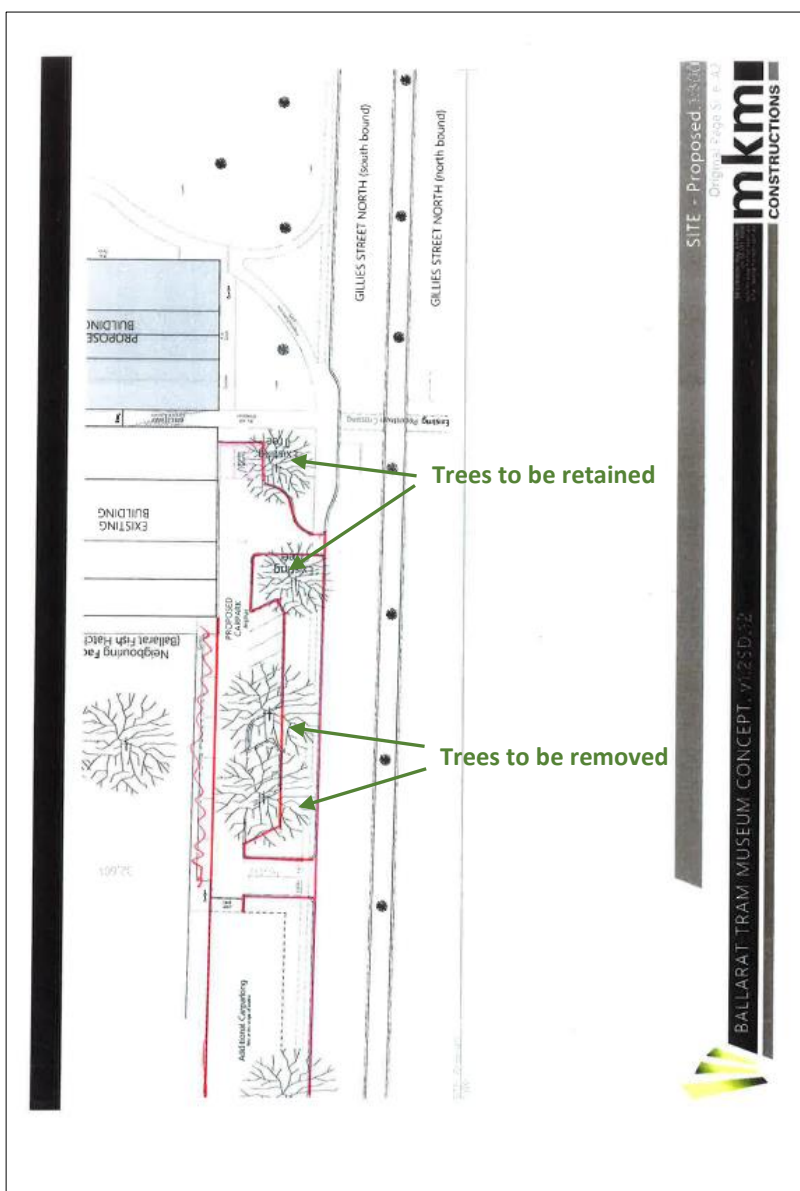
It is understood that a carpark will be constructed at the front of the Ballarat Tram Museum to accommodate guests. As a result, 2 trees have been marked for removal to accommodate the carpark. Two other trees are to be retained within the carpark area.

Retained trees are to be protected during construction of the carpark in accordance with AS4970-2009 Protection of Trees on Development Sites.

Development of the carpark must consider the Tree Protections Zone and Structural Root Zones of the trees.

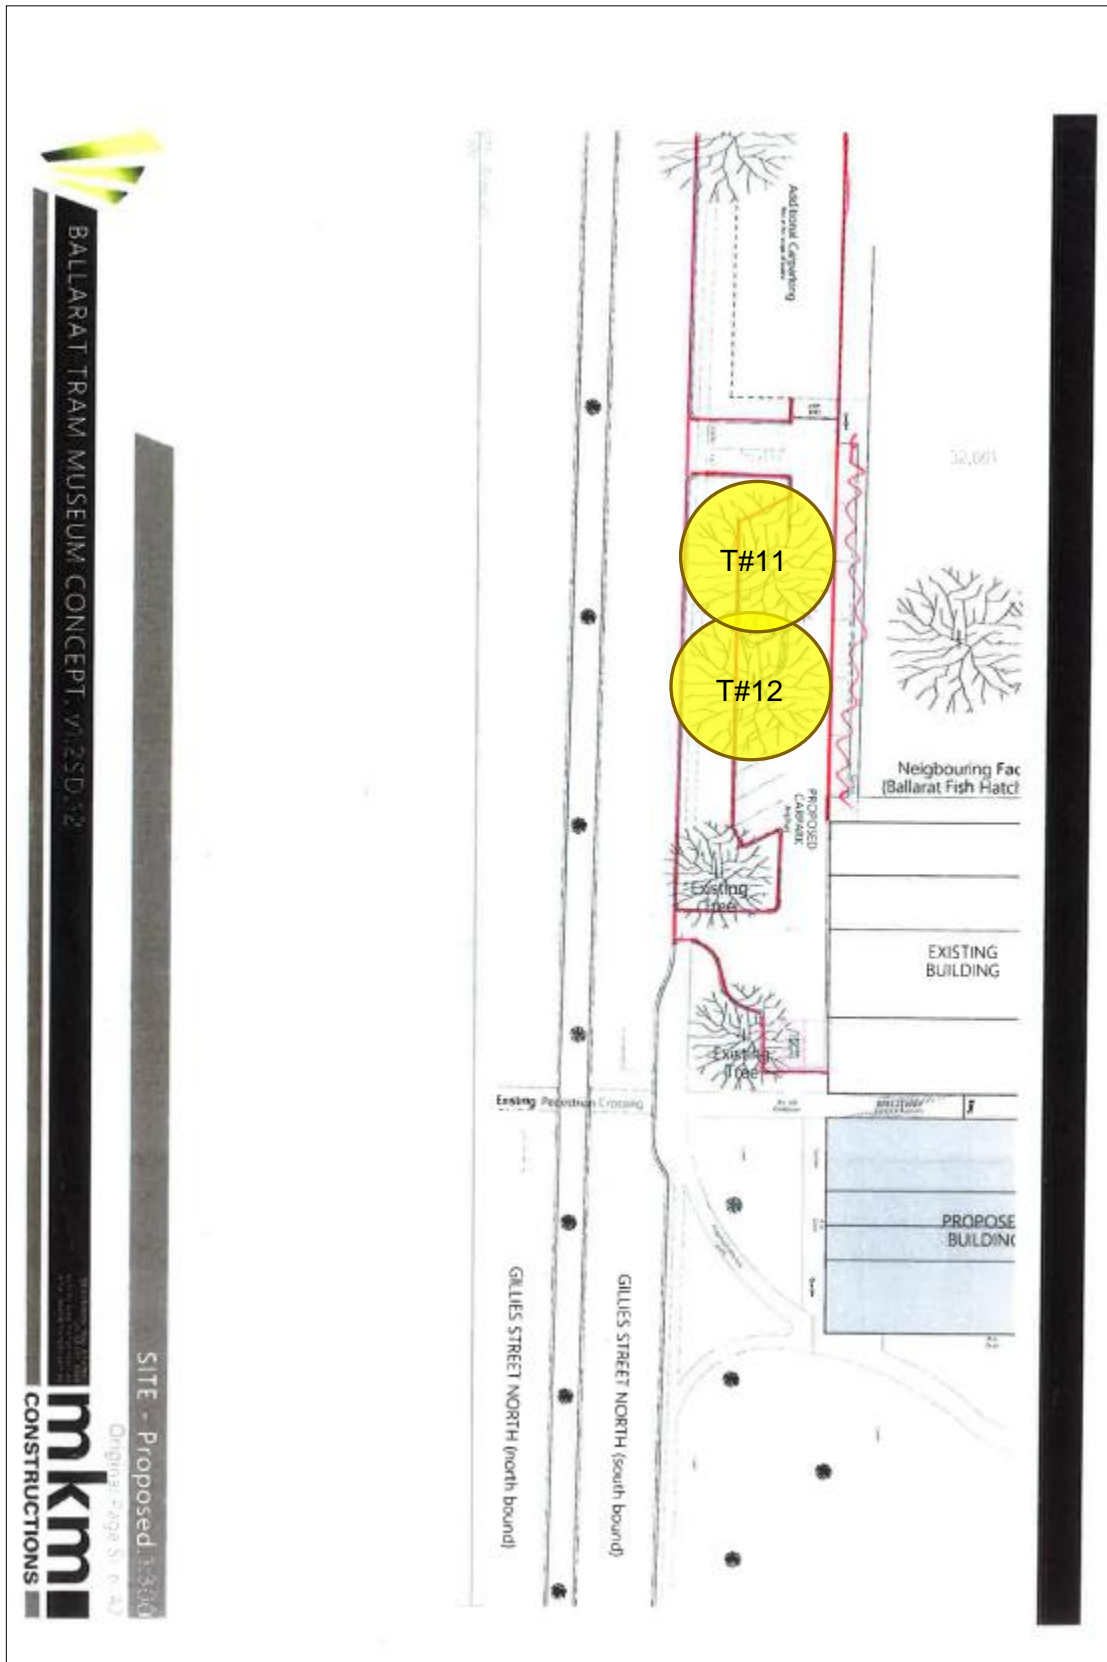
Site Plan – Proposed carpark - Ballarat Tram Museum, Gillies Street, Lake Wendouree

- Both trees are exotic Salix species. They have a Useful Life Expectancy of 5 to 15 years and a Retention Value of Moderate.
- The trees are in varying states of senescence with dieback and significant root decay.
- Both trees cannot be retained in light of the proposed carpark construction.
