# Villa Alba

## Condition Survey and Stabilization of critical surfaces

14 February 1997

prepared by Andrew Thorn

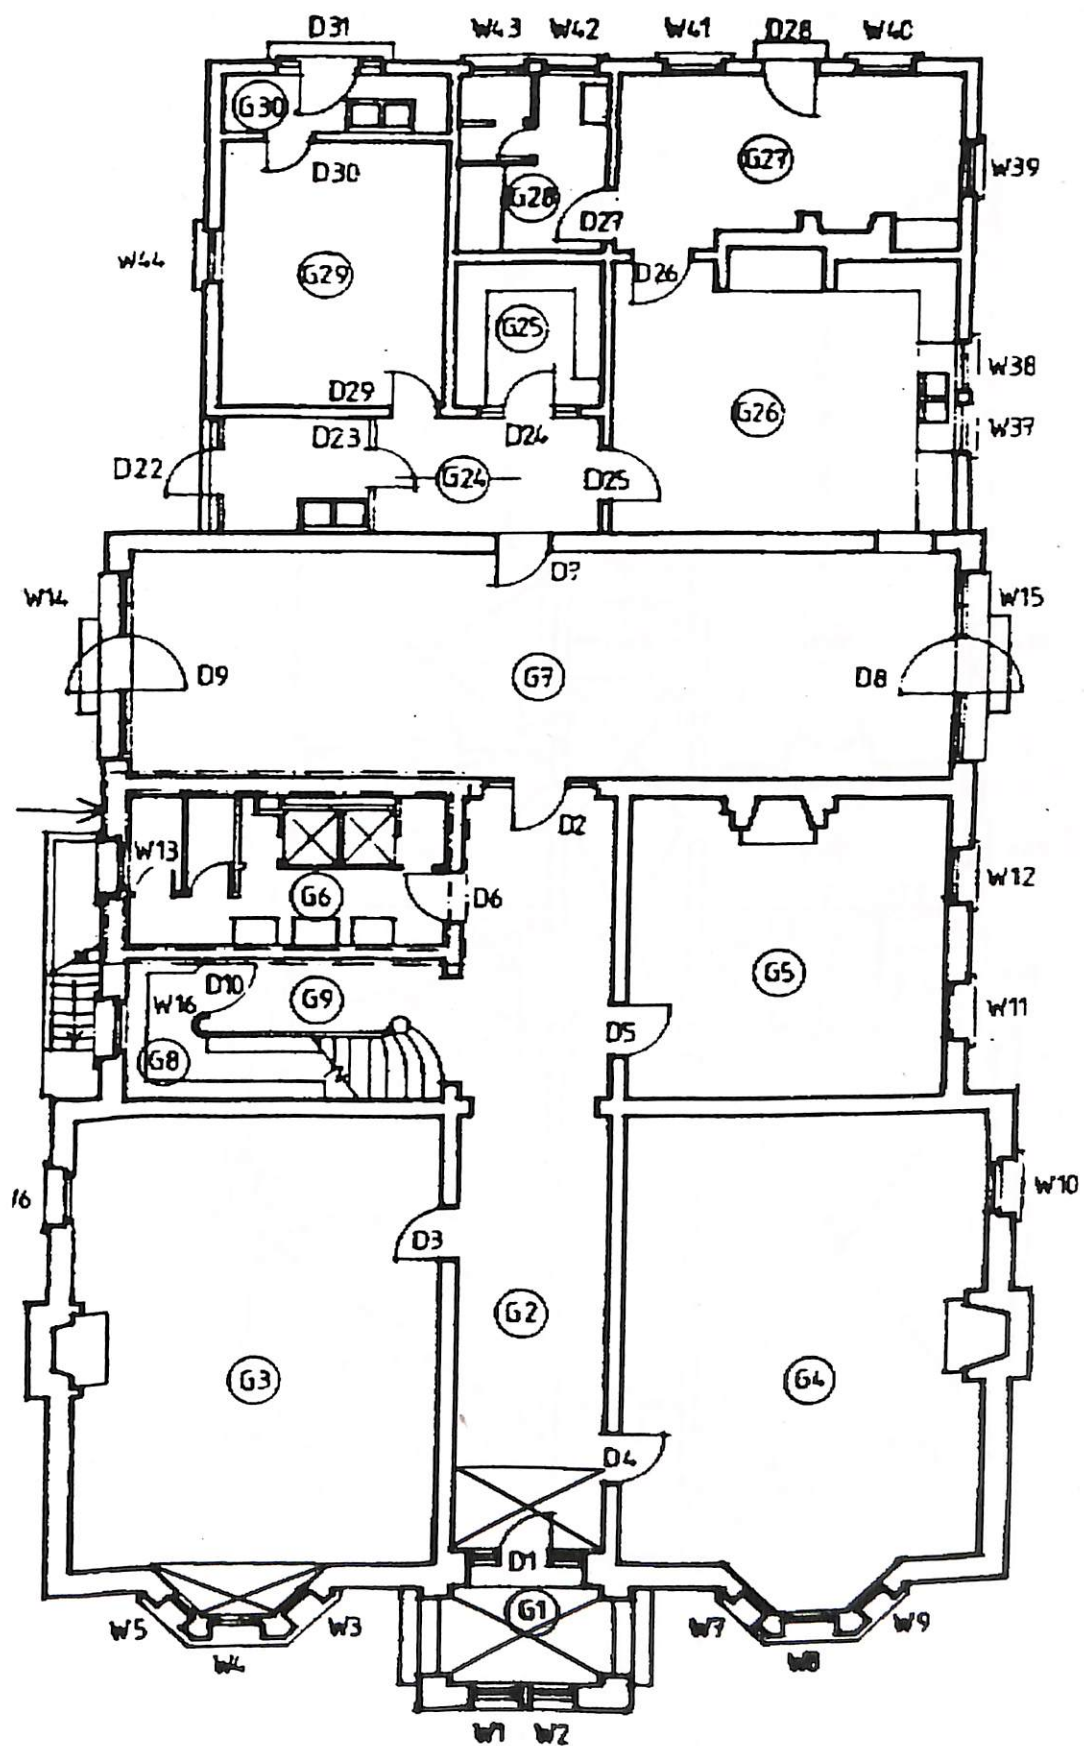
Figure 1. Ground floor room numbering (after Sanderson 1989)

The two plans show the ceilings that have fallen since 1986 marked with a cross. Given the wide range of lost areas and randomness of the event it is relatively obvious that any ceiling remains in danger of collapse. Artcare recommended some time ago that all significant ceilings should be stabilized as a precautionary measure, especially those on the first floor.

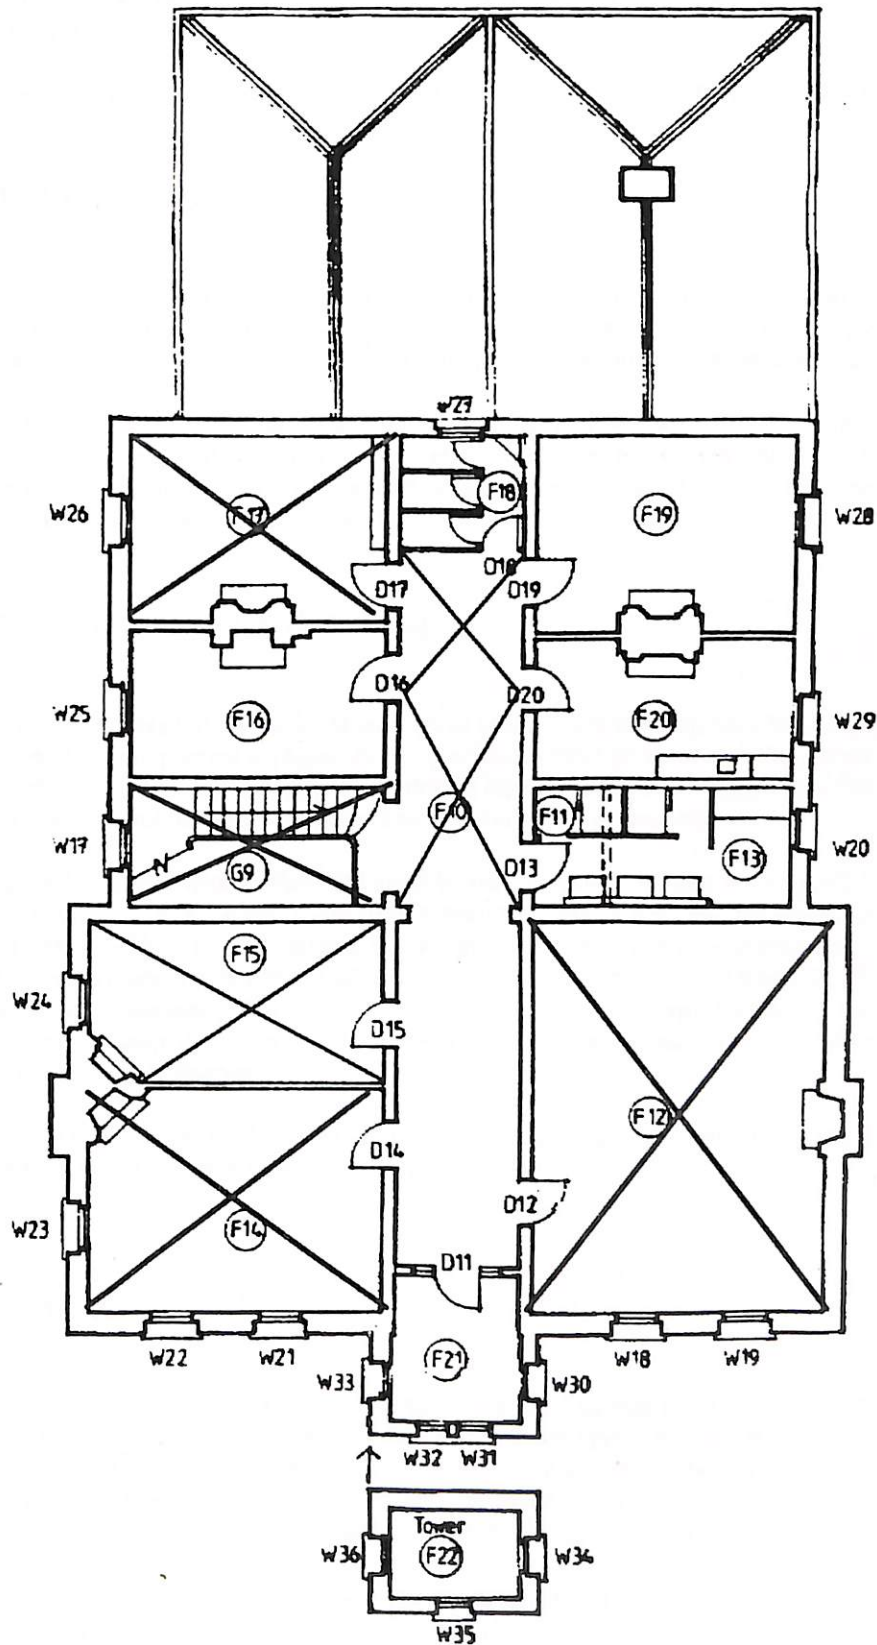
**Figure 2. First floor room numbering (after Sanderson 1989)**

Red hatched rooms have been stabilized in 1996. Black hatched rooms have been stabilized between 1986-1995.
