**VILLA ALBA MUSEUM LANDSCAPE RECONSTRUCTION**

**ARCHAEOLOGICAL TEST EXCAVATIONS PHASE 2**

**A report to Villa Alba Museum Inc and Heritage Victoria**

**October 2002**

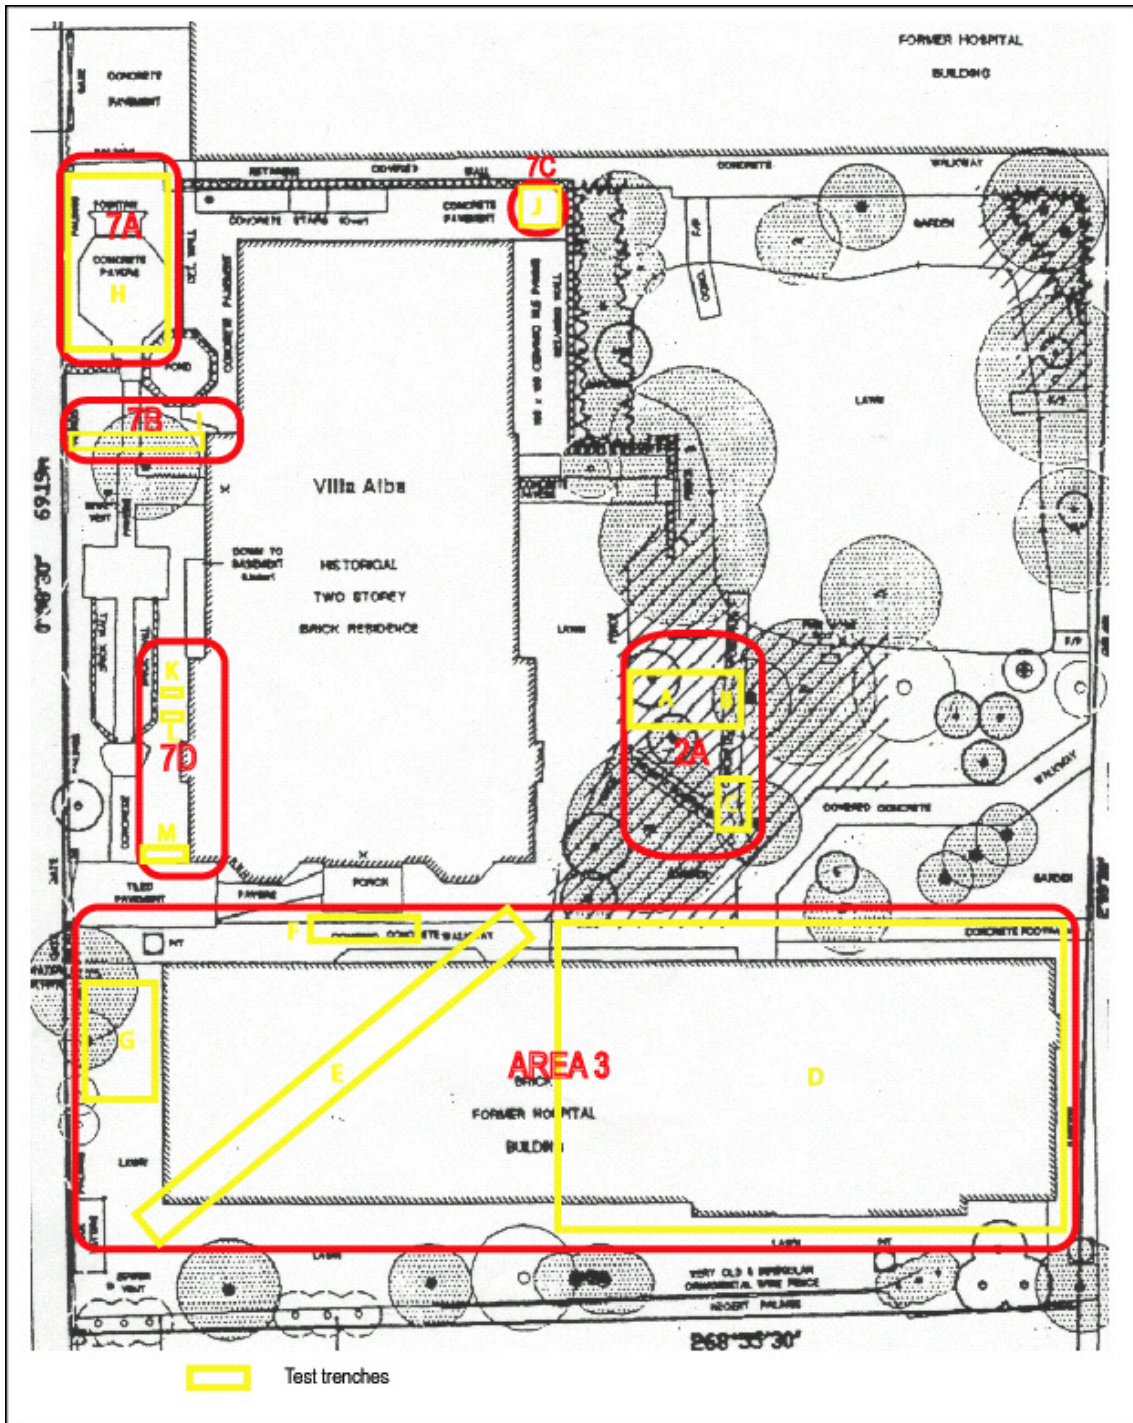
Figure 3.1 Location of excavated trenches.

A diagonal trench (Figure 3.1) dug across the area immediately south of the Villa Alba mansion revealed an expanse of dark organic soil (context 41) consistent with a wide garden bed located across the centre of the trench. A single intact timber edging tile was also recovered from the fill in the north section of the trench. However due to considerable disturbance to the north and south no evidence of paths or of a definitive garden border was observed.

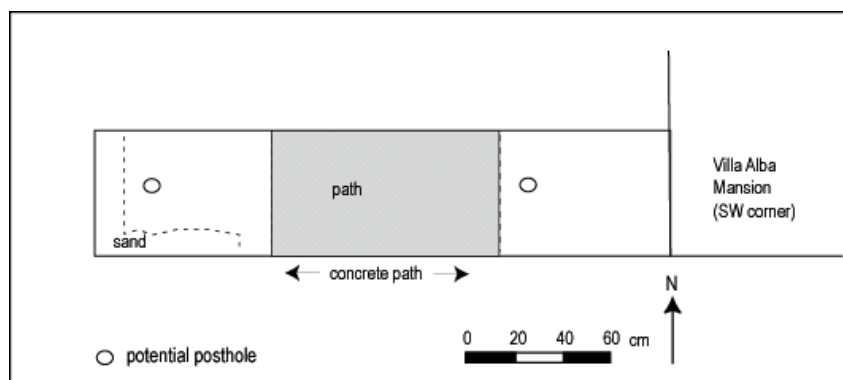
Figure 4.7. Area 7D Trench M, plan view.

An east-west slit trench was dug adjacent to the southwest corner of the Villa Alba mansion, north of an existing concrete path. Beneath a shallow layer of vegetation and topsoil (contexts 120, 121) the centre of the trench was dominated by a square of compact dull orange clay with embedded gravel (context 122) which extended to the north and south boundaries of the trench, located 68 centimetres from the mansion (see Figure 4.7). This location is consistent with that of the path remnants recovered between the conservatory and the mansion.

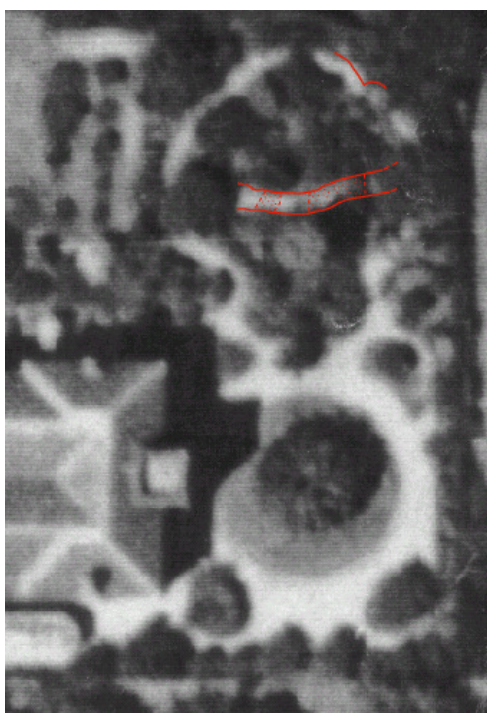
Figure 5.1. Area 3, c.1945 aerial photograph with garden path overlay (in red).

The recovery of sections of wood-lined path in Area 3 was particularly useful as the 19<sup>th</sup> century design of the parterre in this area is not well documented in historical records. In Figure 5.1 the archaeological evidence has been overlaid onto a c1945 aerial photograph as a tentative "test of fit" (the placement is conjectural only and should be reviewed by the Villa Alba landscape architect). The recovery of these landscape features provides an indication of surface treatment, evidence of wooden edging tiles, and an original surface level for future garden reconstruction (Plates 2, 3).

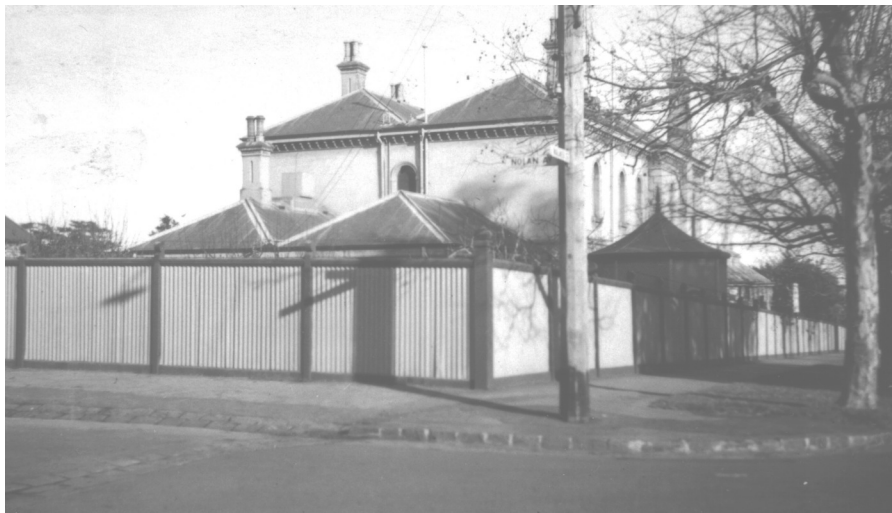
Figure 5.4. Villa Alba with octagonal toilet structure near fence (no date).

- Brick foundations consistent with the remains of a two-seater toilet block were located under two layers of concrete paving.
- Nine postholes consistent with an octagonally-shaped structure were located at the same level as toilet block foundations in the north, northwest and south.
- A small section of white gravel located outside the projected boundary of the octagonal structure may indicate a path or type of surface treatment.
- No evidence of a threshold path was recovered at the north entry of the octagonal structure.

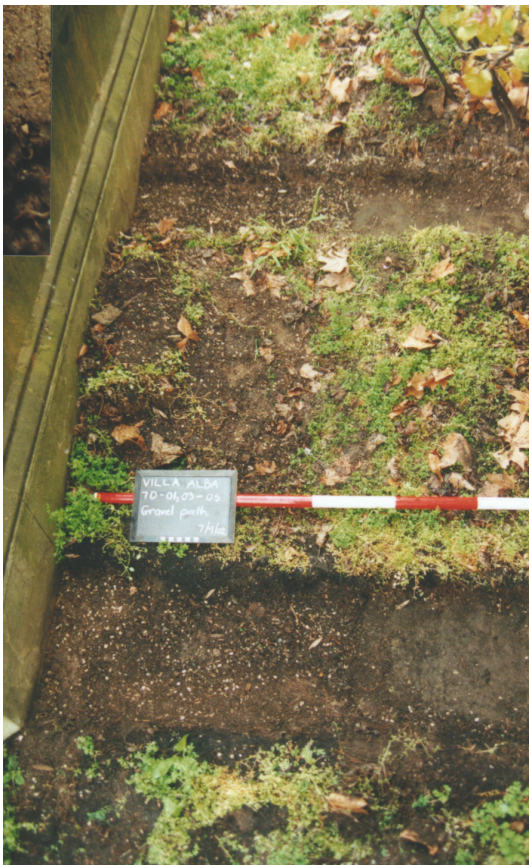
Plate 8. Area 7D Trenches K and L, looking north.

Two east-west slit trenches were dug between the former conservatory and the west wall of the Villa Alba mansion, 1.10 m apart. The stratigraphy in each trench was the same. Beneath a layer of vegetation and topsoil (contexts 110, 111) a loose layer of soil containing white gravel (context 112) overlying a layer of white gravel in a compact surface (context 113) was recovered at the west end of each trench adjacent to the east face of the conservatory wall. These gravel layers are consistent with the remains of a path running north-south adjacent to the conservatory wall. The path fragments were 68 and 72 centimetres wide respectively, located 8 cm below the current ground surface. They did not extend to the west face of the mansion. See Figure 4.6.
