# CURVE VICTORIA STREET.

OPPOSITE HEUGLE'S SHOP (NEAR HODDLE ST.)

LINE 2.

LINE 2. PLAN B6.

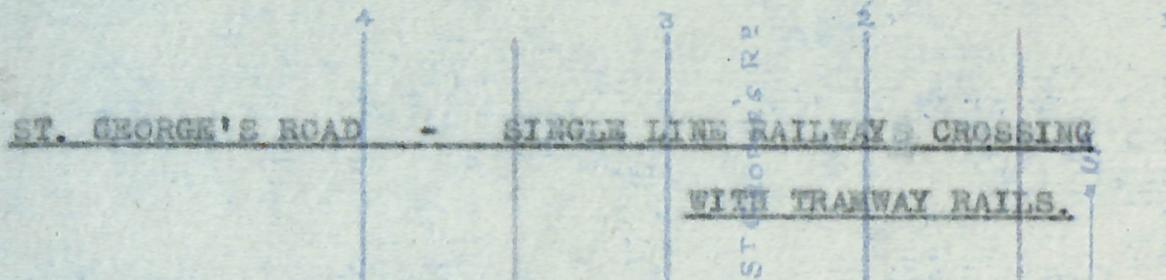
DESCRIPTION OF 3.

1. Tram-rails at seven places near their intersections are not level with railway rails and railway guard rails, resulting in hammering and wear at intersections.  
Hamm'd & Sunk  
Fish-plates are presumably loose at several intersections.
2. There is a wide joint ( $1/4"$ ) on No. 1 Rail, on North East side of railway-crossing.
3. Length of Railway-rail (about 6'0") on South side of Tram track (between Nos. 1 and 3 rails) is loose in its chairs, causing excessive vibration, and loosening of adjacent paving.  
BAD JOINT  
WIDE  
TR. RAIL  
HAMMERED & SUNK
4. Paving blocks are loose, and tar surface shattered in places, presumably due to angle fishplates being loose.  
TRAIL RAIL  
SL. HAMM.  
& SUNK  
PAVING  
BLOCKS  
SHATTERED  
ANGLE  
FISHPLATES  
LOOSE  
TROY STATION  
RAIL JOINT  
LOSE
