RATHDOWN STREET

SCHEDULE OF SHUNTS.

NORTH CARLTON LINE.

T
R
A
M
C
A
R
D
E
P
O
T

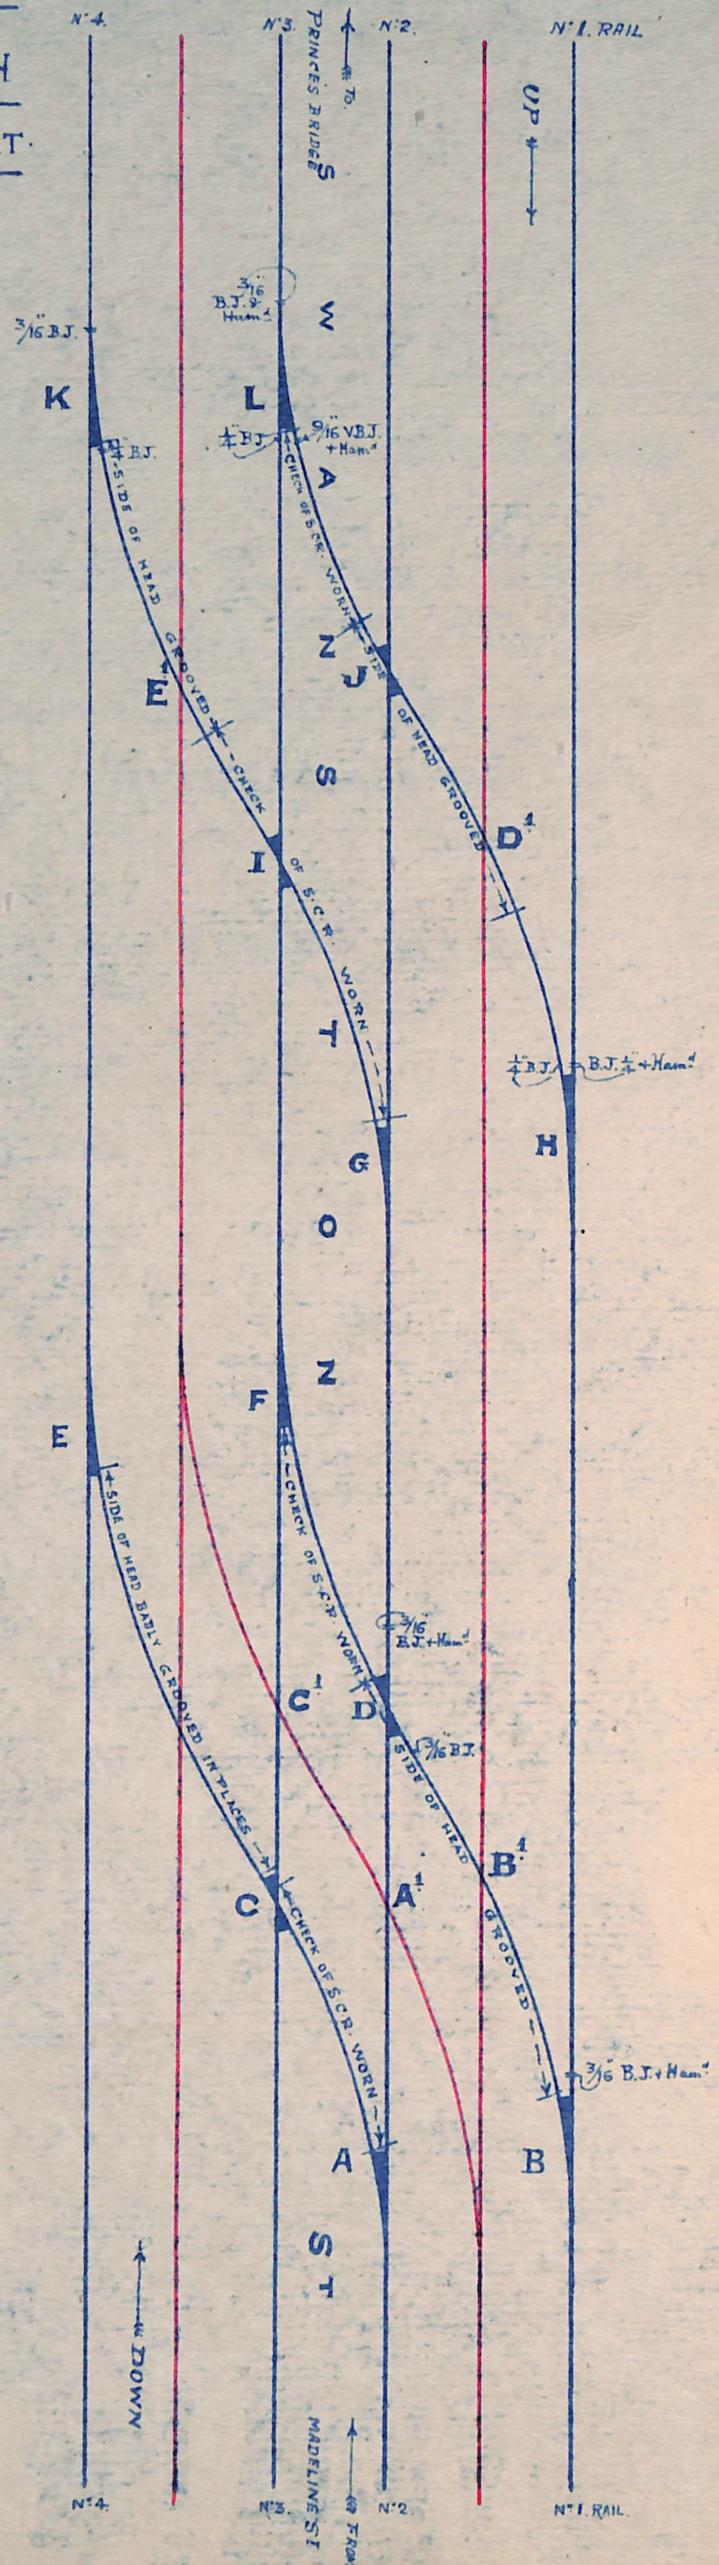
SWANSTON STREET · NEAR JUNCTION WITH
QUEENSBERRY STREET.

- A { Heel Rocking . Tongue Worn
Tread of Point-Casting Badly Worn.
- B { Heel Rocking . Tongue Worn.
Tread of Point-Casting Badly Worn.
- C Hammering at Rail Intersections.
- D Bad Hammering at D° D°
- E { Heel Rocking . Tongue Worn.
Point-Casting Worn
- F Heel Rocking . Tongue Worn
- G { Heel Rocking . Tongue Worn.
Tread of Point-Casting Badly Worn.
- H { Heel Rocking . Tongue Worn, and High at Heel.
Tread of Point-Casting Worn.
- I
- J
- K { Heel below level of Rail, and Rocking.
Tongue Worn.
- L
- A¹ Hammering at Rail and Slot Intersection.
- B¹ { Hammering - D° - D° D°
Side of Tread of Rail Grooved.
- C¹ Hammering at Rail Intersections.
- D¹
- E¹

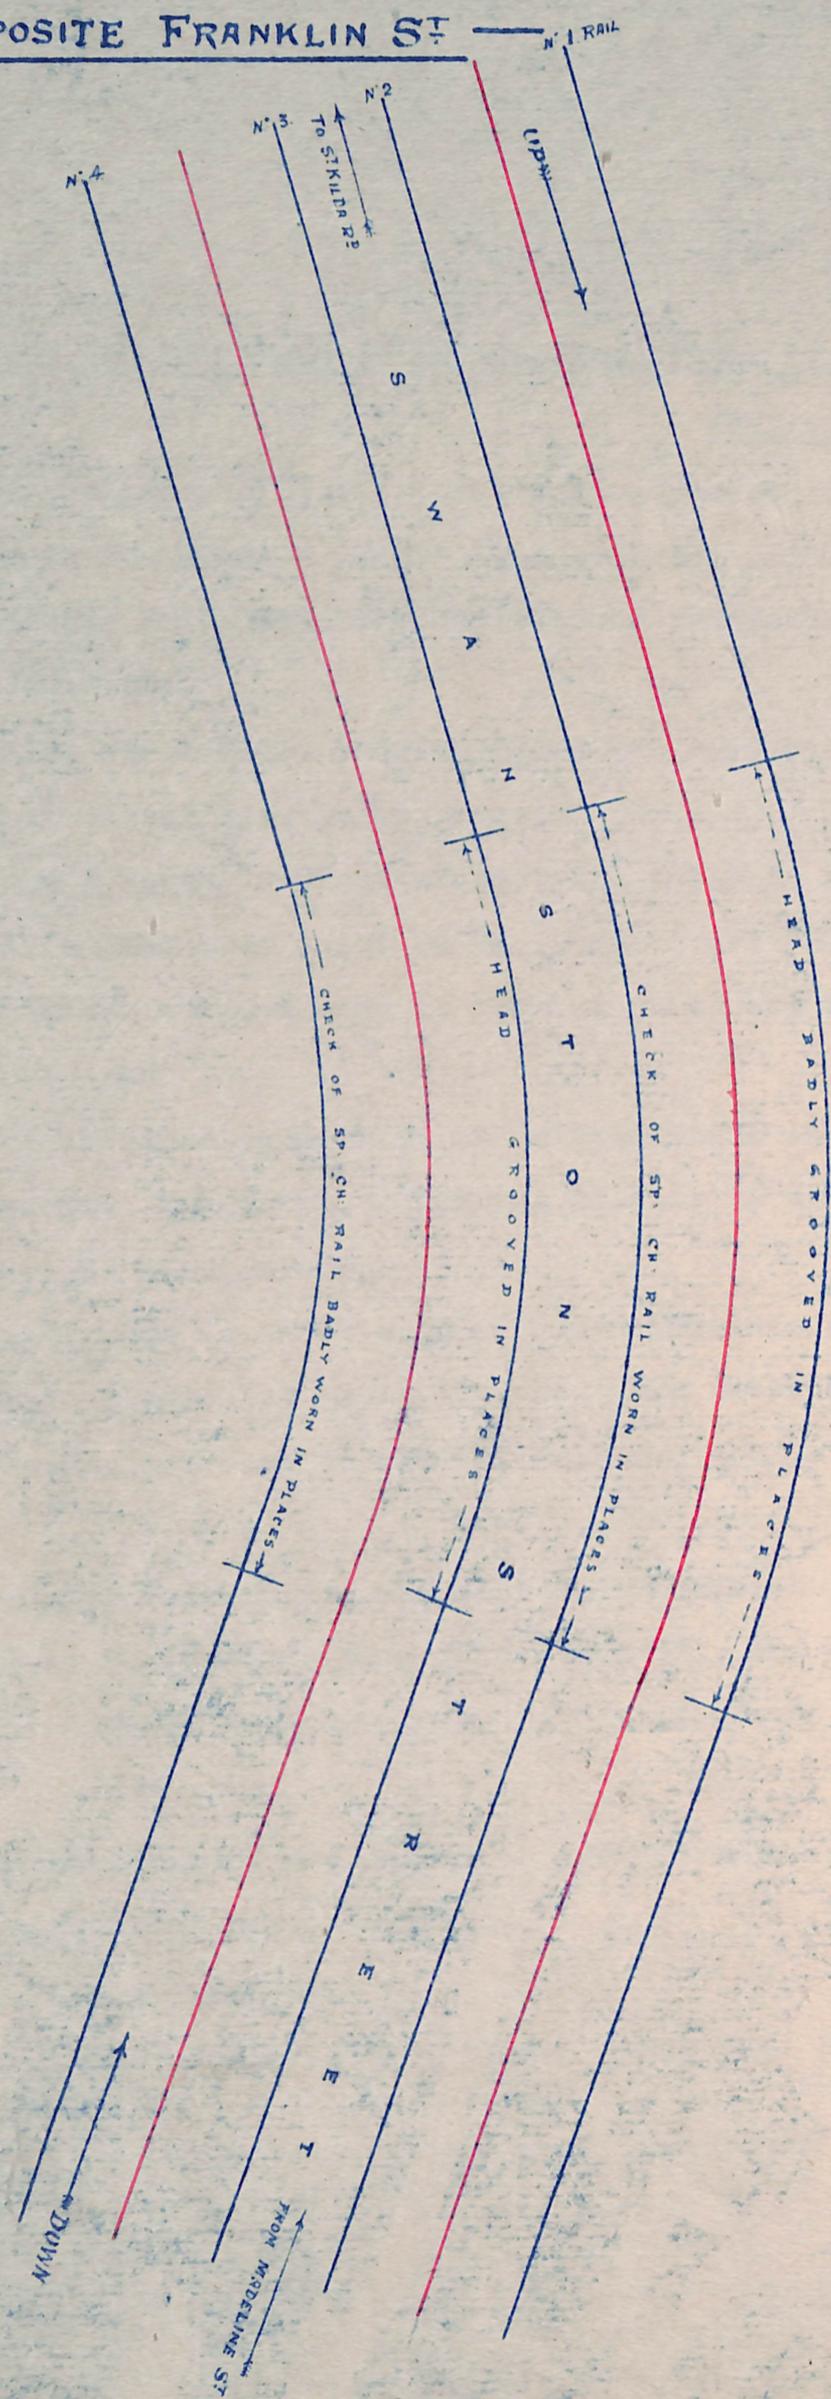
CURVE SWANSTON STREET

1. The Special Checks to check-rails of Nos. 2 and 4 Rails are worn to varying degrees, and badly so in places.
2. The sides of heads of opposite rails (Nos. 1 and 3) are grooved to varying amounts, and badly so in places, as a result of the above check wear.
