SIGNALLING AND OPERATIONS ON THE TRAMWAY SYSTEM IN BENDIGO, VICTORIA.

By P.J. Barry.

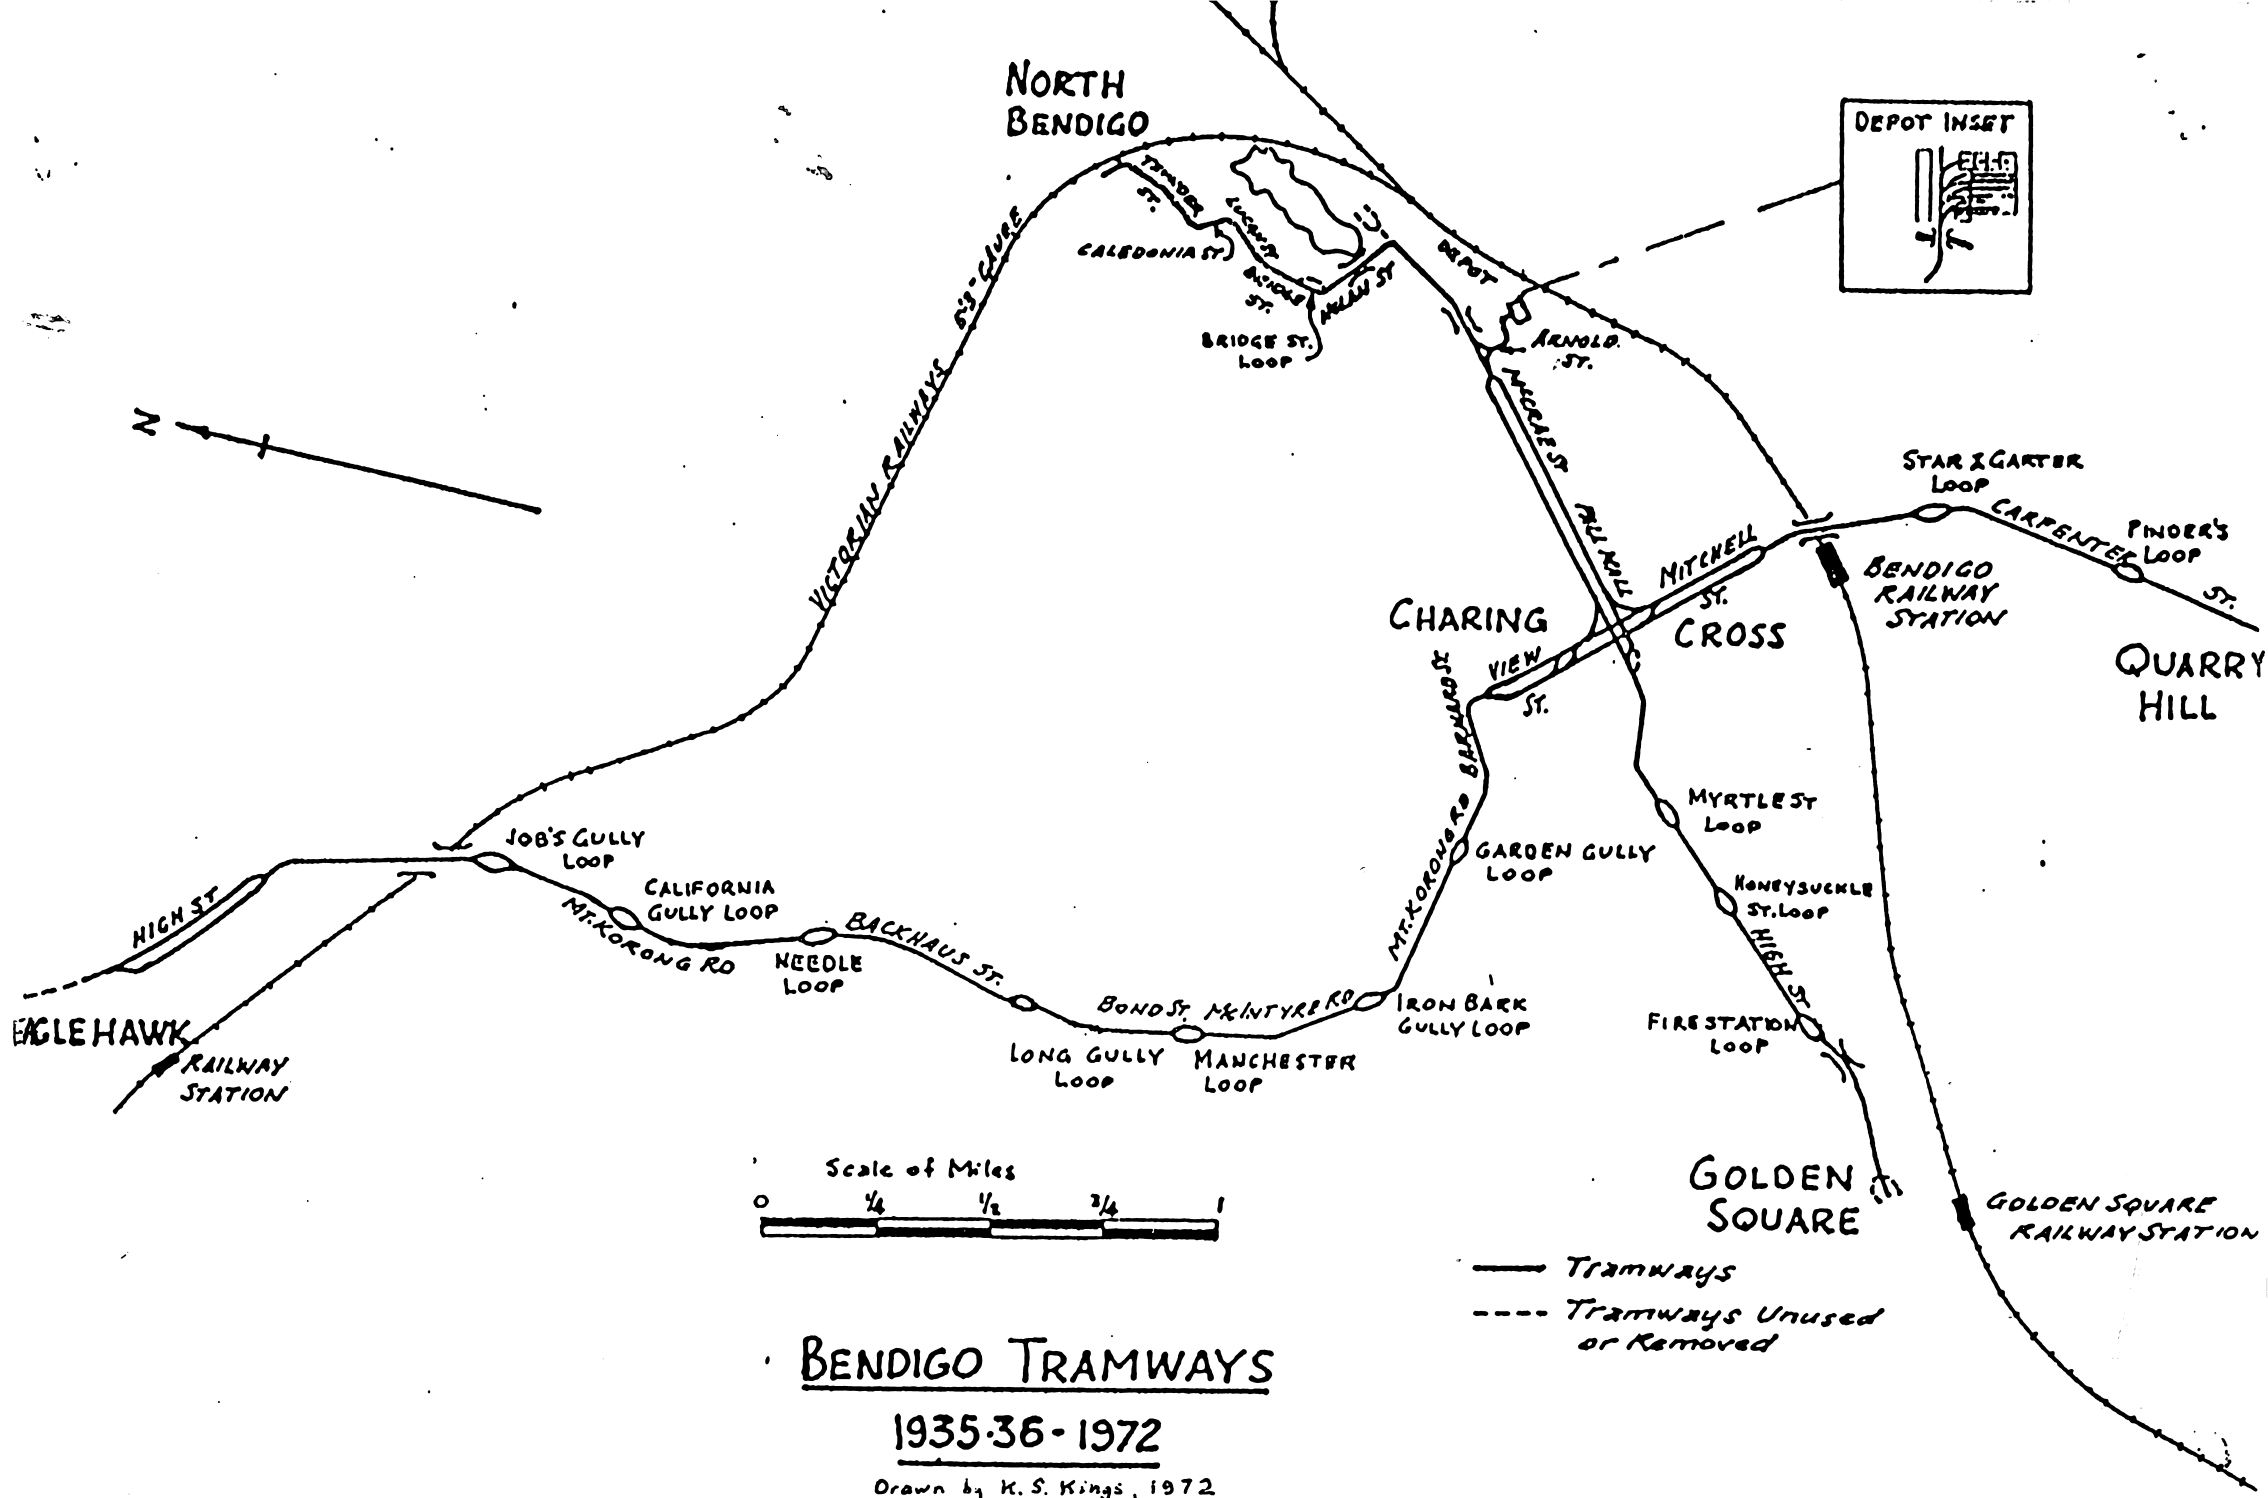
As shown on the map, the four tramway routes in Bendigo, Victoria, were laid out in the form of a cross, with the meeting point being at the Fountain at Charing Cross. On the South Eastern leg towards Quarry Hill, Double Track extended 30 chains to the main access road to the Railway Station, while on the Eaglehawk route, there was Double Track to the North West for a similar distance, as far as Five Lions' Corner. On the Golden Square-North Bendigo route, Double Track extended from just South of the Charing Cross fountain along Pall Mall to just before the triangular junction to the Depot. There was also Double Track for some sixty chains in Eaglehawk, just prior to the terminus.
