CURVE · WELLINGTON PARADE ·

OPPOSITE SPRING STREET

LINE 1
PLAN 6.

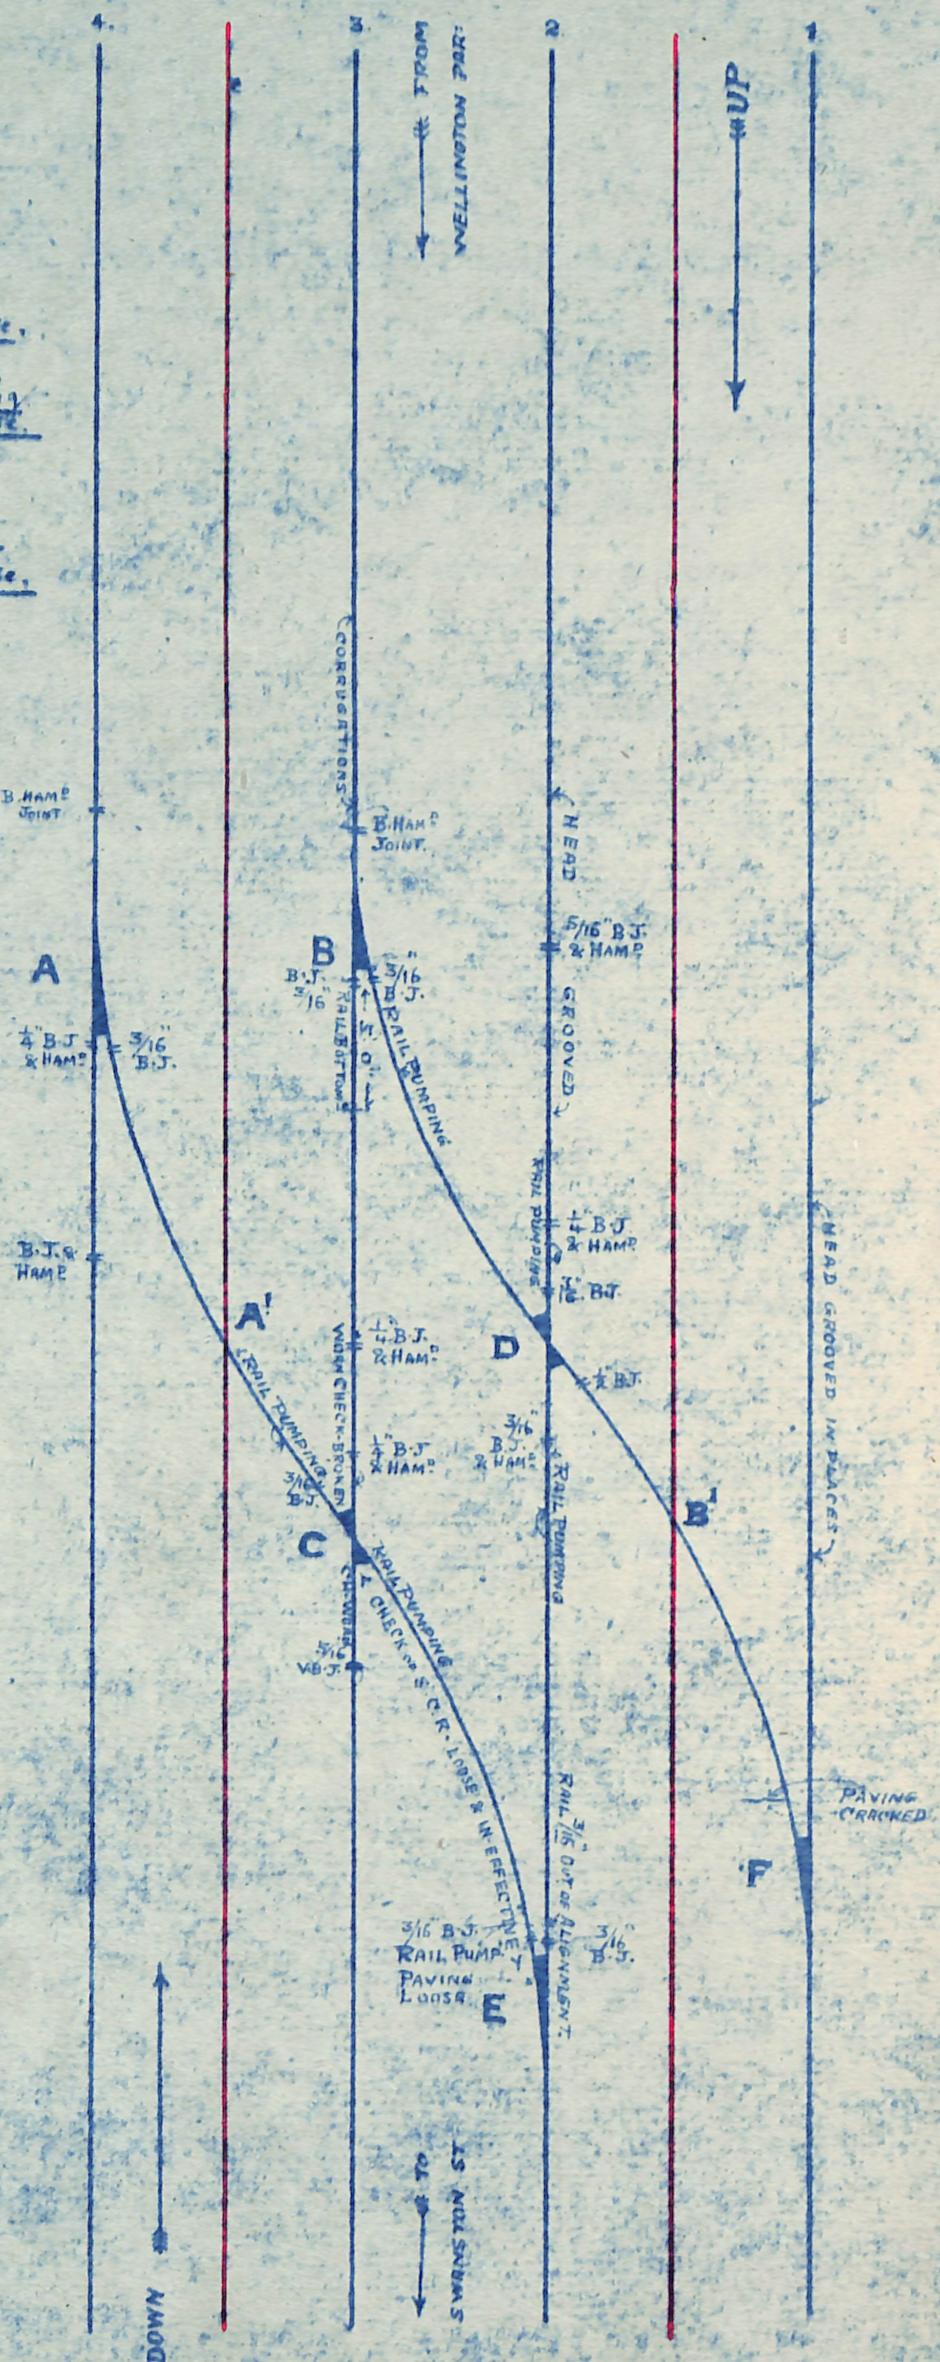
PLAN 7.

EMERGENCY SHUNT.

FLINDERS STREET

(Opposite Rutter's Shop)

1. The Special Check to Curved inner rail of Shunt, is loose and ineffective in places. Adjacent Points.
2. Three of 4 heels of Points are of loose fit, and rocking. There is also diagonal wear on rail-treads, adjacent to Points. Tongues are worn to varying amounts.

3. On No. 3 Rail (Down Track) for a length of about 5'0" on each side of intersection with Shunt-rail, the ordinary rail-check is badly worn. In one place the Rail-check is broken.

4. No. 3 Rail Main Track-rail (adjacent to Point of Shunt-rail) is bottoming for a length of 5'0" and slight corrugations are apparent.
5. No. 2 Rail (Up Track) adjacent to Point of Shunt-Rail, - is $\frac{3}{16}$ " out of Alignment. Slightly Hammered. At the intersections of Tram-rails, and Slat-rails with the Points and Crossings, in many cases, hammering is taking place.

6. 15 of the Joints of tram rails, adjacent to rail crossings and points and at other places are wide, varying from $1/4"$ to $1/2"$, and in several cases are hammered.

7. Paving, (adjacent to Points, and rail-intersections) in five places is loose and blocks are pumping.

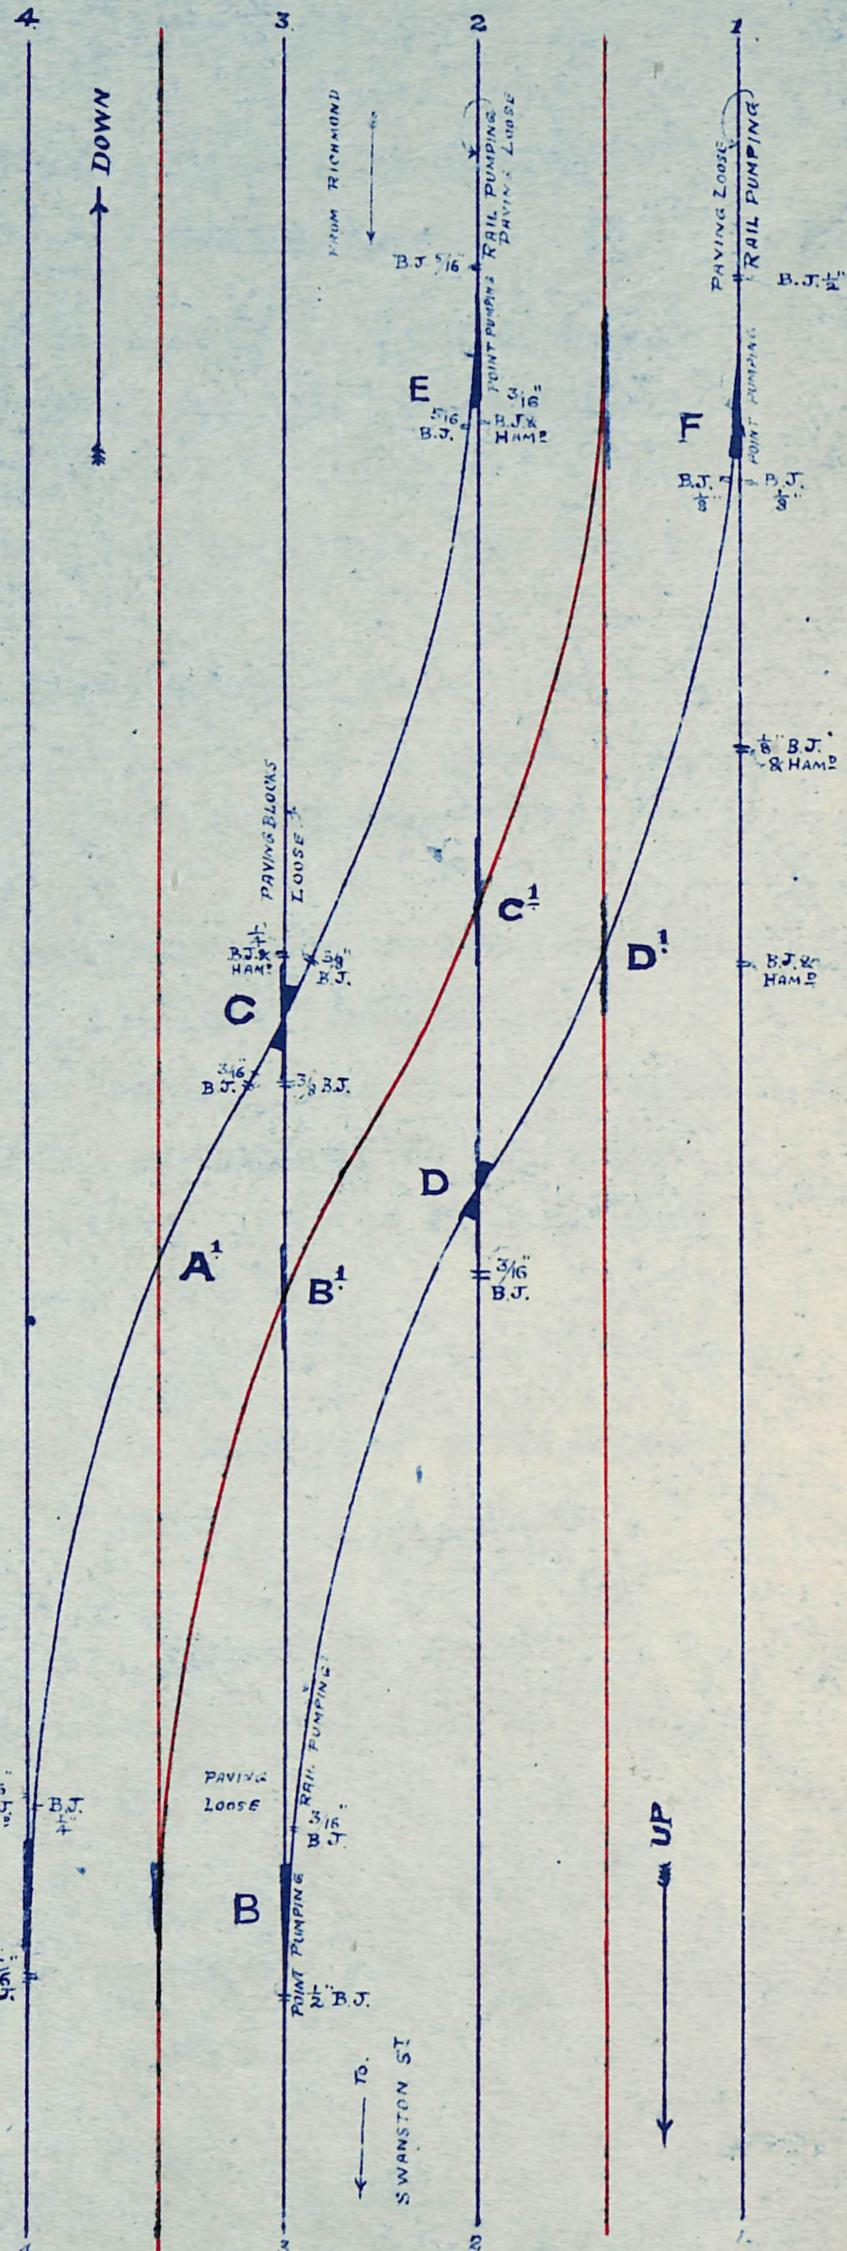
EMERGENCY SHUNT - FLINDERS STREET

OPP. METROPOLITAN GAS CO'S OFFICES.

No. 1 Rail (Up Track). The Point of Shunt, also a short length of adjacent rail (East side) are pumping and Fishplates presumably loose.

No. 2 Rail (Up-Track). The Point of Shunt, also a short length of rail adjacent to Point (East side) are pumping and fishplates presumably loose.

No. 3 Rail (Down Track) - The Point of Shunt, also a short length of adjacent curved rail, are pumping, and ~~xxxx~~ fishplates presumably loose. Diagonal Crossing on Tread of Point. Curved.

No. 4 Rail (Down Track) A 3" length of check of Point is broken and missing.

Paving blocks on each side of pumping rails and Points, also at several other places are loose, and tarred surface shattered.

Two of the four Heels of Points are of loose fit, and rocking. The treads of these two Points are diagonally worn. Tongues of the four Points are worn to varying amounts.

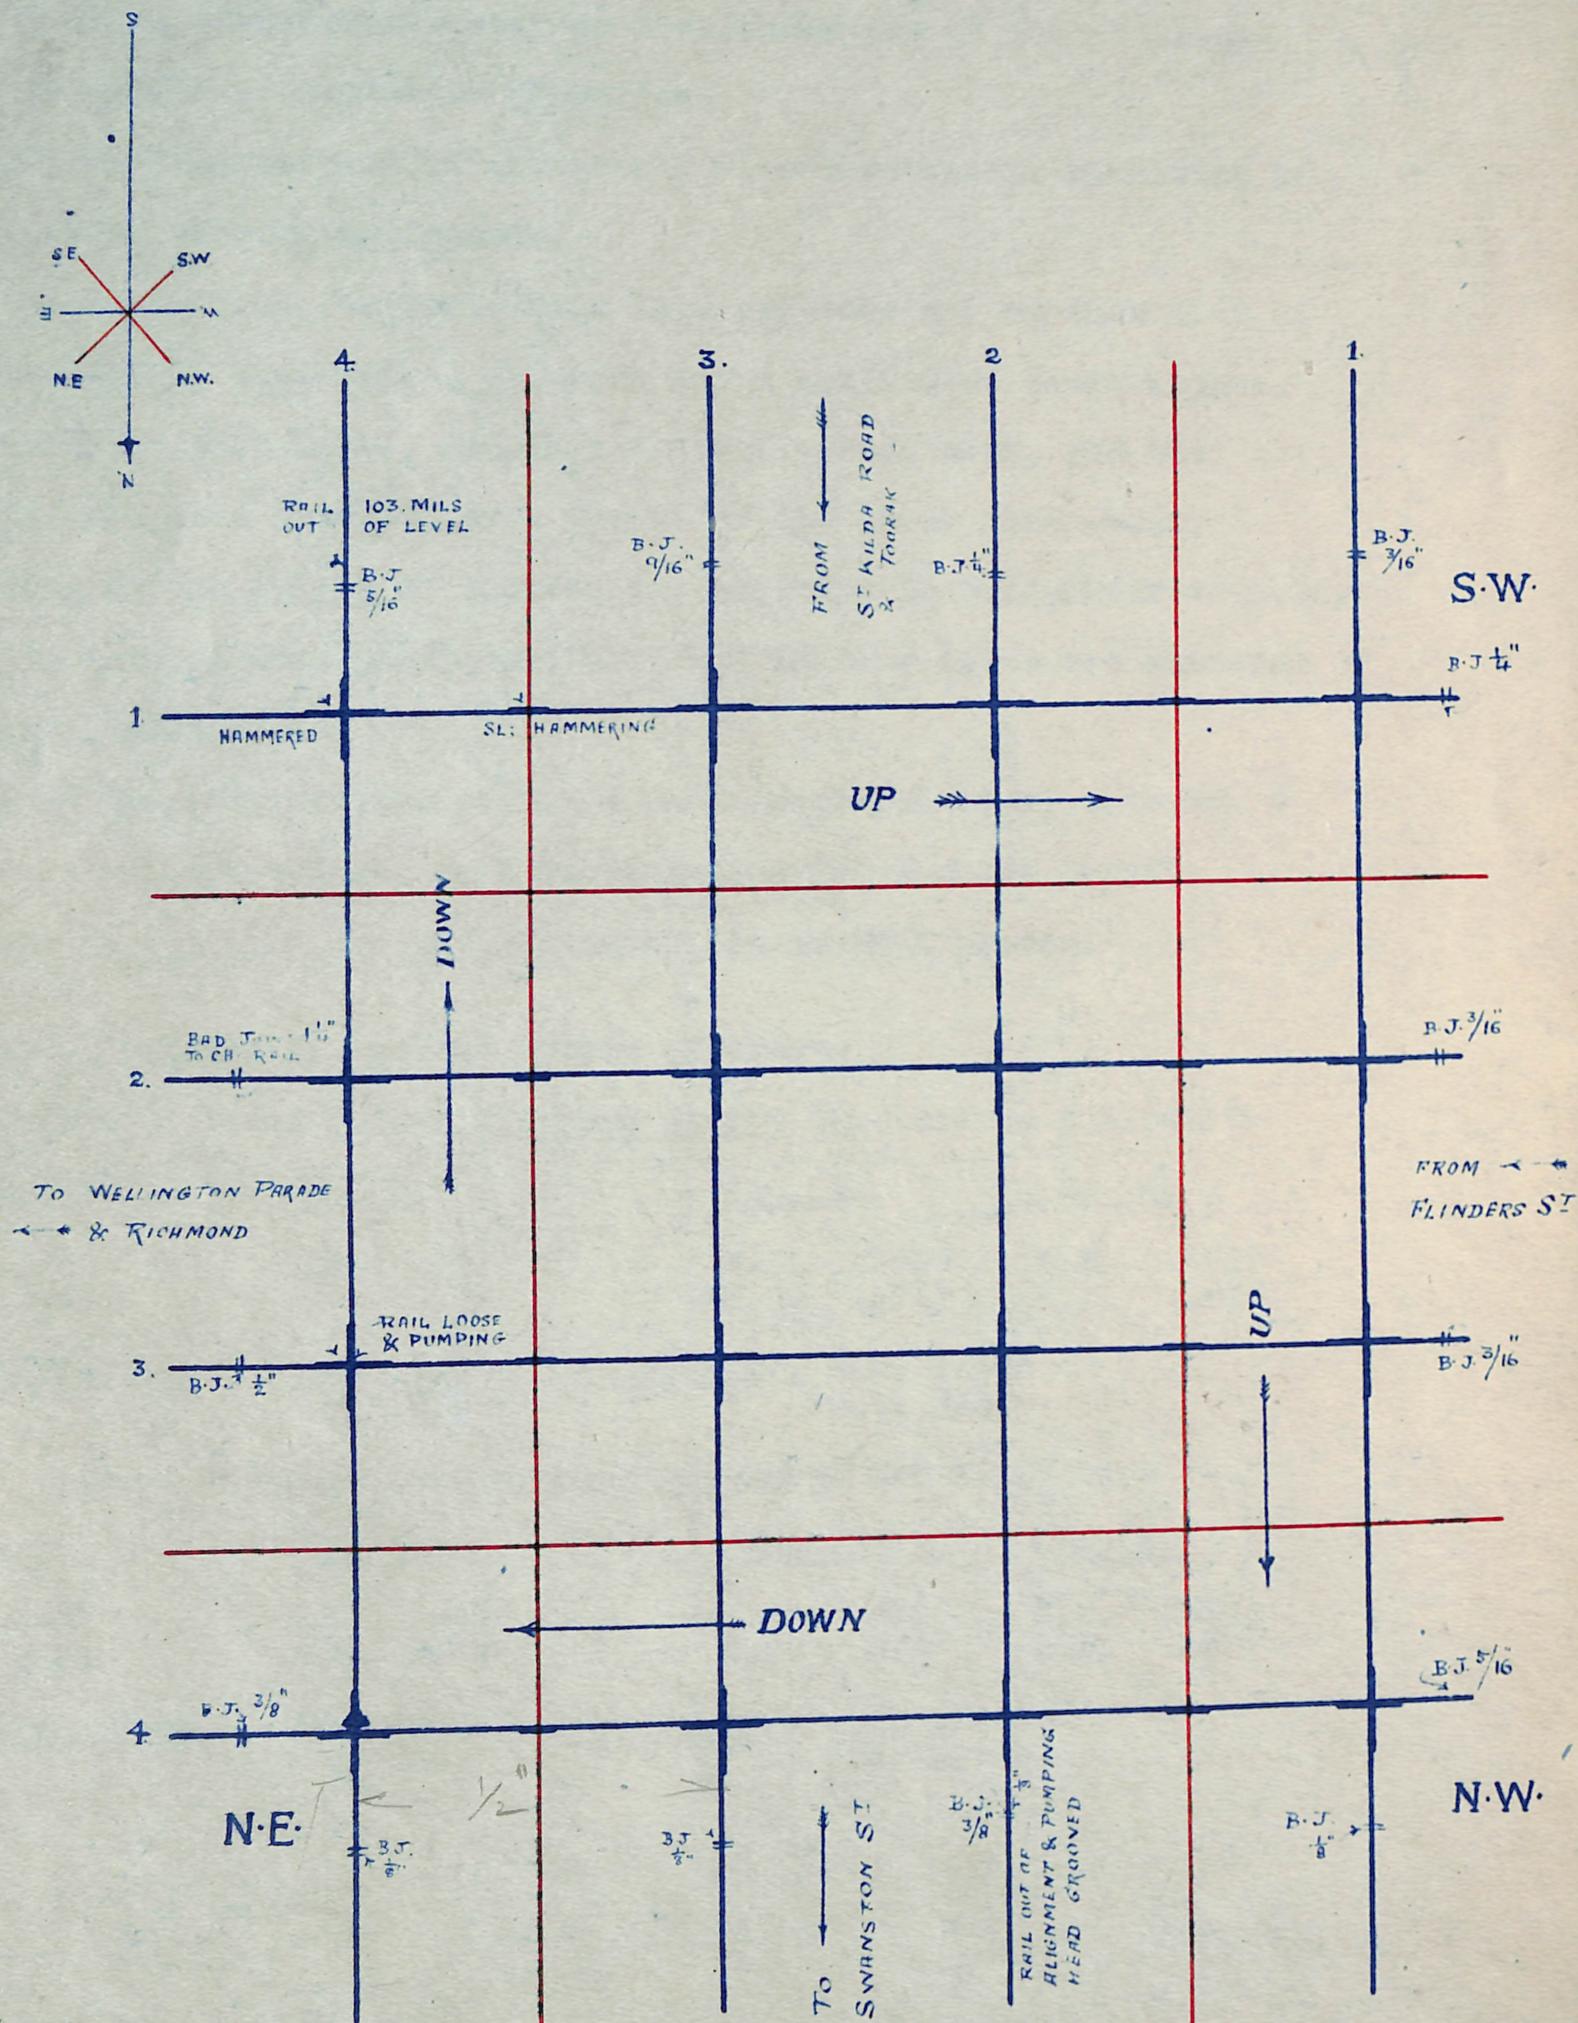
RIGHT-ANGLE CROSSING

FLINDERS ST WITH SWANSTON ST

1. There is considerable wear on Tram-rails at the intersections, and at some places it is very considerable, resulting in excessive hammering.

2. The length of No. 2 Rail (Down track) Toorak Line, adjacent to No. 4 Rail (Down Track) Richmond Line, is $1/8"$ out of alignment. This rail is pumping and adjacent paving is loose, and fishplates are presumably loose.

3. A short length of No. 3 Rail (Down Track) Richmond Line, adjacent to No. 4 Rail (Down Track) Toorak Line, is pumping, resulting in loosening of adjacent paving, and ~~xxxxx~~ fishplates are presumably loose.

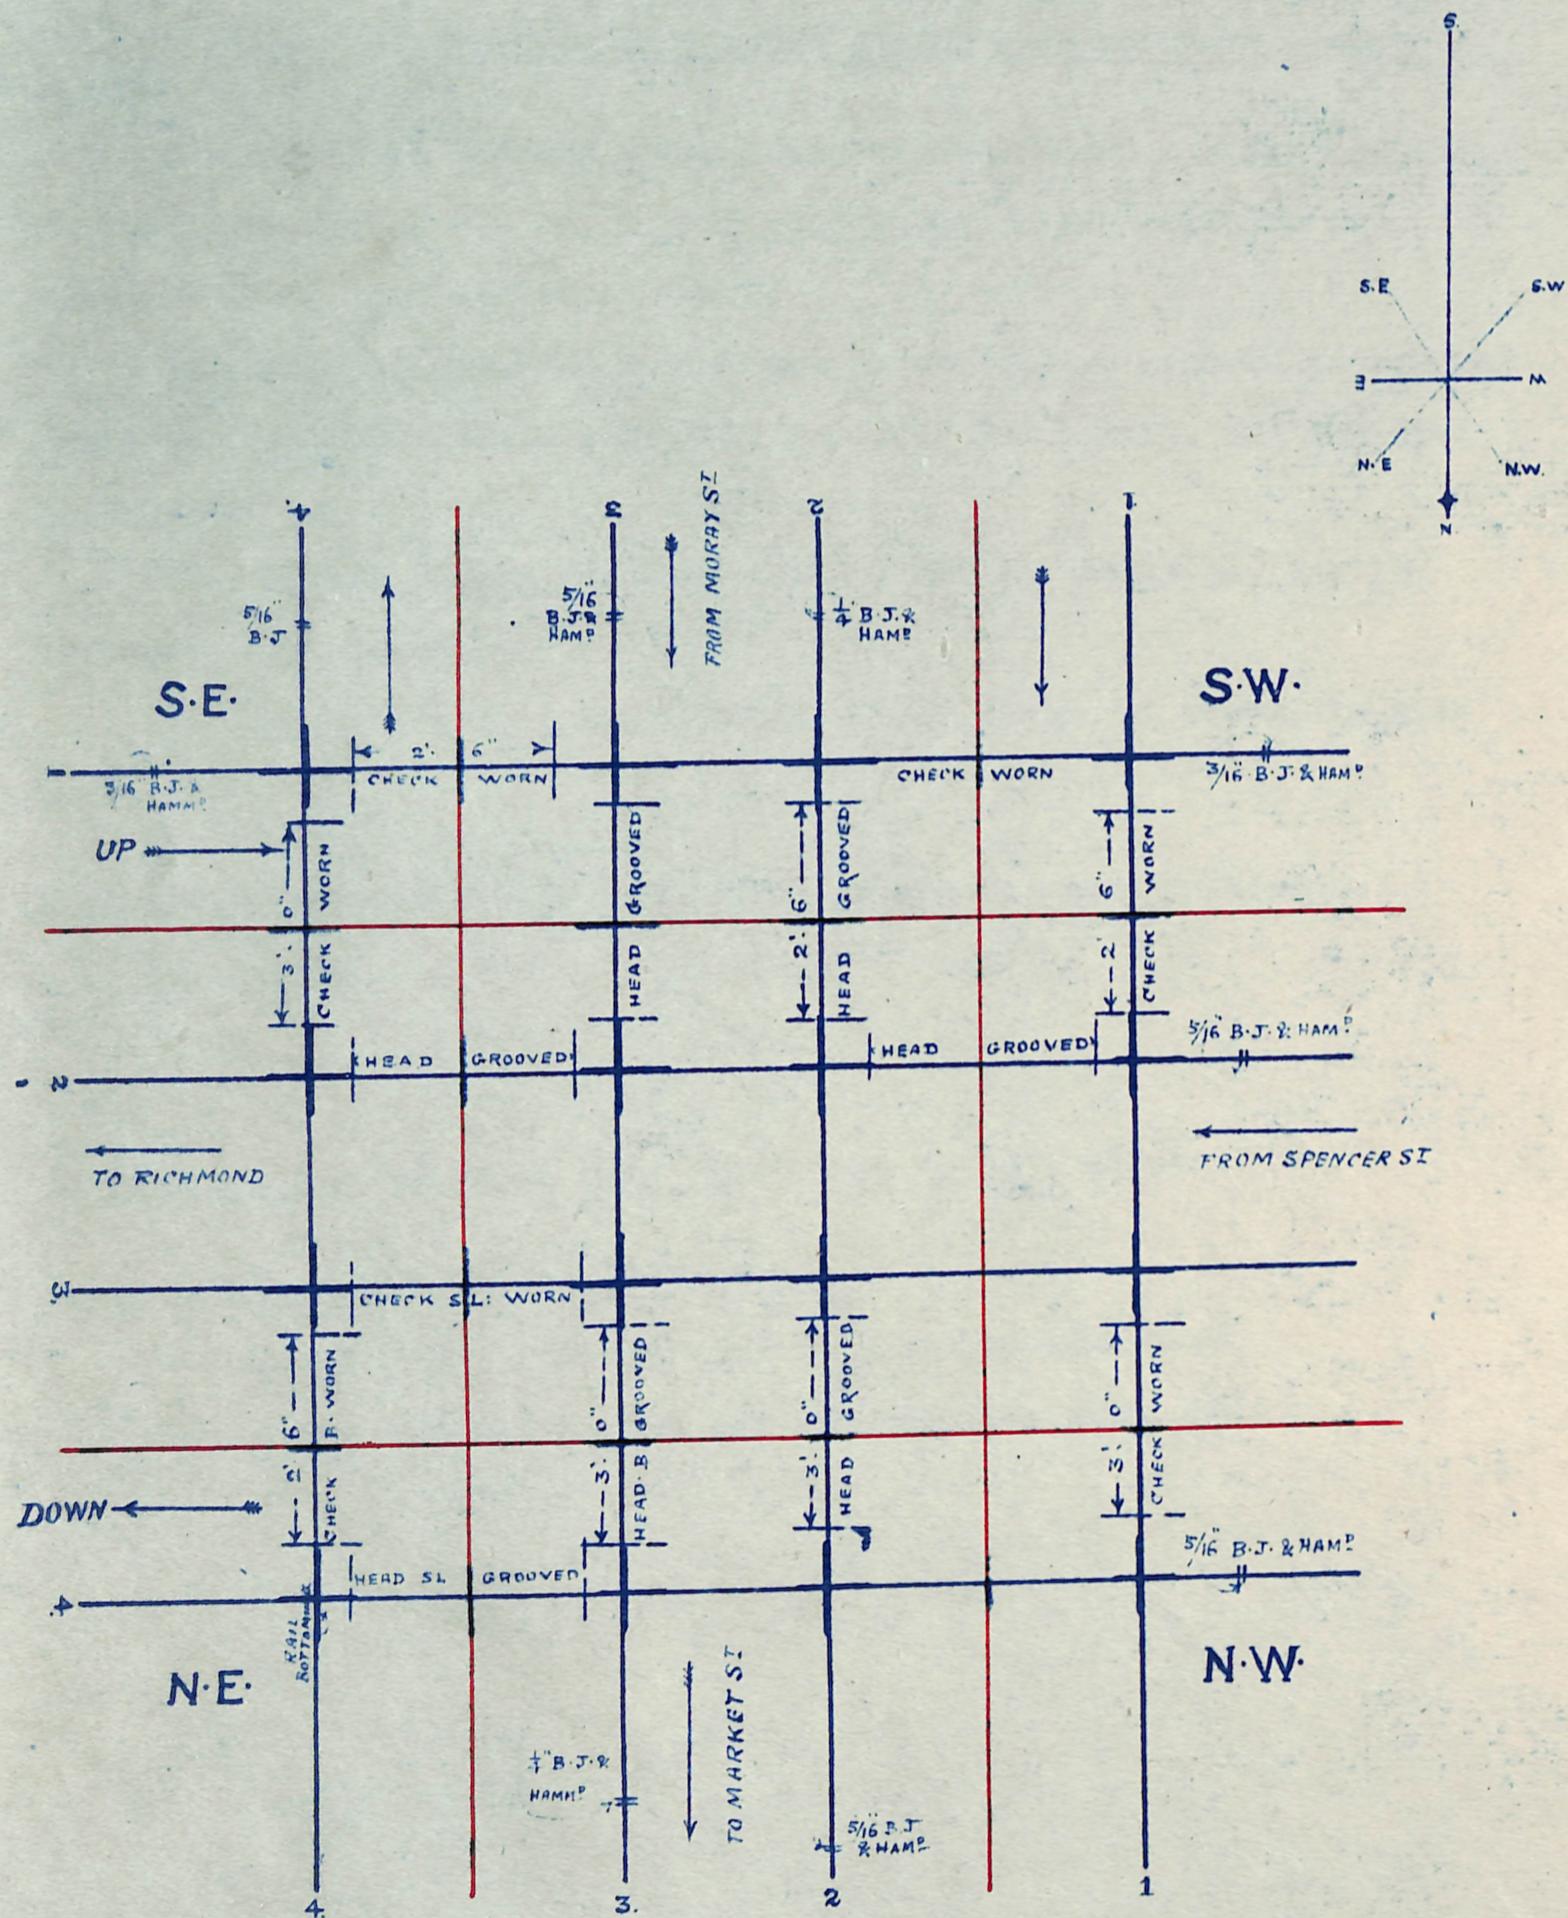
LINE 1. PLAN 10.

RIGHT-ANGLE CROSSING

FLINDERS ST WITH MARKET ST

1. There is considerable wear on the Tram-rails at the intersections, resulting in excessive hammering.
At the intersection of tram-rails with slot-rails, hammering is taking place, to varying degrees.
2. The Tram-rails, between their intersections and on each side of intersections of slot-rails, are worn for a portion of their length, (about 2'6" in each case), and have the rail-check worn, and the opposite rail head grooved, as a result of the above check-wear.
3. Nine of the Joints of Tram-rails, adjacent to rail-intersections, are wide, varying from $3/16"$ to $5/16"$, and in many cases are hammered to varying amounts.
4. Near the intersection of No. 4 Rail (Richmond line) with No. 4 Rail (Port Melbourne Line, rail is bottoming for a short length.
5. The Paving is loose and shattered, in several places.

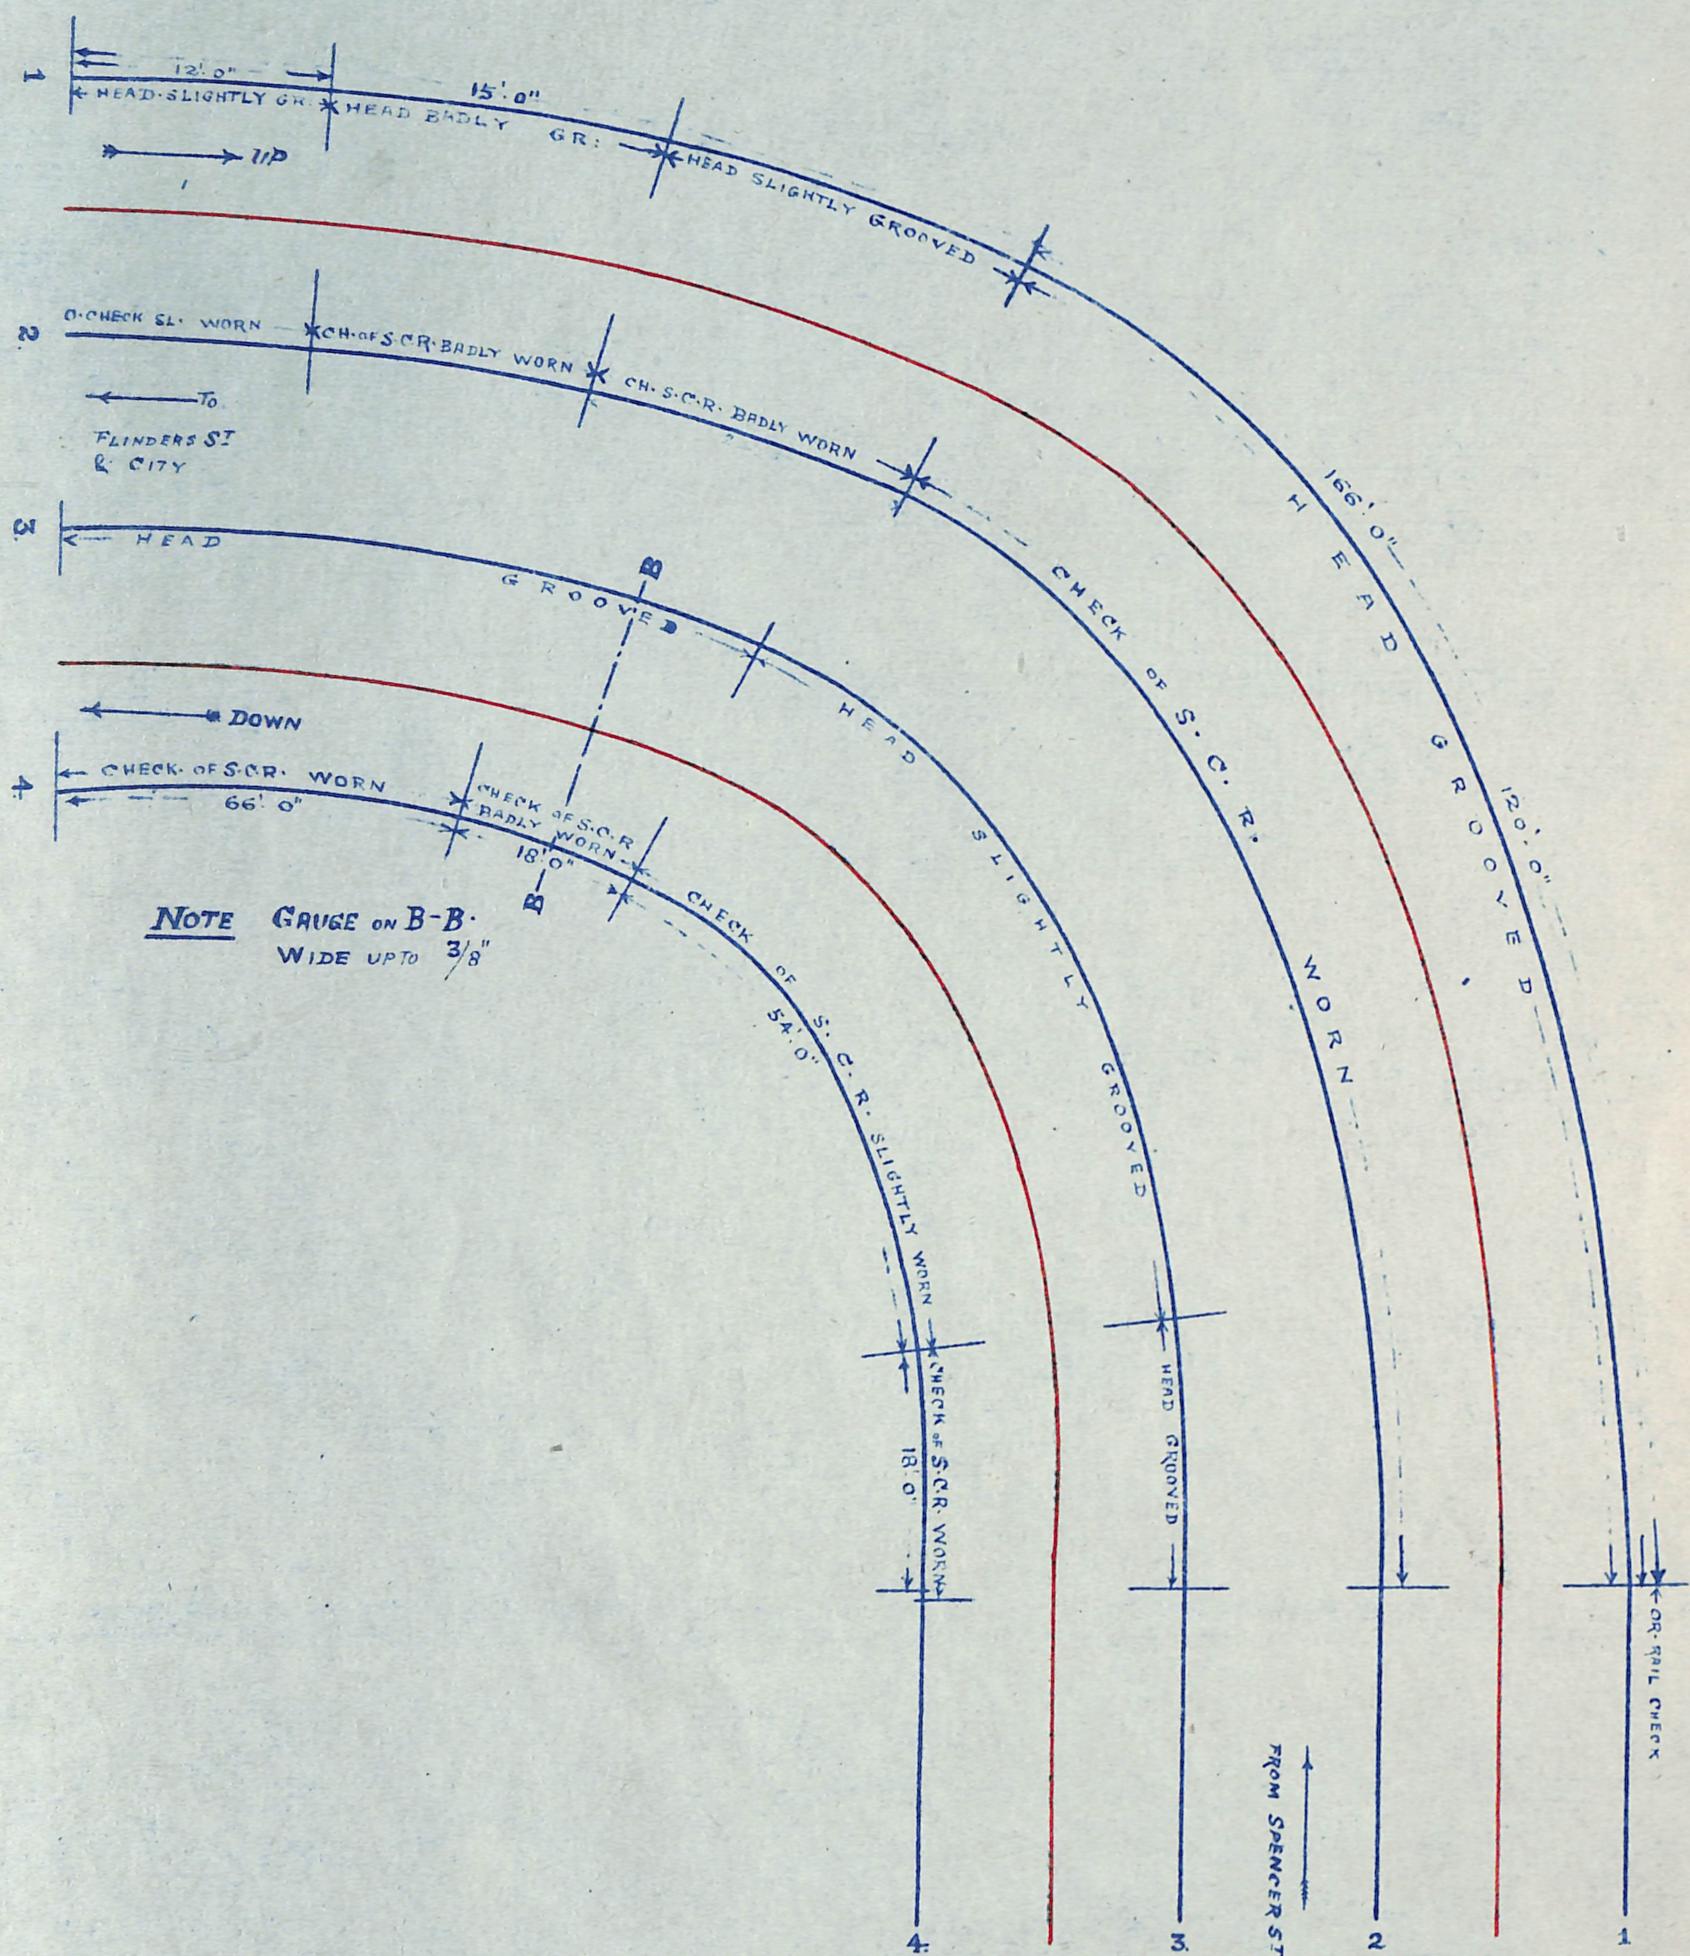
LINE 1.
PLAN 11.

CURVE JUNCTION OF FLINDERS ST.
WITH SPENCER STREET

1. The Checks of Special Check-rails of Nos. 2 and 4 Rails are worn to varying amounts, and No. 2 Rail very badly so for a length of about 24 feet, near centre of Curve.

The Special Checks (to Nos. 2 and 4 Rails) are loose, and ineffective, in places.

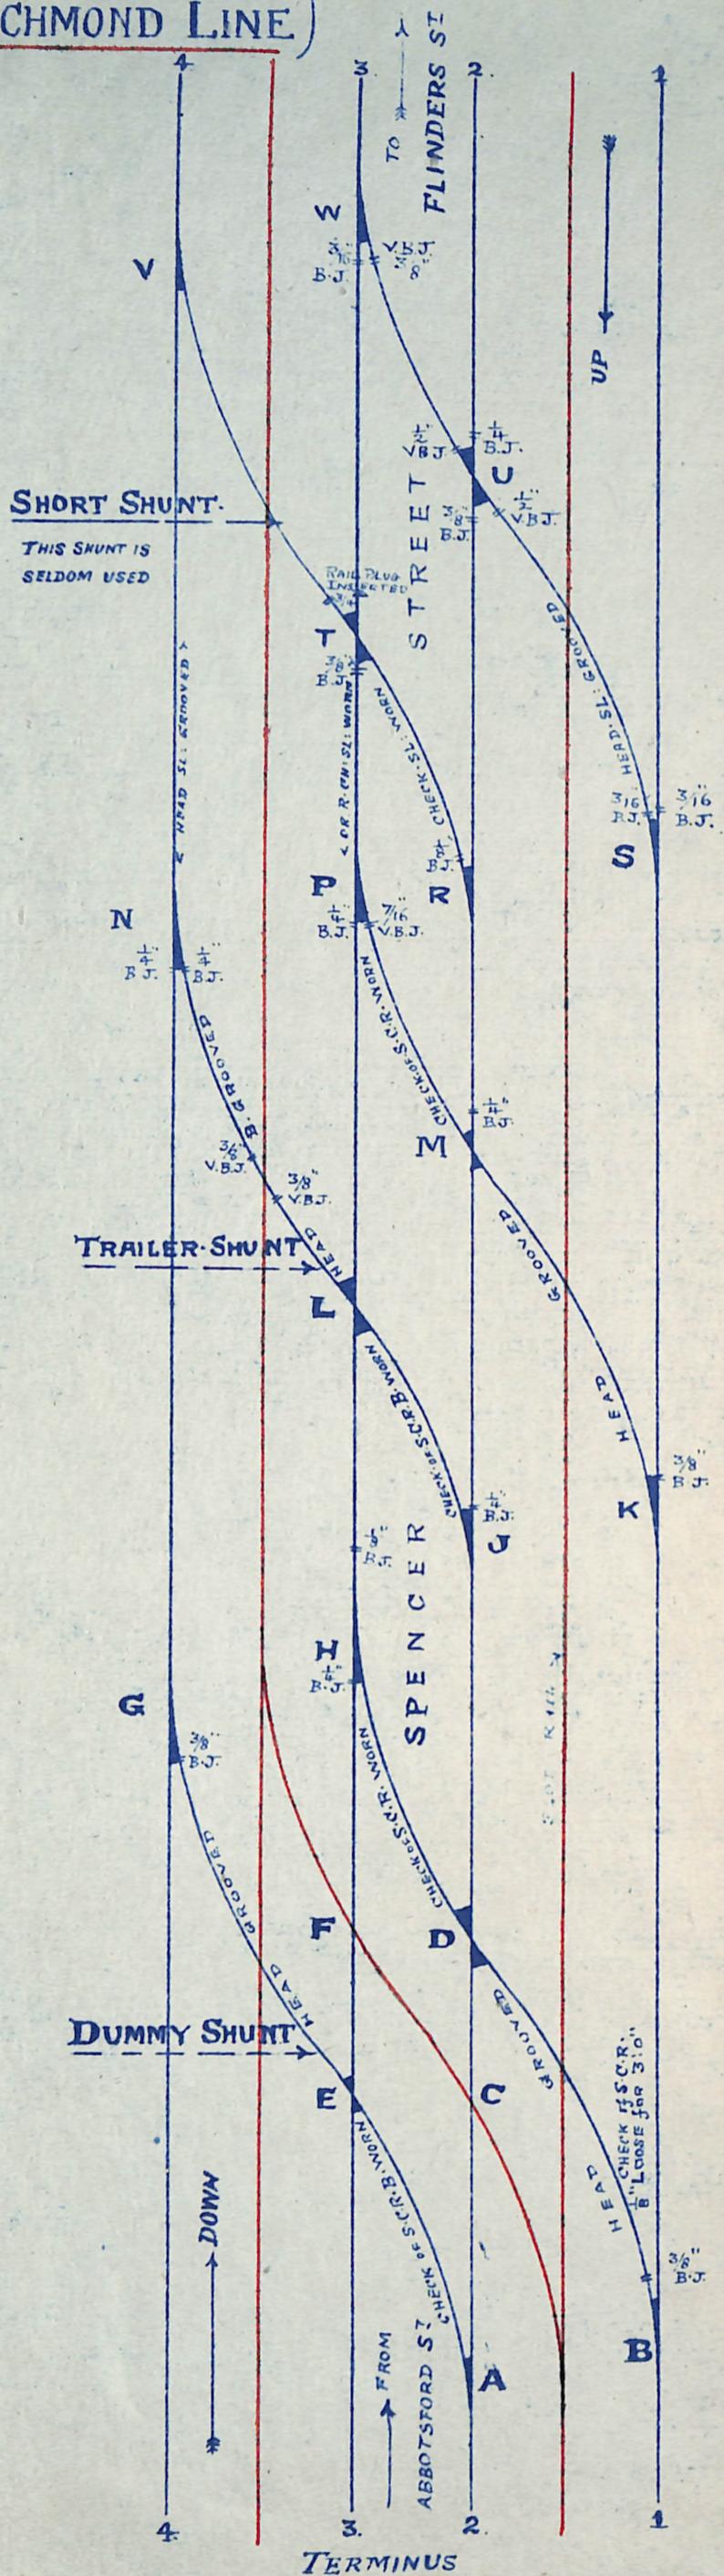
LINE 1. PLAN 12.

SHUNTS AT TERMINUS. (RICHMOND LINE)

1. D The curved rails of each of the Dummy and Trailer Shunts (three in all) are worn to varying amounts; on five of the six Inner curves the checks of Special check-rails are worn.

E The special checks are loose and ineffective in places.

F On Five of the six Outer Curves, the sides of heads are grooved to varying degrees, as a result of above check-wear.

2. G Length of straight rail (No. 3 Down Track) between Point of No. 1 Trailer Shunt and rail-intersection of No. 2 Trailer-shunt, has the ordinary rail-check slightly worn, whilst the head of opposite rail (No. K4) is slightly grooved as a result of the above check-wear.

5. L Seven heels of the twelve Points are of loose fit and rocking.

N Tongues are worn to varying amounts.

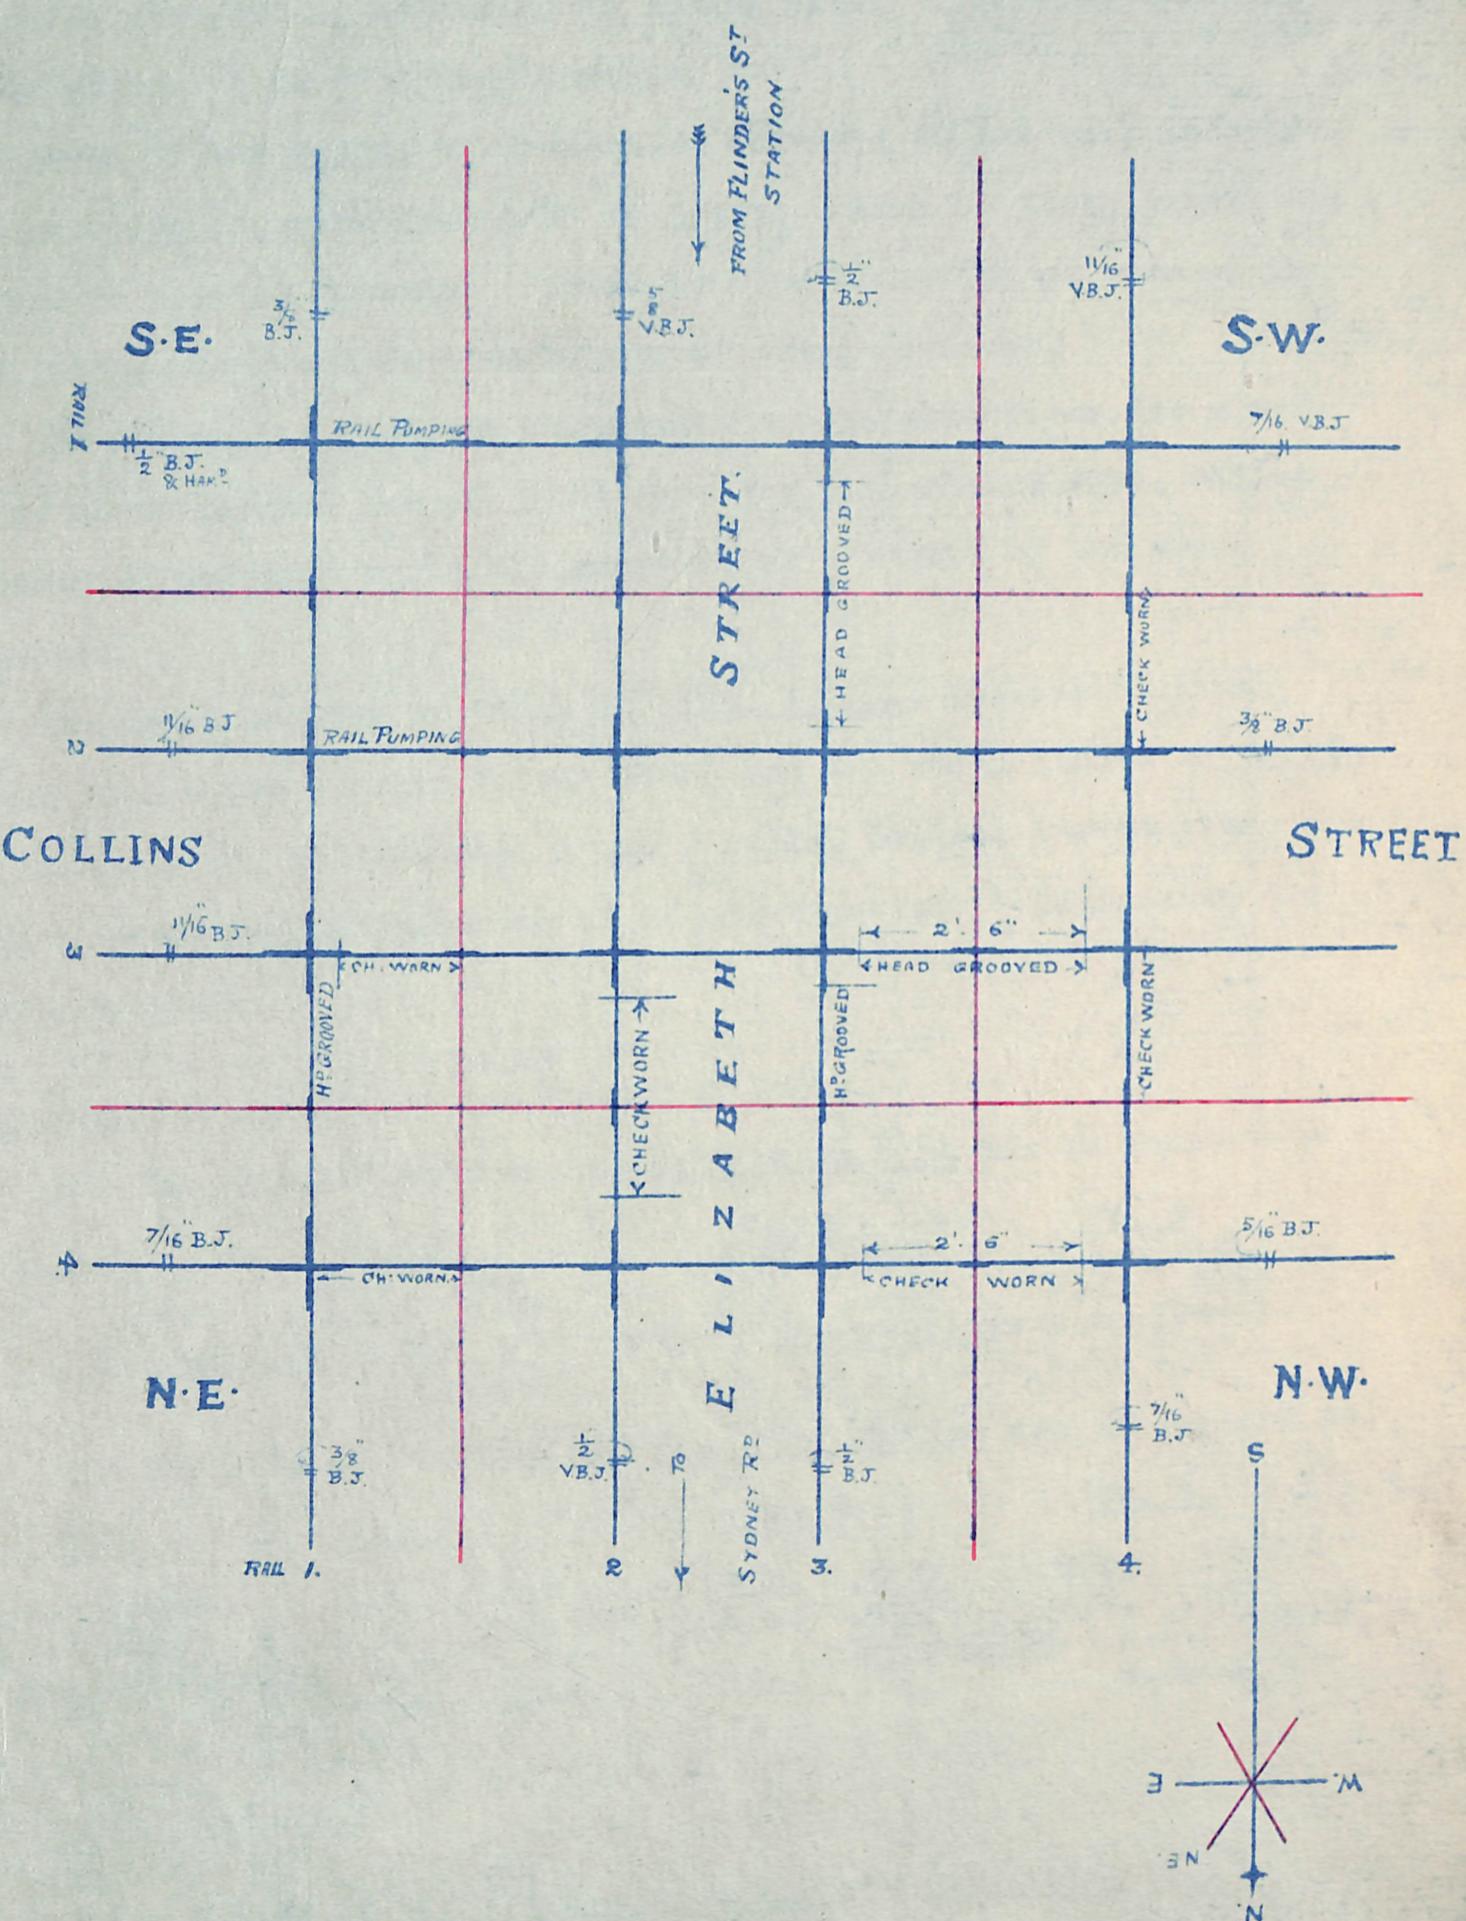
PLAN A.2.

RIGHT-ANGLE CROSSING. JUNCTION OF
COLLINS STREET WITH ELIZABETH ST.

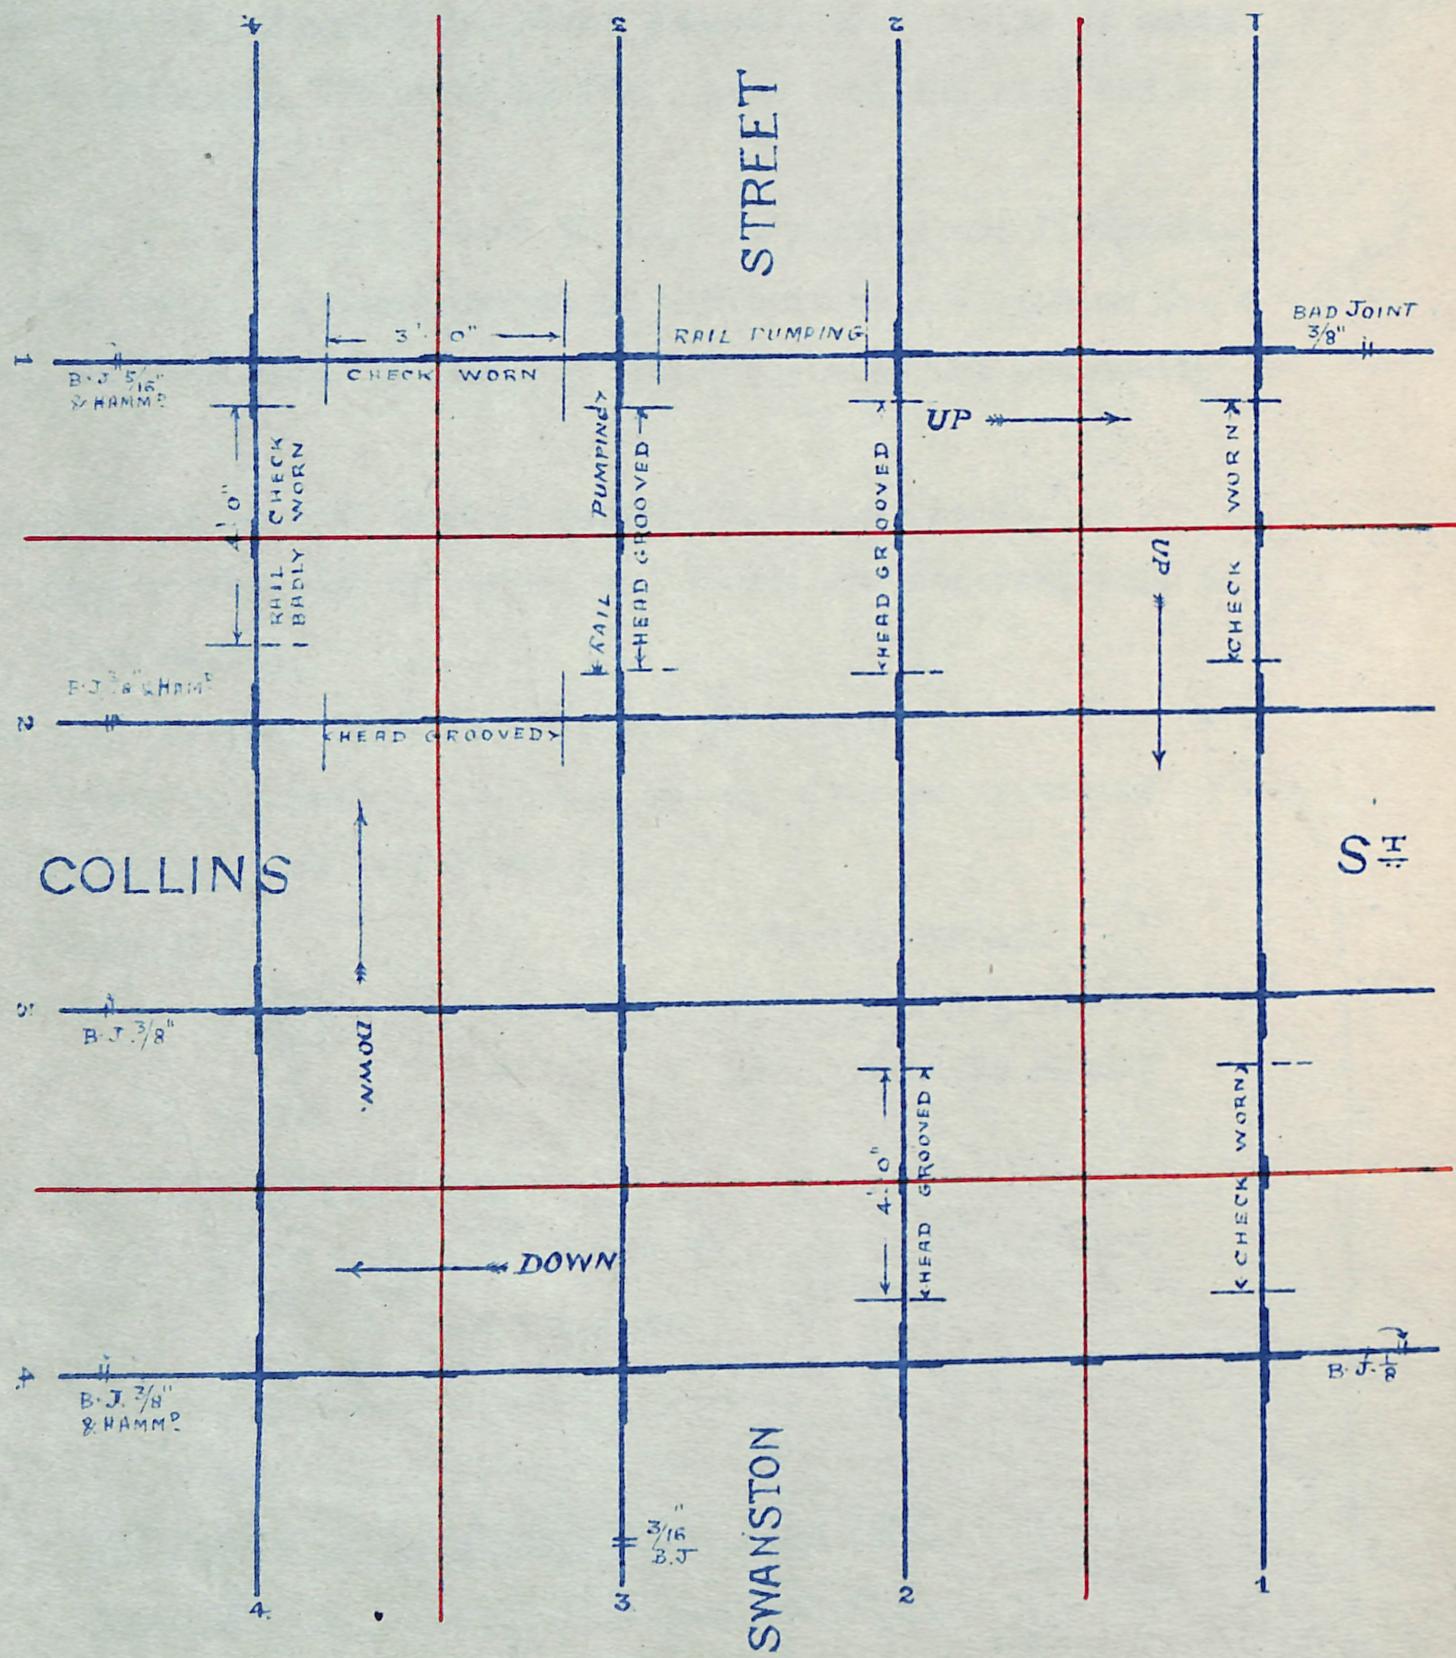
RIGHT-ANGLE CROSSING JUNCTION OF

COLLINS ST WITH SWANSTON ST

Fish plates,

In Fairly Good Order, but loose in places.
