"LESS VULNERABLE" SPOT FOR POLE

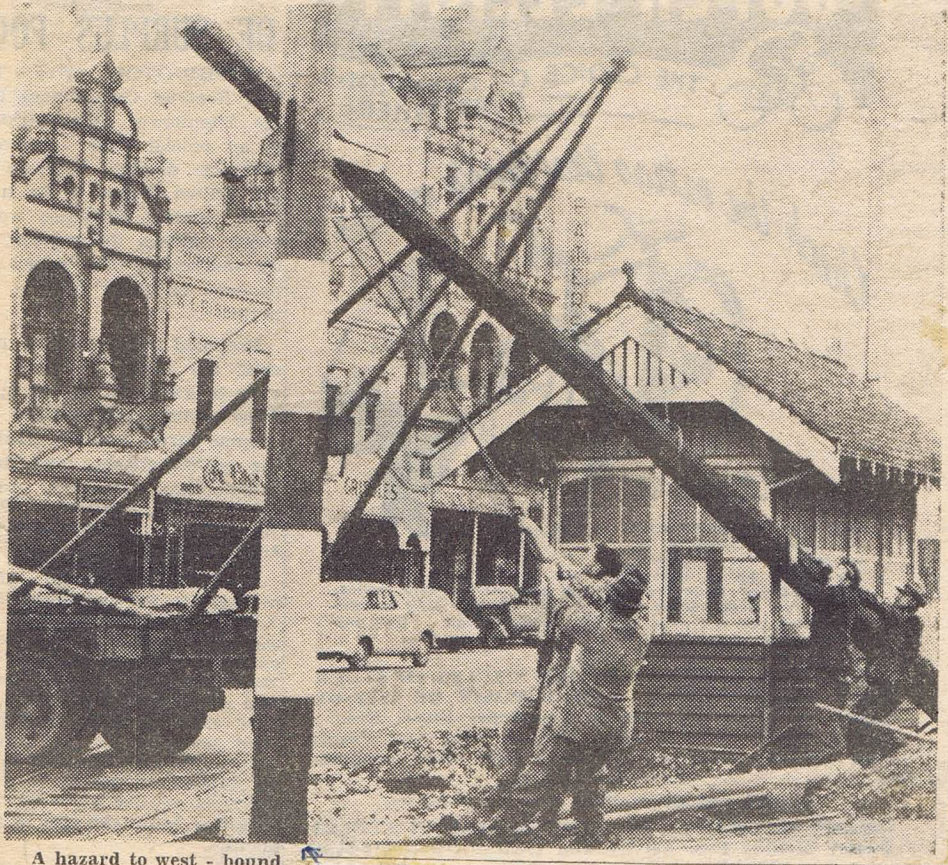
A hazard to west-bound tram drivers, the wooden standard at the junction of the Sturt street tramlines, near Grenville street, is being replaced by another pole, which the SEC manager, Mr H. Linaker, said yesterday would be placed in a "less vulnerable spot."

In the picture above, the old pole is shown in the foreground, while being raised is the one which will replace it. The new pole will be about three yards west of the old one.

This new pole put up on Wed. 24-6-53

The replacement has also necessitated the installation of a smaller pole near the north Sturt street track.

This will carry the tramway's lights signal switch, which was originally on the old pole. While most of the wires will be transferred to the new pole within the next day or so, the complete changeover will not be completed until Sunday morning, when the tram traction wires will be changed over.

old pole taken down Sunday 28th June 1953

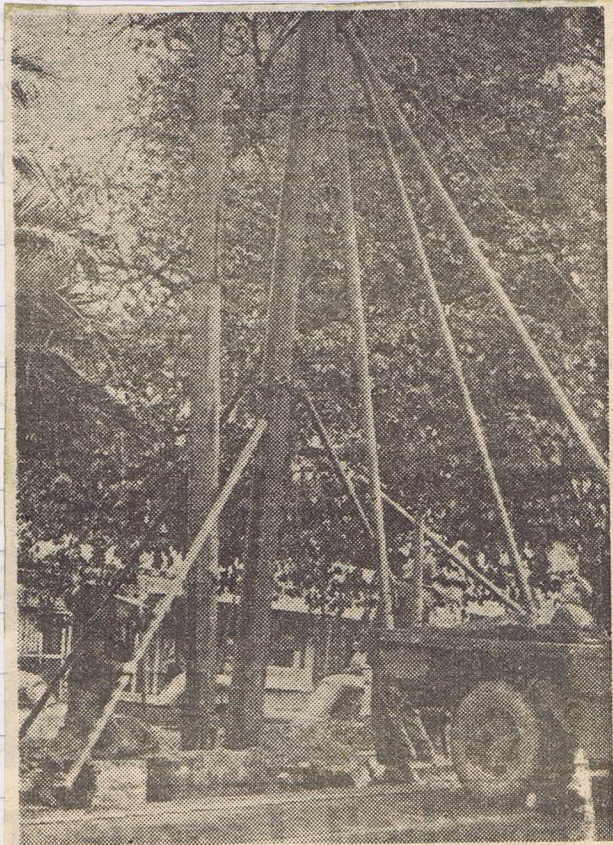
Pole near Courier office.

Numerous wooden standards supporting tramway overhead wires in Sturt street and other parts of the city's tramway circuits have rotted at the base and are being replaced. This is yesterday's picture of the replacing of one of the standards at the eastern end of Sturt street.
